Report Title: Geotechnical Report 11 Cook Terrace, Mona Vale

Report Date: 25/11/20

GEOTECHNICAL INVESTIGATION:

New Pool at 11 Cook Terrace, Mona Vale

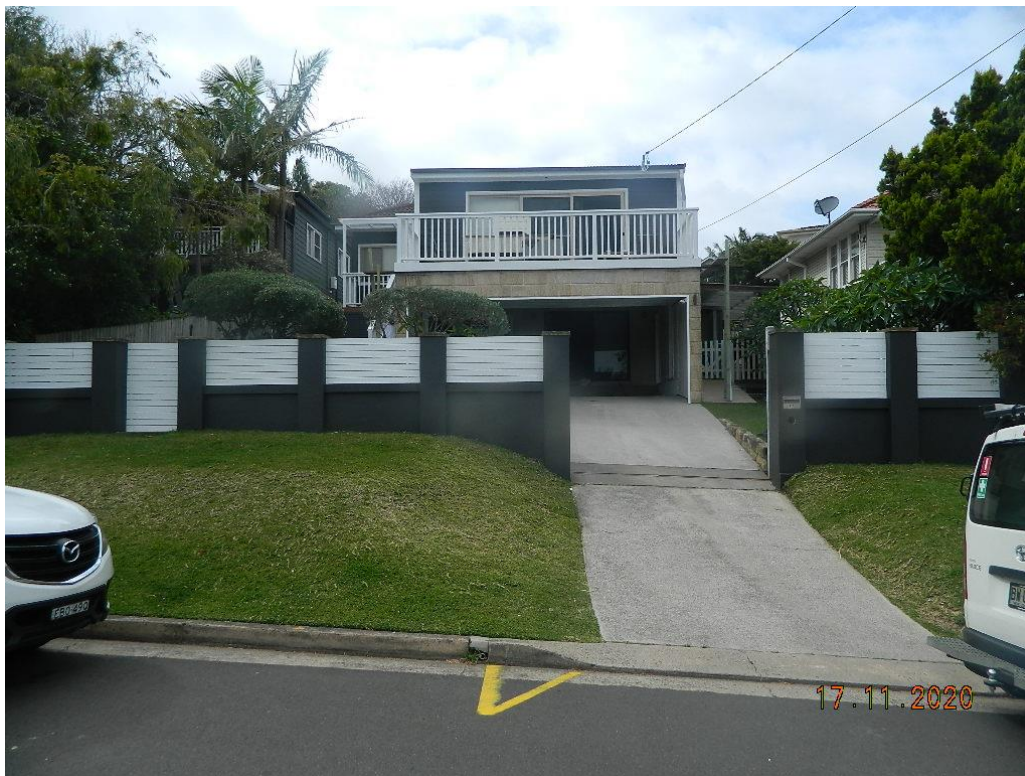
Photo 1

- 2.3** At the road frontage a concrete driveway runs up the slope to a garage attached to the existing house (Photo 1). The part two storey rendered and timber clad house is supported by brick walls and a concrete slab (Photos 1 to 3). The supporting walls display no significant signs of movement. A low brick retaining wall along the NE common boundary supports fill on the NW neighbouring property. A concrete deck with roof extends off the uphill side of the house (Photo 4). A gently sloping lawn terraced by a low timber retaining wall extends from the deck to the uphill property boundary (Photo 5). A stable timber shed is located near the uphill property boundary (Photo 6). No signs of slope instability were observed on the

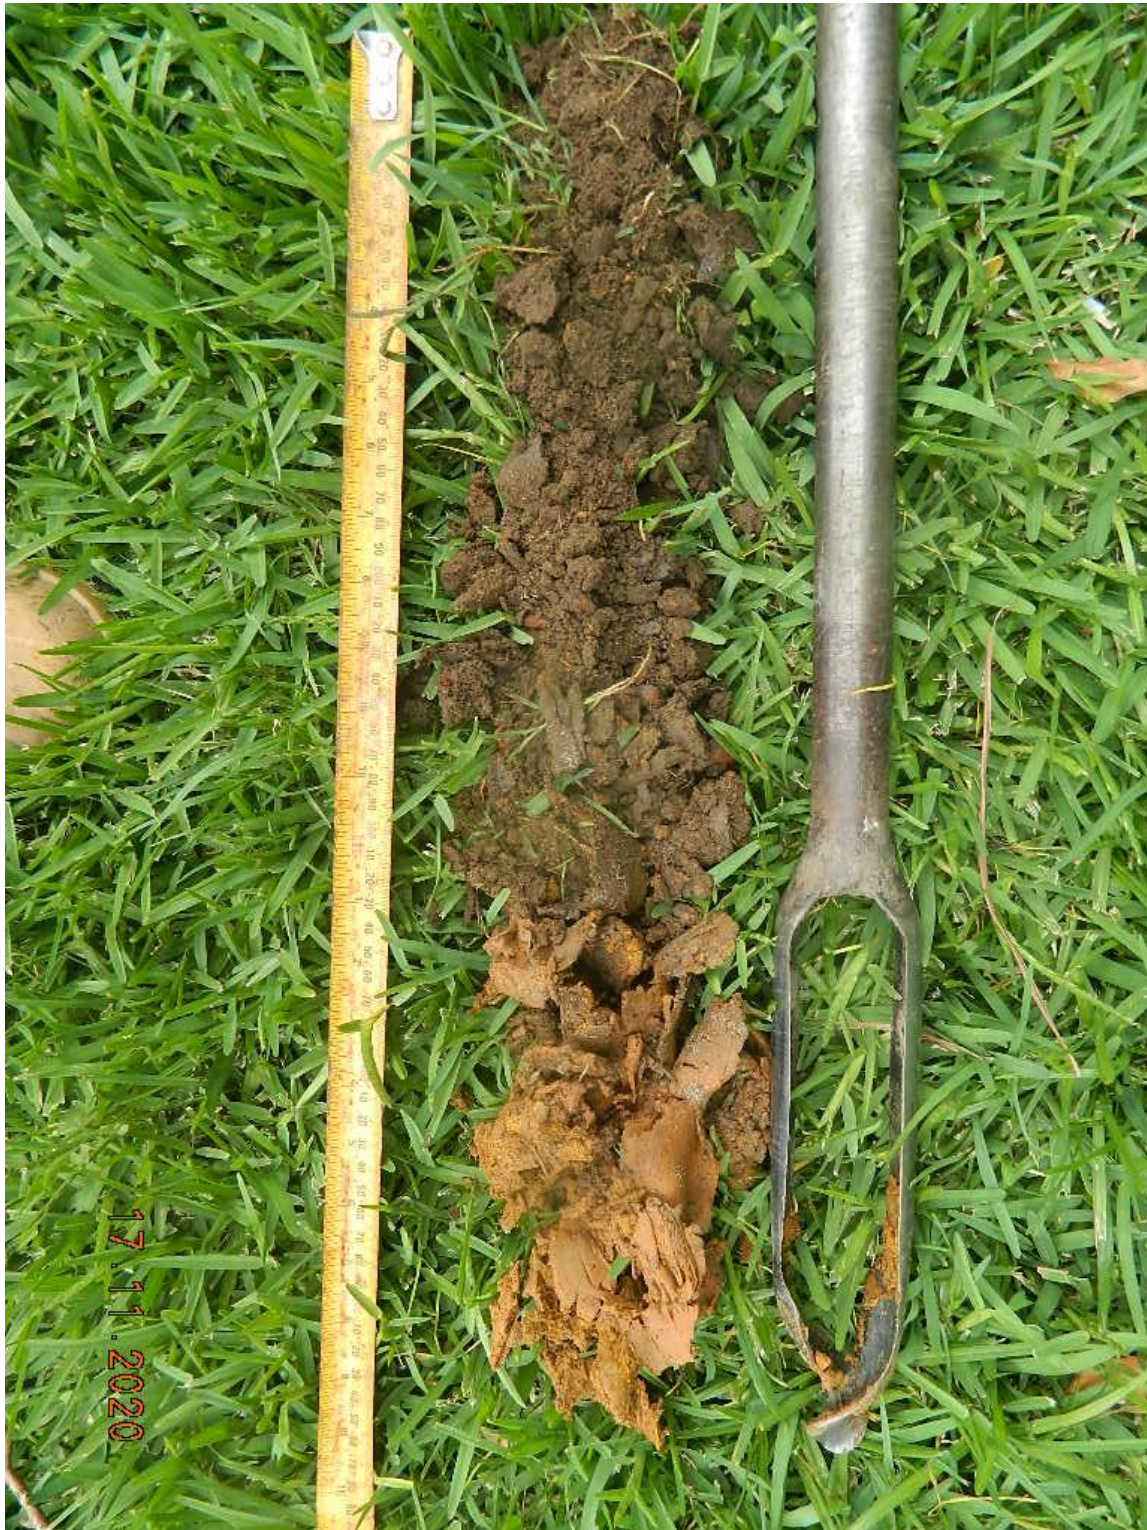
AUGER HOLE 1 (~RL35.3) – AH1 (photo 7)

Depth (m)	Material Encountered
0.0 to 0.3	TOPSOIL , brown, moist, fine to medium grained with fine trace organic matter.
0.3 to 0.5	CLAY , light brown orange, firm to stiff, moist.

End of Hole @ 0.5m in firm to stiff clay. No watertable encountered.

Photo 7: AH1 – Downhole is from top to bottom.

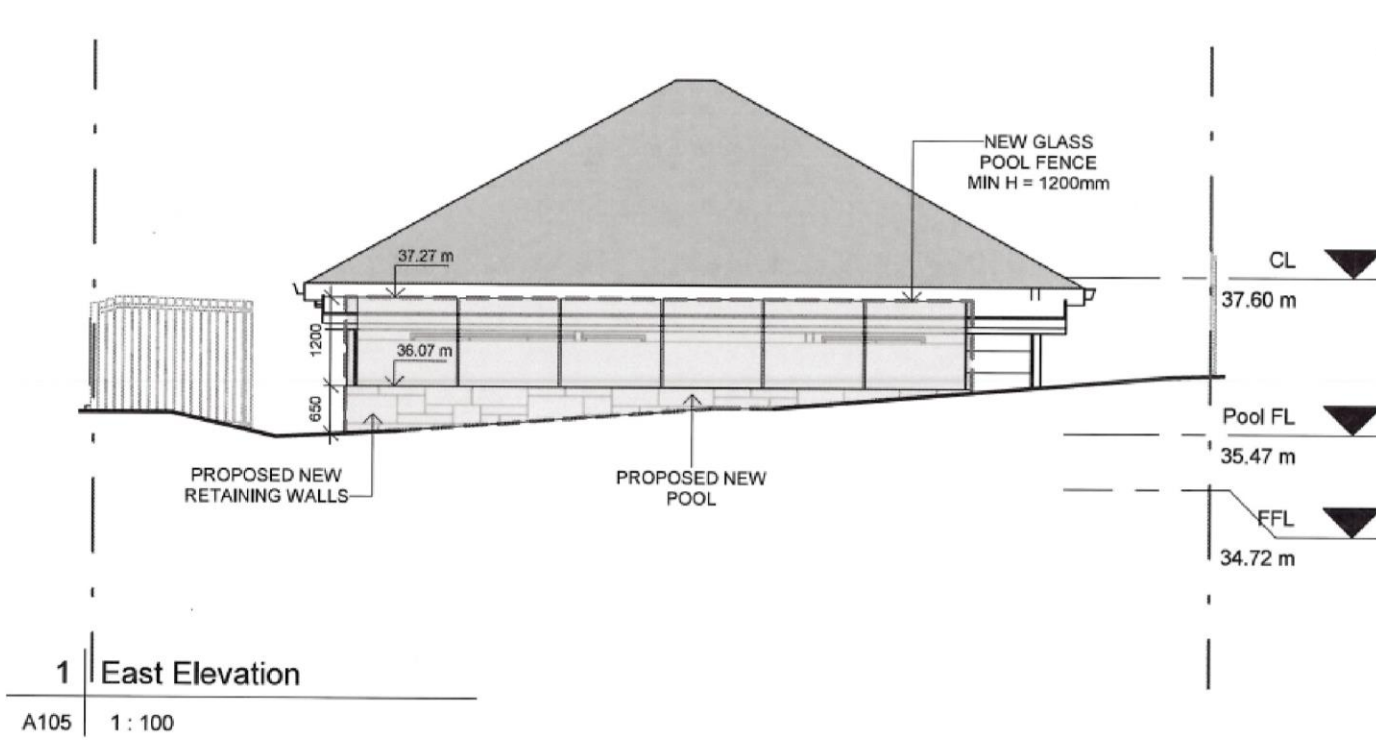
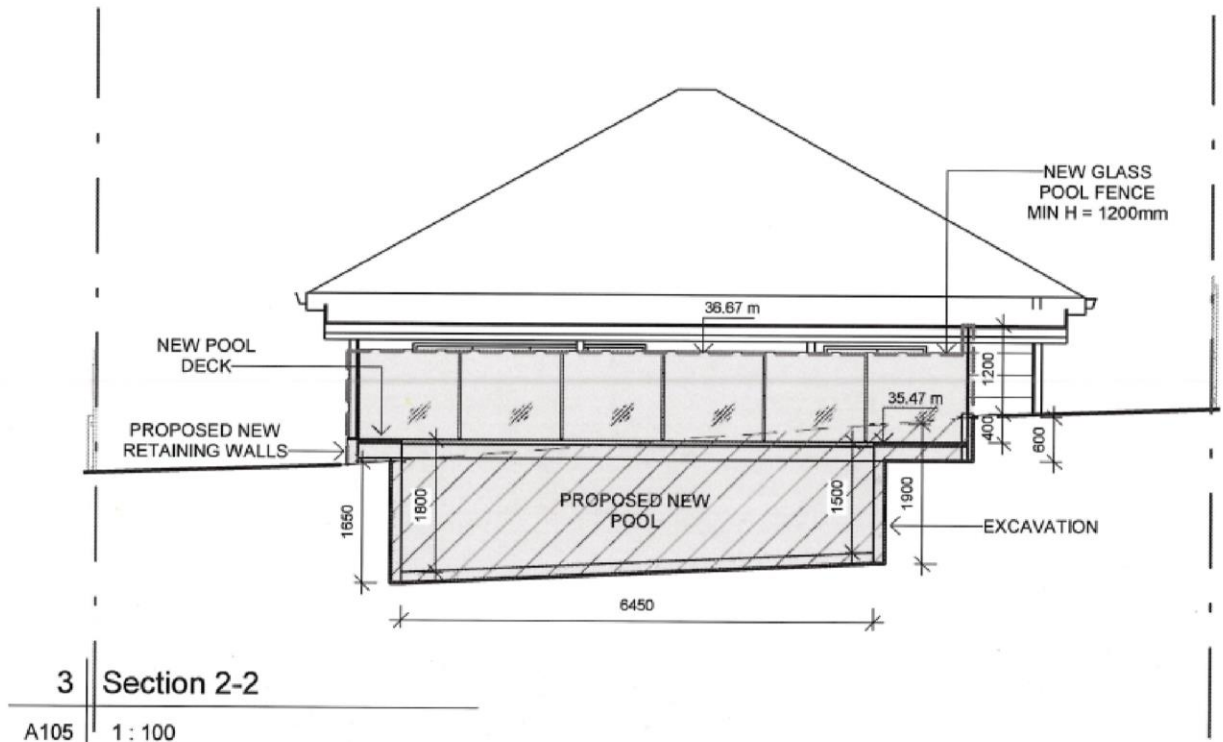
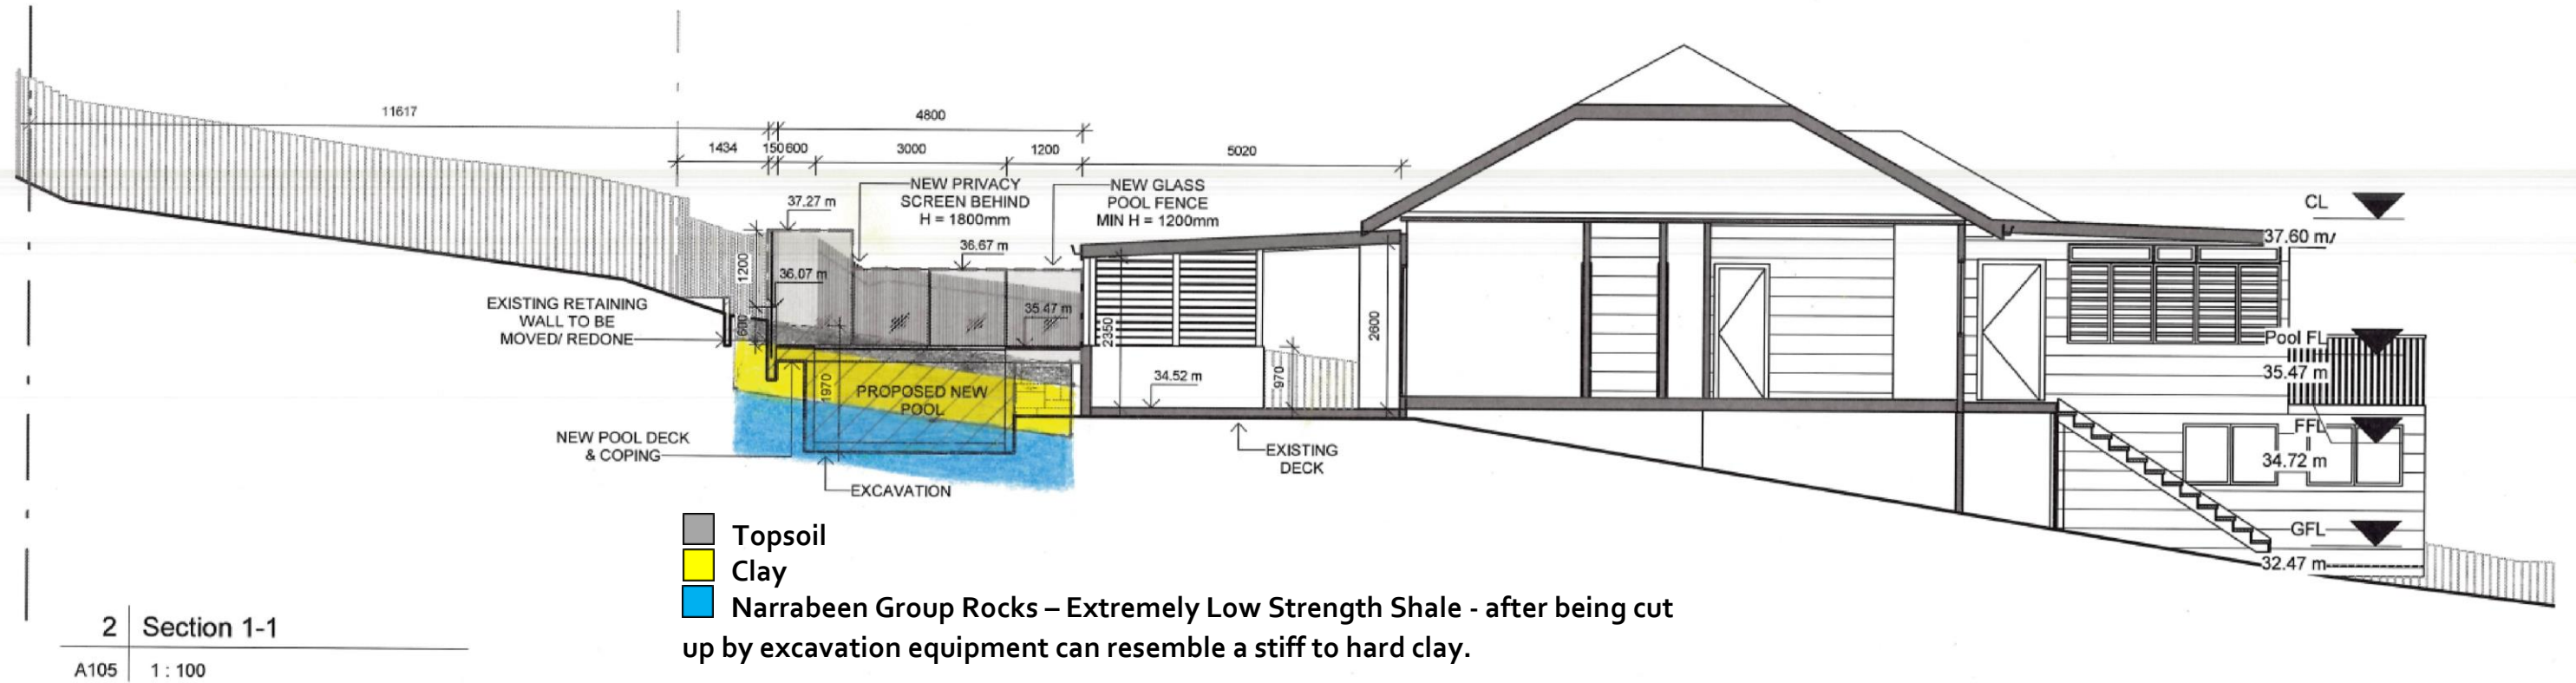
TYPE SECTION – Diagrammatical Interpretation of expected Ground Materials

The slope materials are colluvial at the near surface and residual at depth. In the test locations, the ground materials consist of a thin topsoil over firm to stiff clays. The clays merge into the weathered zone of the underlying rocks at an average depth of ~1.1m below the current surface. The weathered zone of the underlying rock is interpreted as Extremely Low Strength Shale. It is to be noted that this material is a soft rock and can appear as a mottled stiff clay when it is cut up by excavation equipment. See Type Section attached for a diagrammatical representation of the expected ground materials.

Topsoil
 Clay
 Narrabeen Group Rocks – Extremely Low Strength Shale - after being cut up by excavation equipment can resemble a stiff to hard clay.
