Report Title: Geotechnical Report 26 Darley Street, Mona Vale  
Report Date: 26/7/19  
Author: BEN WHITE  
Author's Company/Organisation: WHITE GEOTECHNICAL GROUP PTY LTD

## **GEOTECHNICAL INVESTIGATION:**

### **New Aged Care Centre at 26 Darley Street, Mona Vale**

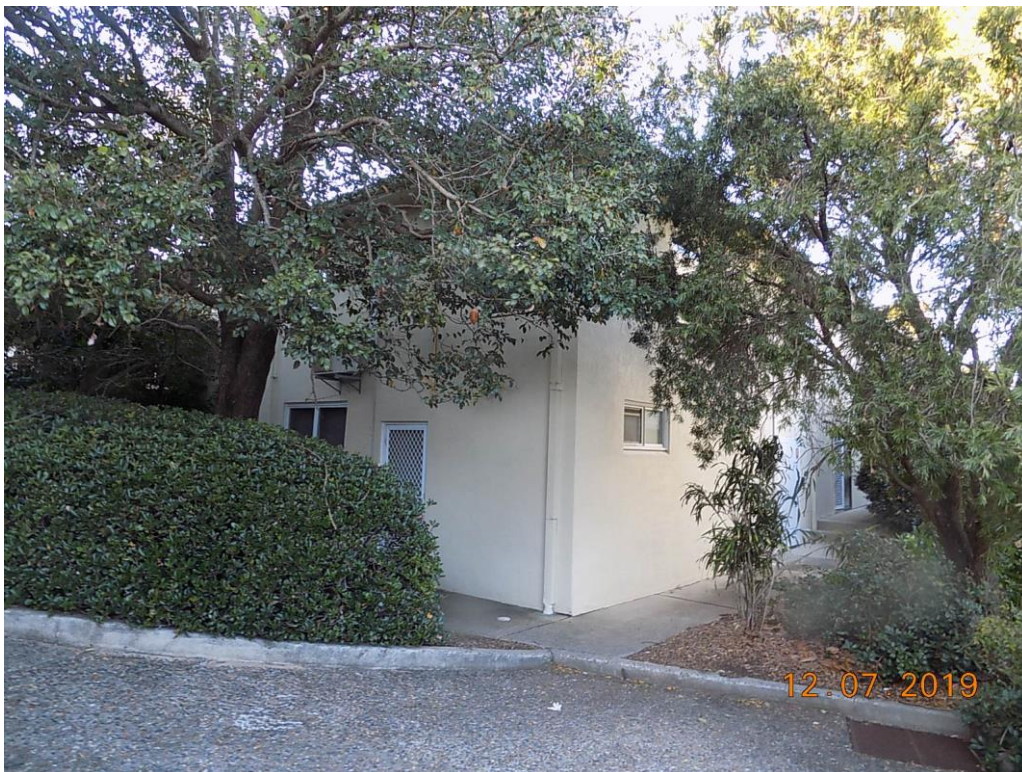
Photo 4

- 2.1** The site was inspected on the 12<sup>th</sup> July, 2019.
- 2.2** This residential property is level with the road and has a NW aspect. The block runs longways to the NE so the slope is a cross-fall. It is located on the gently graded middle reaches of a hillslope. The natural slope rises across the property at an average angle of <5°. The slopes above and below the property continue at similar angles.
- 2.3** At the NW end of the road frontage, a concrete driveway runs to a parking area at the W corner of the building (Photo 1). At the SE end of the road frontage, a concrete and brick-paved driveway runs along the SE side of the building and wraps around the NE side (Photos 2 & 3). The part two-storey brick and concrete block building and surrounding landscaping works will be demolished as part of the proposed development (Photo 4).

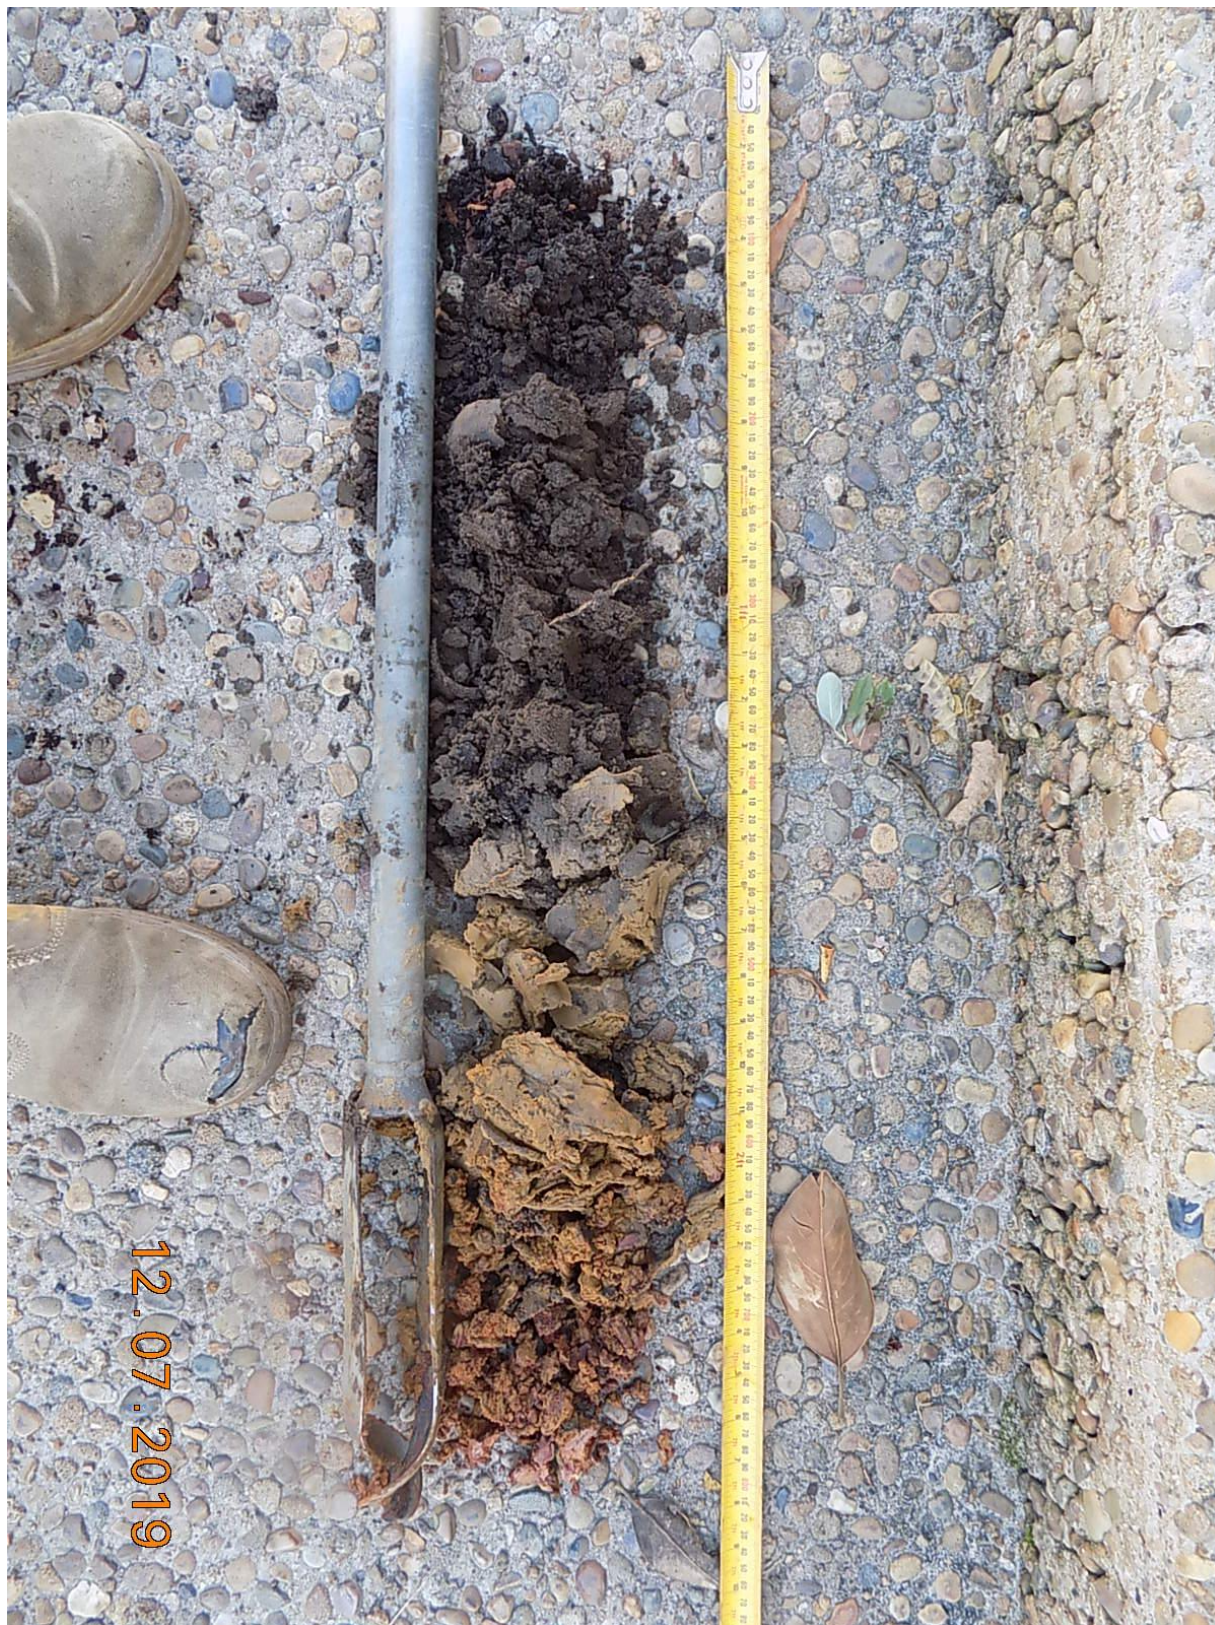
##### AUGER HOLE 1 (~RL12.1) – AH1 (Photo 5)

Depth (m)	Material Encountered
0.0 to 0.2	<b>TOPSOIL</b> , sandy soil, dark brown, loose, damp, fine to medium grained with fine trace organic matter.
0.2 to 0.4	<b>CLAYEY SAND</b> , dark brownish grey, loose, damp, fine to coarse grained with fine trace organic matter.
0.4 to 0.6	<b>CLAY</b> , brown, firm, damp, fine grained.
0.6 to 0.8	<b>CLAY</b> , weathered shale, brown and mottled purple, very stiff, dry, fine grained.

End of hole @ 0.8m in weathered shale. No watertable encountered.

Photo 5 – AH1: Downhole is from top to bottom.

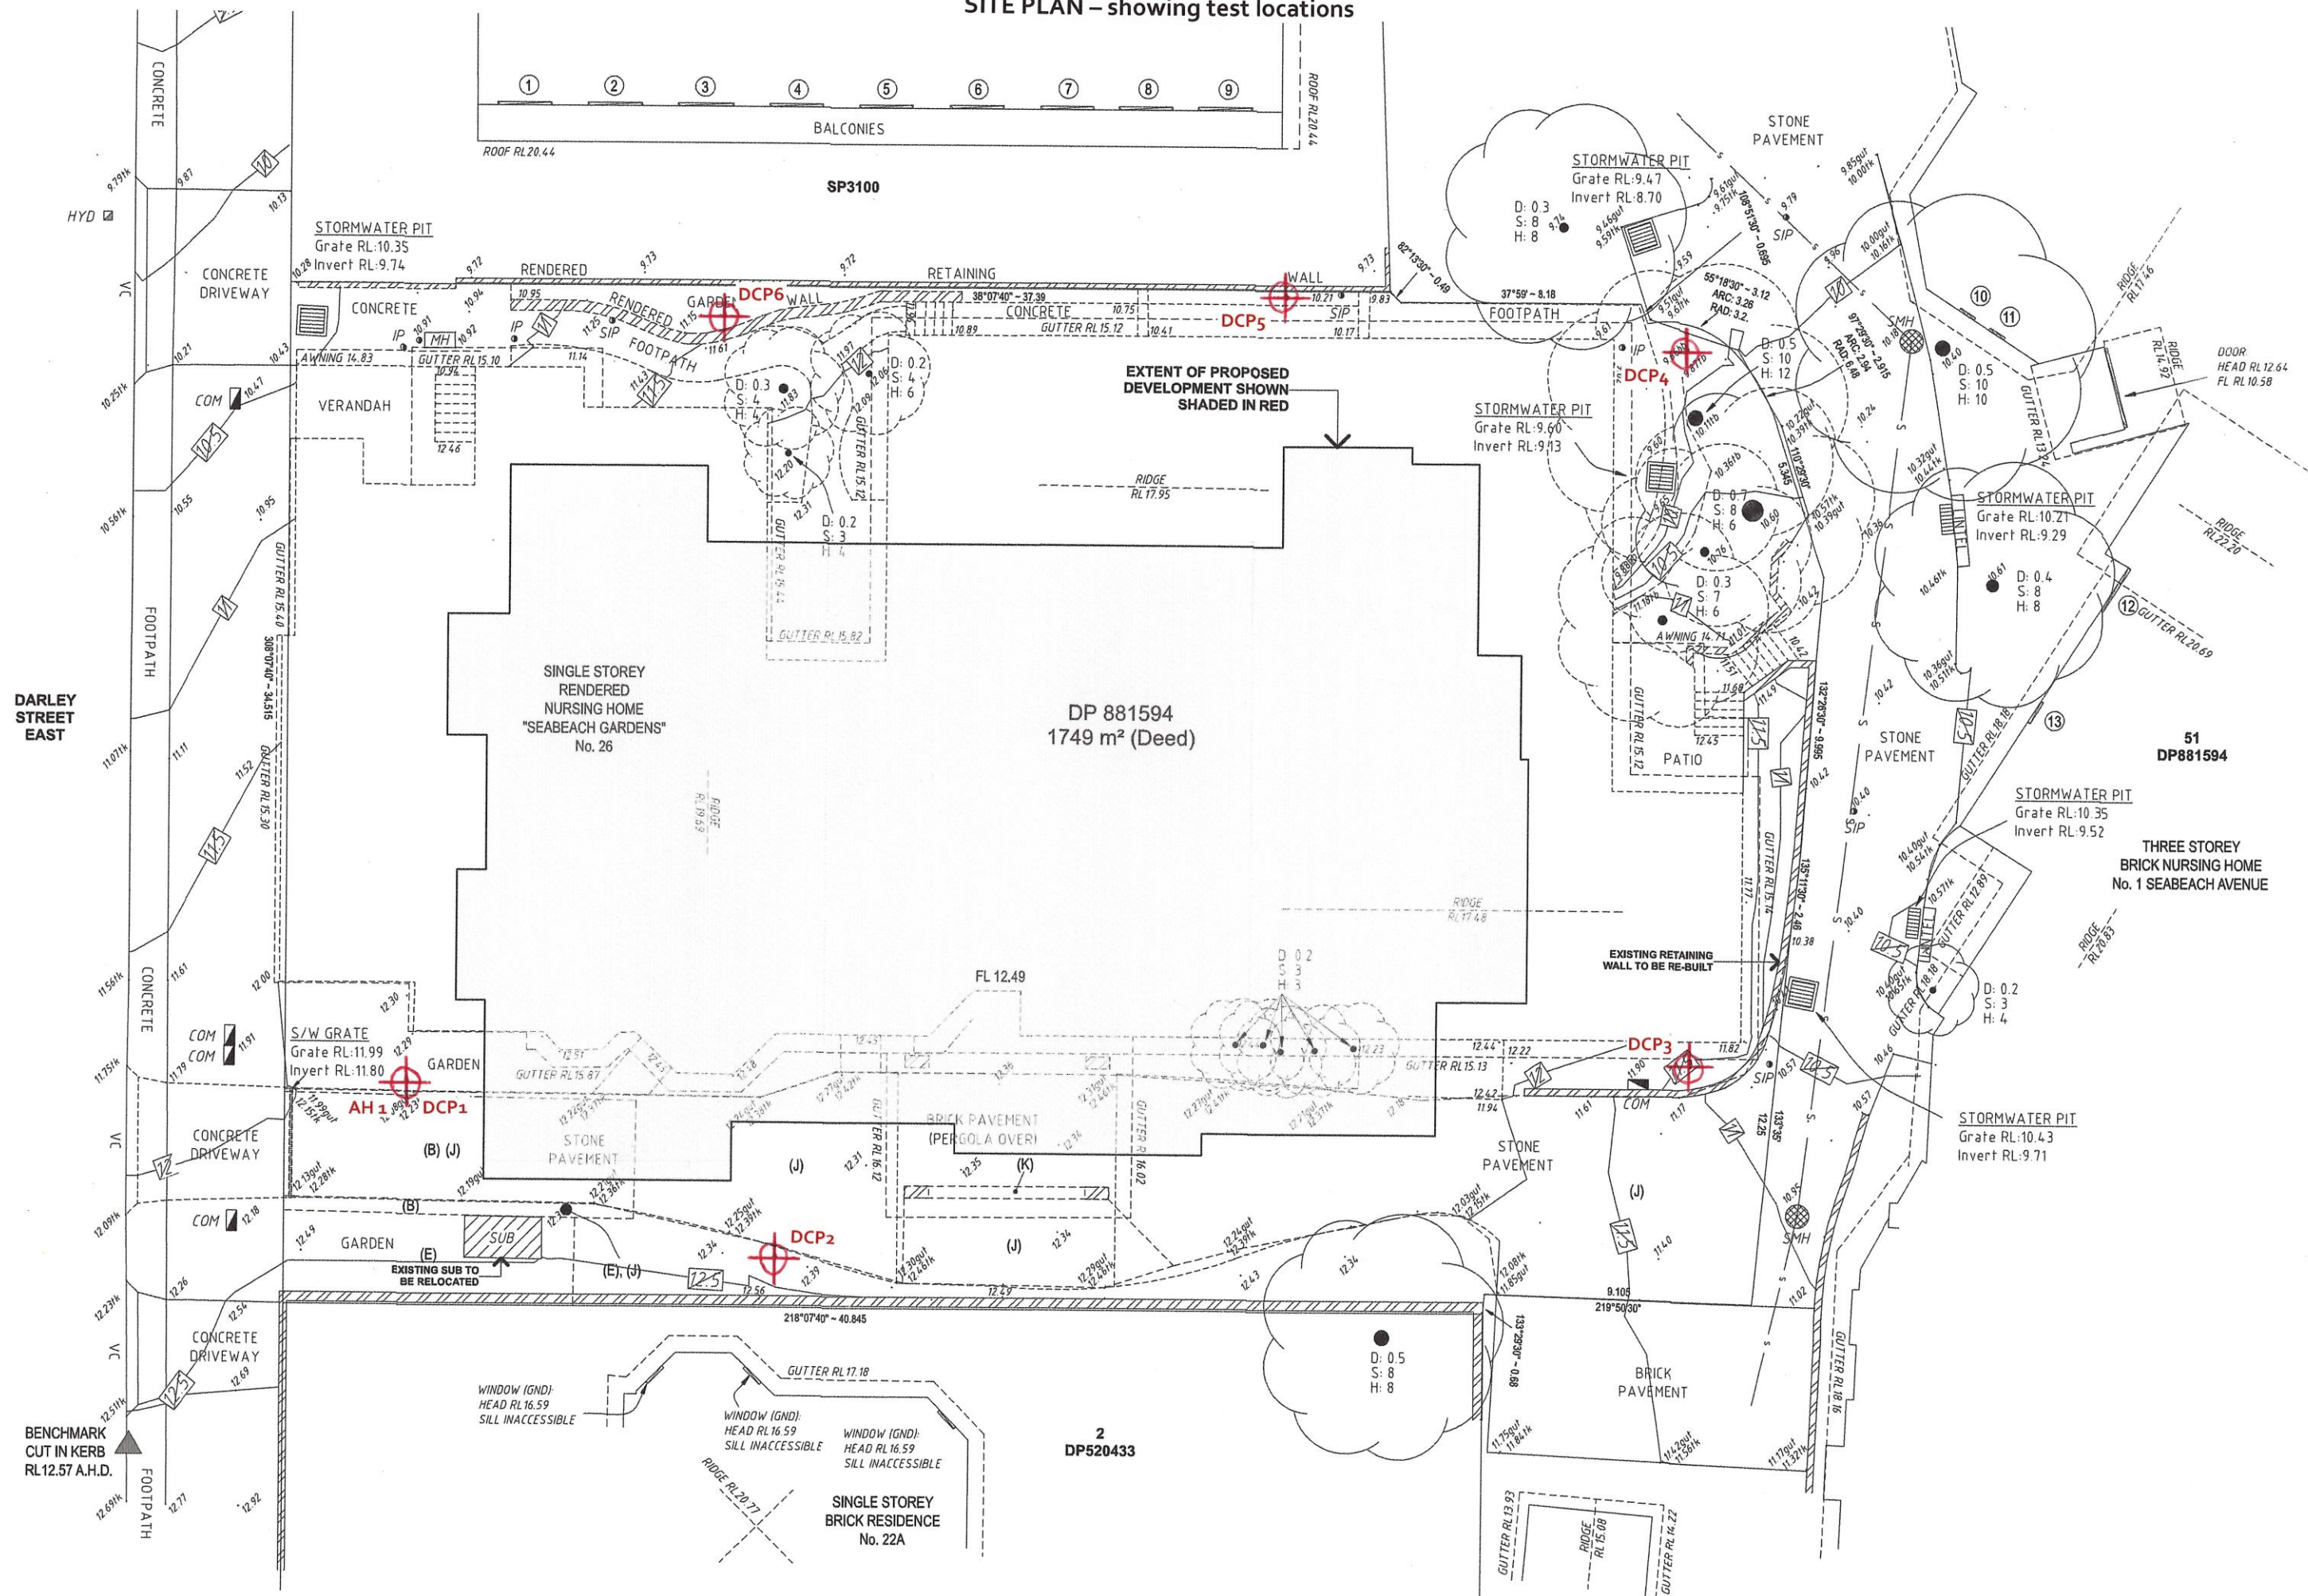
# SITE PLAN – showing test locations

One auger hole (AH) was put down to identify the soil materials. Six Dynamic Cone Penetrometer (DCP) tests were put down to determine the relative density of the overlying soil and the depth to weathered rock. The locations of the tests are shown on the site plan. It should be noted that a level of caution should be applied when interpreting DCP test results. The test will not pass through hard buried objects so in some instances it can be difficult to determine whether refusal has occurred on an obstruction in the profile or on the natural rock surface. This is not expected to be an issue for the testing on this site and the results are as follows:

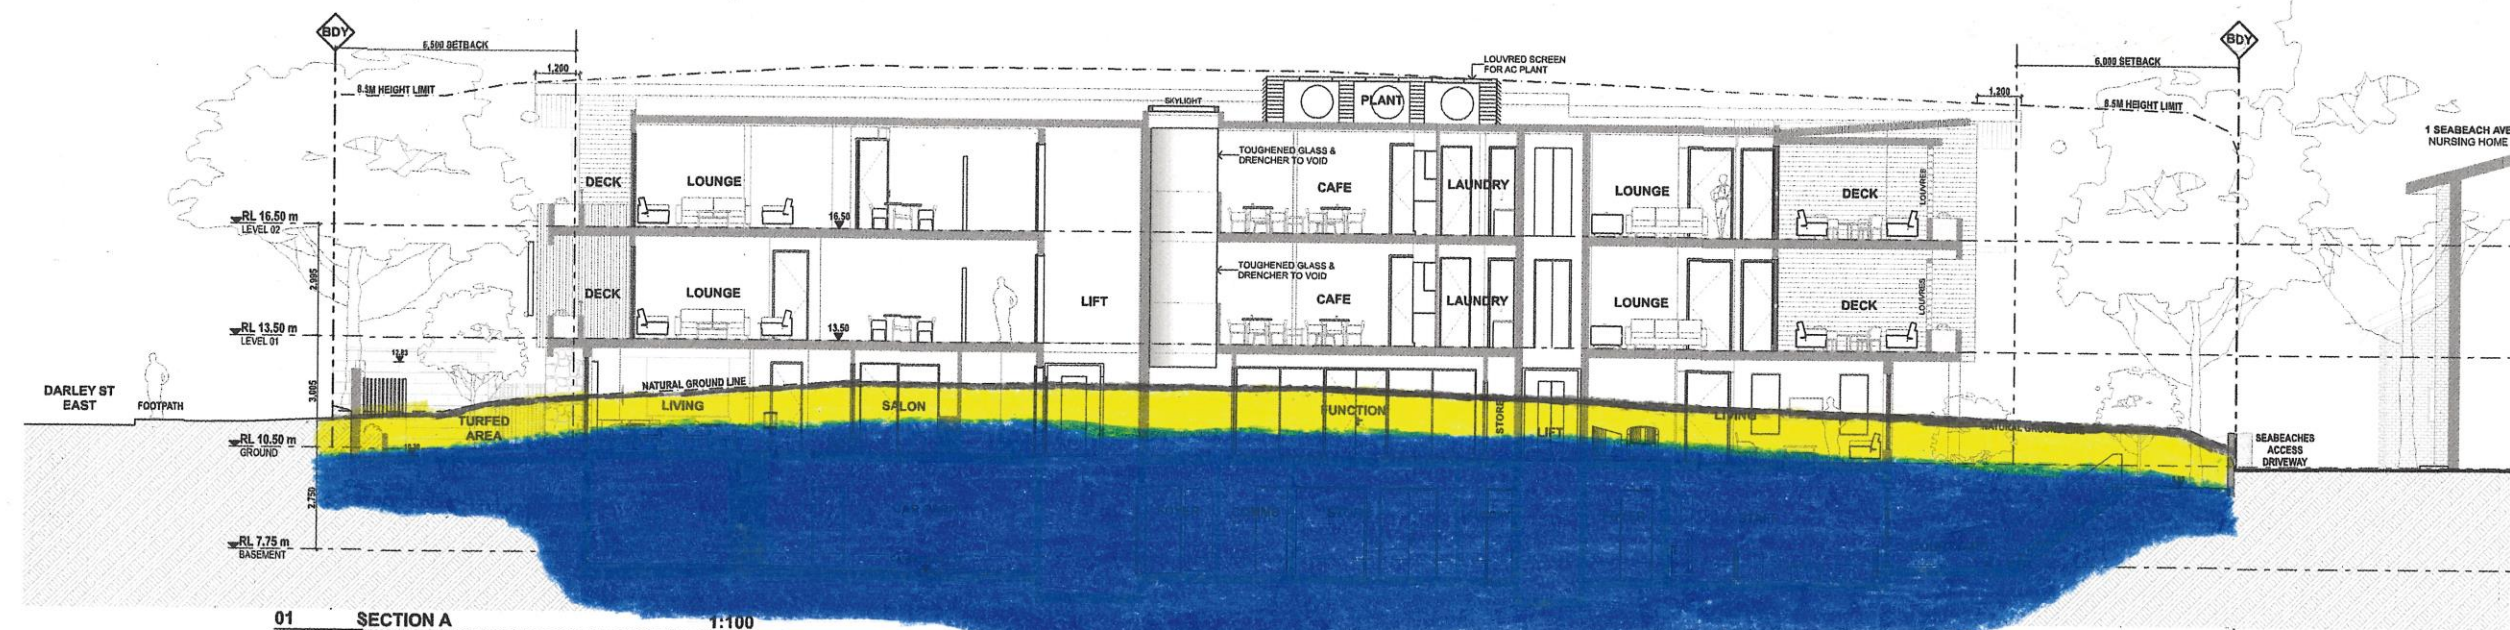
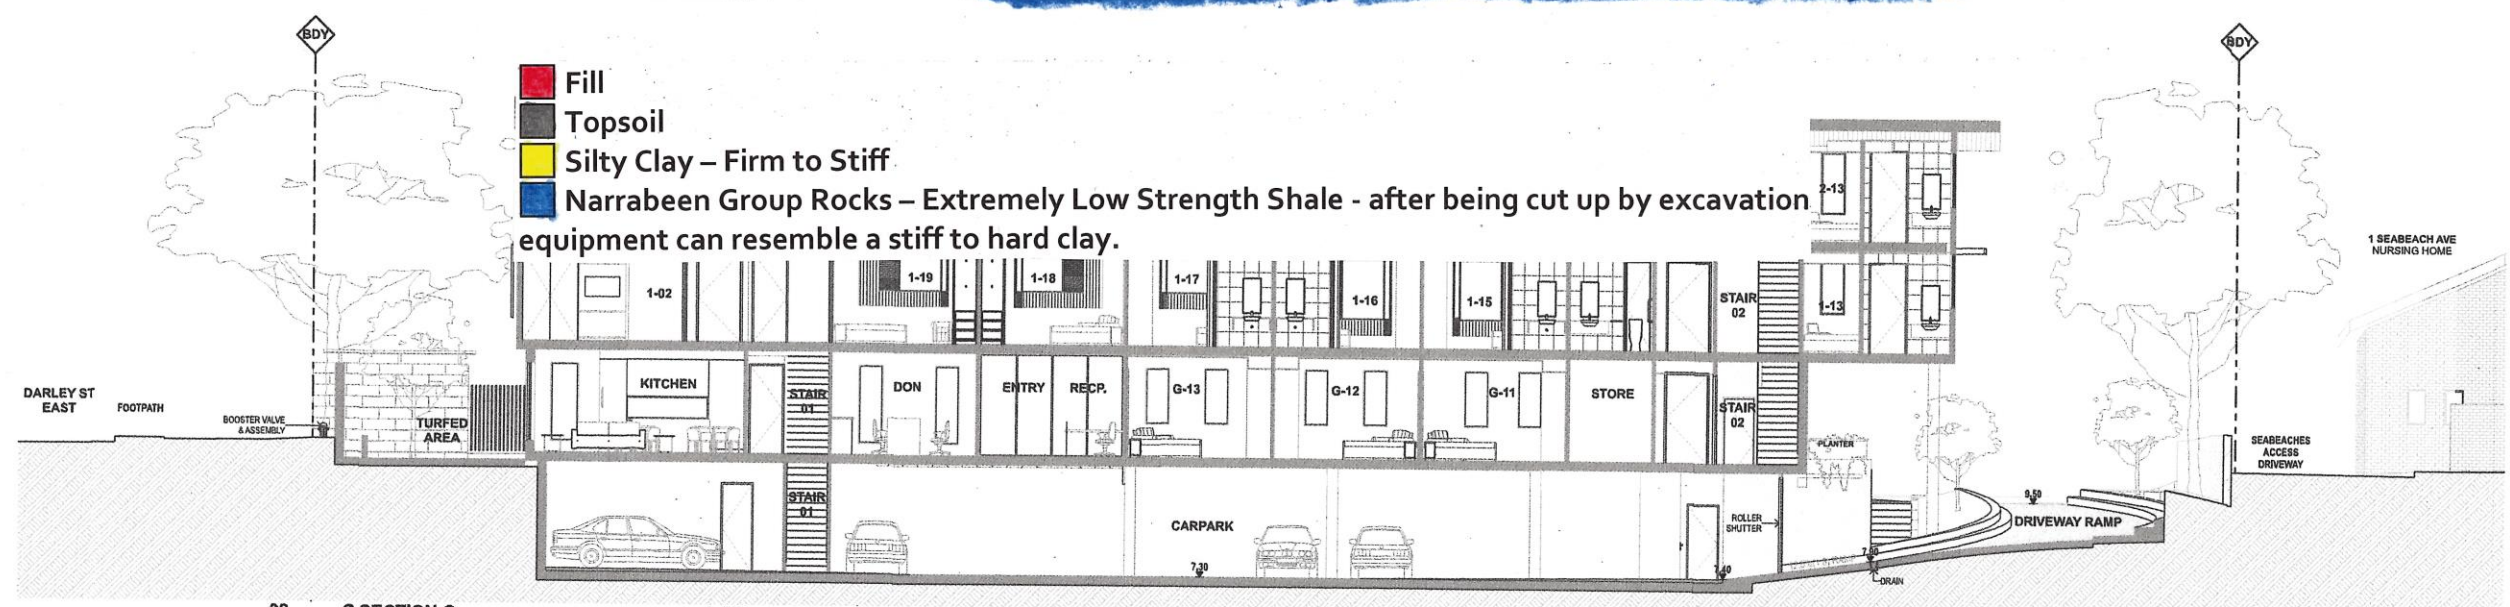
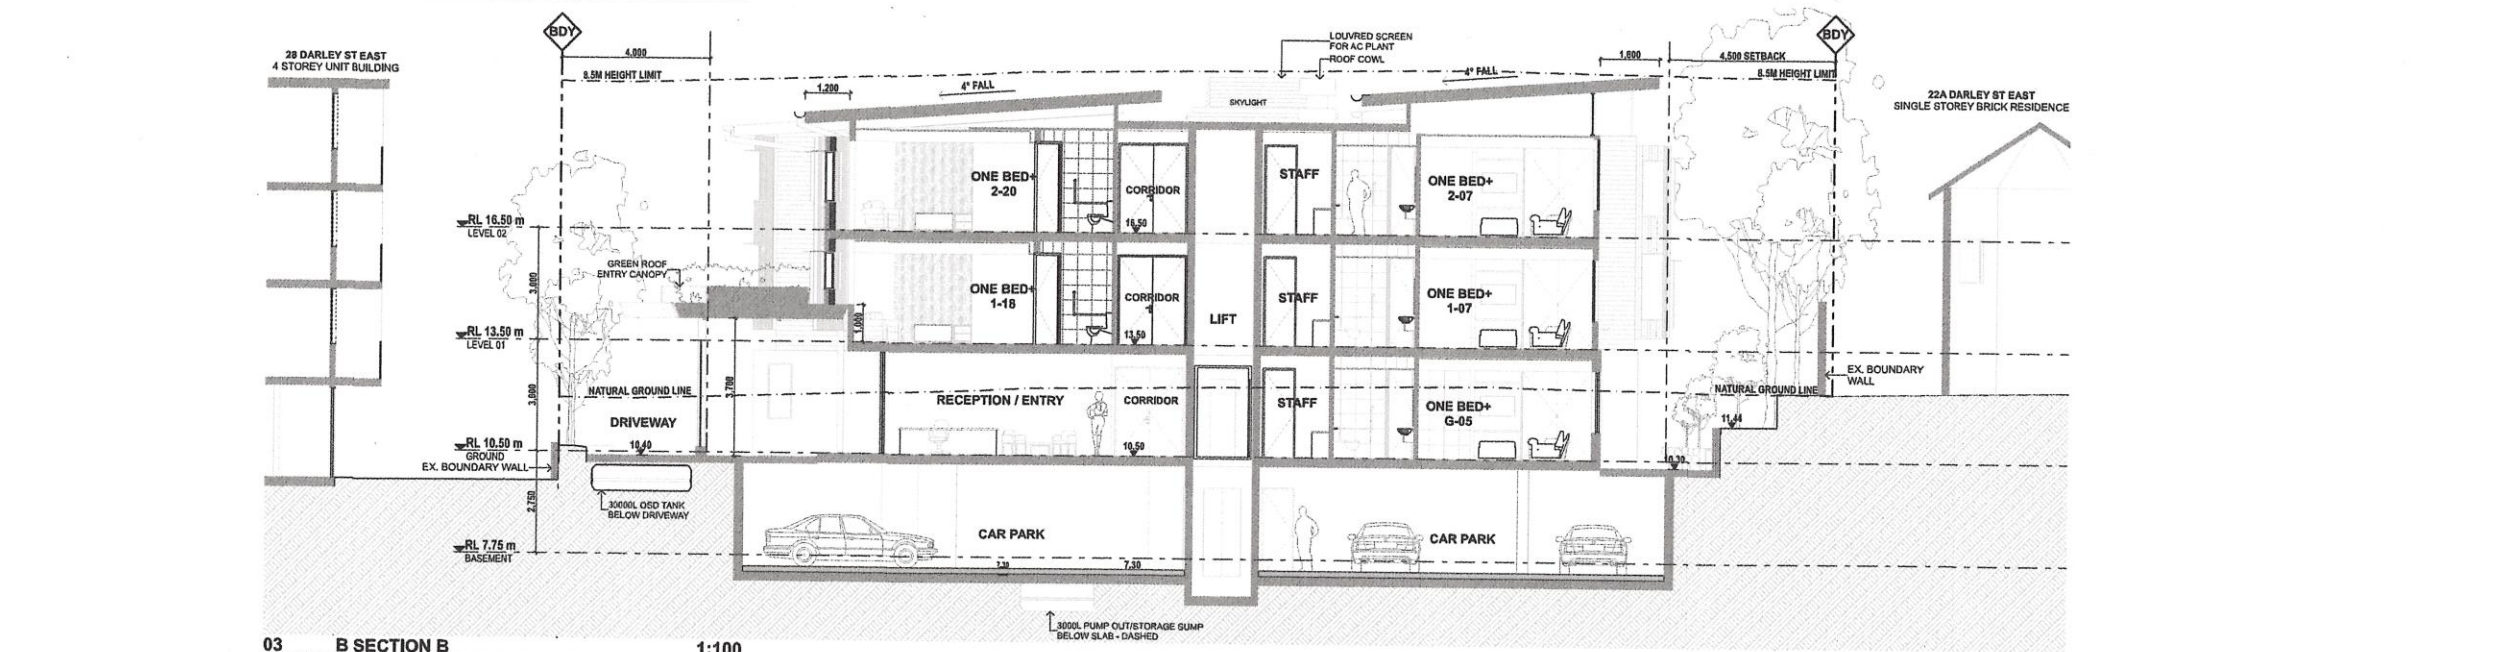
TYPE SECTION – Diagrammatical Interpretation of expected Ground Materials

The slope materials are colluvial at the near surface and residual at depth. They consist of a thin sandy topsoil over firm to stiff clays. In the test locations, the clays merge into the weathered zone of the underlying shale at an average depth of ~1.0m below the current surface. The weathered zone is interpreted as Extremely Low Strength Shale. It is to be noted that this material can appear as a mottled stiff clay when it is cut up by excavation equipment.

See Type Section attached for a diagrammatical representation of the expected ground materials.
