# Geotechnical Assessment

**Project:** Alterations & Additions  
19 Dress Circle Road, Avalon Beach NSW

**Ref:** AG 23052  
8 August 2024

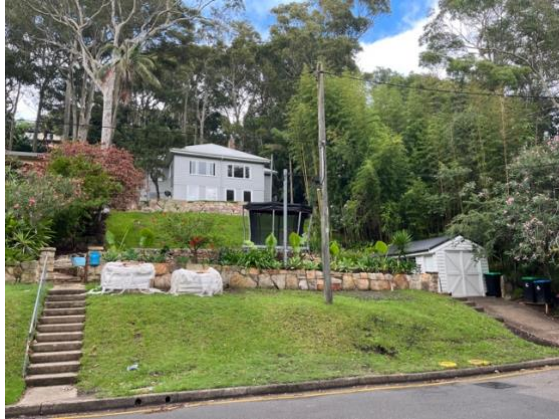
**Photo 1:** Site frontage

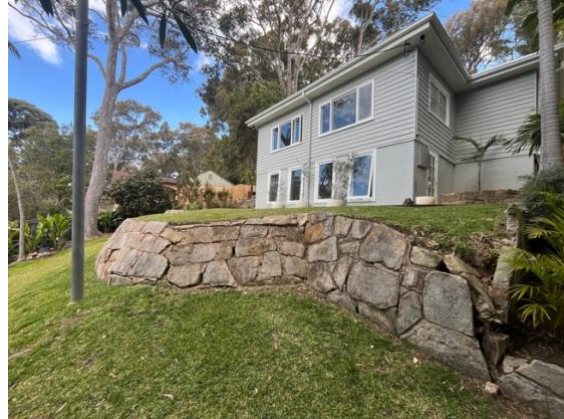
**Photo 2:** Dwelling frontage

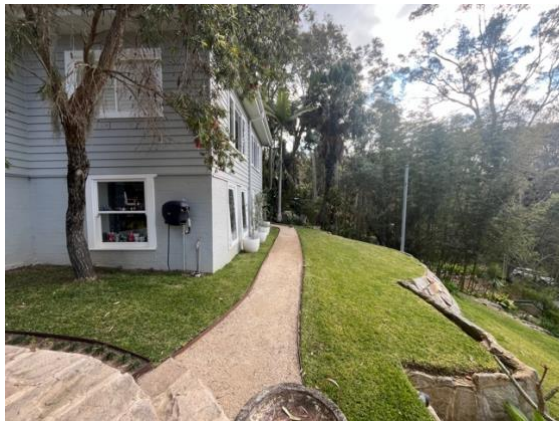
**Photo 3:** Dwelling frontage

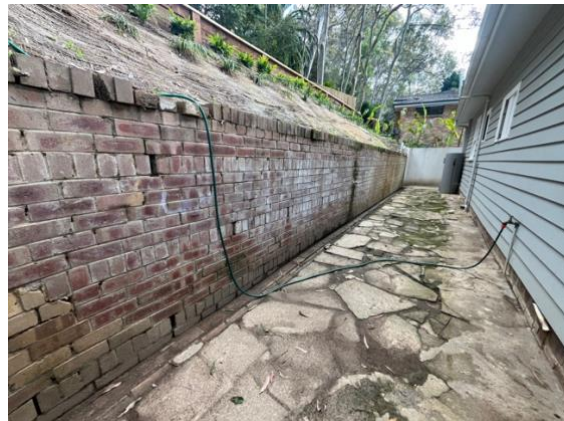
The existing building at the site is a two-storey house with a terraced front yard and backyard areas and is generally in good condition. A brick wall supports the slope along the rear of the dwelling and is in reasonable condition for its age, with the exception of the eastern return which is cracked and displaced, likely due to tree root growth. The western return of this wall is rendered masonry, appears to have been more recently constructed and is in good condition.

**Photo 4:** Brick wall at dwelling rear

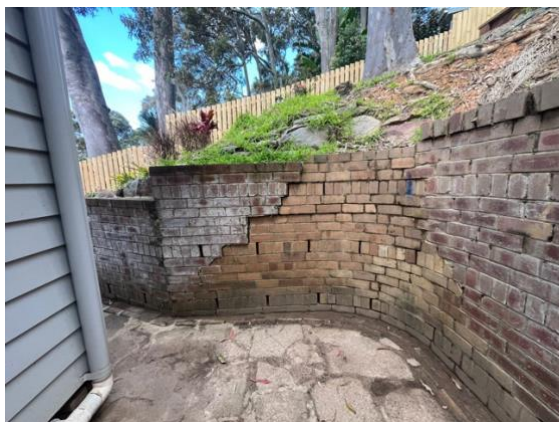
**Photo 5:** Damaged return (eastern side) of the brick wall at the dwelling rear

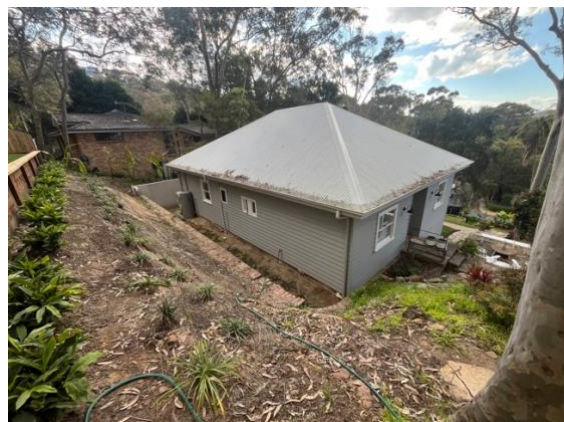
**Photo 6:** Dwelling rear
