Report on Geotechnical Investigation

Approved Mixed-Use Development 231 Whale Road, Whale Beach

Prepared for Leslie Cassar

Project 45636.02 November 2023

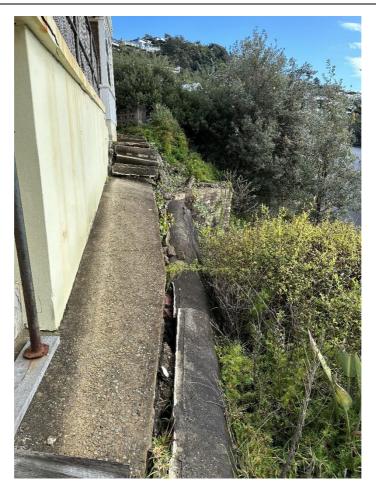
- The western portion of the existing building is mostly in a good to fair condition. Towards the
 eastern side of the building, significant cracking was observed in the external balcony and also
 along the external concrete footpath and stairs which is situated close to the crest of a steep 7-9 m
 high batter which appears to have been temporarily supported with gravel bags. The slope on the
 eastern side of the site (above Surf Road) and small retaining wall at its base indicate significant
 slope instability (refer Photos 1 to 4 in Appendix E).
- Cracking in the concrete footpath possibly caused by temporary propping of the balcony above, or slope instability, or both (Refer Photo 3 in Appendix E); and
- Medium to high strength sandstone outcrop observed to the north of the subject site, along the boundary between Surf Road and 233 Whale Beach Road.

Photo 1 – View of cracking along the external footpath

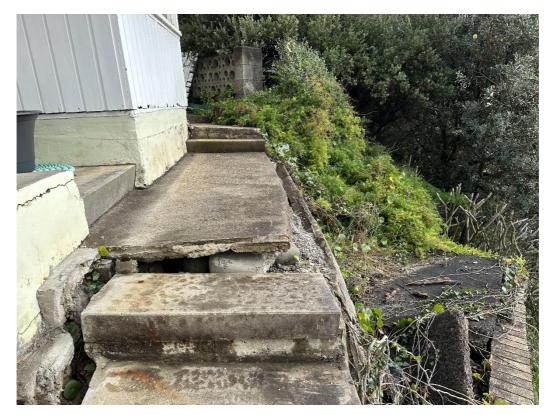
Photo 2 - View of cracking along the external stairs I

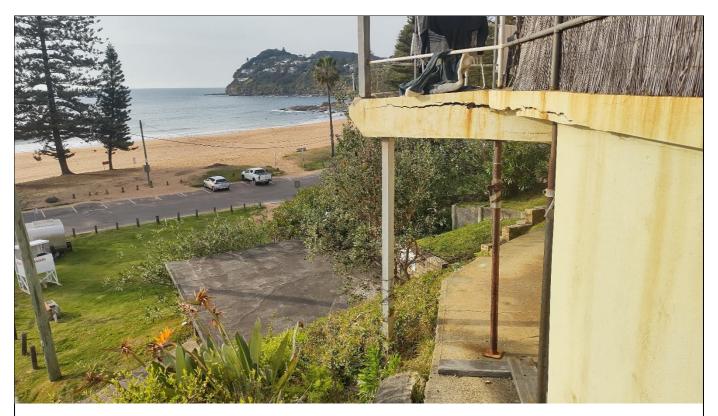
Photo 3 – View of the cracking in the balcony at the eastern side of the site

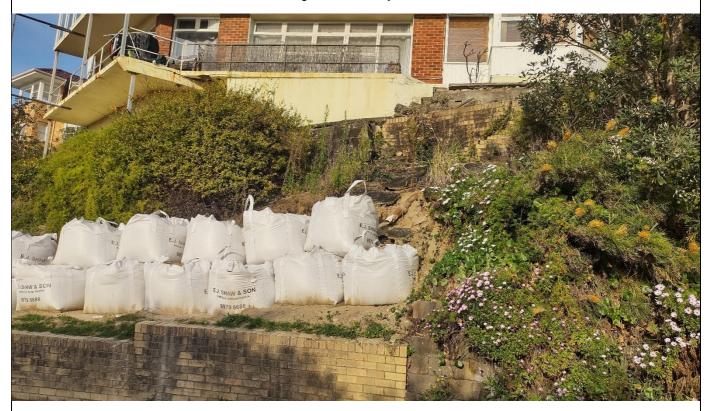
Northern Beaches (Pittwater) Council's Geotechnical Risk Management Policy (GRMP - 2009) indicates that the site lies within Hazard Zone 1 which is defined as an area where the likelihood of instability is assessed to be possible to almost certain. The site is located toward the base of an east-facing hill with an average slope of approximately 15°. The geotechnical inspection indicated strong evidence of current and significant slope instability on the eastern side of the site and advice regarding this hazard has been provided to RCA. The building has significant structural cracks on its balconies and the slope appears to have been temporarily supported with timber props and ballast bags.

Photo 4 – View of the property from Surf Road

It is understood that the residents will soon vacate the building. Once the building has been vacated, and with ongoing survey monitoring and geotechnical inspection, the slope failure hazard above Surf Road will reduce in 'risk' from 2.2×10^{-2} (not tolerable) to 6.6×10^{-5} (tolerable).
