REPORT ON GEOTECHNICAL SITE INVESTIGATION

30 FAIRLIGHT STREET, FAIRLIGHT NSW

Project No.: 2019-200

**GEOTECHNICAL REPORT FOR PROPOSED FOUR STOREY RESIDENTIAL DEVELOPMENT
30 FAIRLIGHT STREET, FAIRLIGHT, NSW**

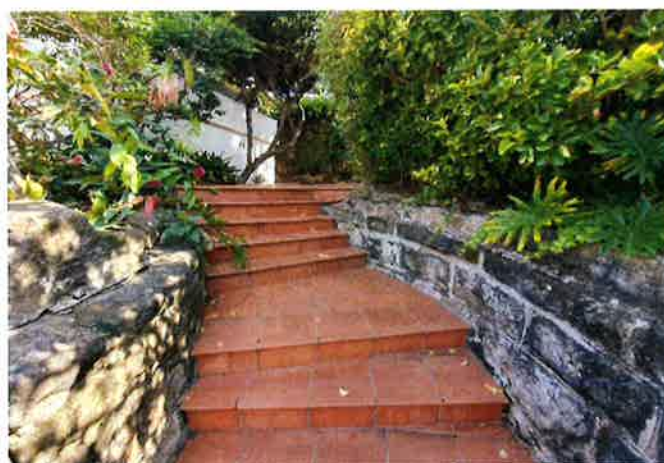
Access to the site is gained from the south east corner of the site. The entrance contains a series of stairs (Photograph-4) which leads to the entrance door of the dwelling (to the west) and a pathway (to the east) between the eastern side of the house and the eastern boundary. To the front of the entrance door is a patio (which is positioned right above the garage). The patio contains a tiled floor and it is surrounded by relatively small gardens along the edges. The patio appears to be in good condition with no significant cracks or undulations present within the patio floor. However, the external walls supporting the gardens contain vertical cracks of approximately 15mm width (Photographs 5&6). It appears that these cracks are due to lateral pressures exerted by the soil or poor lateral reinforcement of the wall structure.

Photograph-4: Staircase at entrance. View looking north.

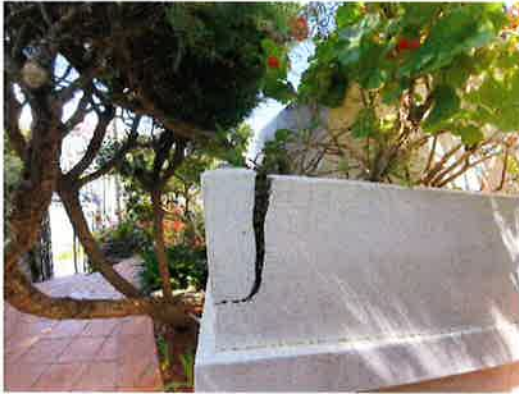
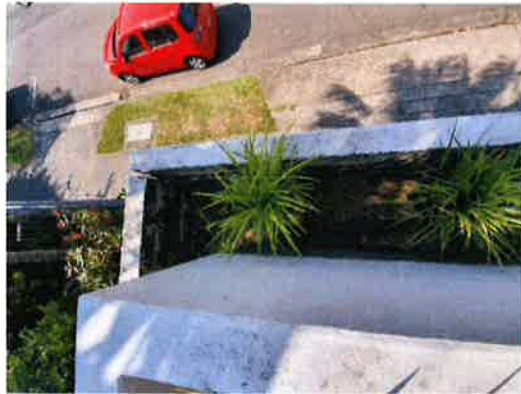
Photograph-5: Garden crack, view looking south. Photograph-6: Front garden crack. View from patio to road reserve

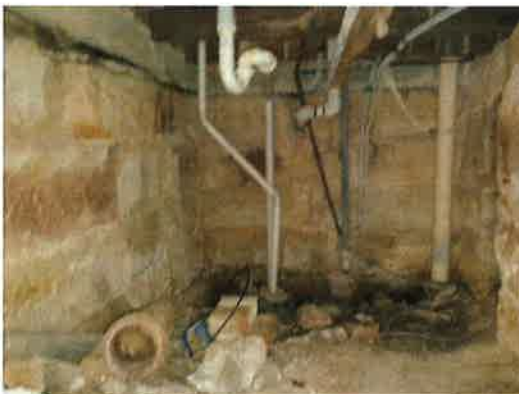
The site is within south dipping topography, therefore, the southern portion of the house is formed/supported by sandstone blocks and columns (Photographs 7&8) of approximately <1.8m in height, which extend to unknown footings. There were no signs of underlying geotechnical issues within the supporting sandstone block and columns, internally or externally.

Photograph-7: Sandstone block wall. View looking south.

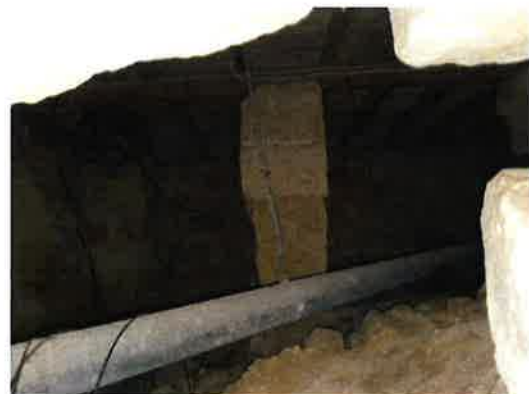
Photograph-8: Sandstone column. View looking west.

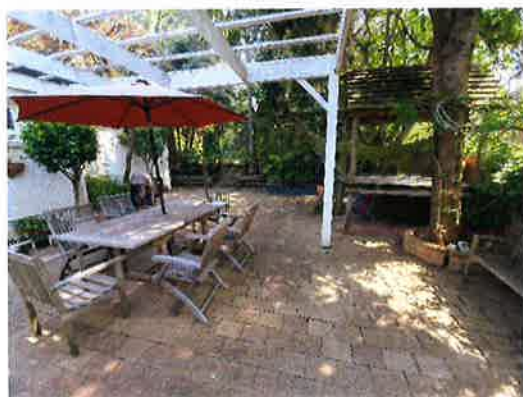
Access to the rear of the site is gained via a narrow (approximately 1.5m wide) paved pathway which leads to a paved rear patio (Photograph-9). The rear patio comprises of an alfresco area at the south west corner with a tree adjacent to the eastern boundary. The paved pathway and patio floor appear to be in good condition, with no cracks. However, a minor undulation (Photograph-10) was observed to the base of the tree, it is likely that this is due to the presence of a tree root.

Photograph-9: Rear patio. View looking North.

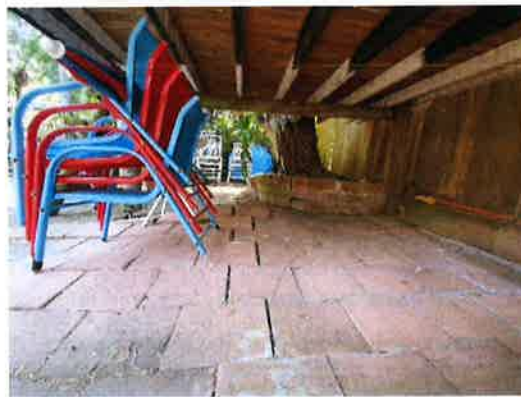
Photograph-10: Minor floor undulation. To the base of of the tree

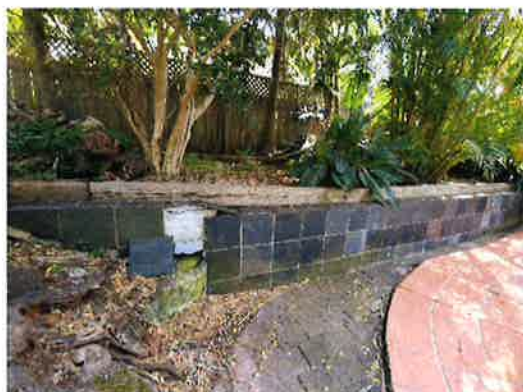
Photograph-12: Concrete tiled retaining wall. View Looking north.

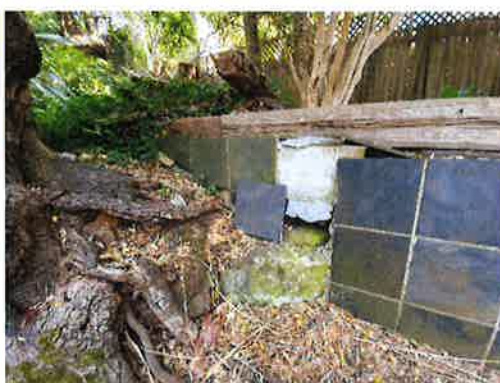
Photograph-13: Rock outcrop. To the base of the tree.

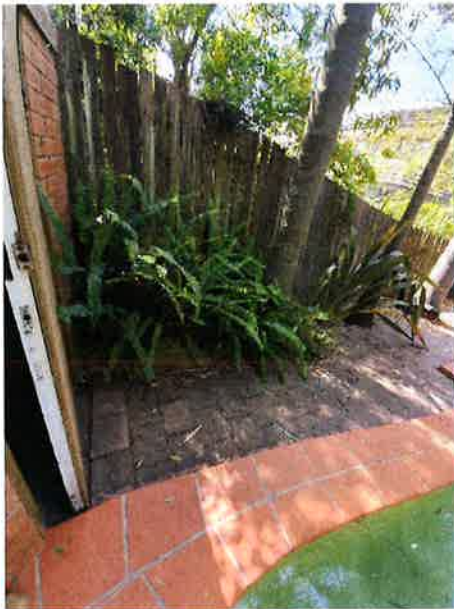
Photograph-14: Second rock outcrop. View looking east

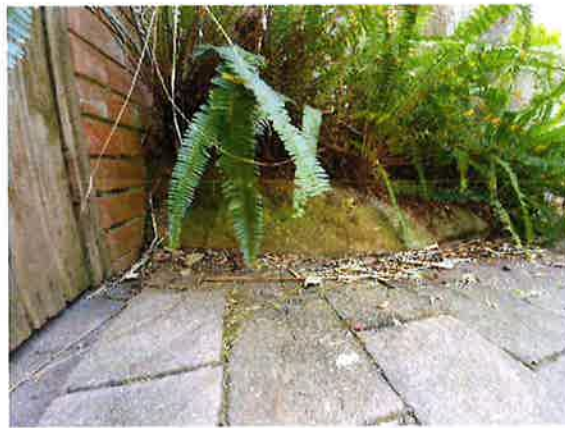
Photograph-15: Close up to rock outcrop. View looking east.

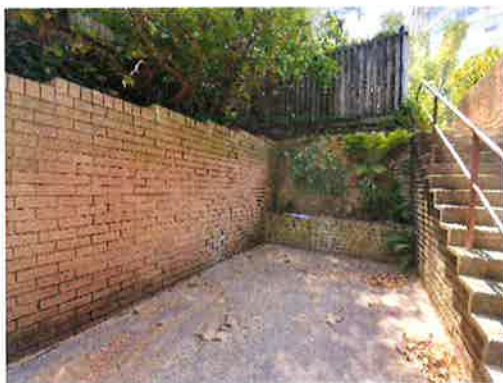
The neighbouring property to the east of the site, No. 28, contains a driveway and a four-storey brick apartment building. The concrete driveway extends north along the site's eastern boundary to a raised lawn (approximately 3m height) adjacent to the site's (Photograph 16 & 17) north-east corner. The boundary contains a brick retaining wall which appears to be in good condition with no significant cracks or rotation. The building is located approximately 4.2m off the boundary, appears formed at above ground surface levels and appears in good condition with no sign of cracking or settlement on the external walls.

Photograph-16: No.28 driveway. View looking north
