Report Title: Geotechnical Report 100 Hilltop Road, Avalon
Report Date: 30/7/24

GEOTECHNICAL INVESTIGATION:

New House at **100 Hilltop Road, Avalon**

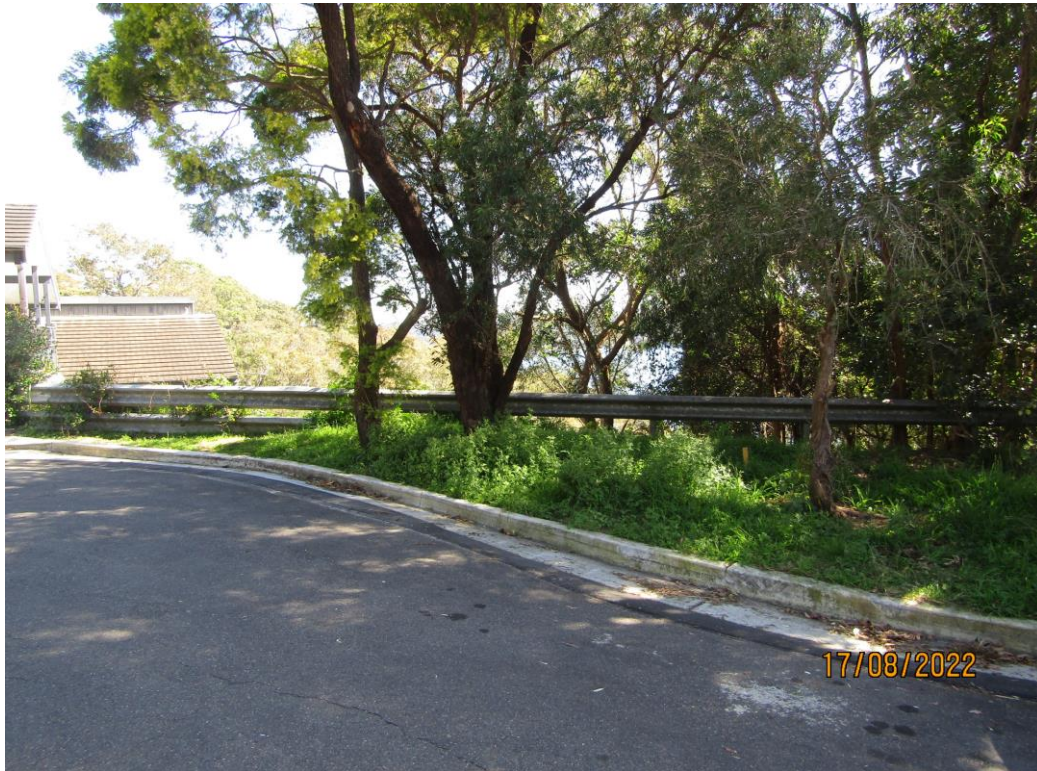
Photo 1

- 2.3** Fill provides a level platform for the road and road reserve (Photo 1). The fill is supported by a concrete crib retaining wall that is estimated to be up to ~4.0m high (Photo 2). Part of the wall is obscured by vegetation and could not be adequately assessed. The visible portion of the wall appears to be currently stable. The vacant block is thickly vegetated (Photos 3 & 4). Sandstone bedrock is outcropping at the

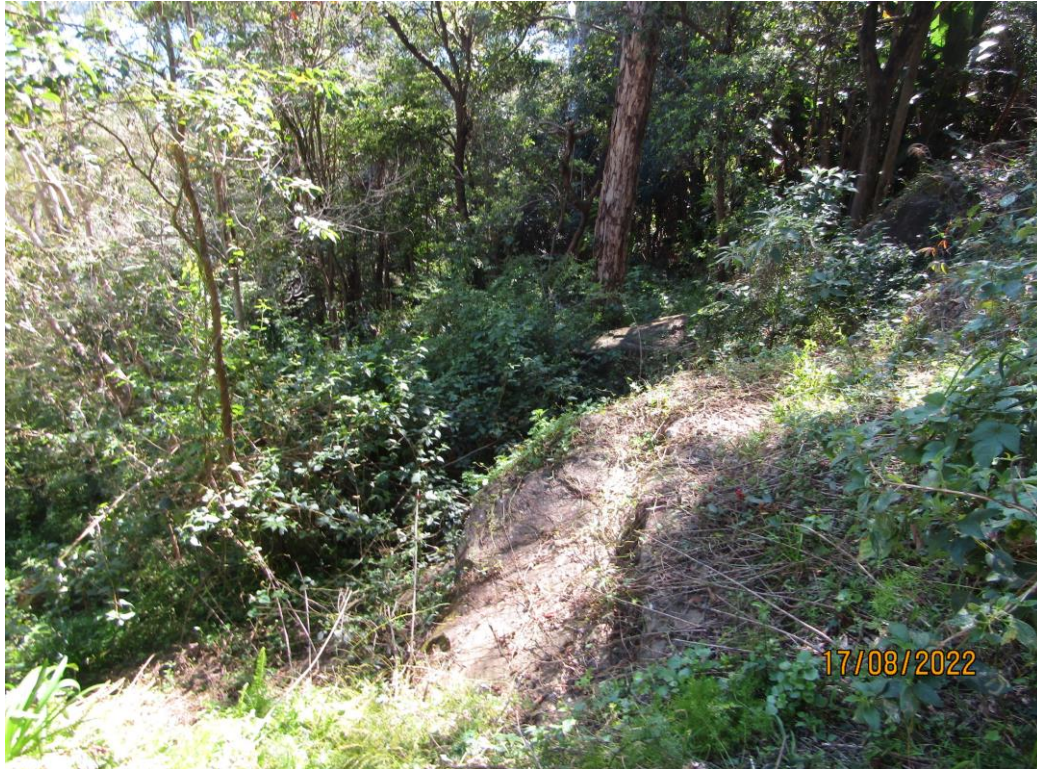
Photo 5

upper middle portion of the property (Photo 5). Detached sandstone joint blocks are embedded in stable positions in the slope (Photos 6 & 7).

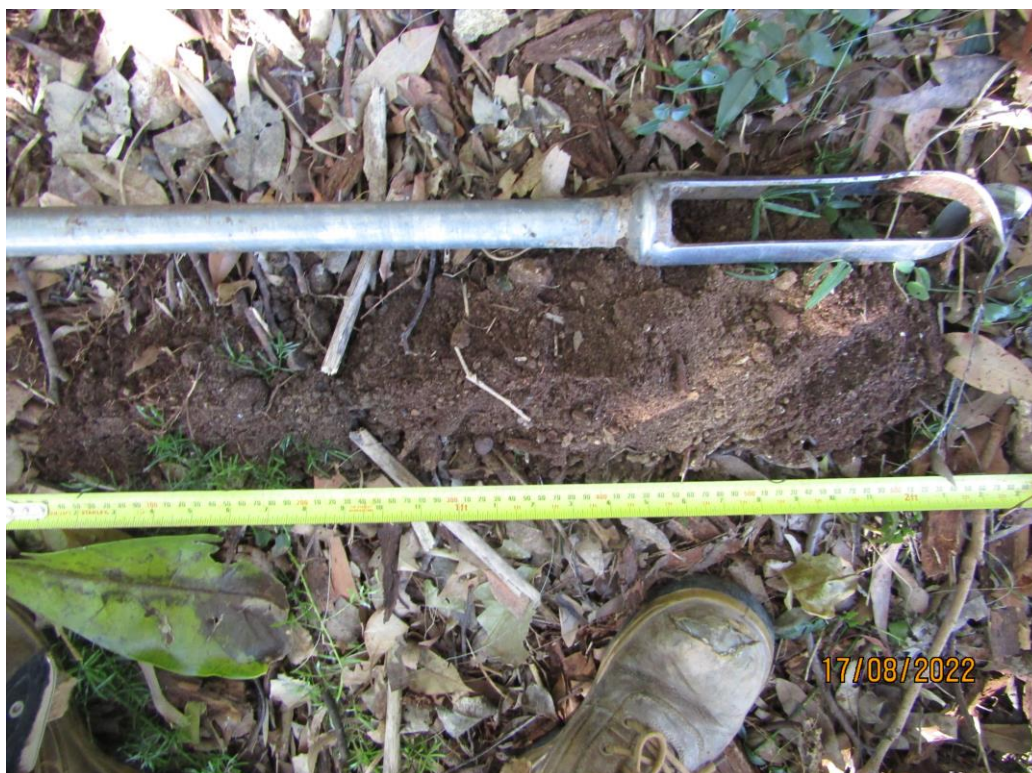
AUGER HOLE 1 (~RL71.8) – AH1 (Photo 8)

Depth (m)	Material Encountered
0.0 to 0.6	COLLUVIUM , soil and clay, dark brown, orange, dry, fine to course grained.

Refusal @ 0.6m in colluvium. No water table encountered.

Photo 8: AH1 – Downhole is from left to right.

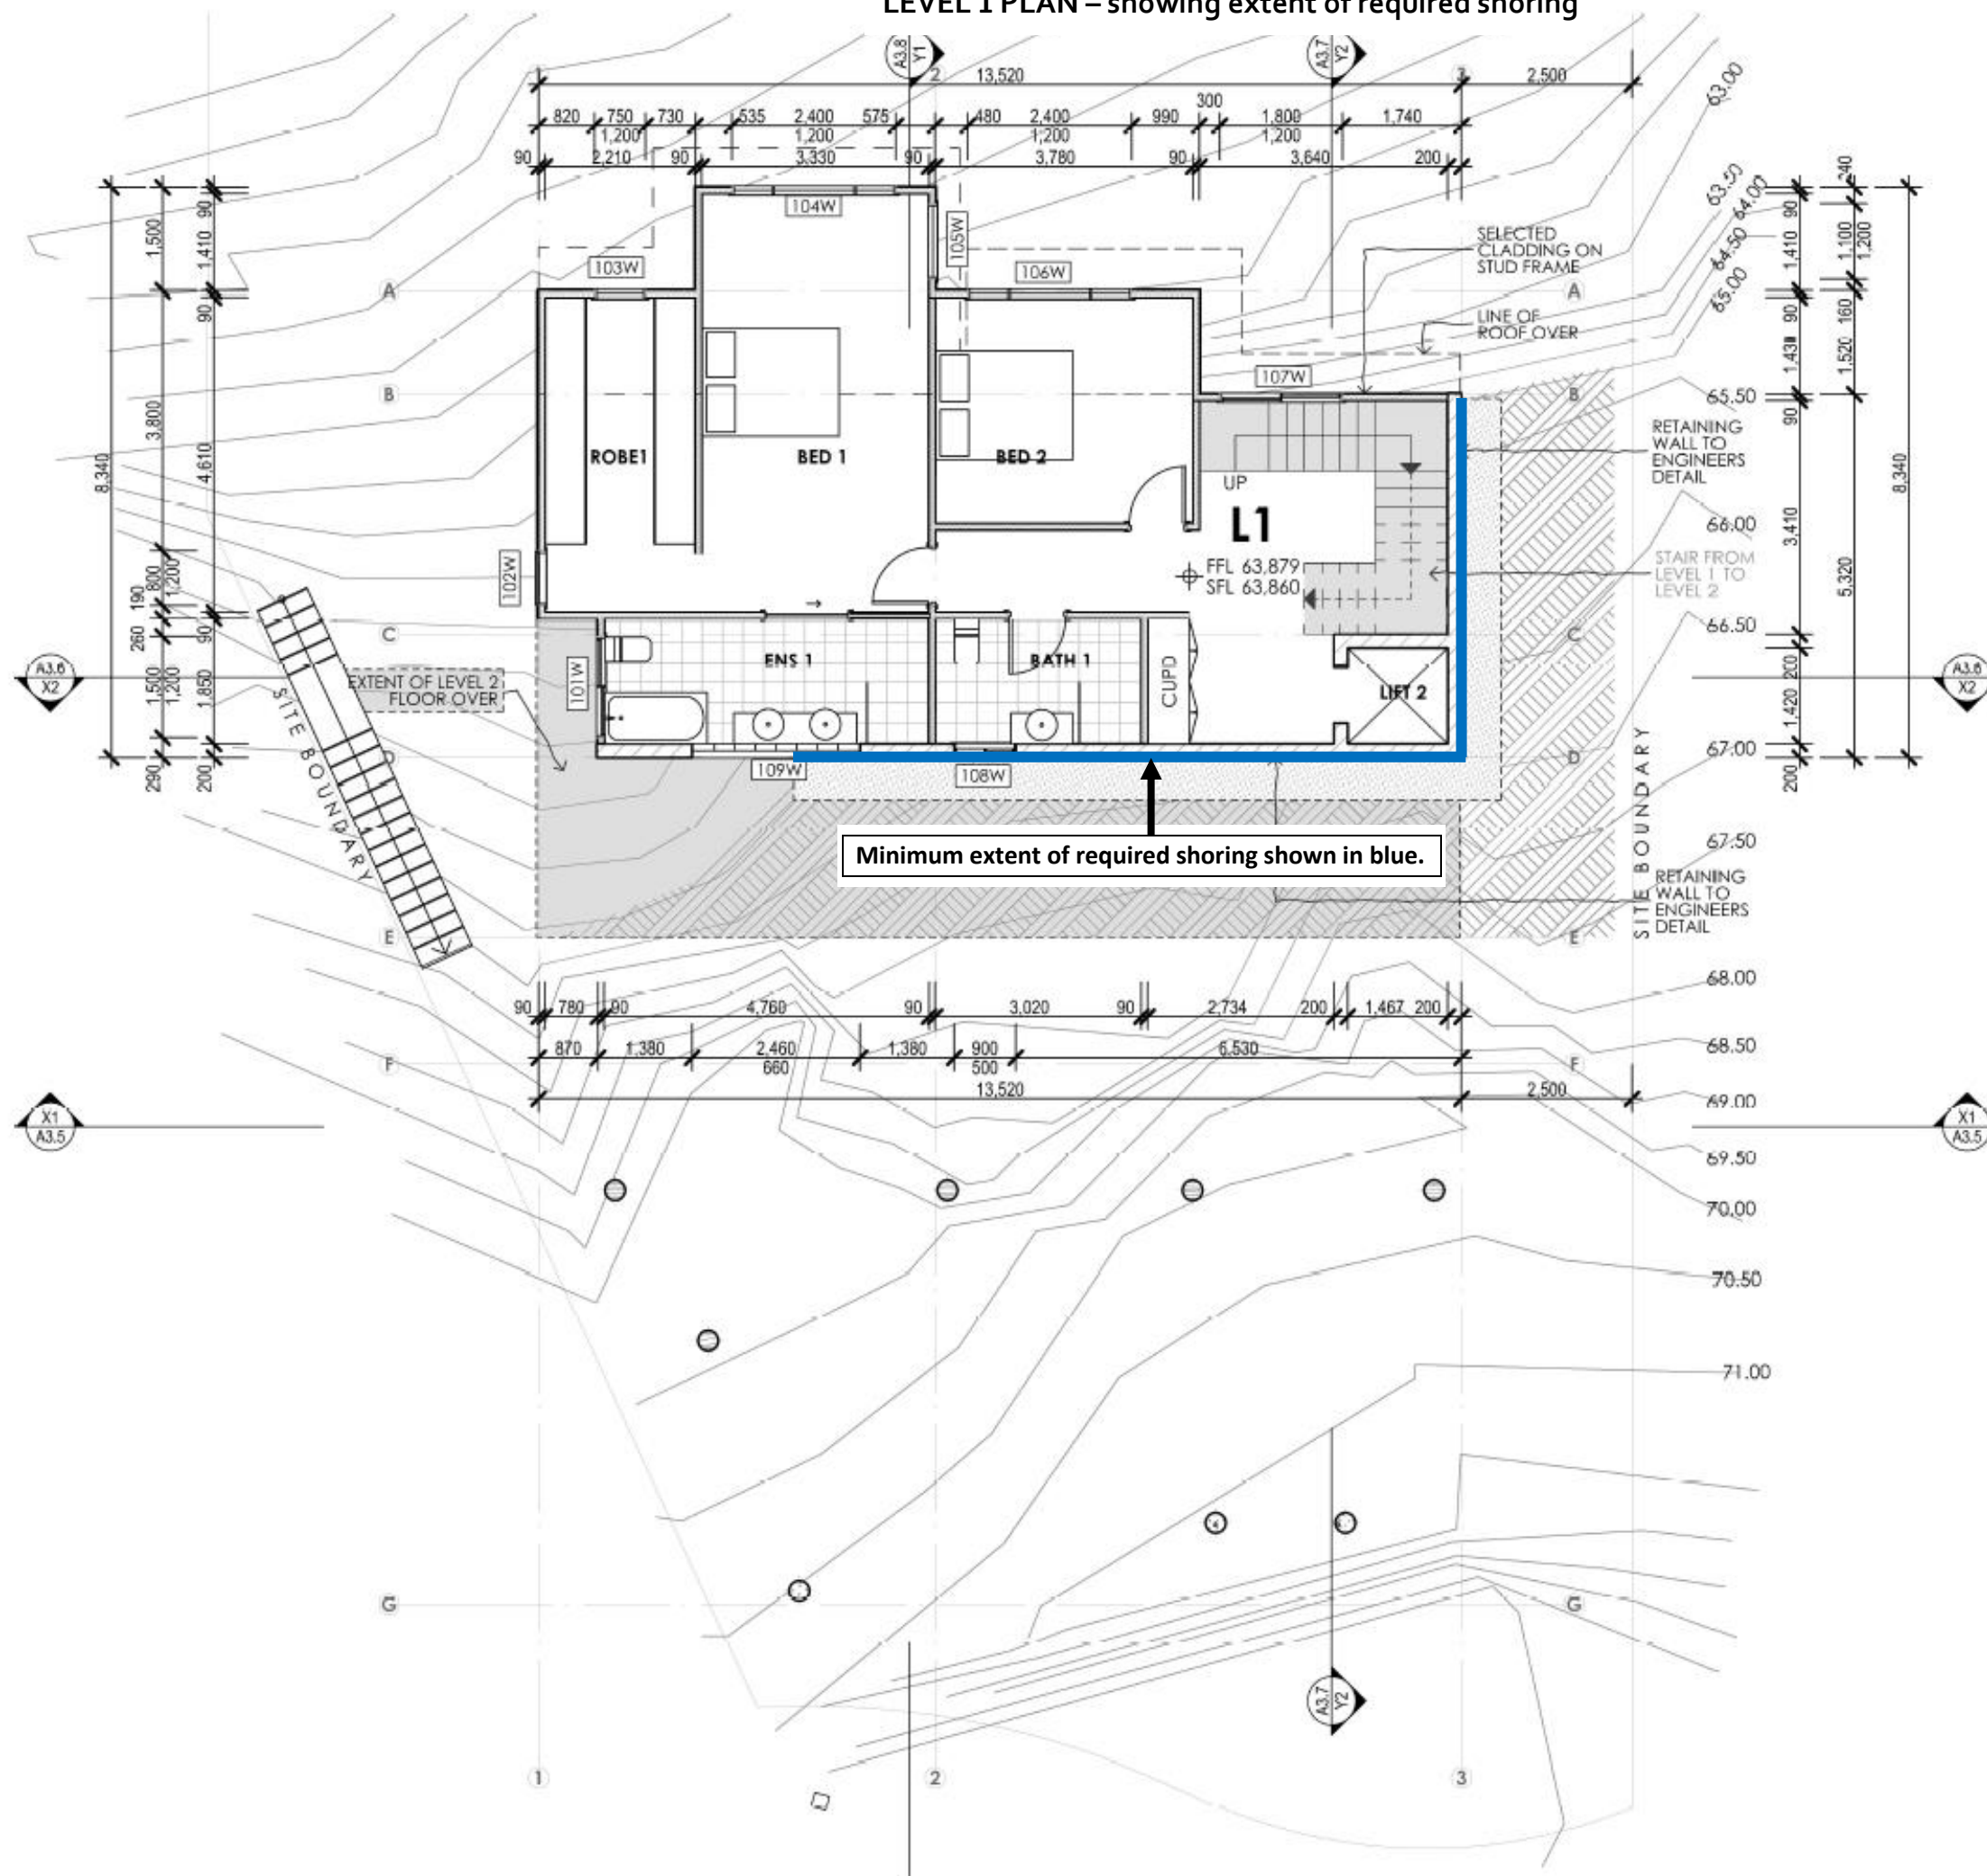
LEVEL 1 PLAN – showing extent of required shoring

The NE common boundary will be within the zone of influence of the Level 1 and 2 portions of the excavation. In this instance, the zone of influence is the area above a theoretical 30° line (from horizontal) through colluvium and a 45° line through clay / weathered rock from the base of the excavation or the top of Medium Strength Rock, whichever comes first, towards the surrounding structures and boundaries.

Due to the steep grade of the slope, the presence of detached sandstone joint blocks across the slope, the depth of the excavation and the proximity of the excavation to the NE common boundary, all sides of the Level 1 and 2 portions of the excavation will require ground support prior to the commencement of the excavation. See the Site Plan attached for the minimum extent of the required shoring shown in blue.

A spaced pile retaining wall is one of the suitable methods of support. Pier spacing is typically ~2.0m but can vary between 1.6 to 2.4m depending on the design. As the excavation is lowered in 1.5m lifts, infill sprayed concrete panels or similar are added between the piers to form the wall. Drainage is to be installed behind the panels. To drill the pier holes for the walls, a pilling rig that can excavate through Medium to High Strength Rock will be required. The piers can be temporarily supported by embedment below the base of the excavation or

with a combination of embedment and propping. The walls are to be tied into the Level 1 and 2 slabs to provide permanent bracing after which any temporary bracing can be released.
