Arborist Impact Assessment

Proposed Development

40 Myoora Road, Terrey Hills, NSW

September 2024

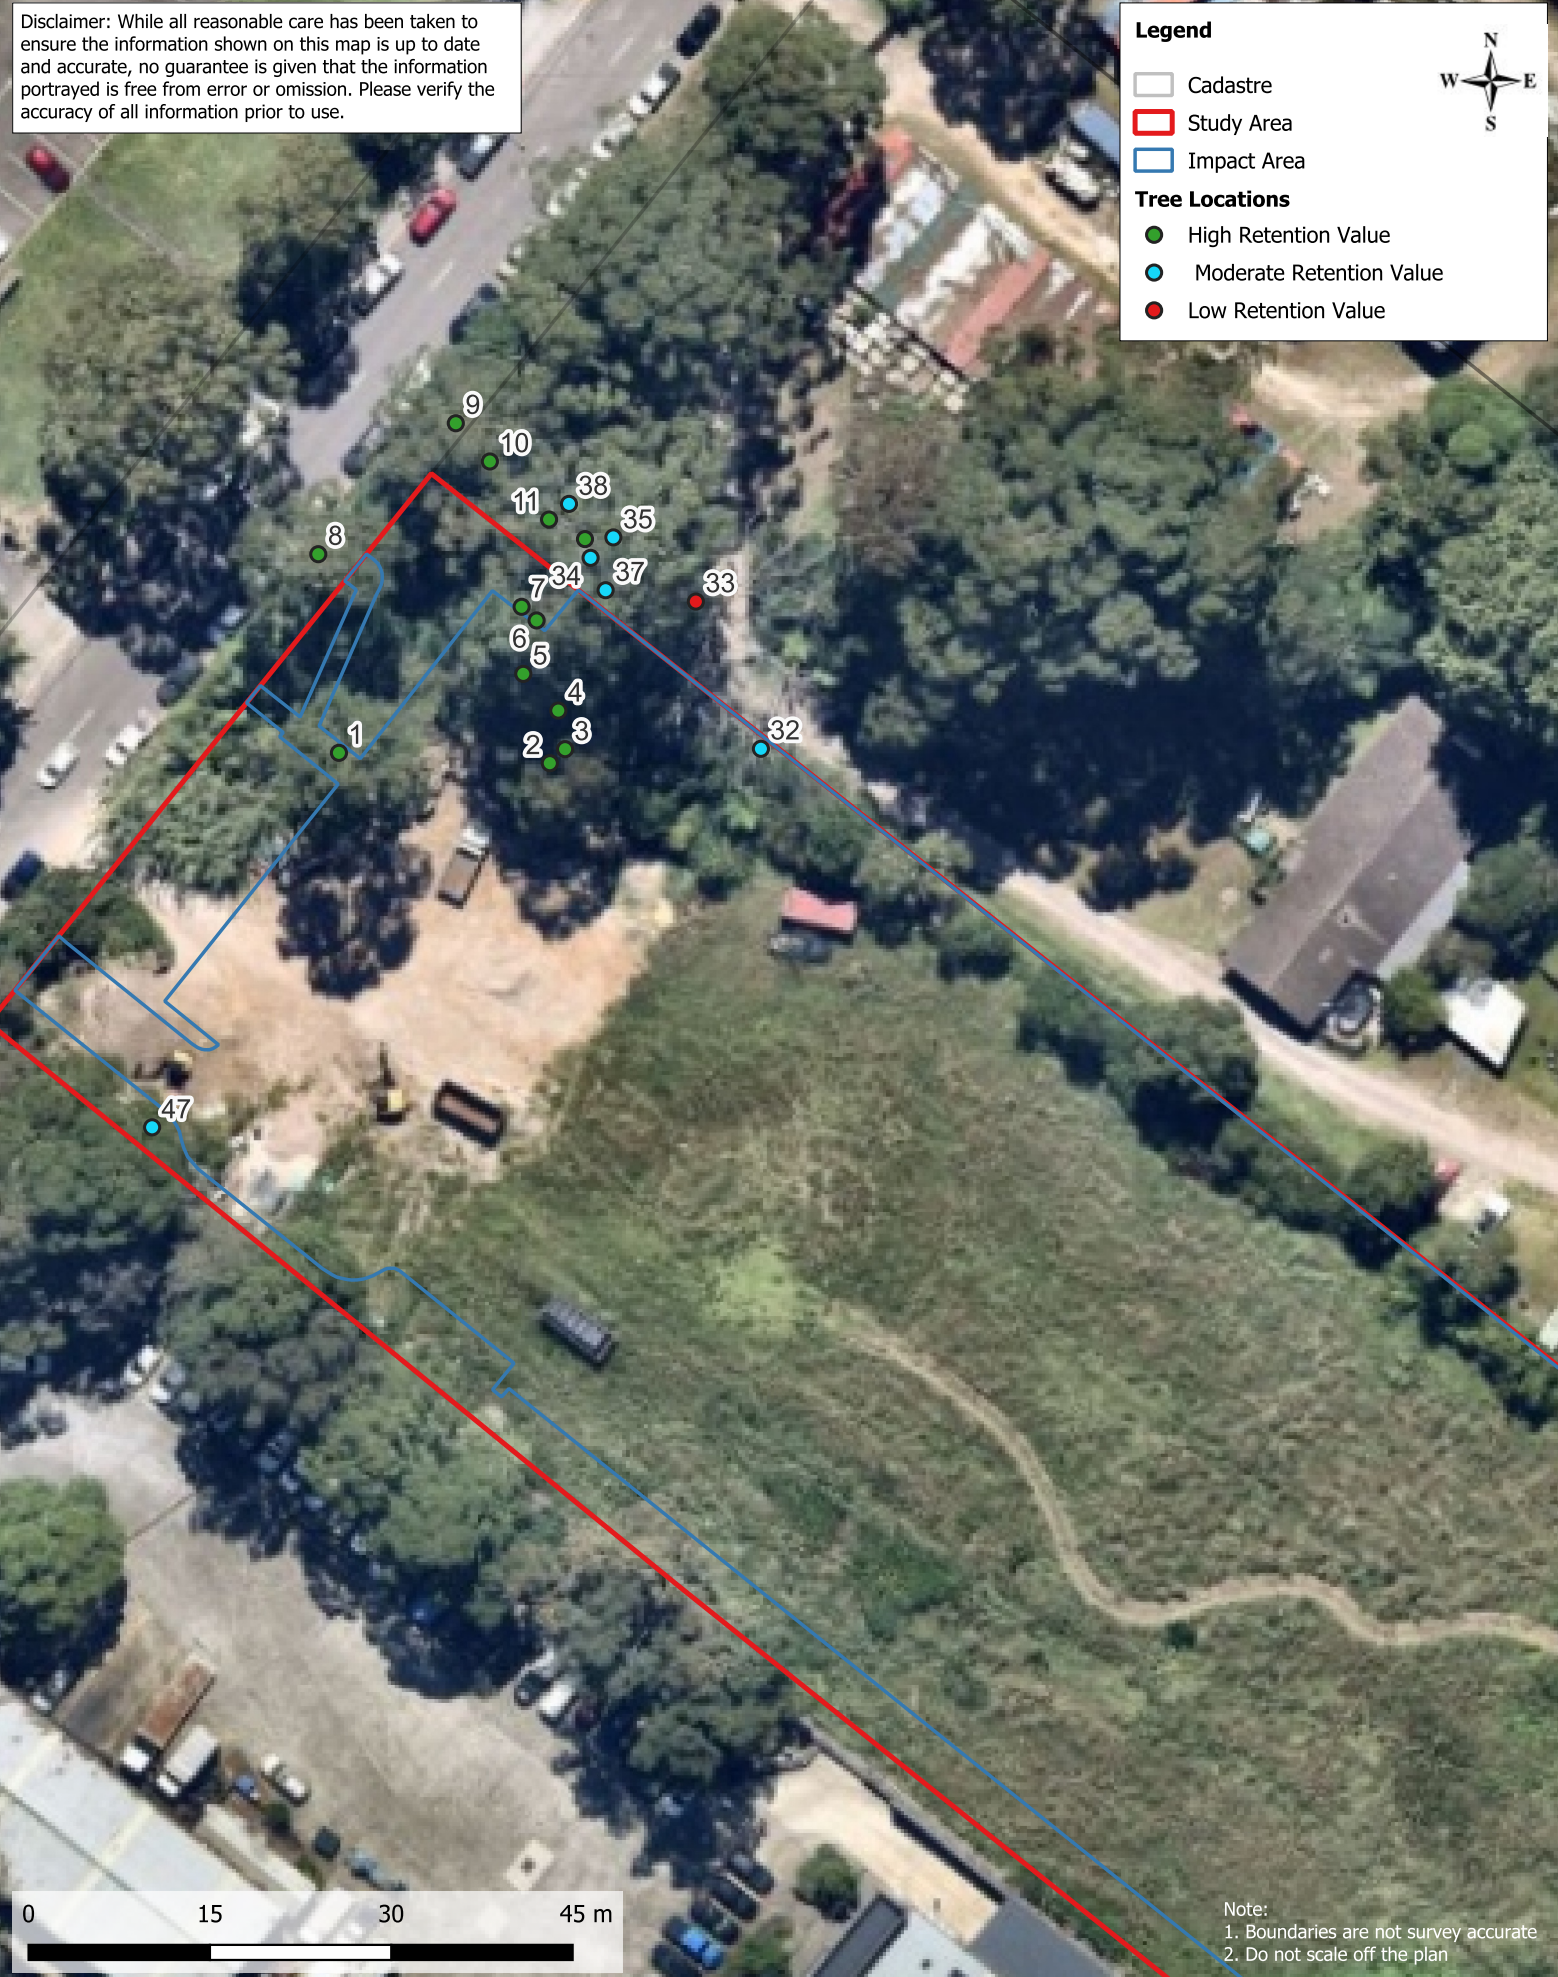
Figure 3 - Tree Location (West)
Location: 40 Myoora Road, Terrey Hills, NSW
Client: H & E Architects

A total of 24 trees identified within the site and neighbouring properties were assessed. Observations were made for each assessed tree (**Appendix A**). Tree locations are shown in **Figures 3**.

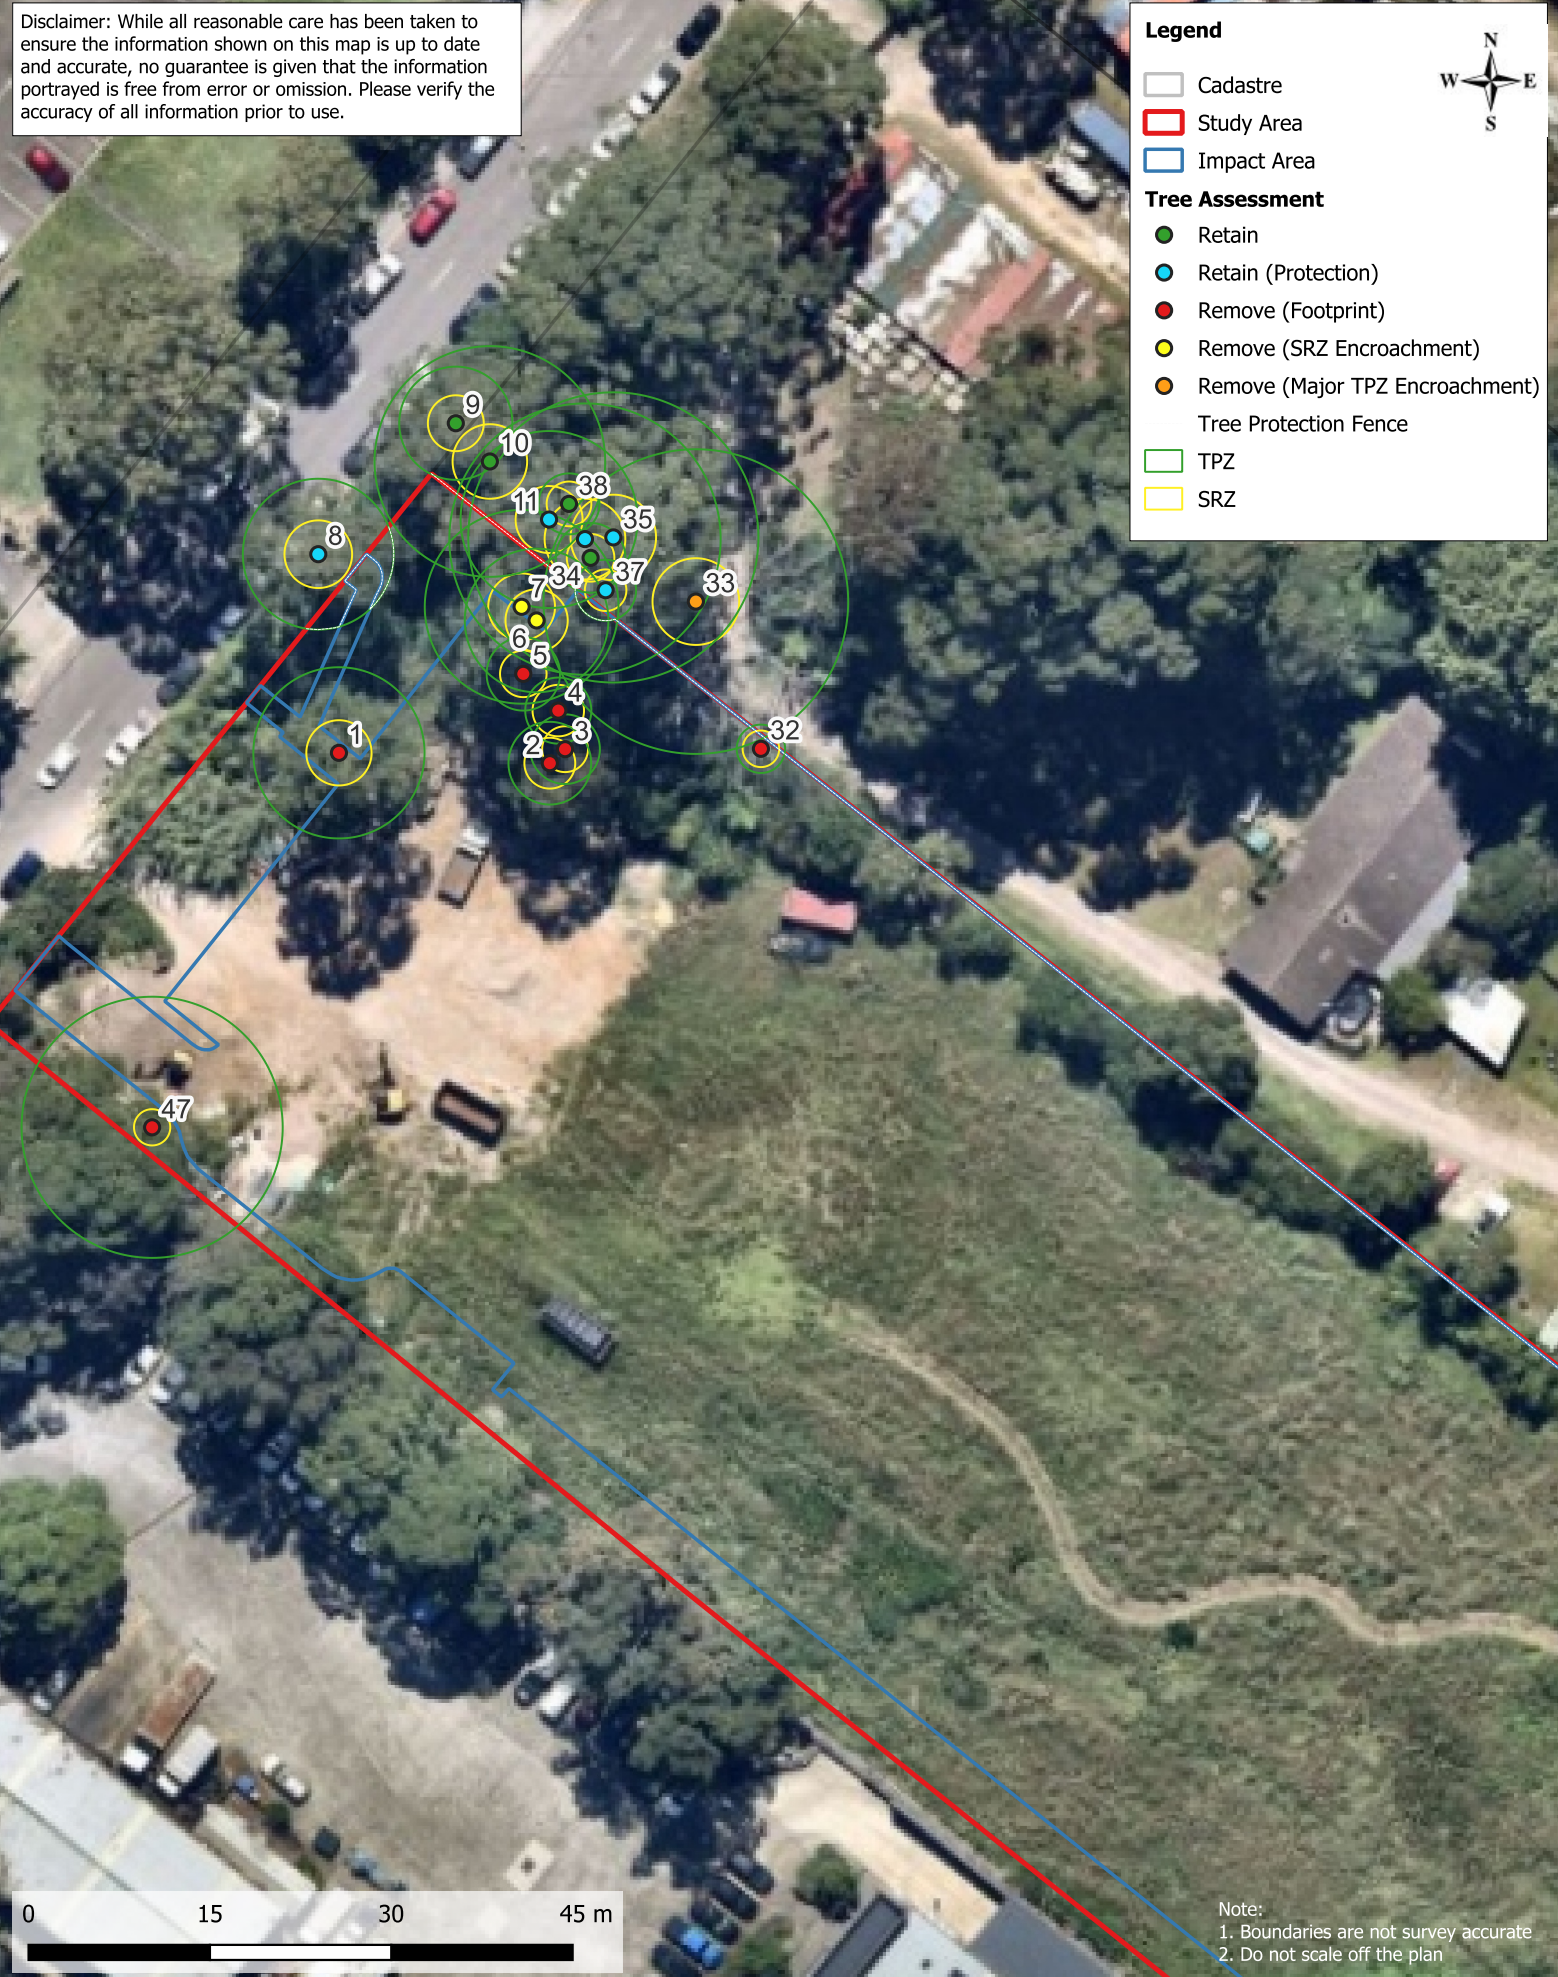
Figure 5 - Tree Assessment (West)

Upon review of the supplied proposal footprint, nine (9) trees will require removal as they are located within the development footprint. These include:

- Five (5) High (Trees 1, 2, 3, 4, 5)
- Three (3) Moderate (Trees 24, 32, 47); and
- One (1) Low Retention Value Trees (Tree 15).

Upon review of the supplied proposal footprint, two (2) trees will require removal as these trees will be impacted by predicted structural root zone encroachment. These include:

- Two (2) High (Trees 6, 7).

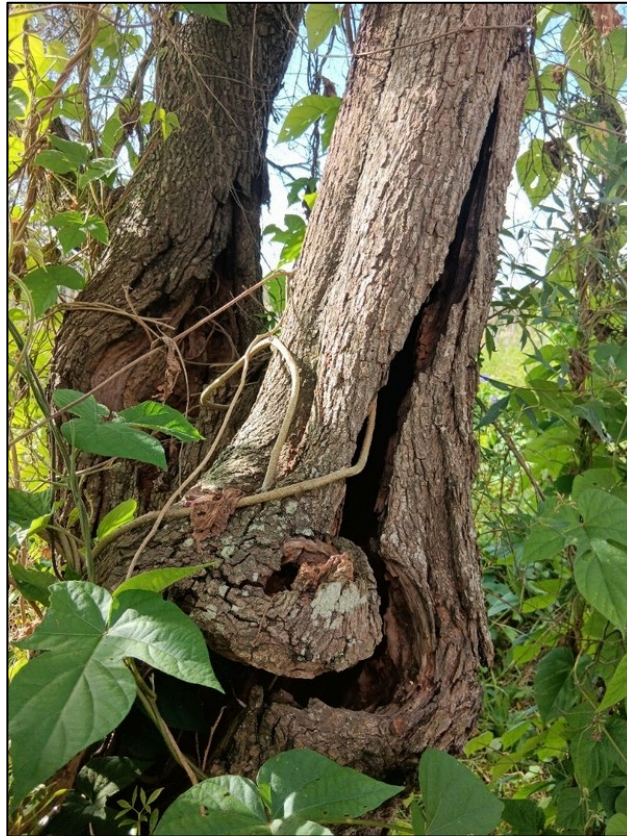
- Tree 15 – *Ceratopetalum gummiferum* (NSW Christmas Bush) has two co-dominate leaders with large cracks and fractures below at the base. A small hollow was also located at the base. The twisted form individual contains multiple dead branches and has the canopy crossing and/or rubbing with other nearby trees;
- Tree 18 – *Eucalyptus cinera* (Argyle Apple) has a twisted form. The overall canopy health of the individual display's poor health; and
- Tree 33 – *Eucalyptus grandis* (Flooded Gum) is an overmature individual with abundant deadwood and an asymmetric crown.

Small hollows were located in Tree 15. A hollow bearing tree (HBT) survey has been completed as part of the EAR for this site.

Plate 1 Below: Tree 15 – *Ceratopetalum gummiferum* cracks along the stem

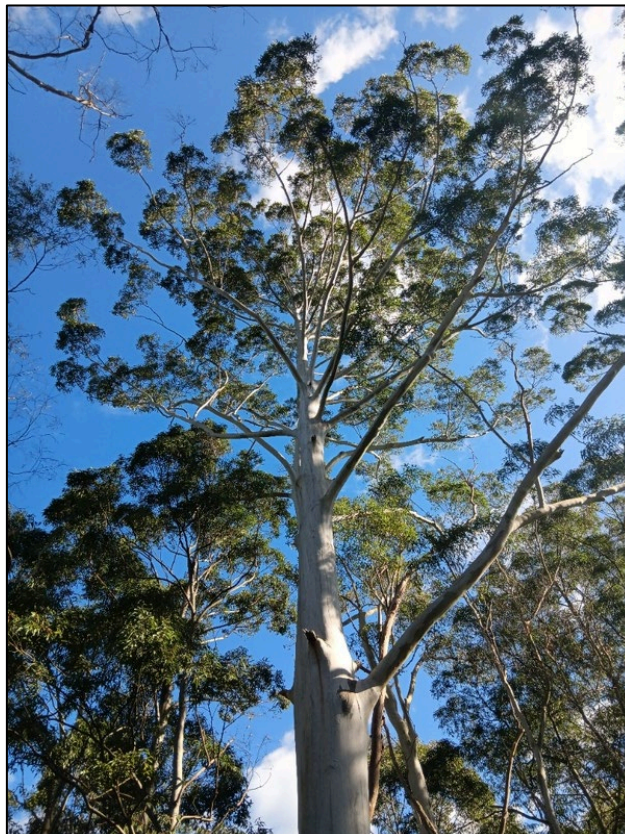
Plate 2 Above: Tree 35 – *Eucalyptus grandis* with evidence of previous failures.

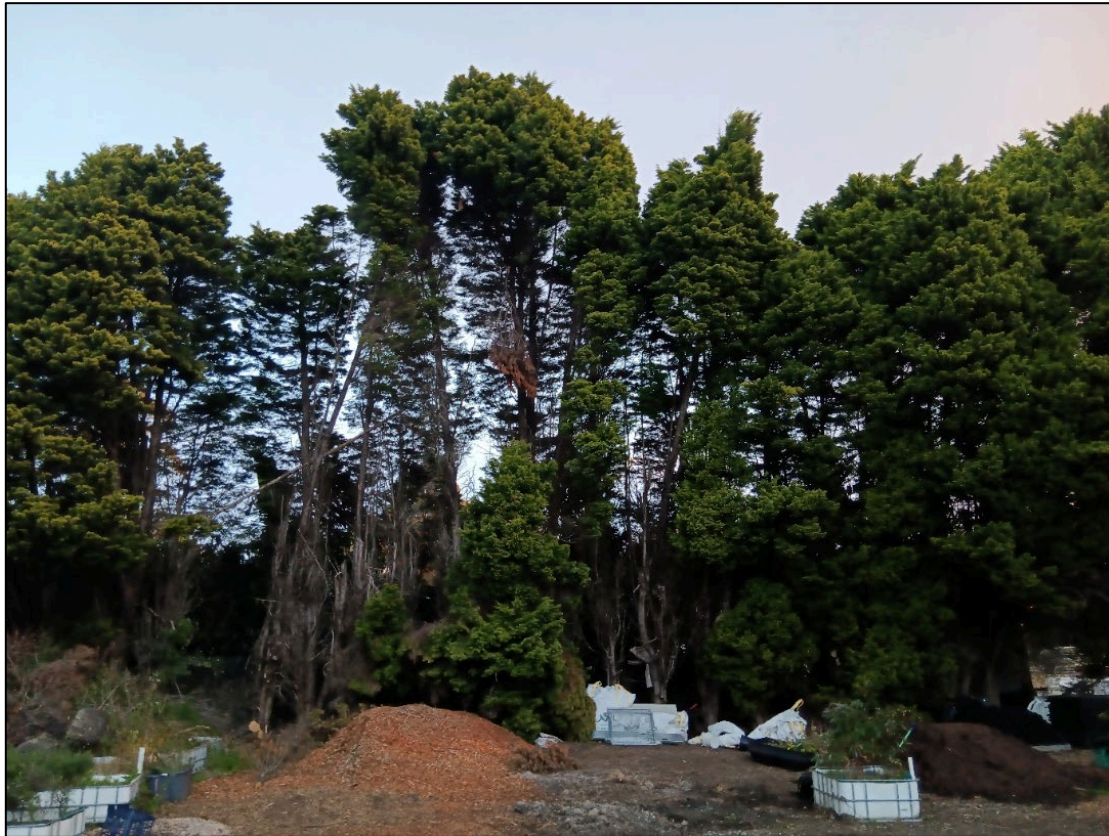
- Stand 1 has approximately 18 *Cupresses sp.* individuals that have an average DBH of 0.31m in overall Fair condition.

Plate 3 Below: Stand 1 – *Cupresses sp.* facing north-west.
