GEOTECHNICAL REPORT

**PROPOSED
NEW RESIDENTIAL DEVELOPMENT**

6 MITCHELL ROAD, PALM BEACH

Project No: 2018-145

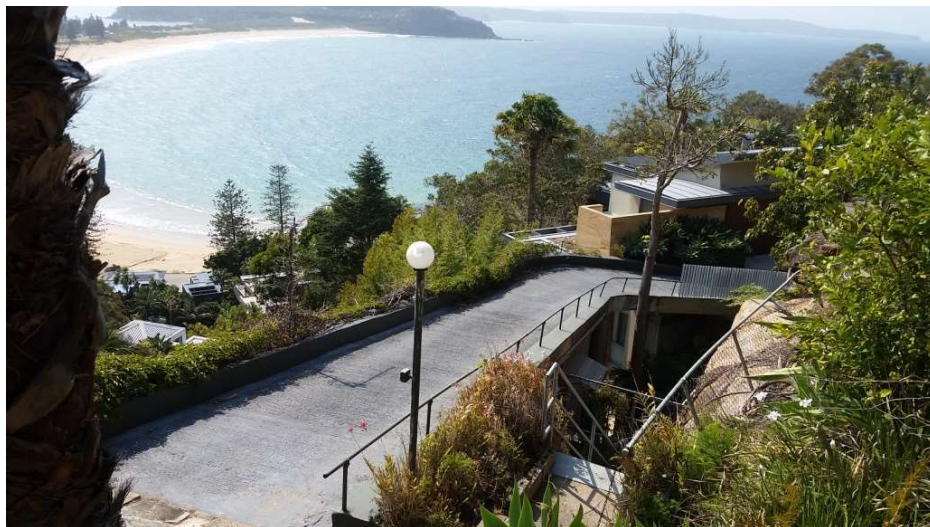
Photograph 2: View of the front of the site, looking north.

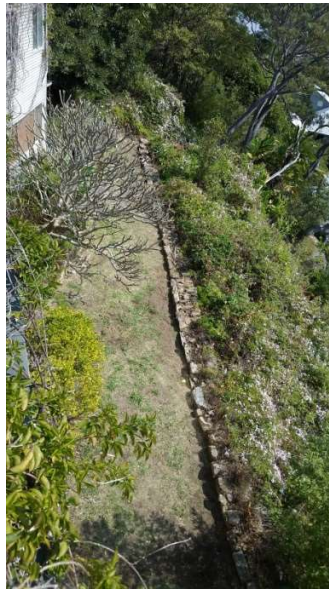
Photograph 3: View of the rear of site, looking west from the driveway directly above dwelling.

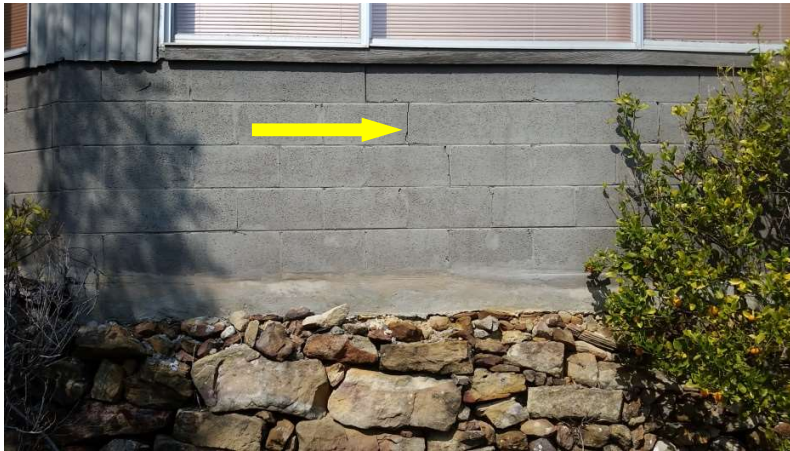
The existing site building comprises a metal and concrete block structure that appears to be in satisfactory condition with some minor cracking observed at the base of the rear wall, see Photograph 4. The cause of the cracking observed is unknown however it may be due to settlement of the underlying dry stack rock wall.

Photograph 4: Cracking observed in the lower section of the rear wall.

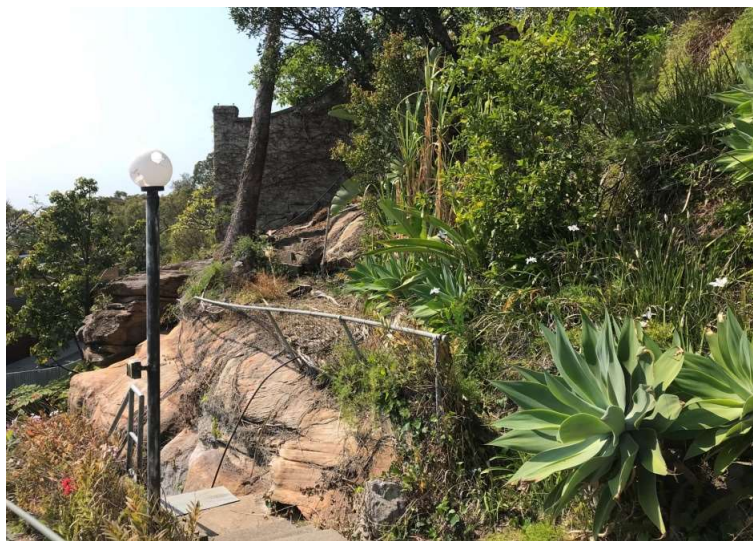
The existing dwelling is accessed via a set of stairs on the south side of the access driveway. A bedrock exposure forms a cliff to the south of the stairs which trends east-west and is formed via a continuous, planar sub-vertical joint defect. The cliff exposes low to medium strength sandstone bedrock and is convex at its crest rising up into the neighbouring properties to the south. Potential signs of previous surface slope movement were observed above the cliff crest including rotating trees and failing fence structures (see Photograph 5) however it was difficult to identify a mechanism for this distress and it may be related to surface creep rather than a deep seated stability issue.

Photograph 5: View of sandstone outcrops above cliff, looking east.

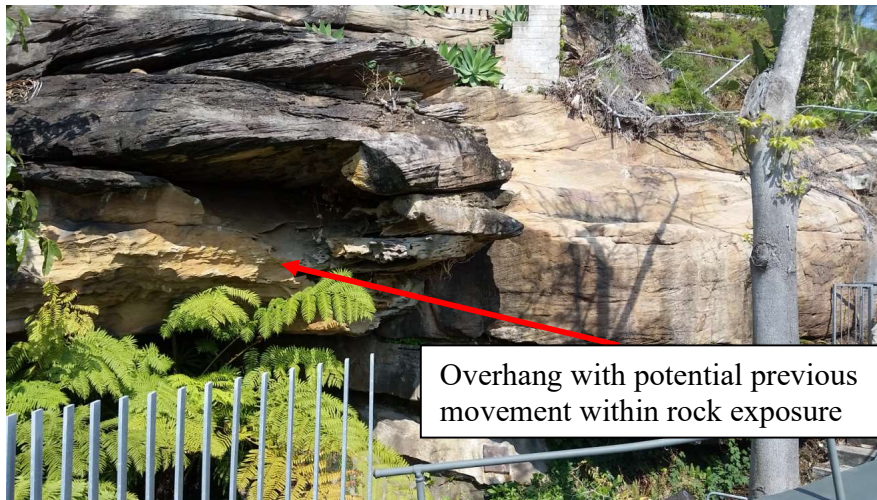
The neighbouring property to the east, No.7 Mitchell Road, comprises a multi-storey rendered residential house that appears less than 20 years old and in good condition. The property is located above the cliff line to the south of the driveway within No.15 Florida Road, with extensive outcrops at its rear extending down to the cliff crest. Within the rear north-west corner of this property the cliff line contains a large overhang structure formed by differential weathering of a lower weaker unit within the cliff geology. This overhang is shown in Photographs 6 and 7.

Photograph 6: View of overhanging sandstone outcrops in No. 7, looking south.

The overhang within No.7 Mitchell Road appears globally stable at present though detailed mapping is not possible without approval of the neighbouring property owner. Based on the location of the overhang and its apparent direction of travel due to failure it is considered a hazard to the site. The scale of the overhang indicates that the risk of instability may need to be mitigated through construction of a support structure, though this would require construction within the neighbouring property. As such discussion with the neighbouring property owner is required.

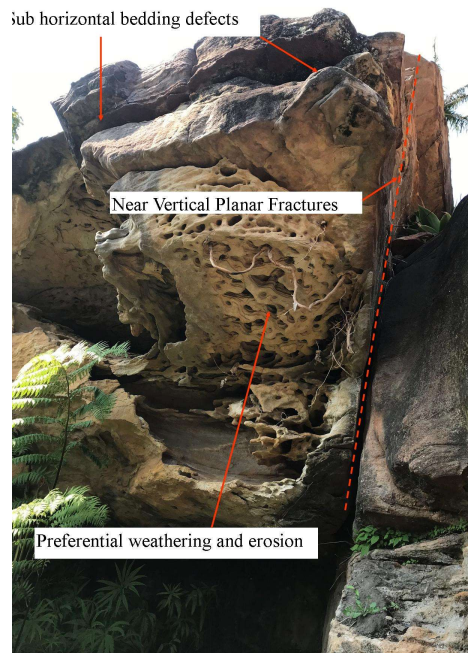
Photograph 7: Horizontal bedding defects, near vertical fractures within the south of the site.

Weathering will continue to increase the overhang dimensions and will result in detachment of the blocks adjacent to the boundary, on the underside of the overhang as shown in Photograph: 7. Whilst relatively small these blocks are expected to create a hazard for the site.

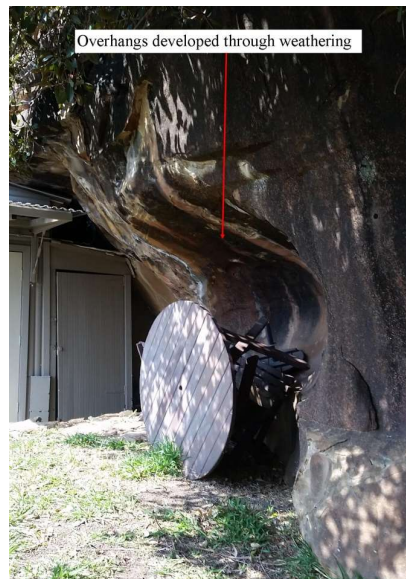
Photograph 8: Overhang/undercutting within the site.

Within the area to the west of the existing site structure, concave undercutting was observed as indicated in Photograph 8. It appears that preferential weathering of the rock mass is occurring and resulting in the concave features indicated in Photograph 8. This has resulted in overhang in the upper sandstone unit that extends over the existing site house, (Photograph 9).

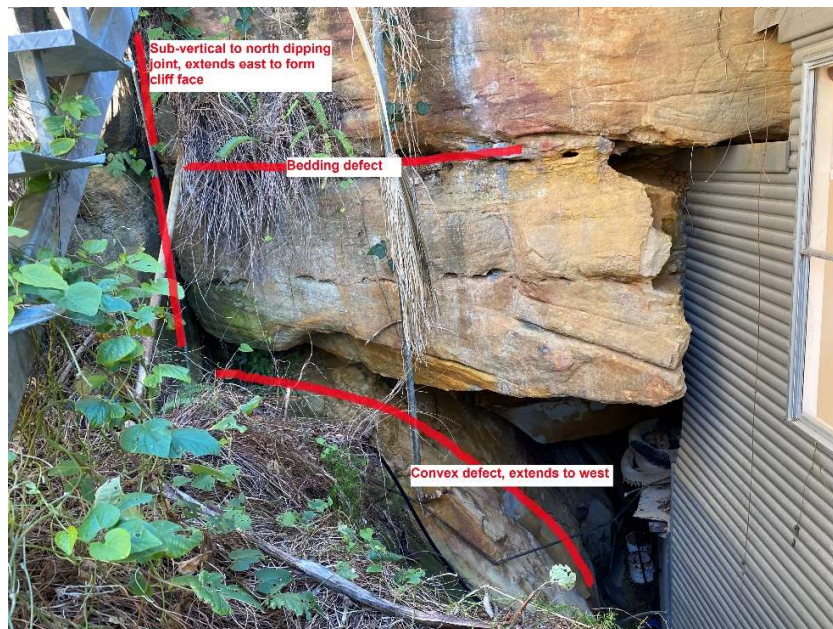
Photograph 9: Defects within bedrock and overhang/undercutting at south-west corner of existing house.

The overhang and curved defect adjacent to the west end of the existing site house also requires additional inspection and it appears that it will require stability measures due to the proposed house excavation. The proposed excavation for the new house structure appears to create a potential for undermining of the lower block of sandstone that is supporting the overlying rock units and overhang. This area should be geotechnically re-inspected following demolition of the existing house and prior to any excavation or construction as this will provide for better inspection and support installation.

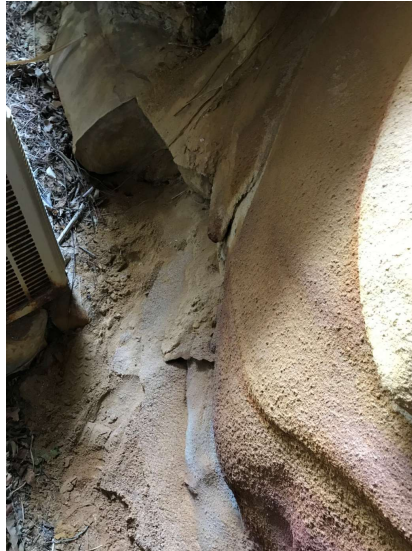
Areas of exposed bedrock which appeared susceptible to erosion were also observed to the south of the site structure and accumulation of eroded sandstone was observed at the toe of the exposure (Photograph 10).

Photograph 10: Accumulation of eroded sandstone to the south of the site structure

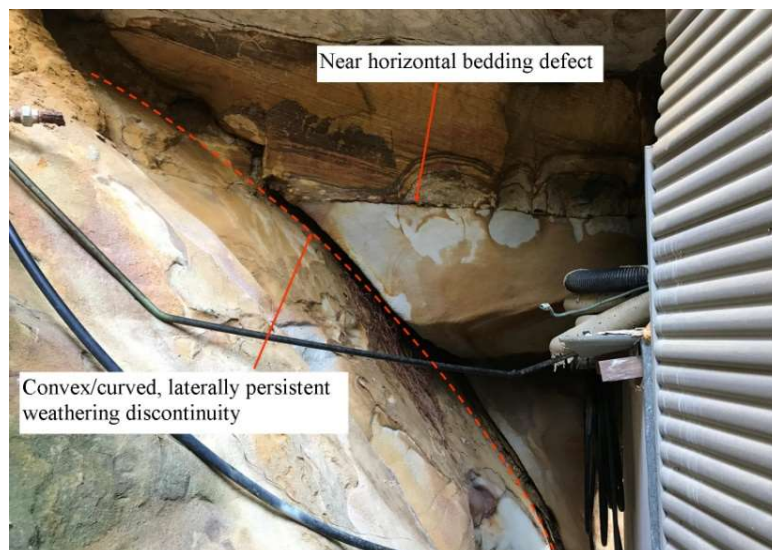
To the south of the site structure, a convex defect was observed in the cliff which appeared to be laterally persistent and trended generally west/east (Photograph 11) through to the sites western side boundary through the lower portion of the cliff exposure. Groundwater was also observed on this defect plane further to the west and within the site. This defect has resulted in separation of the rock to the west of the house at the base of the cliff whilst sub-parallel defects through the units above have also separated those sections (as per Photograph 9).

Photograph 11: convex defects to the rear of the existing site structure.

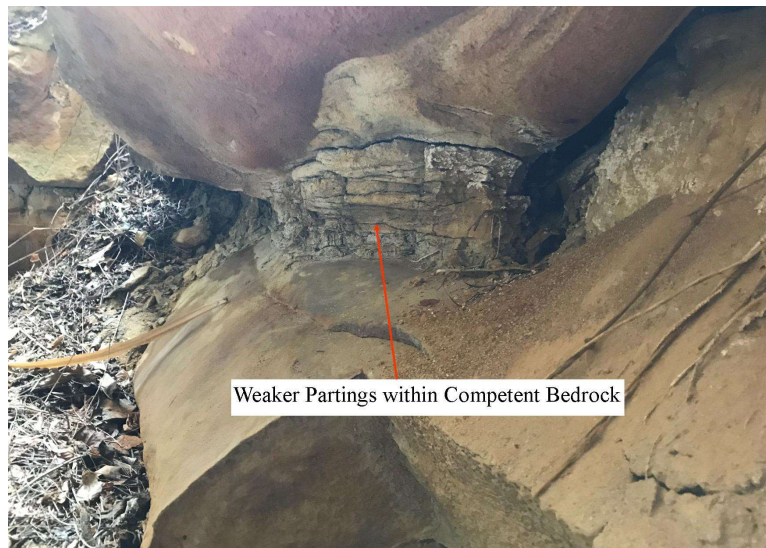
Photograph 12: Weak zones within bedrock

Bedding defects were also observed within otherwise competent sandstone with weaker seams/partings of clay as a result of less competent rock material also encountered, see Photograph: 12.
