## **GEOTECHNICAL INVESTIGATION:**

### **New House and Pool at 23 Acacia Street, Collaroy Plateau**

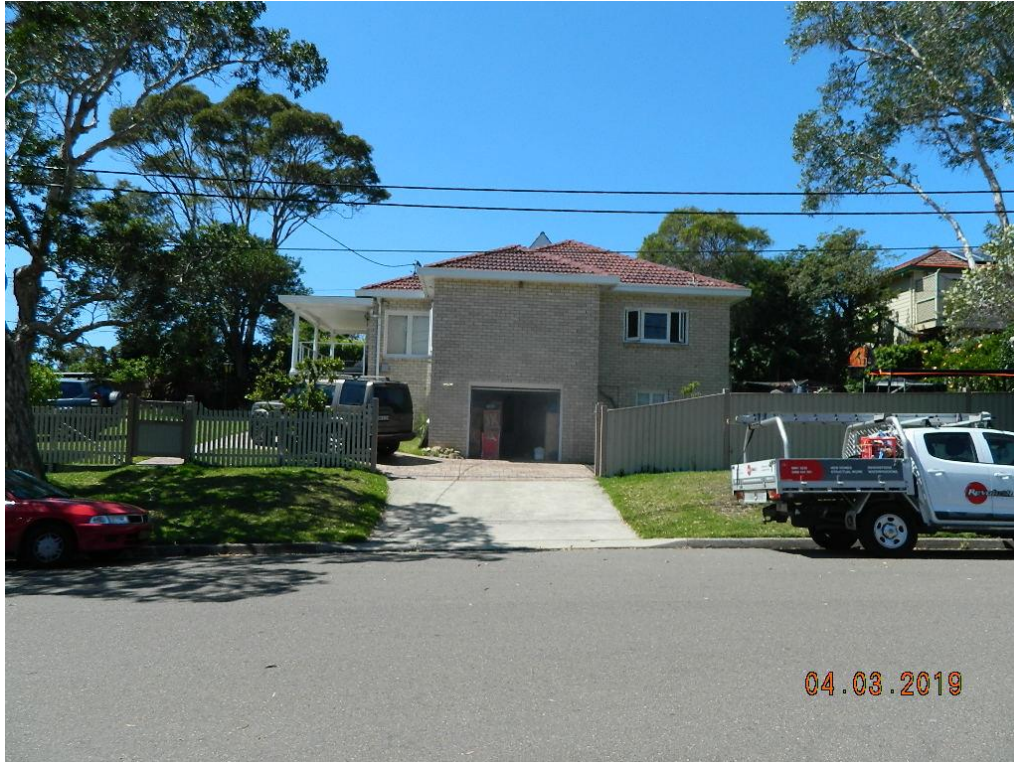
Photo 1

- 2.3** At the road frontage of Essilia Street, a concrete driveway runs to a single garage under the downhill side of the house (Photo 1). The majority of the part two storey brick house will be demolished as part of the proposed works (Photo 3). A gently sloping lawn area extends from the uphill boundary to the property frontages on either side of the house (Photos 4 & 5). No significant signs of movement were observed on the property. No geotechnical hazards that could impact on the subject

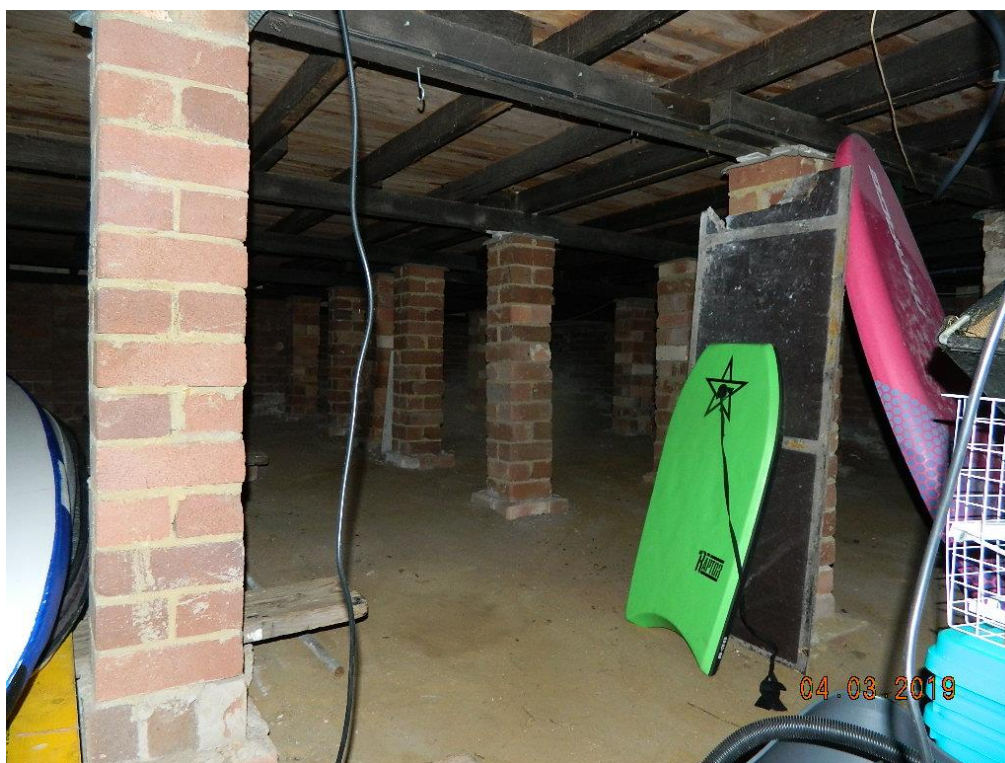
Photo 4

| HAZARDS | Hazard One | Hazard Two | Hazard Three |
|---|--|--|--|
| TYPE | The vibrations from the proposed excavations impacting the existing house walls and neighbouring house to the E. | The proposed excavations undercutting the E common boundary impacting on the E neighbouring property (Photos 8). | The proposed excavation for the house footings of the subject house causing failure of the supporting house walls. (Photo 4). |

We think it likely the footings of the subject house are supported on sand. This is to be confirmed with small pits dug by the builder beside the structures to expose the footing material. Upon completion, the pits are to be inspected by the geotechnical consultant to confirm the footing material. If these structures are founded on Medium Strength Sandstone no additional support is required. If any of the structures are not founded on Medium Strength Sandstone and are within the zone of influence of the excavation they are to be underpinned to Medium Strength Sandstone. In this instance the zone of influence is the area above a theoretical 30° line through sand and soil from the top of Medium Strength Sandstone towards the surrounding structures or boundaries.

If underpinning is required, it is to follow an underpinning sequence as specified by the structural engineer. In no circumstances is the bulk excavation to be taken to the edge of the house wall or footing and then underpinned. The underpins are to be carried out in drives

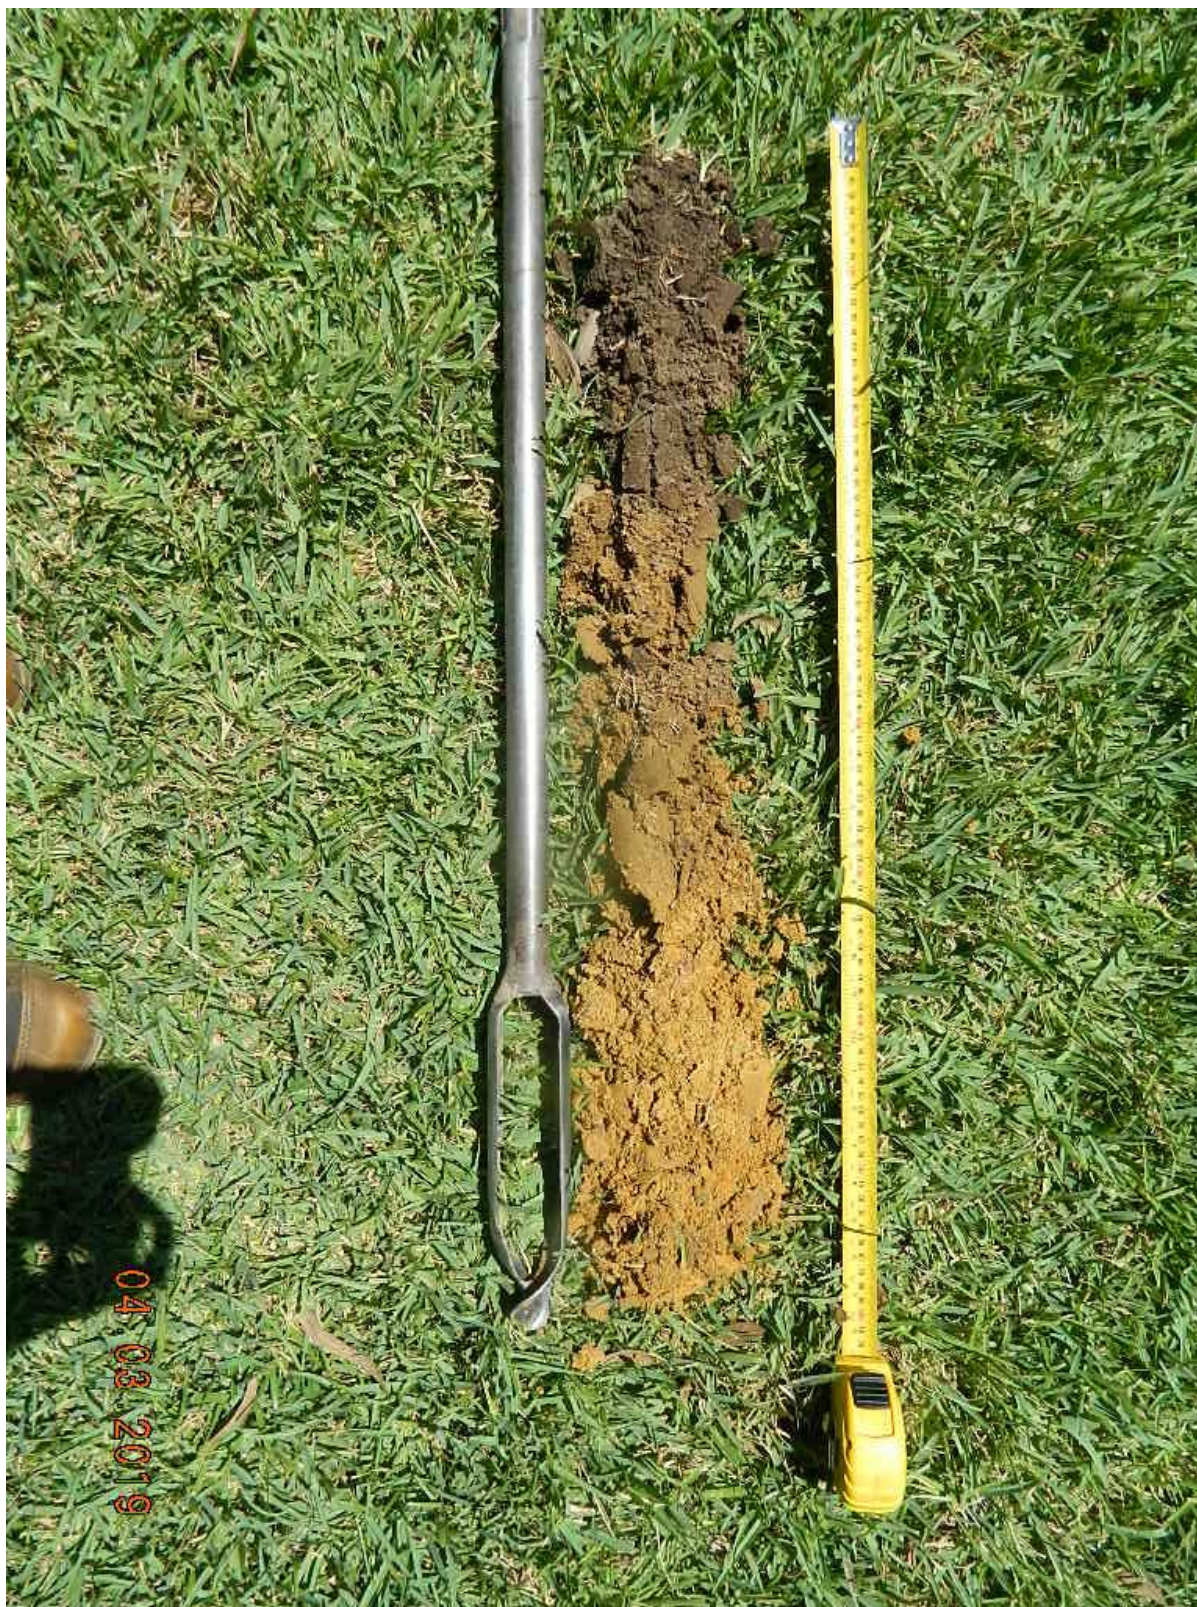
#### AUGER HOLE 1 (~RL96.5) – AH1 (Photo 9)

End of hole @ 0.8m in silty sand, auger refusing on hard surface. No watertable encountered.

Photo 9: Auger Hole 1, Base of hole at base of image.

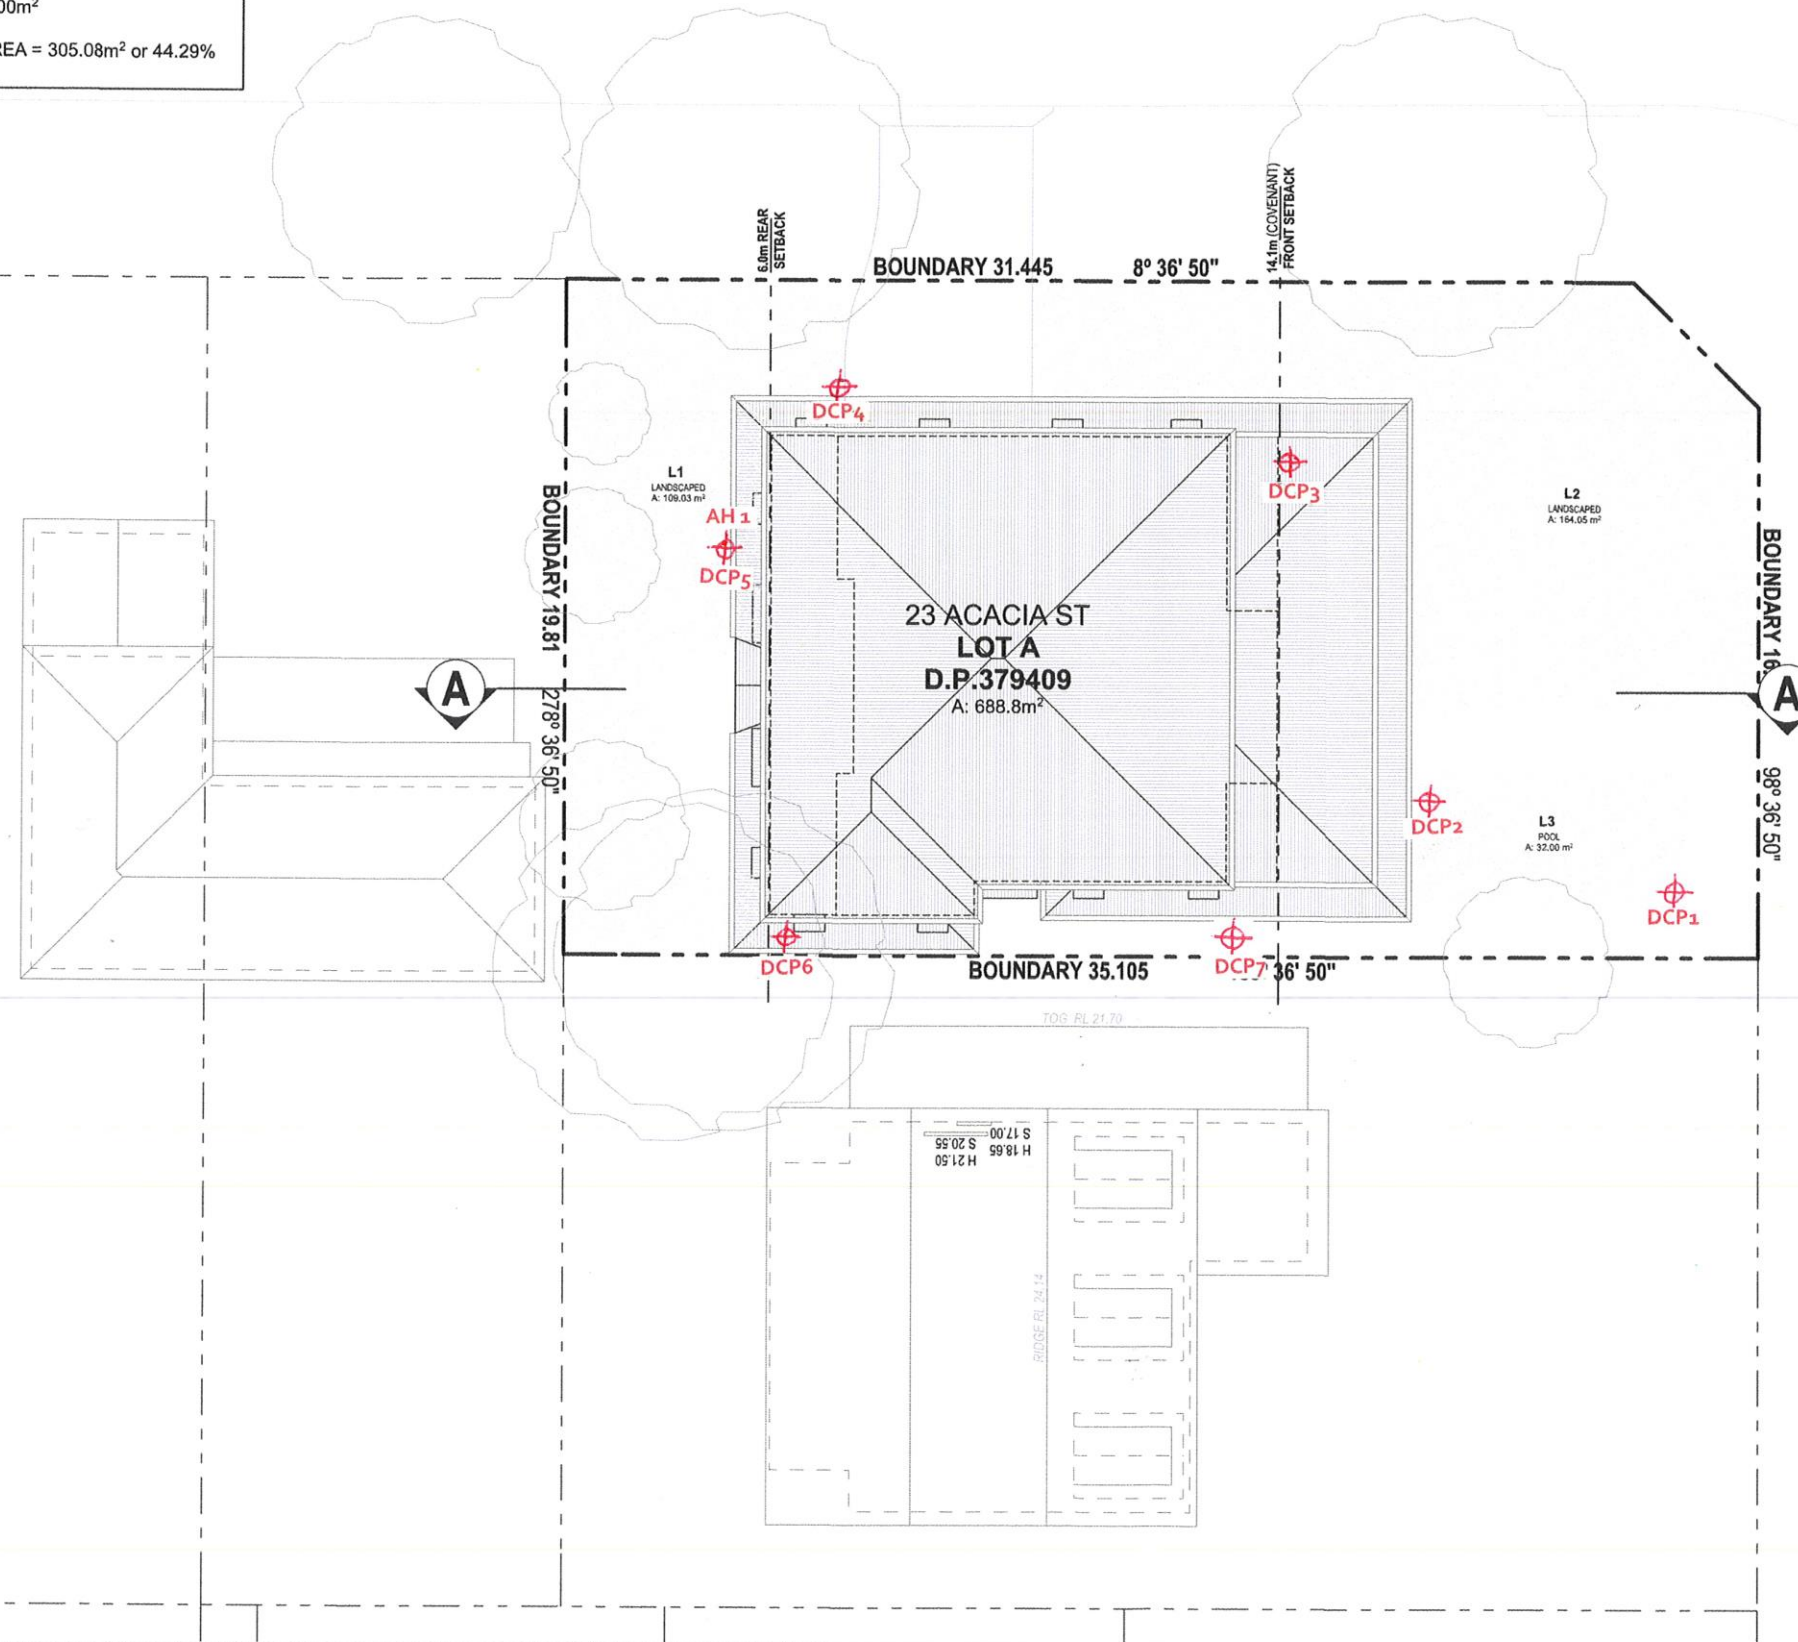
## SITE PLAN – showing test locations

One Hand Auger Hole (AH) was put down to identify the ground materials. Seven Dynamic Cone Penetrometer (DCP) tests were put down to determine the relative density of the overlying soil and the depth to bedrock. The locations of the tests are shown on the site plan. It should be noted that a level of caution should be applied when interpreting DCP test results. The test will not pass through hard buried objects so in some instances it can be difficult to determine whether refusal has occurred on an obstruction in the profile or on the natural rock surface. This is not expected to be an issue for the testing on this site and the results are as follows:

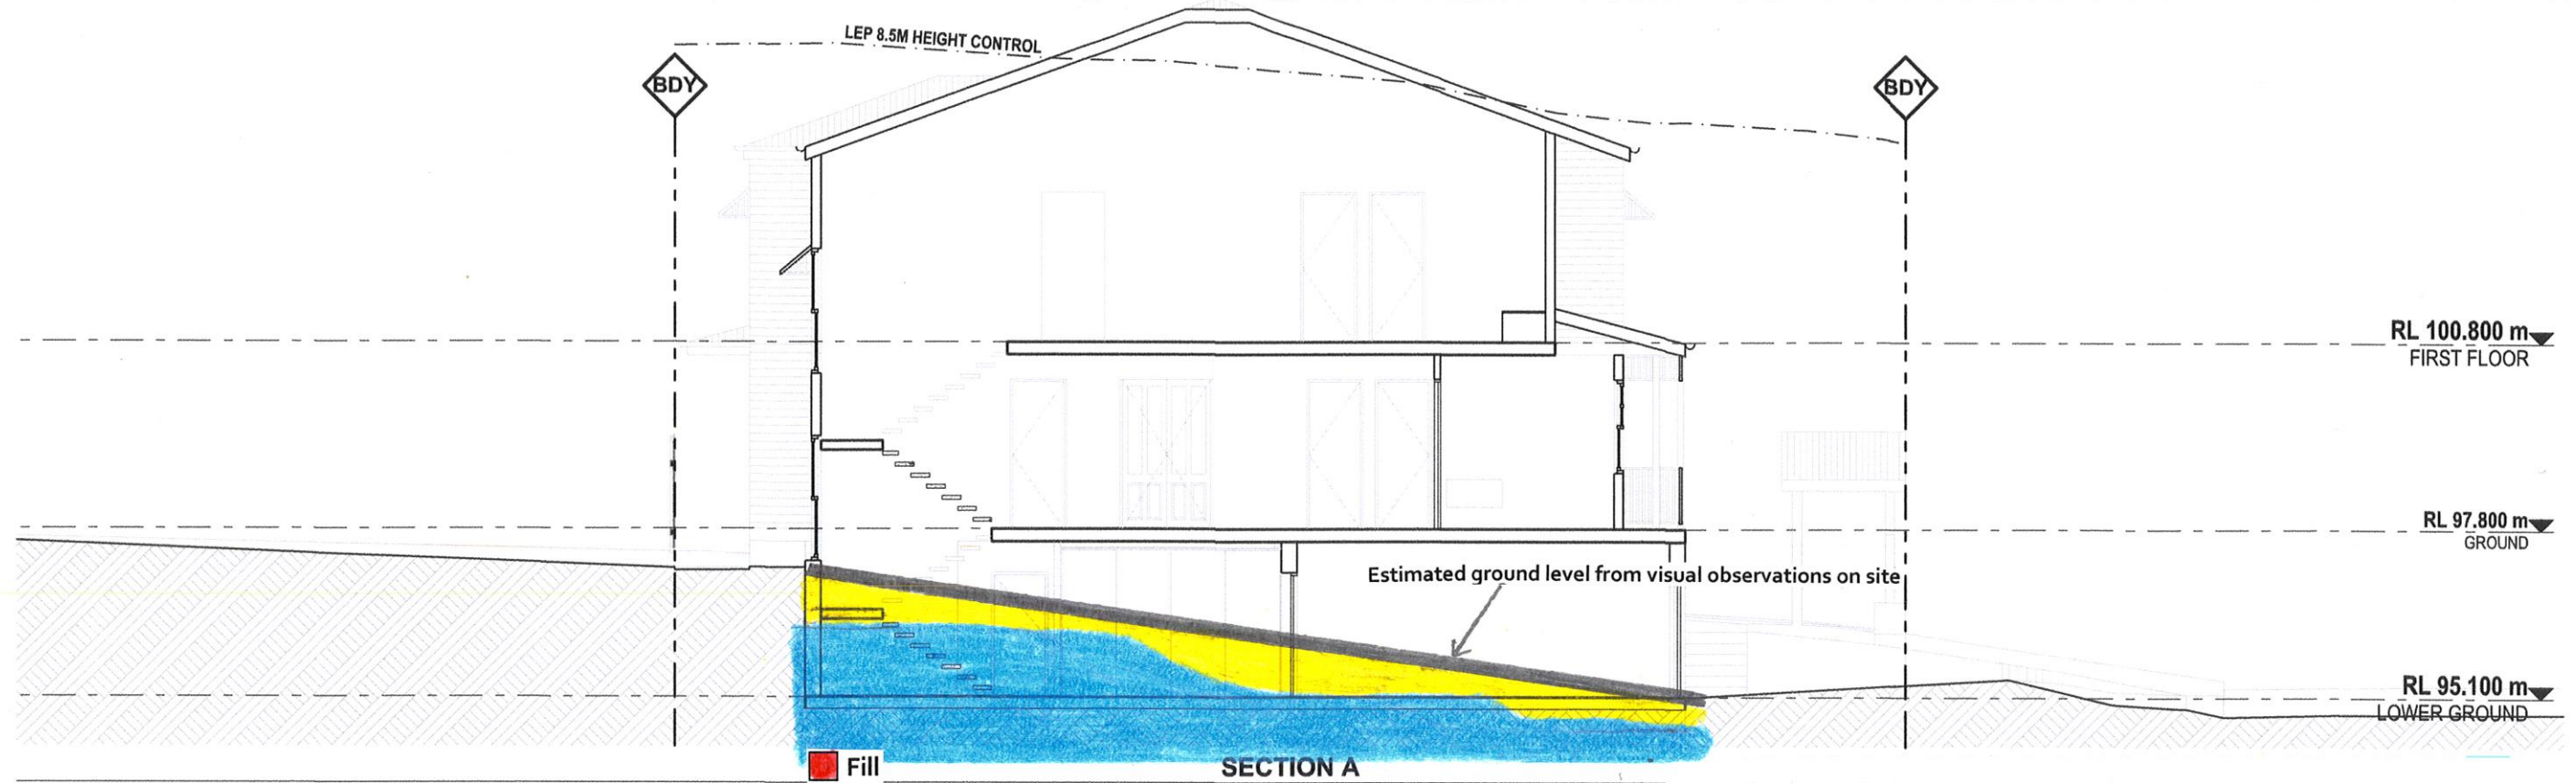
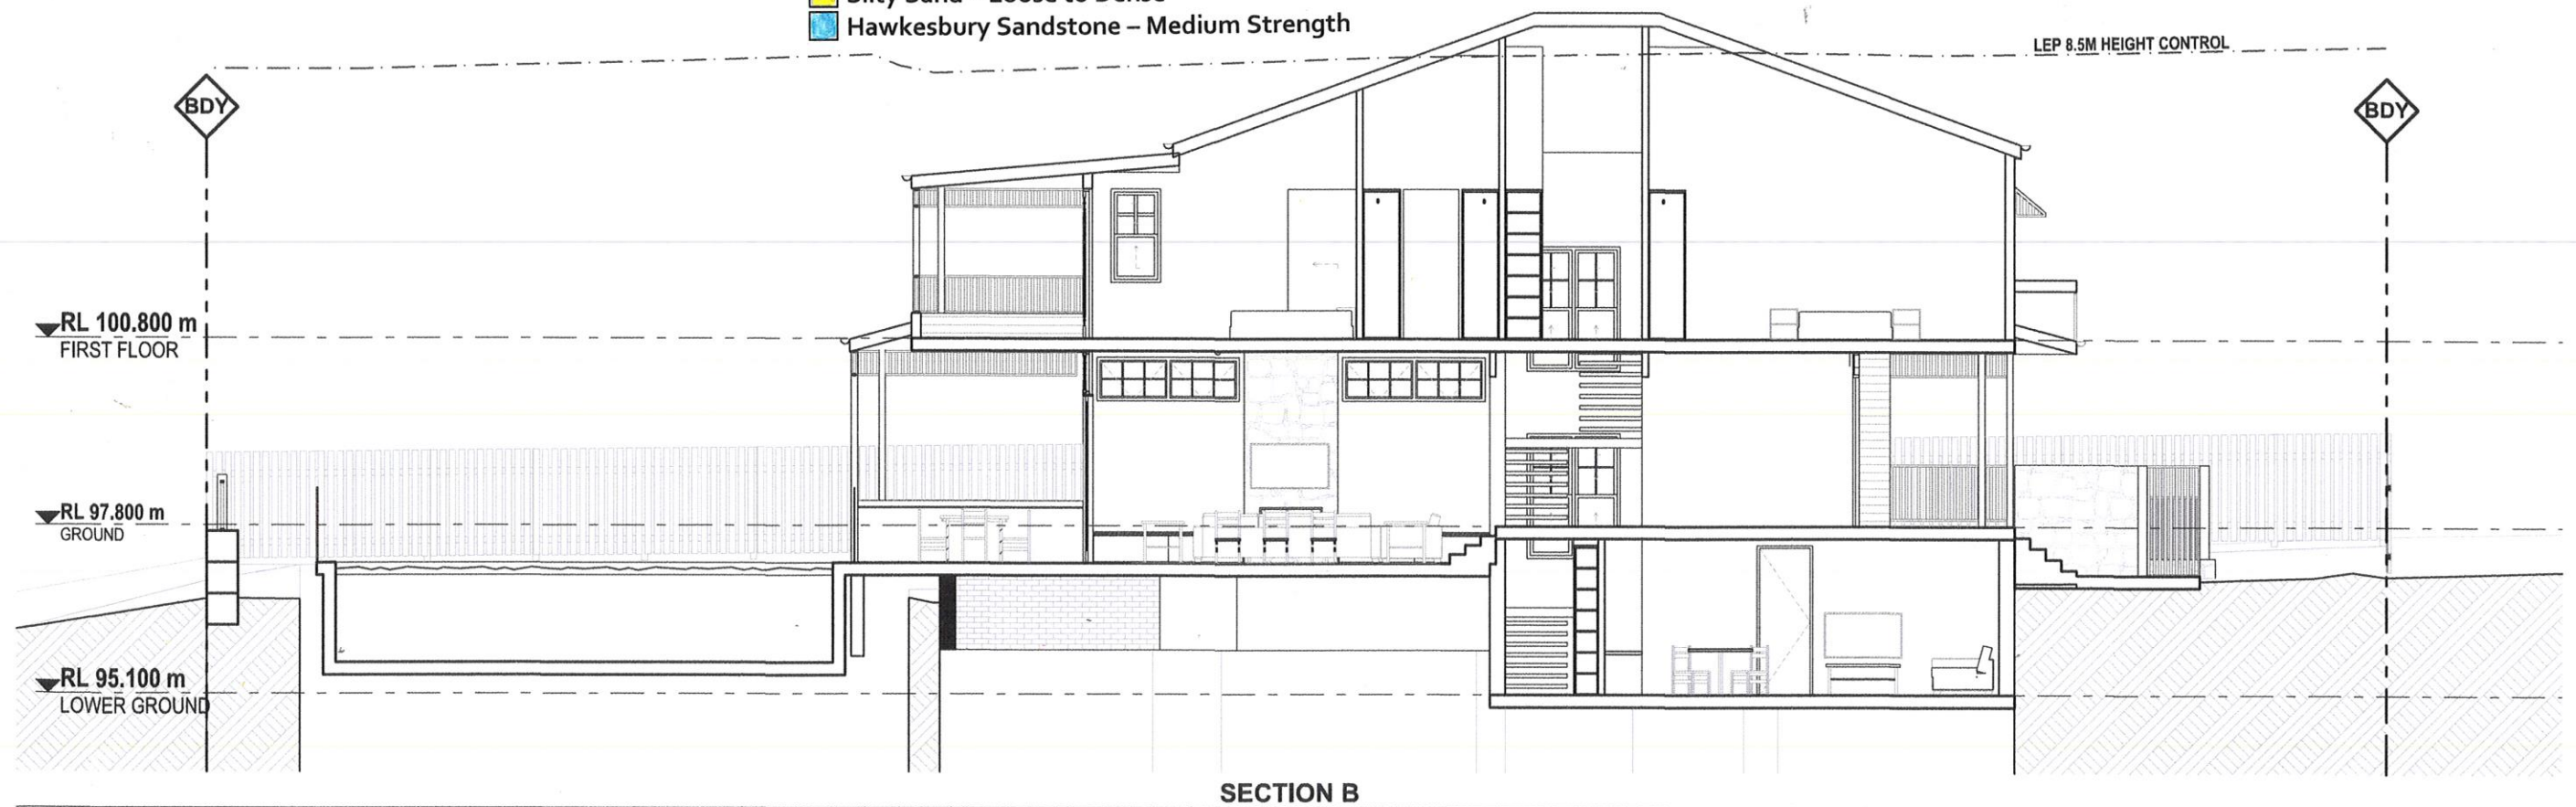
# TYPE SECTION – Diagrammatical Interpretation of expected Ground Materials

The surface features of the block are controlled by the underlying sandstone bedrock that steps up the property forming sub horizontal benches between the steps. Where the grade is steeper, the steps are larger and the benches narrower. Where the slope eases, the opposite is true. The rock is overlain by sandy soils over silty sands that fill the bench step formation. In the test locations, the depth to rock ranged between ~0.9 to ~1.3m below the current surface. No fill was encountered or observed during the ground testing on the property. See Type Section attached for a diagrammatical representation of the expected ground materials.
