## **PRELIMINARY GEOTECHNICAL ASSESSMENT:**

### **42 Beacon Hill Road, Beacon Hill**

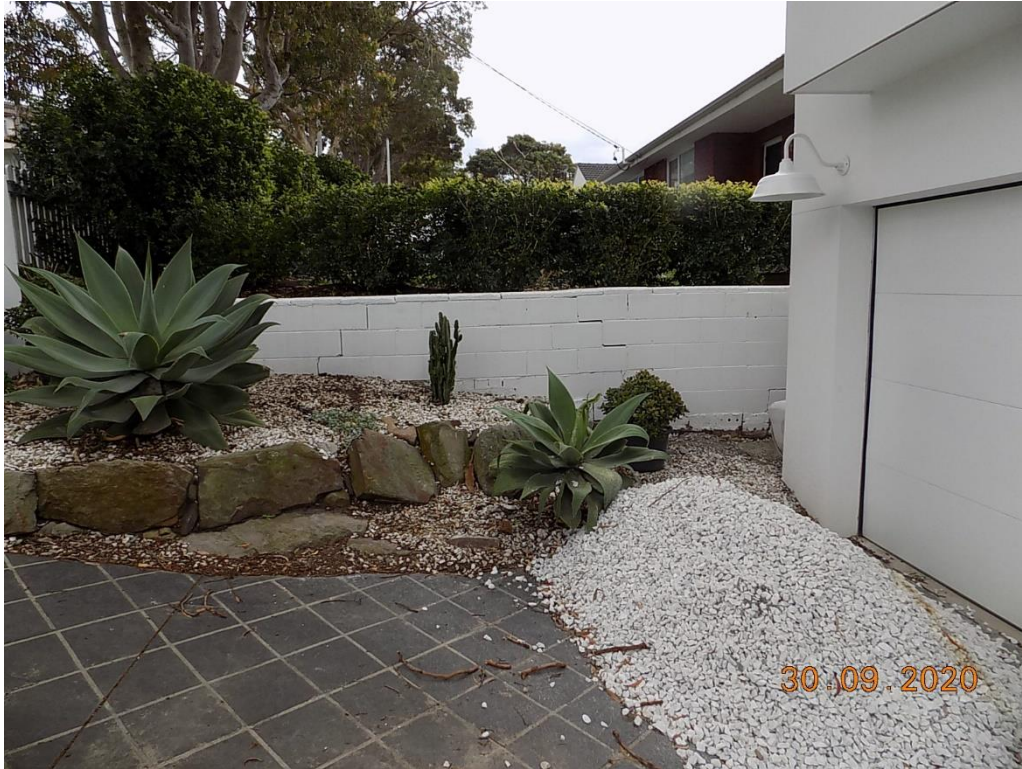
Photo 1

The concrete block retaining wall supporting the fill on the NW neighbouring property is cracked and shows minor settlement (Photo 1). To be prudent, we recommend the retaining wall be inspected by the owners on an annual basis or after heavy prolonged rainfall, whichever occurs first, keeping a photographic record of the inspections. We can carry out these inspections upon request. Should any new movement be observed, the geotechnical consultant is to be engaged to assess the movement and provide remedial advice if necessary.
