J3100. 2nd December, 2020. Page 1.

GEOTECHNICAL INVESTIGATION:

Alterations and Additions at 41 Wallumatta Road, Newport

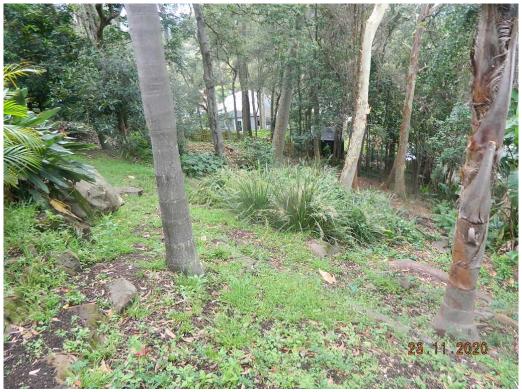
Photo 9

(Photos 7 & 8). Stable sandstone joint blocks are embedded in the moderate slope on

the downhill side of the property (Photos 9 & 10). No signs of slope instability that

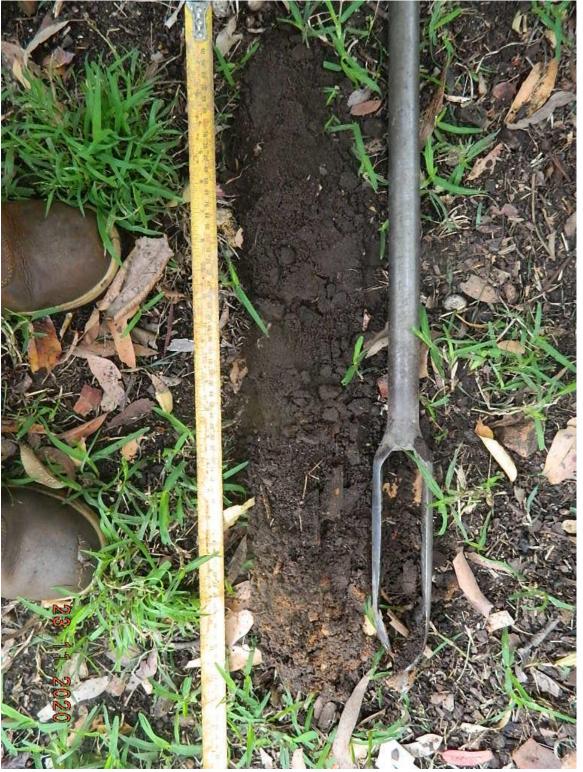
AUGER HOLE 1 (~RL50.1) – AH1 (photo 11)

Depth (m)	Material Encountered
0.0 to 0.5	TOPSOIL , sandy soil, dark brown, moist, fine to medium grained with fine trace organic matter.
0.5 to 0.6	CLAYEY SAND, grey and orange, damp.

Refusal @ 0.6m in clayey sand. No watertable encountered.

Photo 11: AH1 – Downhole is from top to bottom
