REPORT ON GEOTECHNICAL INVESTIGATION

PROPOSED ALTERATIONS AND ADDITIONS

16 HILLCREST AVENUE, MONA VALE, NSW

Project No.: 2025-001

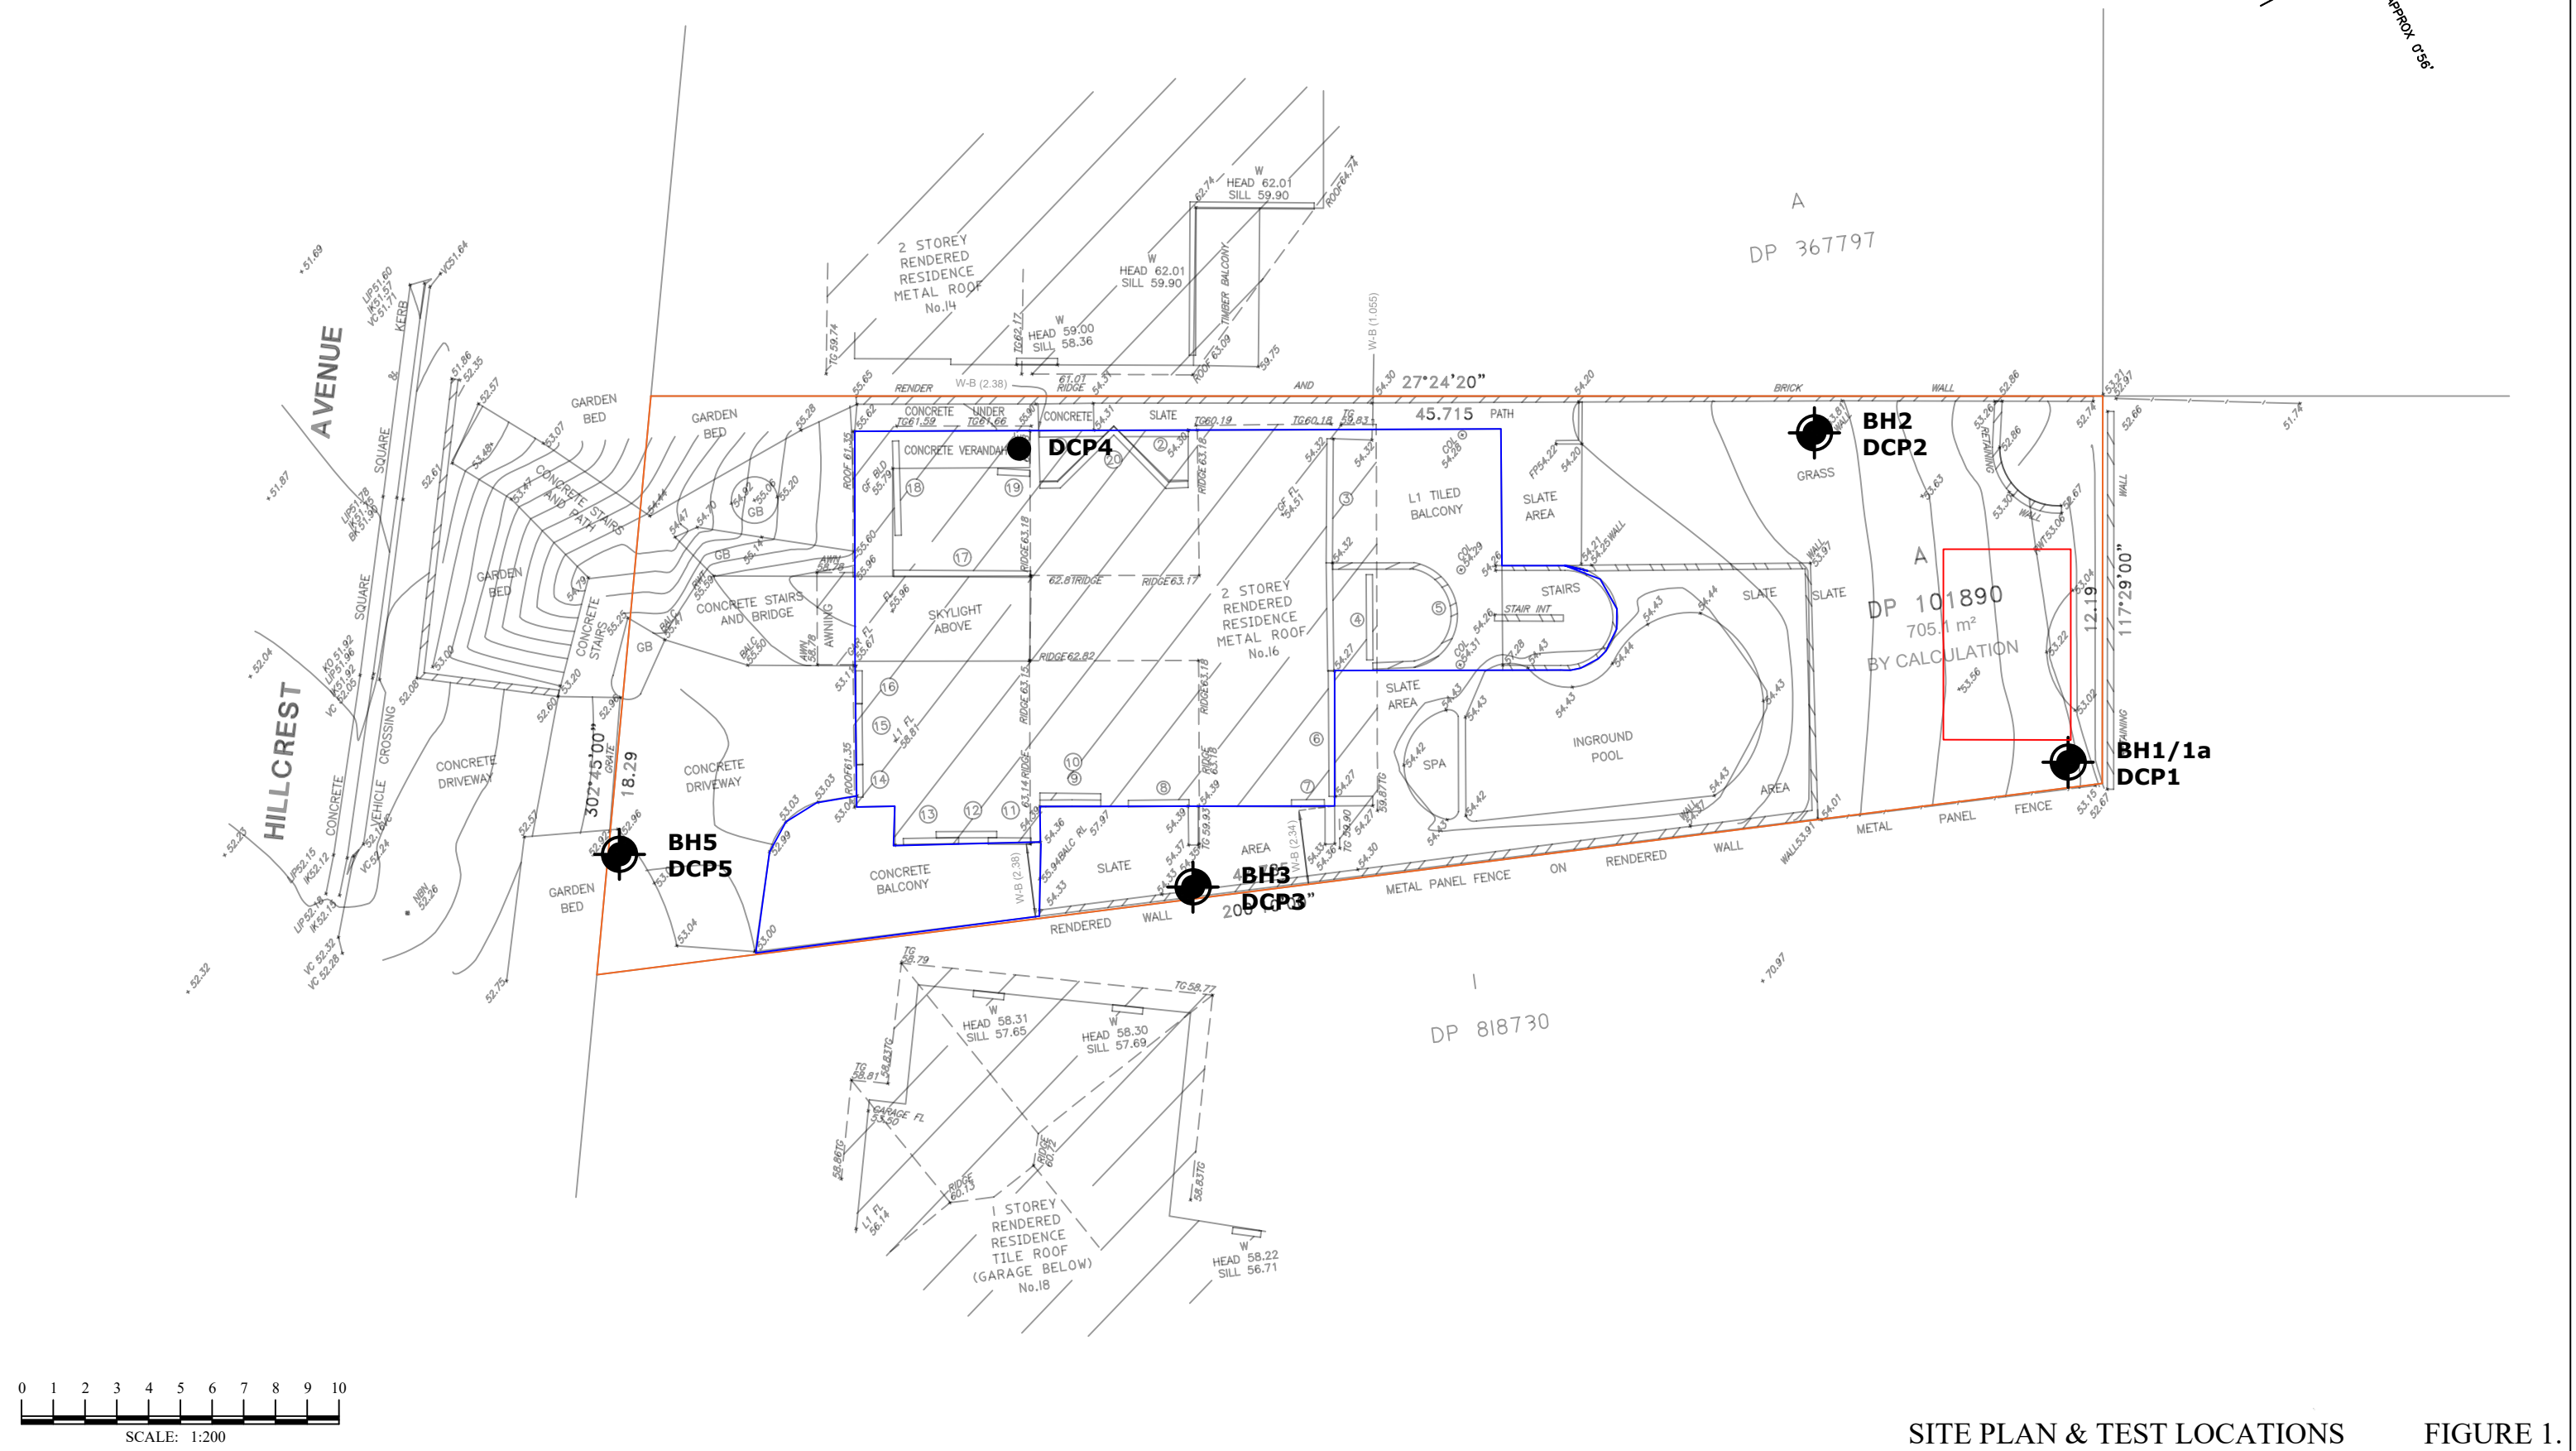
SITE PLAN & TEST LOCATIONS FIGURE 1.

Based on our site investigation and the proposed works, it is considered that the stability hazard associated with the proposed works is limited to the neighbouring property of No. 14 Nareen Parade as well as existing site structures. The hazard is:

The Risk to Life from Hazard A was estimated to be up to **5.21 x 10⁻⁶**, whilst the Risk to Property was considered to be **‘Moderate’**. The hazard was therefore considered to be **‘Unacceptable’** when assessed against the criteria of the AGS 2007 and the Geotechnical Risk Management Policy.

Safe batter slopes do not appear to be feasible along the northern and eastern excavation edges with respect to the neighbouring property. Where safe batter slopes are not achievable, excavation support will need to be implemented to maintain stability external to the site. The relatively small scale nature of the excavation as well as the site conditions will likely allow for the implementation of temporary I-beam & waler support to maintain stability.

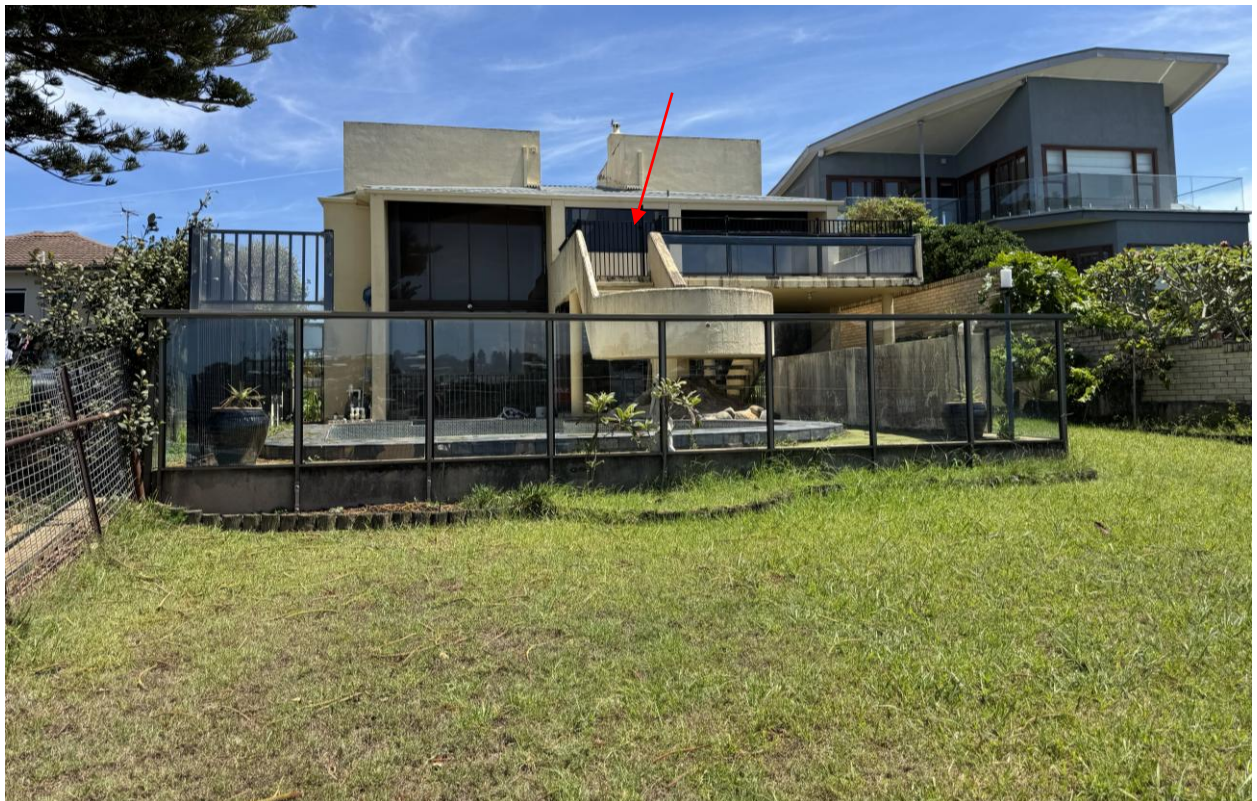
Figure 4: View of seaward face of dwelling, and pool, at site (at arrow) on 12 January 2025, facing SW

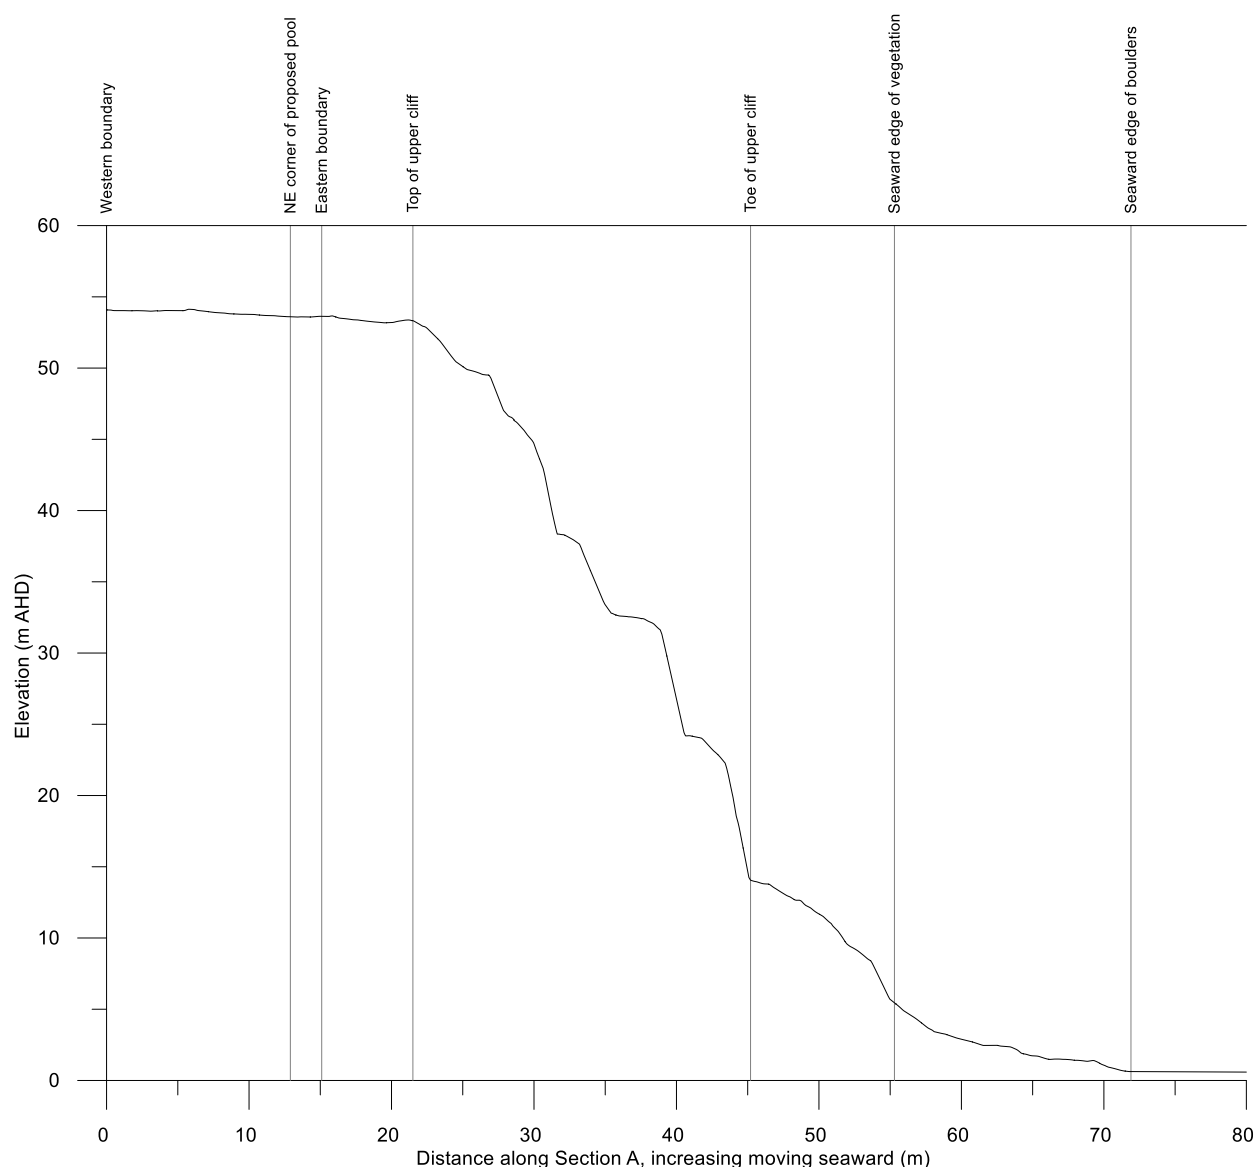
Figure 5: Section A through site, extending seaward through cliff face and rock platform

Ground elevations along Section A approximately vary from about 53m to 54m AHD in the northern part of the site, 53m AHD at the top of the upper cliff, 14.1m AHD at the toe of the upper cliff, 5m AHD at the seaward edge of vegetation, and 0.6m AHD at the seaward edge of the boulders on the rock platform. The existing dwelling has a finished ground floor level of 54.5m AHD. The average slope angle of the upper cliff from 53m AHD down to 14.1m AHD is 59°, but having a stepped profile with steeper (around 75°) and flatter sections.
