MARINE POLLUTION RESEARCH^{PTY LTD}

Proposed Jetty Modifications and Seawall Rebuild at 50 The Avenue Newport, Marine Ecology Impact Summary Statement: DA2022/1759.

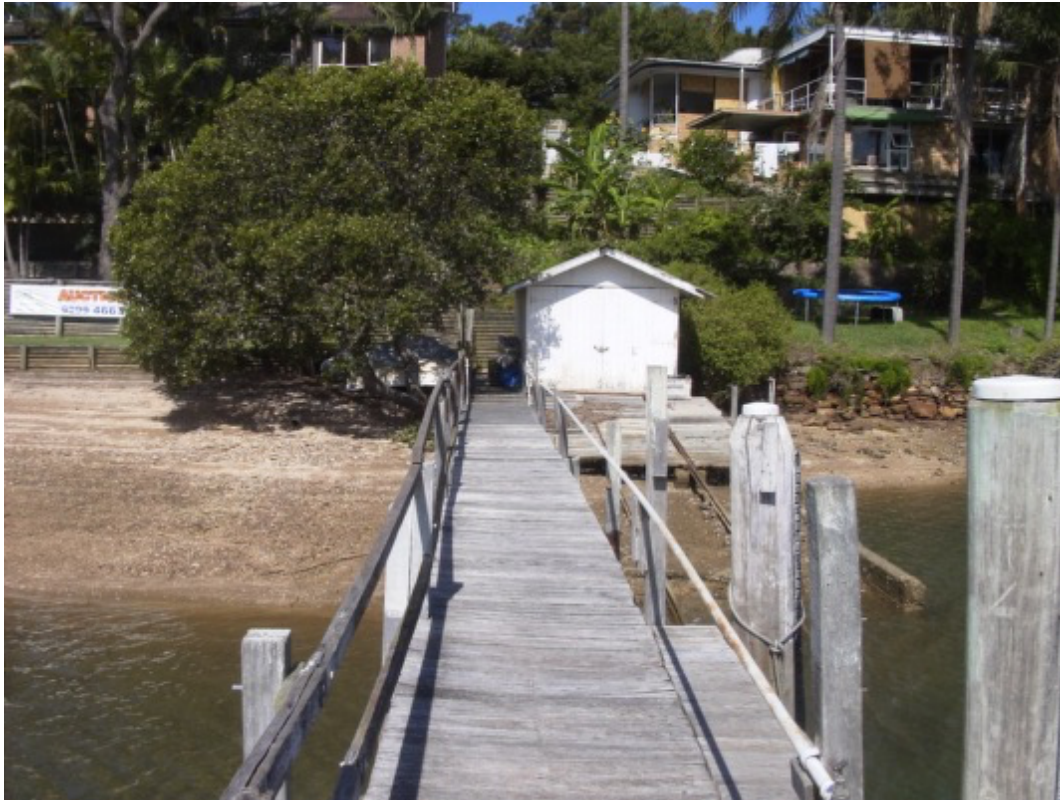
Figure 1 Existing facility April 2008 showing mangroves to north, boatshed, skid, rails and drystone seawall at site.

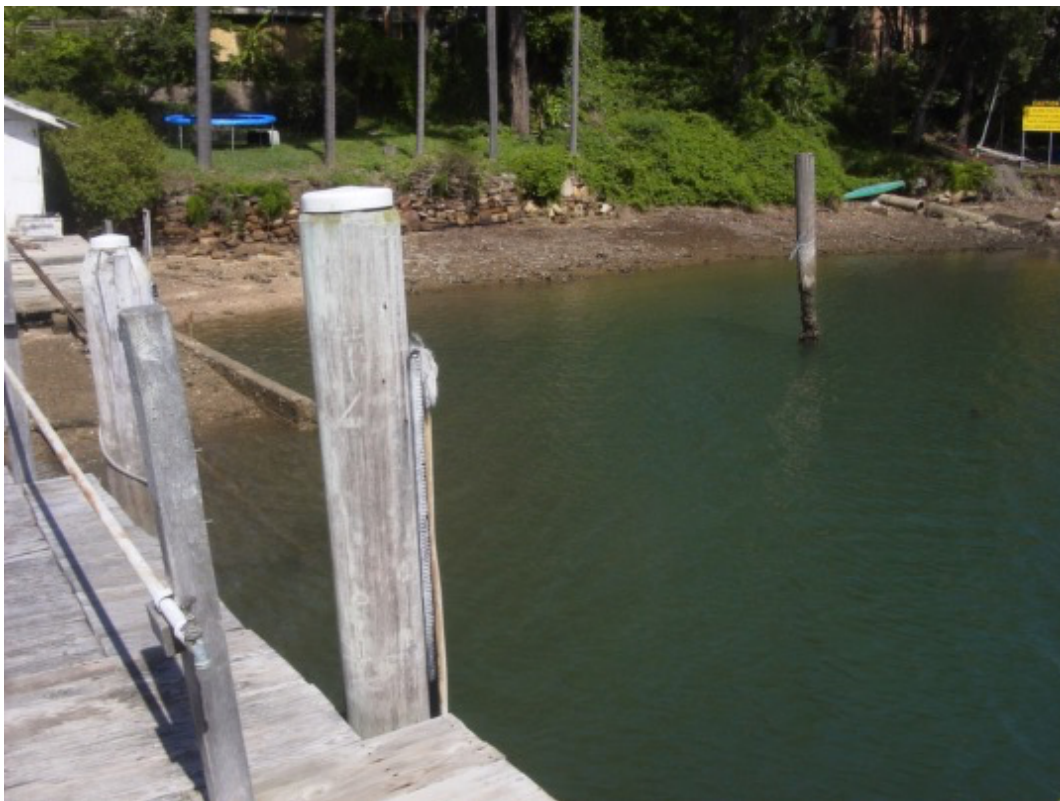
Figure 2 Existing facility April 2008 showing site intertidal and drystone seawall. Note also slipway retaining wall.

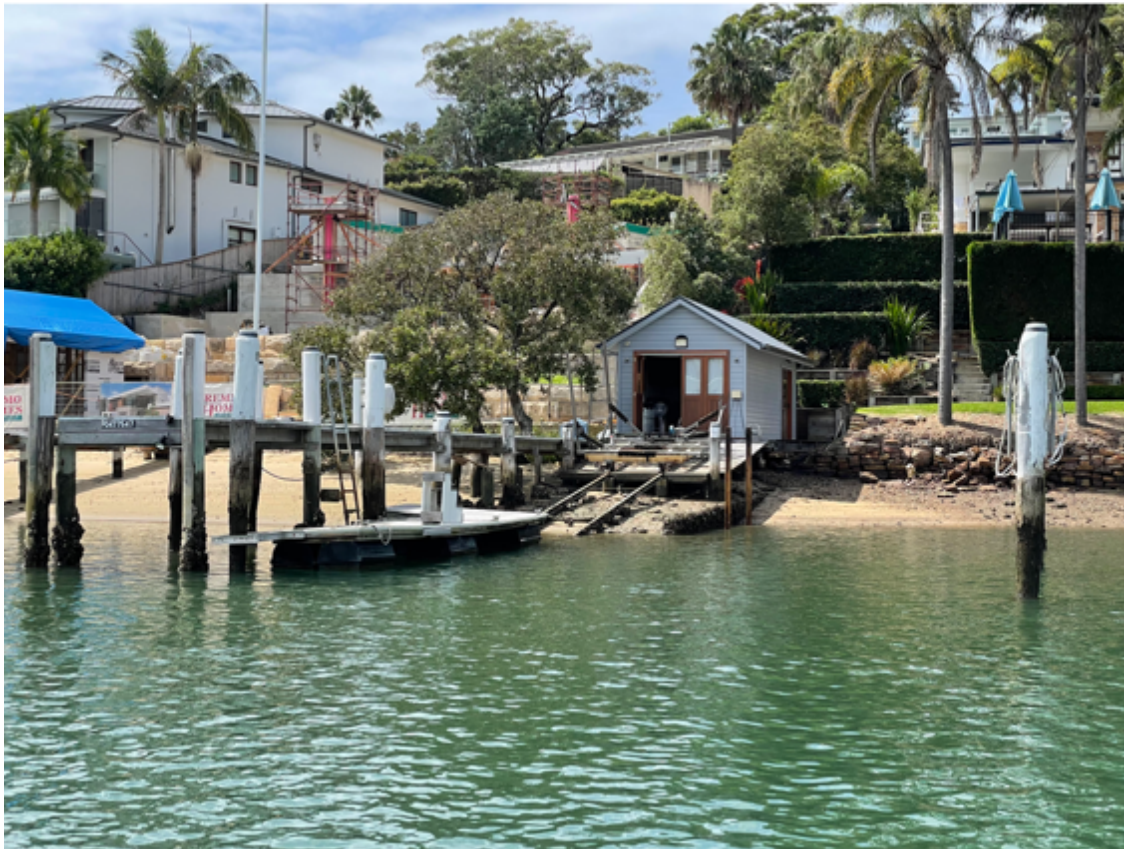
Figure 3 Present existing facility in late 2022 - note mangroves to north, same boatshed, sliprail and retaining wall structure for the slipway and skid and the same dry wall seawall fronting the property.
