SUBSURFACE UTILITY INVESTIGATION REPORT

James Morrison Constructions

12-Oct-2021

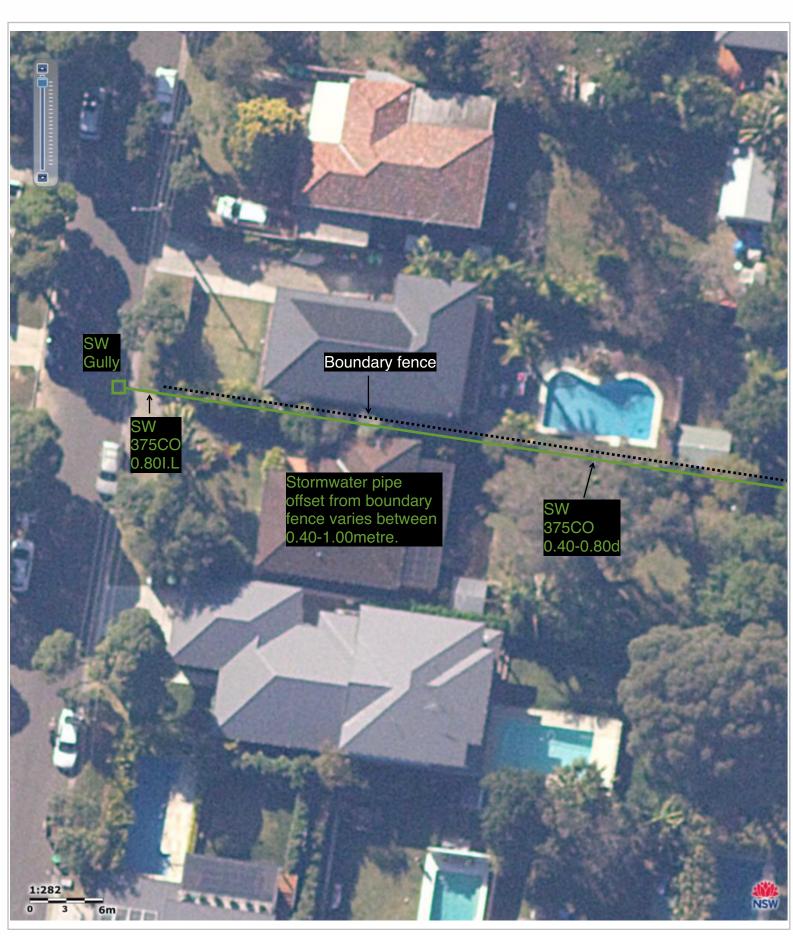
375 concrete pipe has been rodded and tracked from council gully through neighbours garden to out of scope. Pipe varies in depths between 0.40-0.80metres. The offset from the boundary fence is between 0.40-1.00metre.
