Subsurface Utility Information (SUI) Photo Report

PROJECT DETAILS	
Locator: Andrew Borgstrom	Date: 10/9/2018
Job No:	DBYD No: 14891739
Site Address: 16 Cabarita Rd, Avalon	
Works Required: Locate Stormwater and Sewer

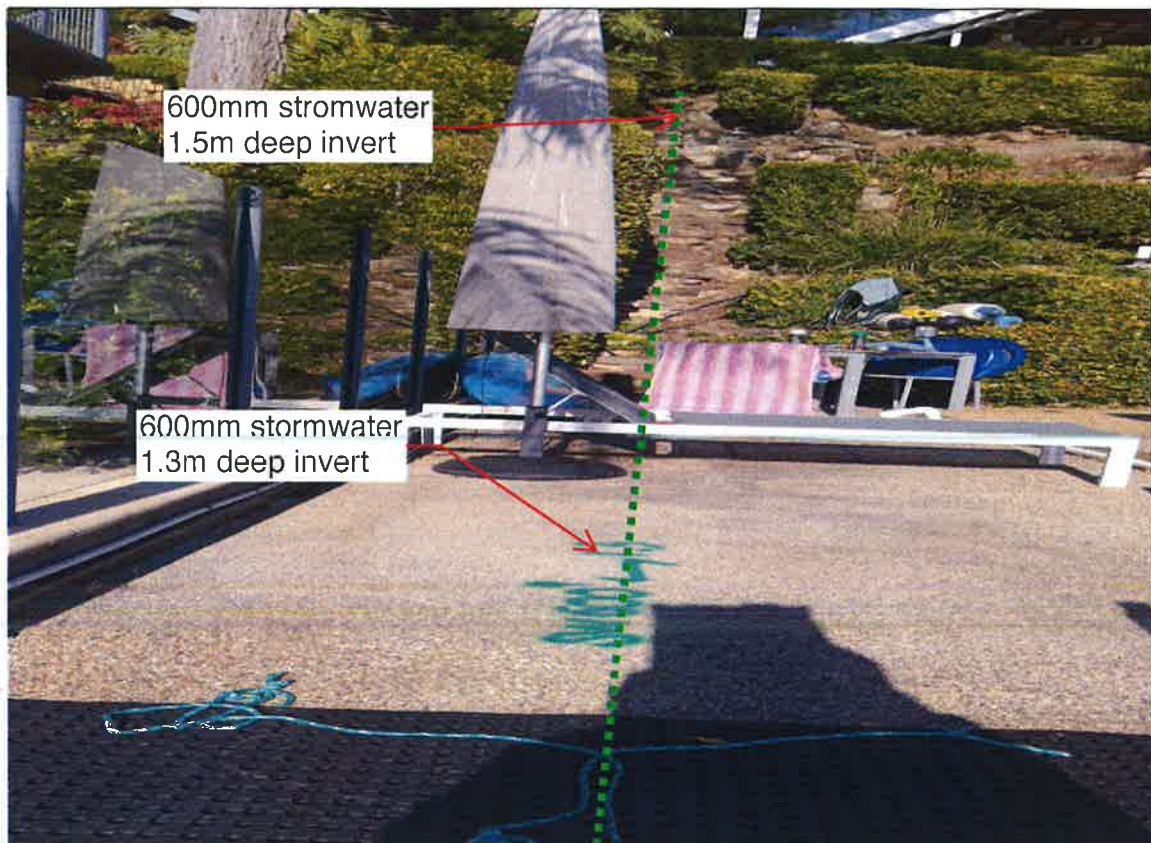
Photo 1 Location: 16 Cabarita Rd, Avalon

This is inverted level, for estimated top of pipe add 600mm.

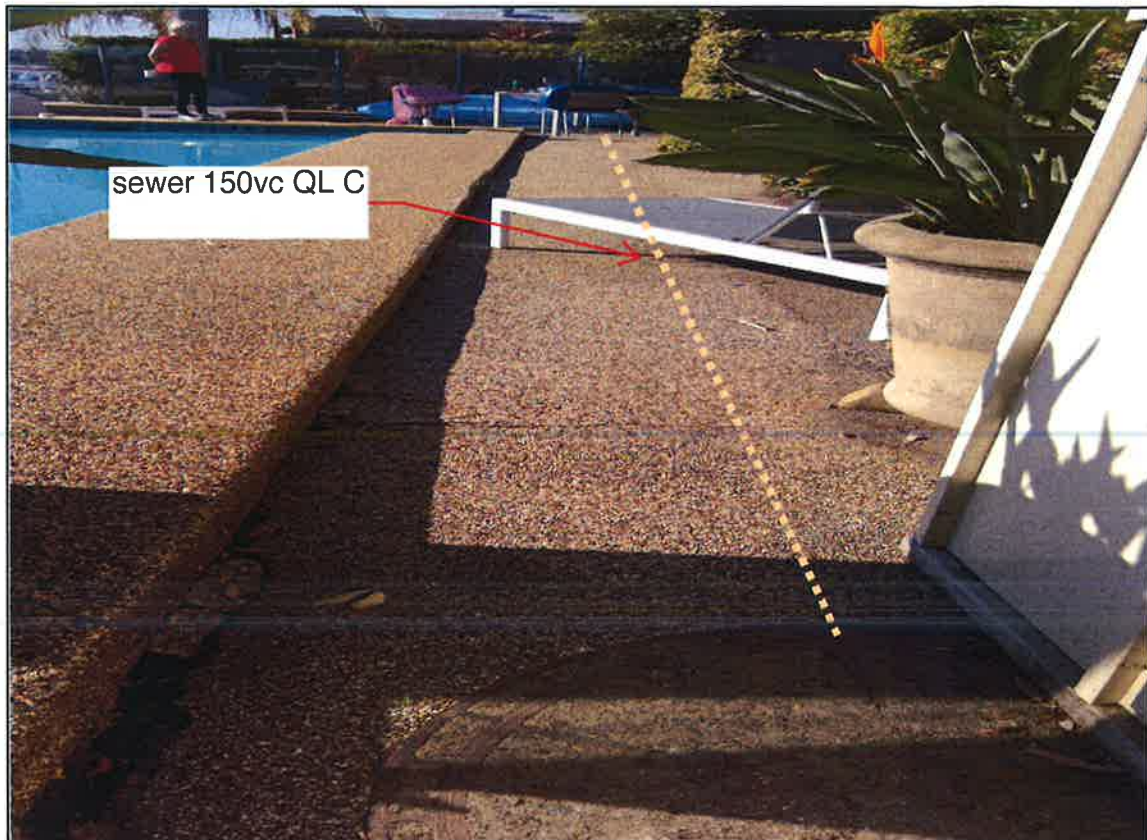
Photo 3 Location: 16 Cabarita Rd, Avalon

Didnt really need to locate the main sewer line, manhole lined up with lamp hole for QL C on sydney water dials had this at 0.6m invert, client requested this to be noted as we were unable to open access points
