GEOTECHNICAL INVESTIGATION:

Alterations and Additions at 35 Coles Road, Freshwater

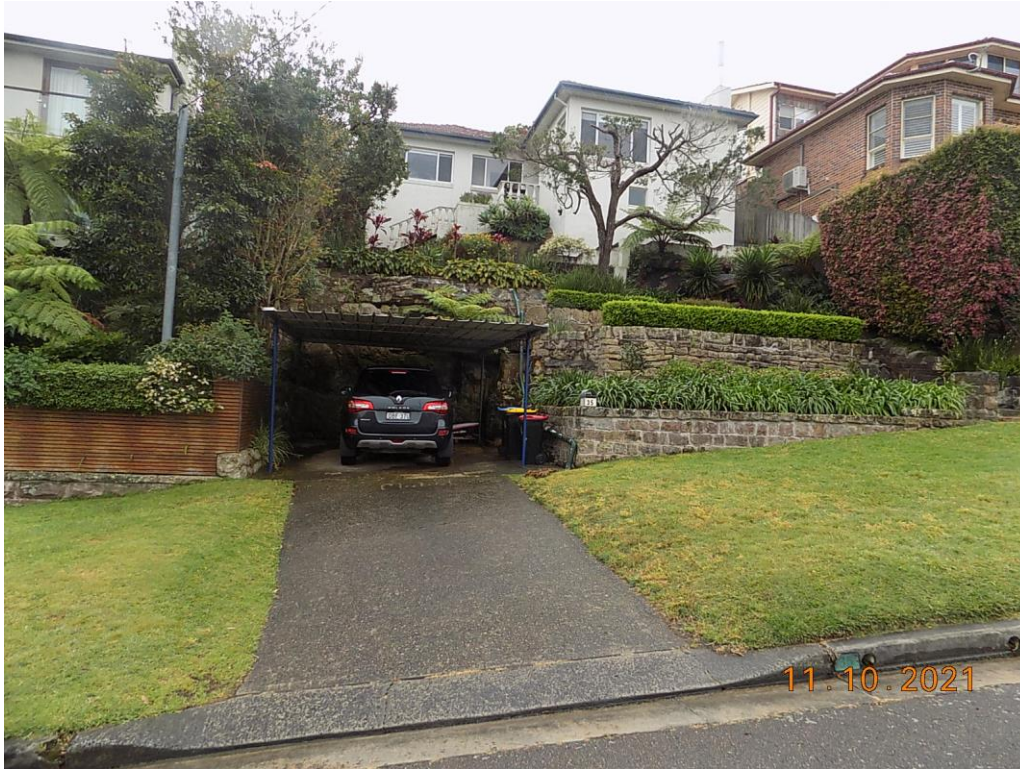
Photo 1

2.3 At the road frontage, a concrete driveway runs to a carport on the downhill side of the property (Photo 1). The ~3.5m cut for the carport has been taken entirely through outcropping Competent Medium Strength Sandstone (Photo 2). The carport will be demolished and replaced with a new garage as part of the proposed development. Between the road frontage and the house is a series of stable sandstone block retaining walls that terrace the slope (Photo 3). A level lawn area rises immediately above the cut for the carport (Photo 4). The fill batter for the lawn is lined with sandstone flagging, ~0.5m high. Stepped cracking was observed through the mortar of the flagging wall in some places. Competent Medium Strength Sandstone can be seen outcropping on the W side of the property (Photos 5 & 6). The single-storey rendered brick house is supported on brick walls and brick piers (Photo 7). The brick walls show no significant signs of movement and the brick piers stand vertical. Some of the supporting walls were observed to be supported directly onto outcropping sandstone bedrock across the downhill side of the house. Immediately above the house is a large outcrop of competent Medium Strength Sandstone. that is slightly undercut to ~1.5m (Photos 8 & 9). Given the thickness of the supporting cantilever arms with no additional significant visible geological defects, the undercut rock is considered to be stable. Above the large rock outcrop is another level patio and lawn area (Photo 10).

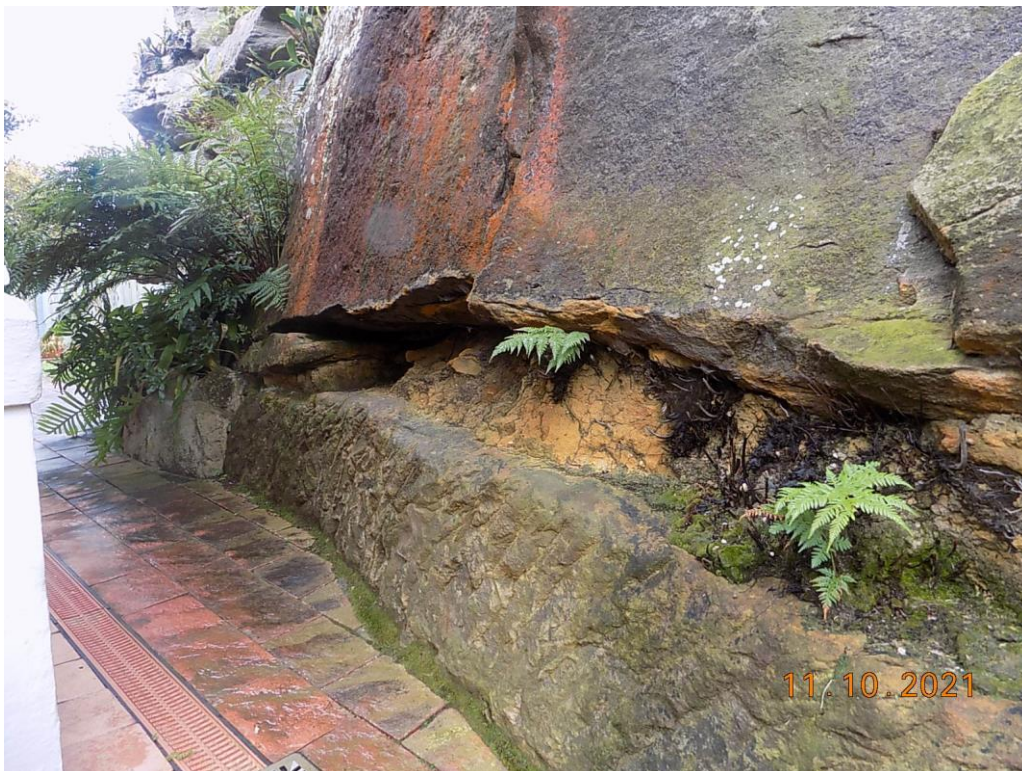
Photo 8

No geotechnical hazards were observed above or beside the property. The moderate to steeply graded slope that rises across the property and continues below is a potential hazard (**Hazard One**). The undercut rock faces (Photos 8 & 9) above the house are a potential hazard (**Hazard Two**). The vibrations from the proposed excavations are a potential hazard (**Hazard Three**). The proposed excavations are a potential hazard until retaining walls are in place (**Hazard Four**).

HAZARDS	Hazard One	Hazard Two
TYPE	The moderate to steep slope that rises across the property and continues below failing and impacting on the proposed works.	The undercut rock faces (Photos 8 & 9) failing and causing damage to the subject house and proposed works.
LIKELIHOOD	'Unlikely' (10^{-4})	'Rare' (10^{-5})
CONSEQUENCES TO PROPERTY	'Medium' (12%)	'Major' (60%)
RISK TO PROPERTY	'Low' (2×10^{-5})	'Low' (6×10^{-5})
RISK TO LIFE	8.3×10^{-7} /annum	8.3×10^{-7} /annum
COMMENTS	This level of risk is 'ACCEPTABLE'.	This level of risk is 'ACCEPTABLE'.

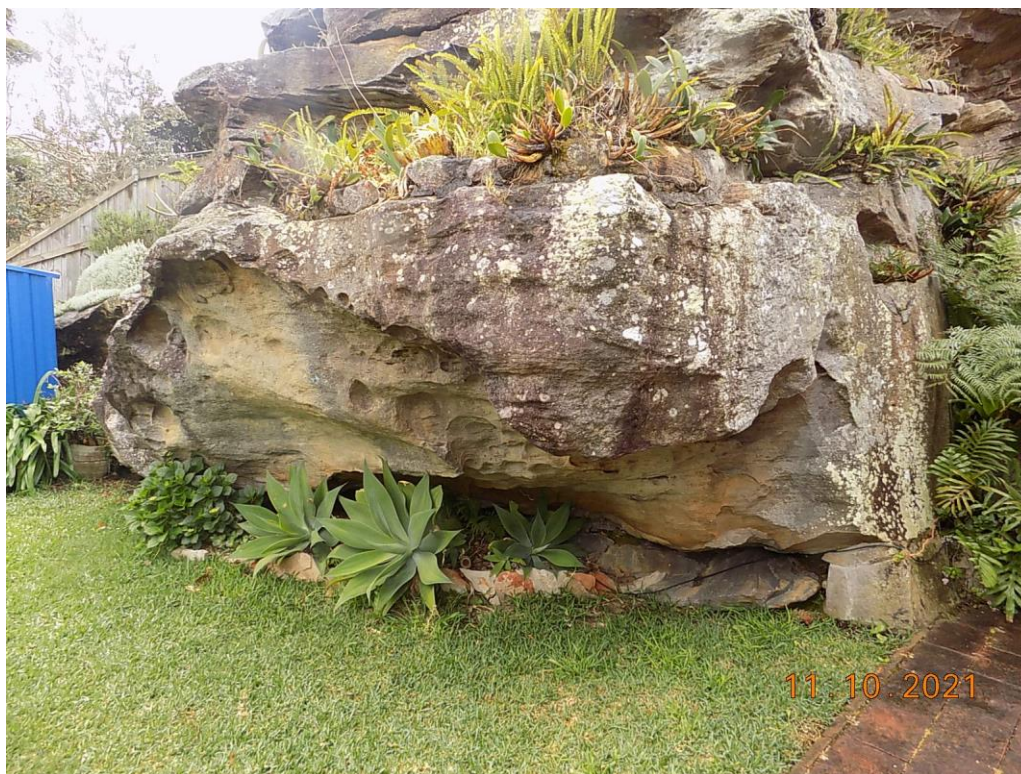
Photo 9

AUGER HOLE 1 (~RL54.4) – AH1 (Photo 9)

Depth (m)	Material Encountered
0.0 to 0.8	FILL , dark brown mixed with yellow and white sand, fine to medium grained, loose, fine trace of organic matter, dry.

Refusal @ 0.8m. Auger grinding. No water table encountered.

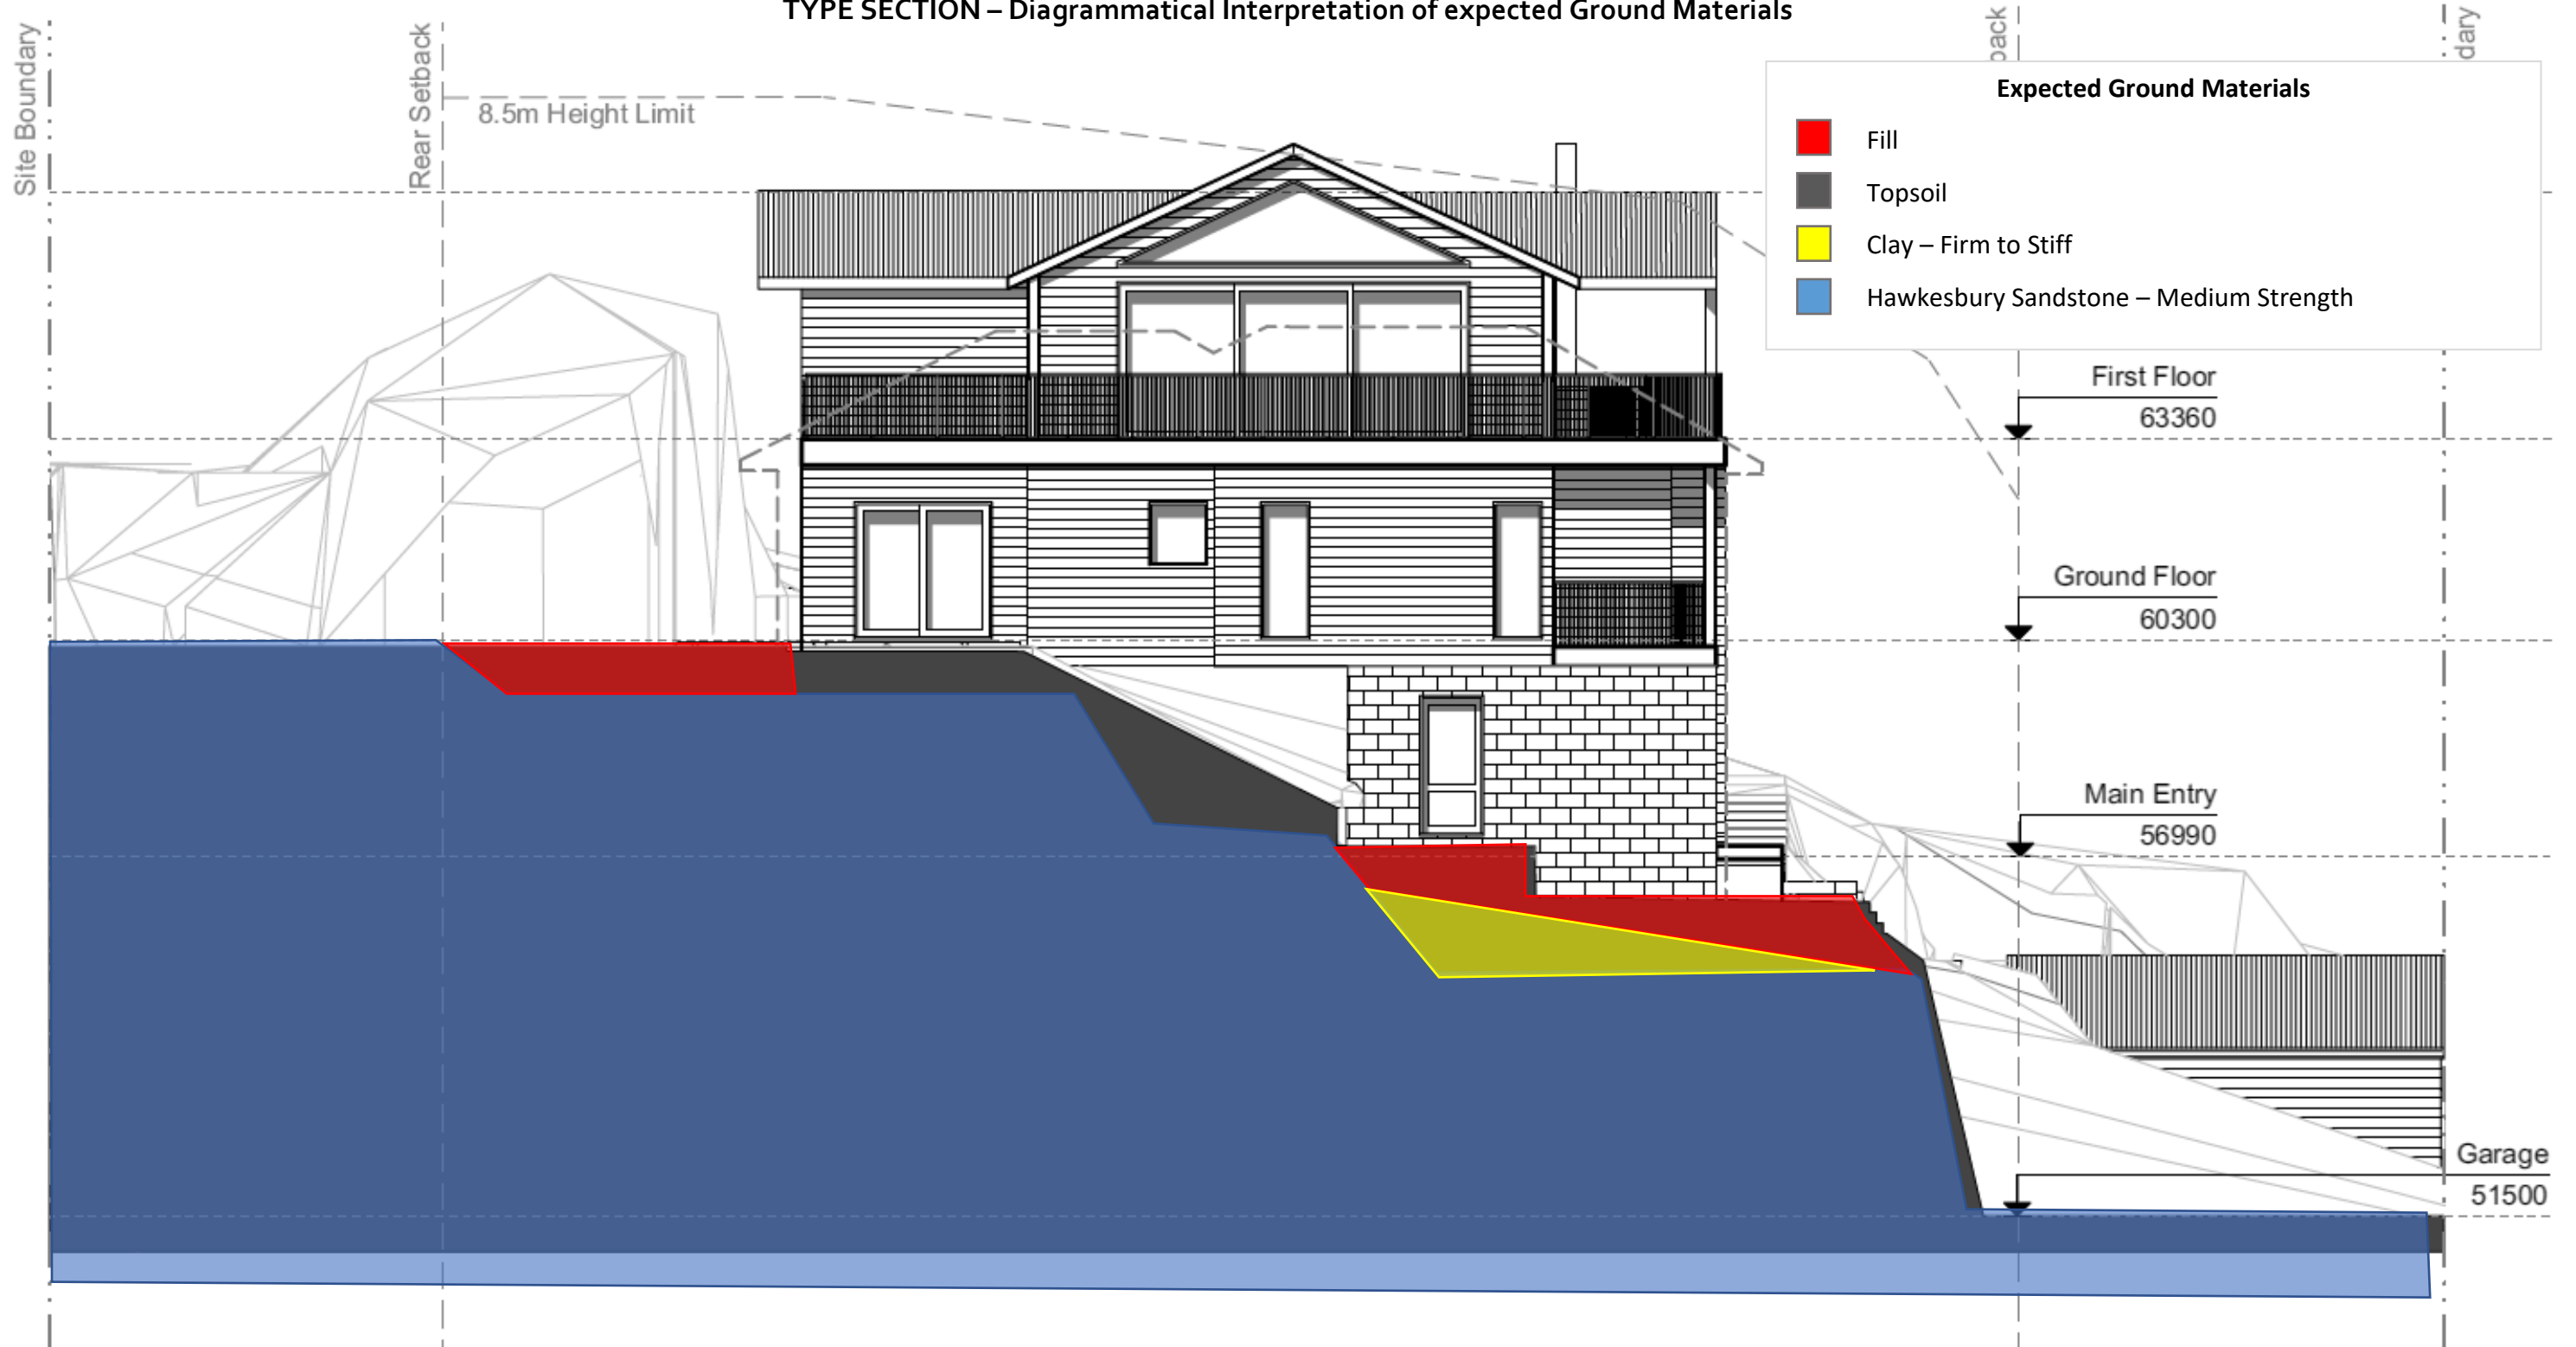
TYPE SECTION – Diagrammatical Interpretation of expected Ground Materials

The surface features of the block are controlled by the outcropping and underlying sandstone bedrock that steps up the property forming sub-horizontal benches between the steps. Where the grade is steeper, the steps are larger and the benches narrower. Where the slope eases, the opposite is true. Where the rock is not exposed, it is overlain by soil and sands that fill the bench step formation. Filling has been placed across the downhill side of the property for landscaping. In the test locations, where the rock was not exposed, it was encountered at depths of between 0.9m and 1.3m below the current surface, being slightly deeper due to the presence of fill and the stepped nature of the underlying bedrock. The outcropping sandstone on the property is estimated to be medium strength or better and similar strength rock is expected to underlie the entire site. See Type Section attached for a diagrammatical representation of the expected ground materials.
