GEOTECHNICAL RISK MANAGEMENT POLICY FOR PITTWATER
FORM NO. 1 – To be submitted with Development Application

Address of site 62 Palm Beach Road, Palm Beach

GEOTECHNICAL INVESTIGATION:

Alterations and Additions at **62 Palm Beach Rd, Palm Beach**

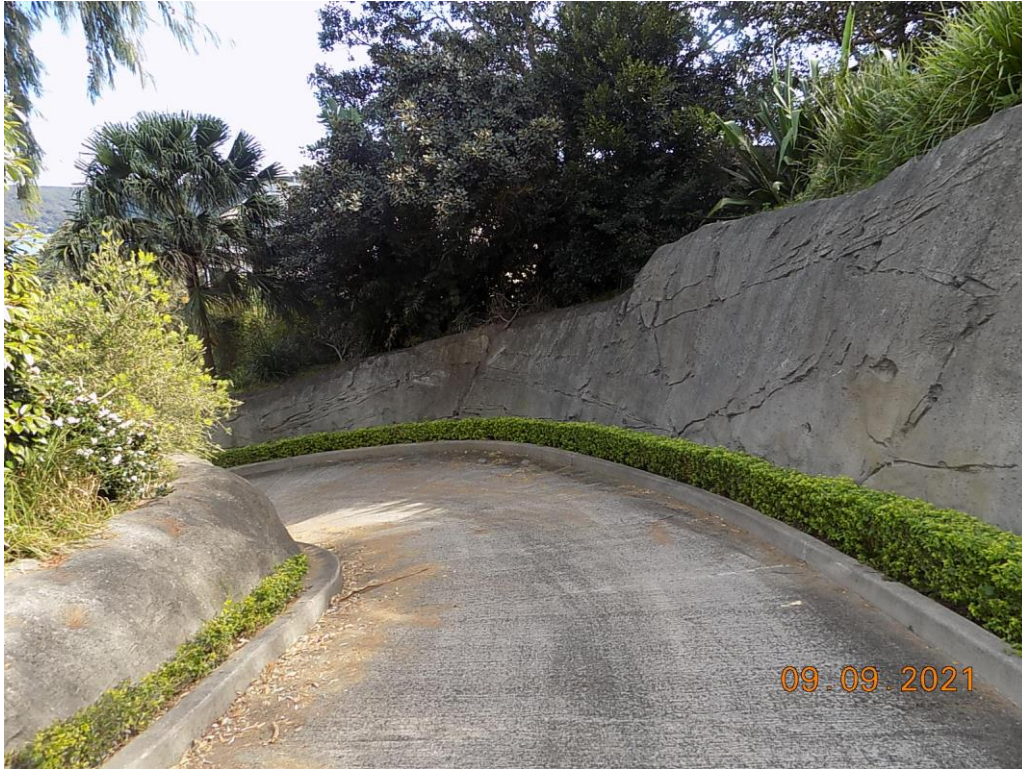
Photo 1

- 2.3** The property is accessed by a Right of Carriageway (ROW) off the uphill side of the road. The cut for the ROW is supported by stable sprayed concrete walls (Photo 1). A concrete driveway continues from the ROW to a parking area and garage underneath the downhill side of the house (Photo 2). The house is currently undergoing renovation works as part of a separate approved application. A stable ~1.5m high sandstone clad, concrete block retaining wall supports the fill for a garden immediately upslope of the parking area (Photo 3). Competent Medium Strength Sandstone can be seen outcropping in several locations across the property. Several of the Sandstone outcrops are undercut and are supported with sprayed concrete

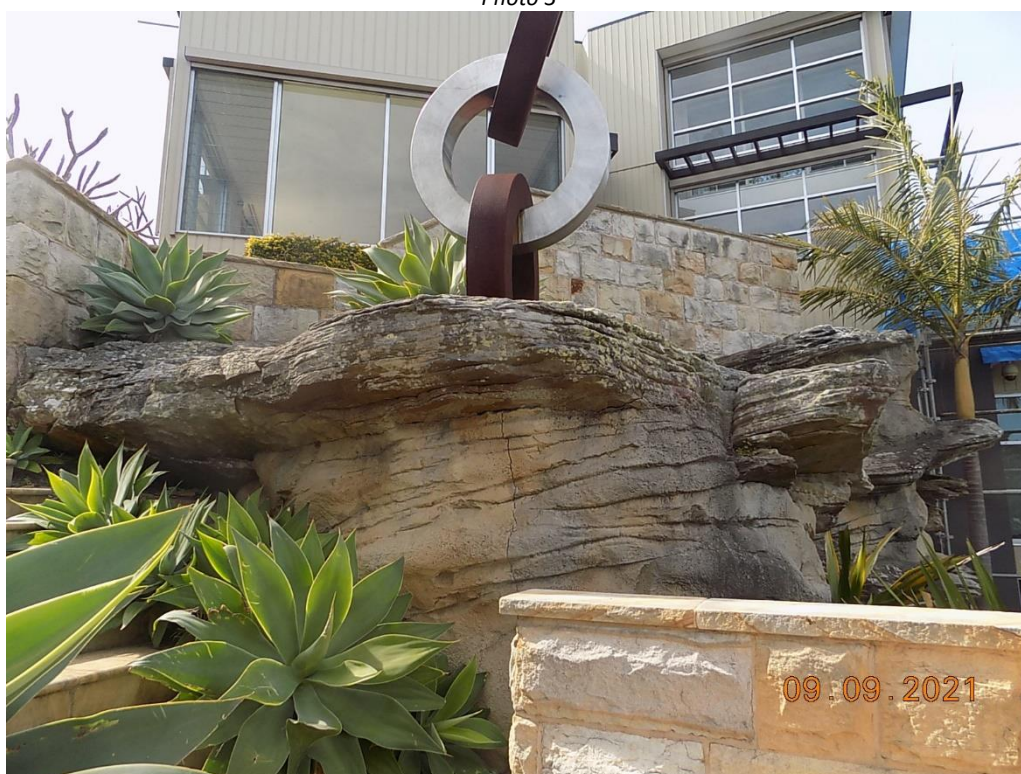
Photo 4

(Photo 4). Some of the external walls of the house can be seen directly supported off of the outcropping rock (Photo 5). The part three-storey rendered brick house is supported on brick walls. The external brick walls show no significant signs of movement. A level patio area extends off the uphill side of the house (Photo 6). A large sandstone floater is resting on the slope on the N side of the property. It has 5 rock bolts securing it to the slope and is supported by two brick piers underneath. This floater is considered stable (Photo 7 & 8). A cut for the level patio area is supported by a ~0.9m high, stable, rendered brick retaining wall. This wall is to be removed as part of the proposed works.

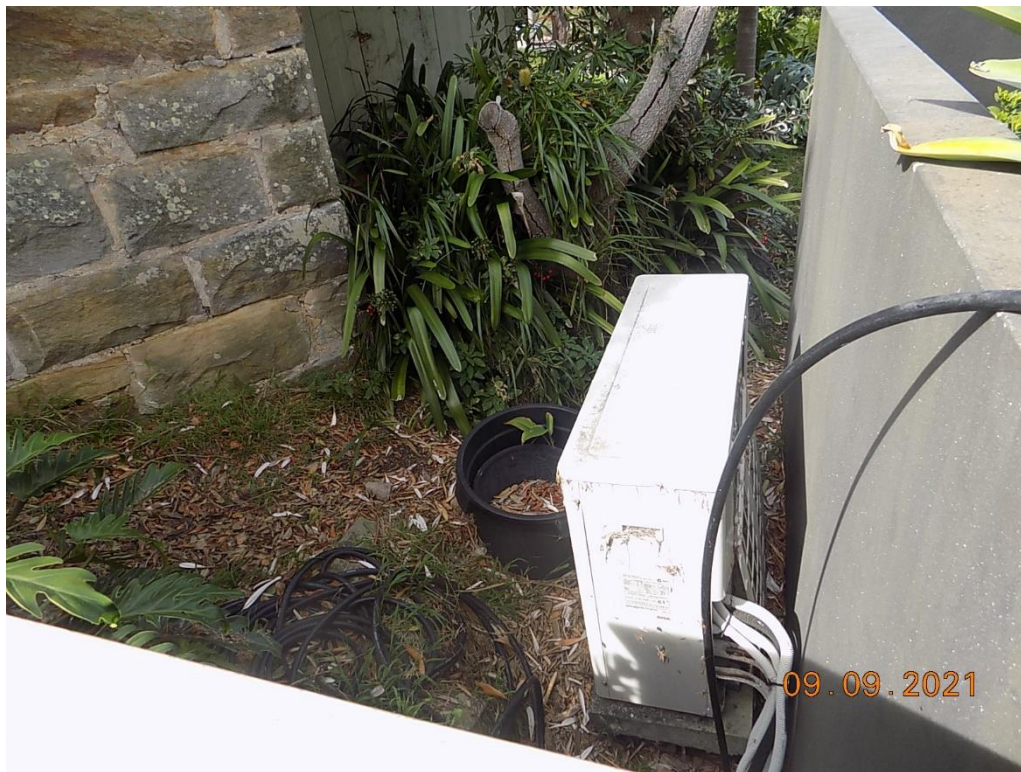
Photo 9

- Near flush with the E neighbouring stone shed (Photo 9).
- ~2.5m from the subject house.
- ~7.0m from the E neighbouring house.

Where the E neighbouring stone shed (Photo 9) falls within the zone of influence of the excavation, exploration pits in this location will need to be put down by the builder to determine the foundation depth and material. The pits are to be inspected by the geotechnical consultant.

If the stone shed is found to be supported below the zone of influence of the excavation or on rock, the excavation may commence. If it is not supported below the zone of influence or on rock, the wall will need to be underpinned prior to the excavation commencing. See the minimum extent of required shoring shown on the site plan attached.

The owners of the E neighbouring property will need to provide their permission for the underpinning works. If permission cannot be granted, our office is to be contacted to provide an alternative means of support.

- The exploration pits to determine the foundation material along the W wall of the E neighbouring stone shed are to be inspected by the geotechnical consultant to determine if underpinning is necessary. This is to occur before the bulk excavation for the extension commences.

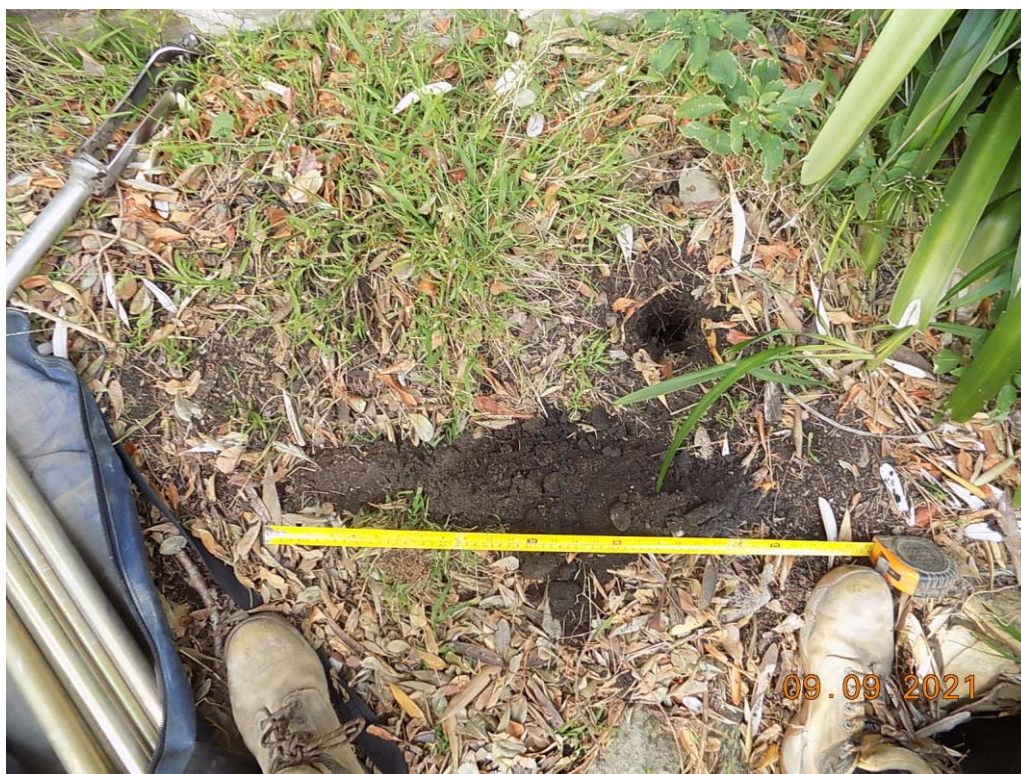
Photo 10 (left to right)

AUGER HOLE 1 (~RL57.5) – AH1 (Photo 10)

Depth (m)	Material Encountered
0.0 to 0.3	SANDY SOIL , dark brown, medium grained, loose, fine trace of organic matter, dry.
0.3 to 0.6	SAND , black and grey, medium grained, loose to medium dense, dry.

Refusal @ 0.6m on rock. No water table encountered.

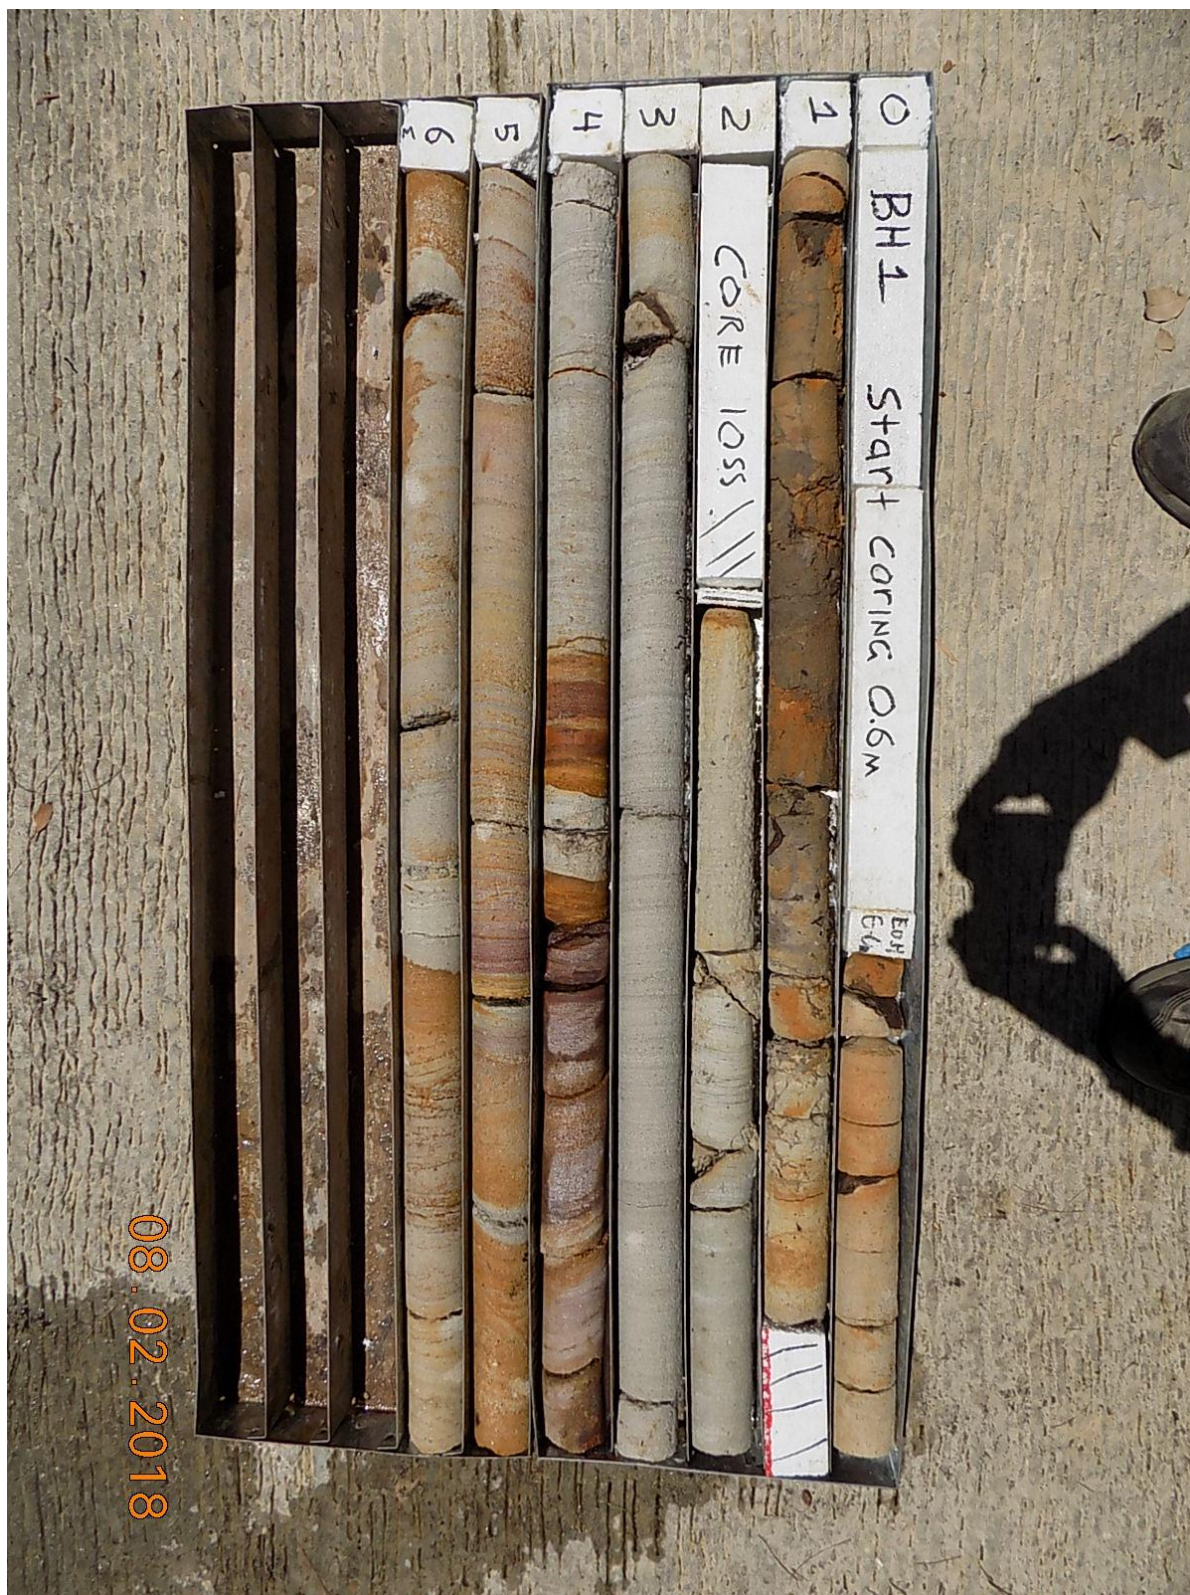
Photo 11

BOREHOLE 1 ~RL47.4 – BH1 (Photo 11)

Depth (m)	Material Encountered
0.0 to 0.6	SANDY SOIL, grey sandy soil with sandstone gravel.
0.6 to 1.0	SANDSTONE FLOATER, floating boulder.
1.0 to 1.5	CLAYEY SAND, yellow/brown firm to stiff.
1.5 to 1.9	VERY LOW STRENGTH SANDSTONE
1.9 to 2.4	CORE LOSS, driller lost return water
2.4 to 2.8	VERY LOW STRENGTH SANDSTONE
2.8 to 4.0	MEDIUM STRENGTH SANDSTONE
4.0 to 4.2	LOW STRENGTH SANDSTONE
4.2 to 7.0	MEDIUM TO HIGH STRENGTH SANDSTONE, 0.05m thick clay seam @ 6.6m.

End of hole @ 7.0m in medium strength to high strength sandstone.

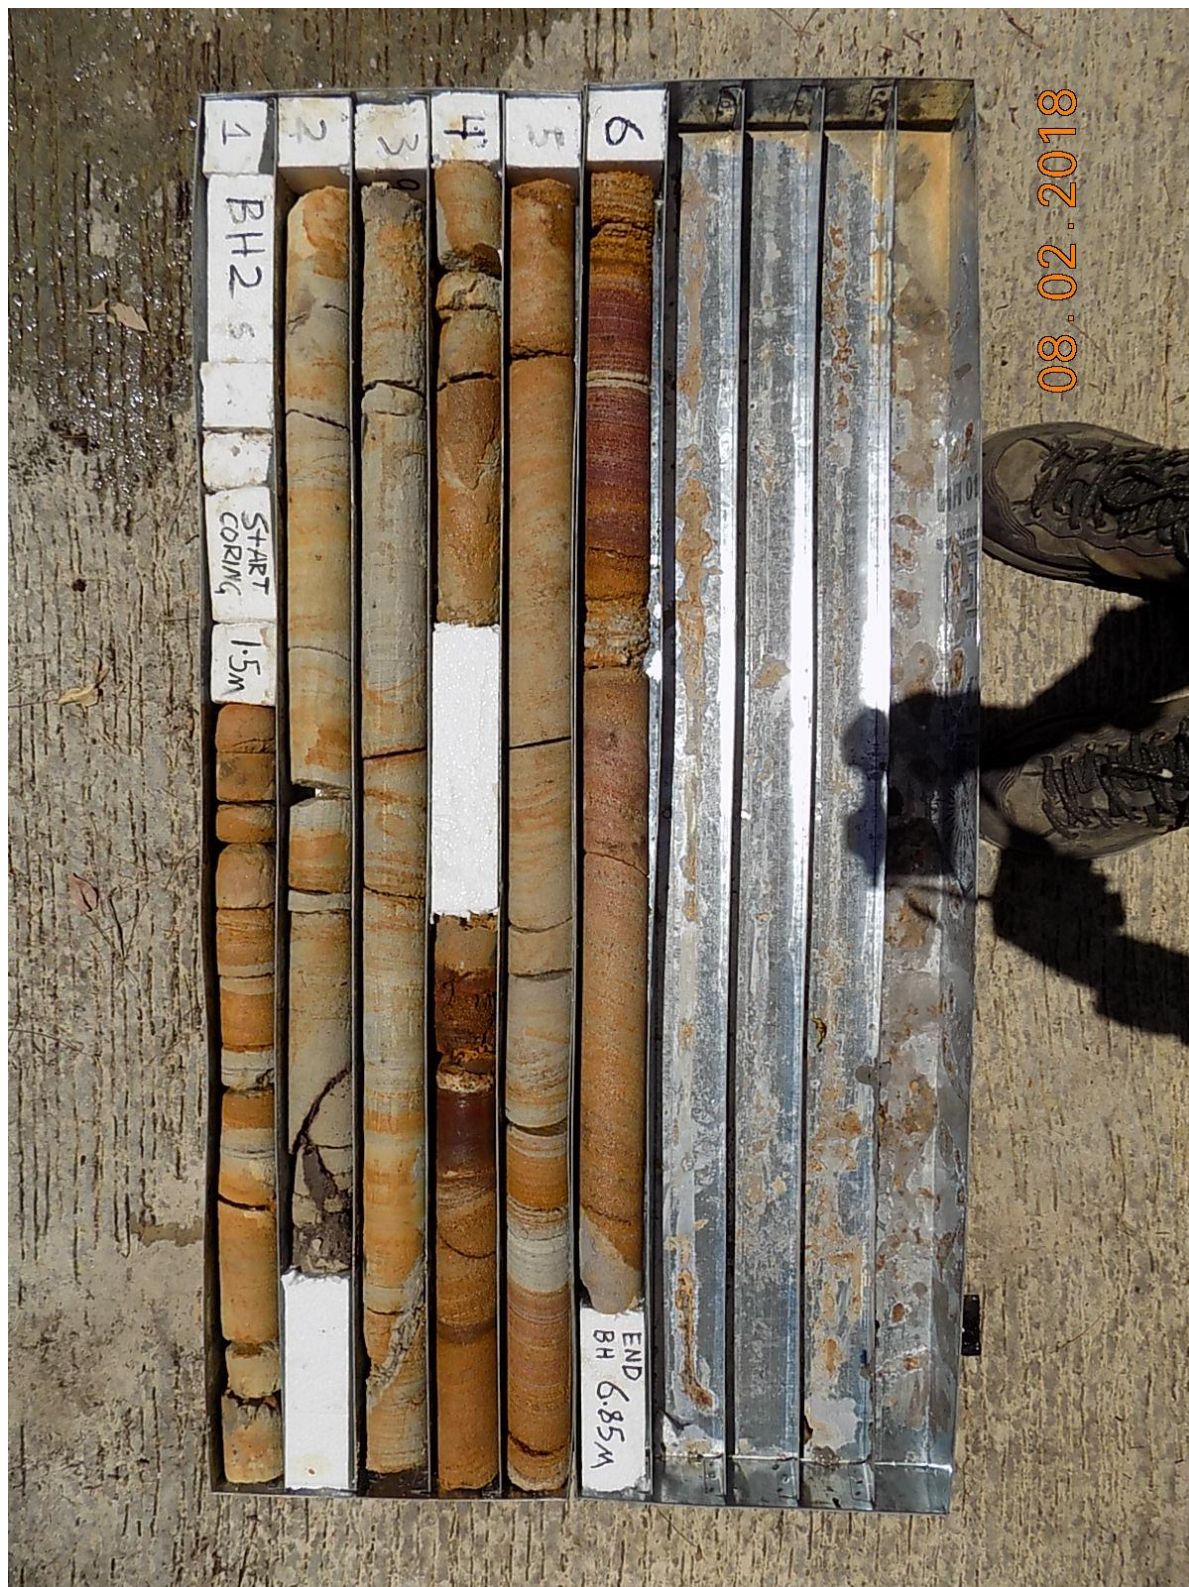
Photo 12

BOREHOLE 2 ~RL48.3 – BH2 (Photo 12)

Depth (m)	Material Encountered
0.0 to 1.0	SANDY SOIL grey sandy soil with sandstone gravel.
1.0 to 1.5	CLAYEY SAND yellow/brown firm to stiff.
1.5 to 4.0	LOW STRENGTH to MEDIUM SANDSTONE, variable strength through interval.
4.0 to 4.4	VERY LOW STRENGTH SANDSTONE
4.4 to 4.6	CORE LOSS
4.6 to 4.7	CLAY SEAM

4.7 to 6.9 MEDIUM TO HIGH STRENGTH SANDSTONE, Clay seams @ 6.0 to 6.1m
& @ 6.3 to 6.4m.

End of hole @ 6.9m in medium strength to high strength sandstone.

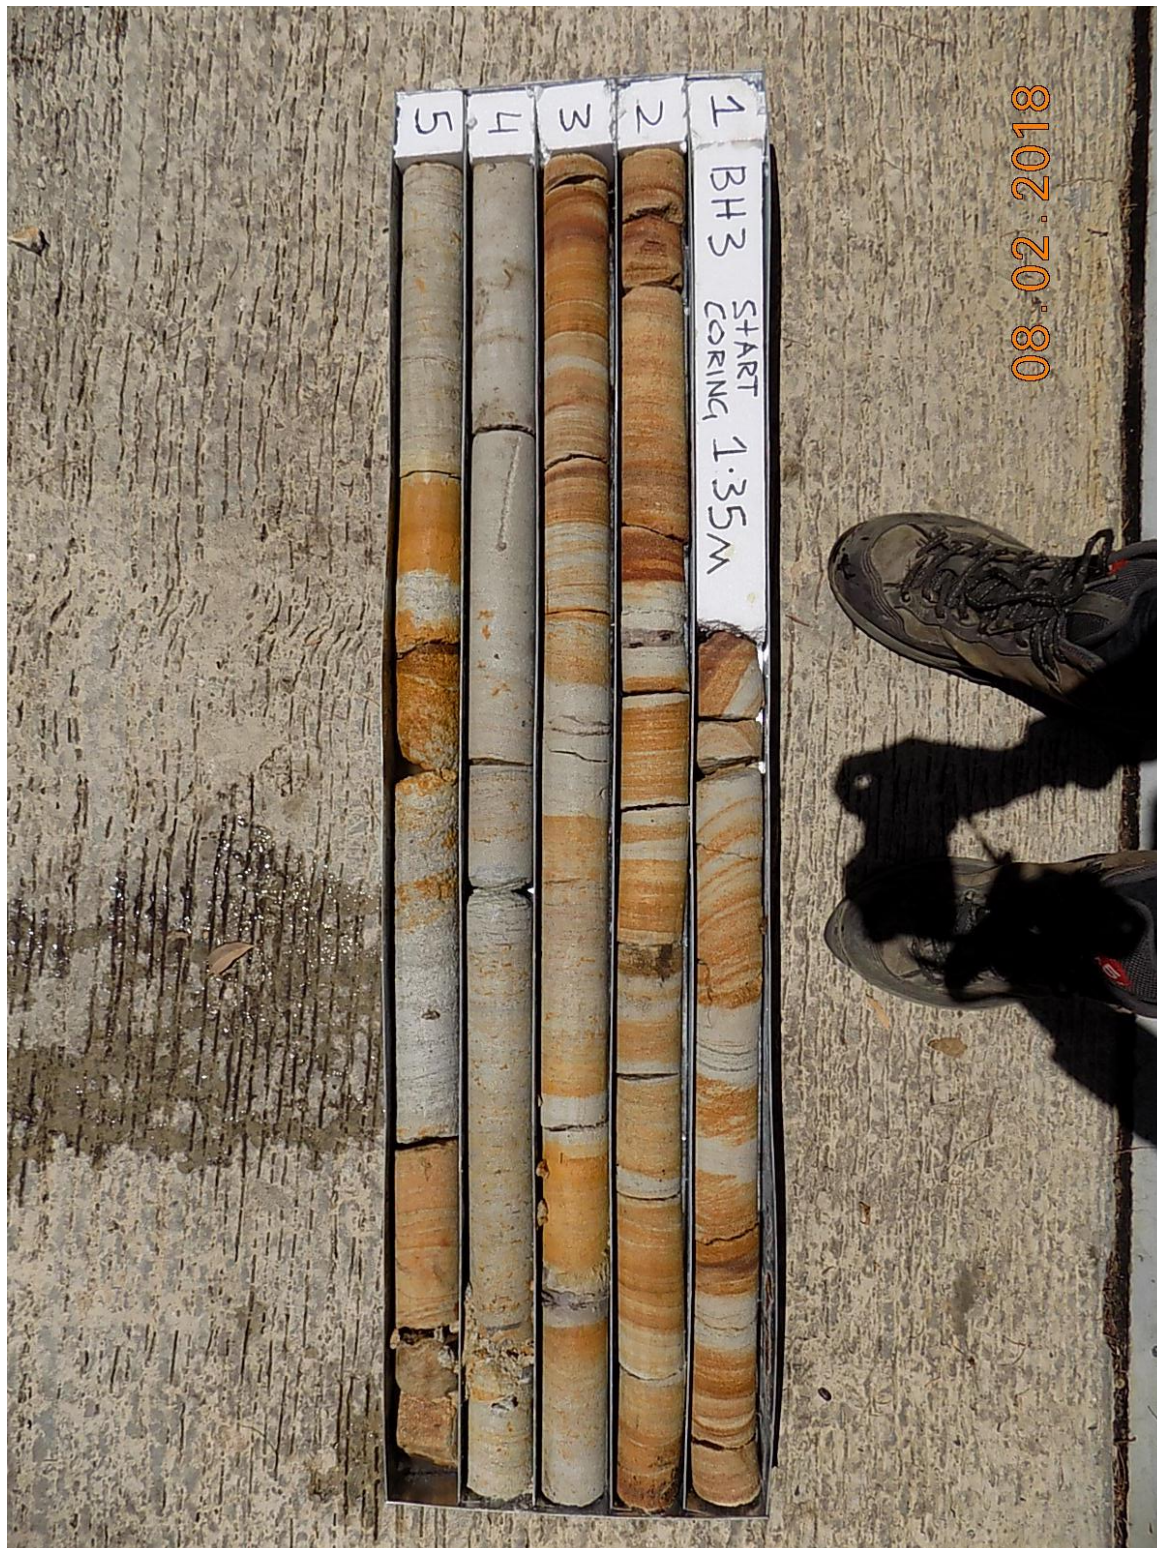
Photo 13

BOREHOLE 3 ~RL50.5 – BH3 (Photo 13)

Depth (m)	Material Encountered
0.0 to 1.0	SANDY SOIL grey sandy soil with sandstone gravel.
1.0 to 1.4	CLAYEY SAND yellow/brown firm to stiff.
1.4 to 2.4	MEDIUM STRENGTH SANDSTONE
2.4 to 2.5	LOW STRENGTH SANDSTONE
2.5 to 3.4	MEDIUM STRENGTH SANDSTONE
3.4 to 3.9	LOW STRENGTH TO MEDIUM STRENGTH SANDSTONE
3.9 to 4.4	MEDIUM STRENGTH SANDSTONE
4.9 to 5.7	LOW STRENGTH SANDSTONE, 0.05m clay seams @ 4.9 & 5.4m.
5.7 to 6.0	MEDIUM STRENGTH SANDSTONE

End of hole @ 6.0m in medium strength sandstone.

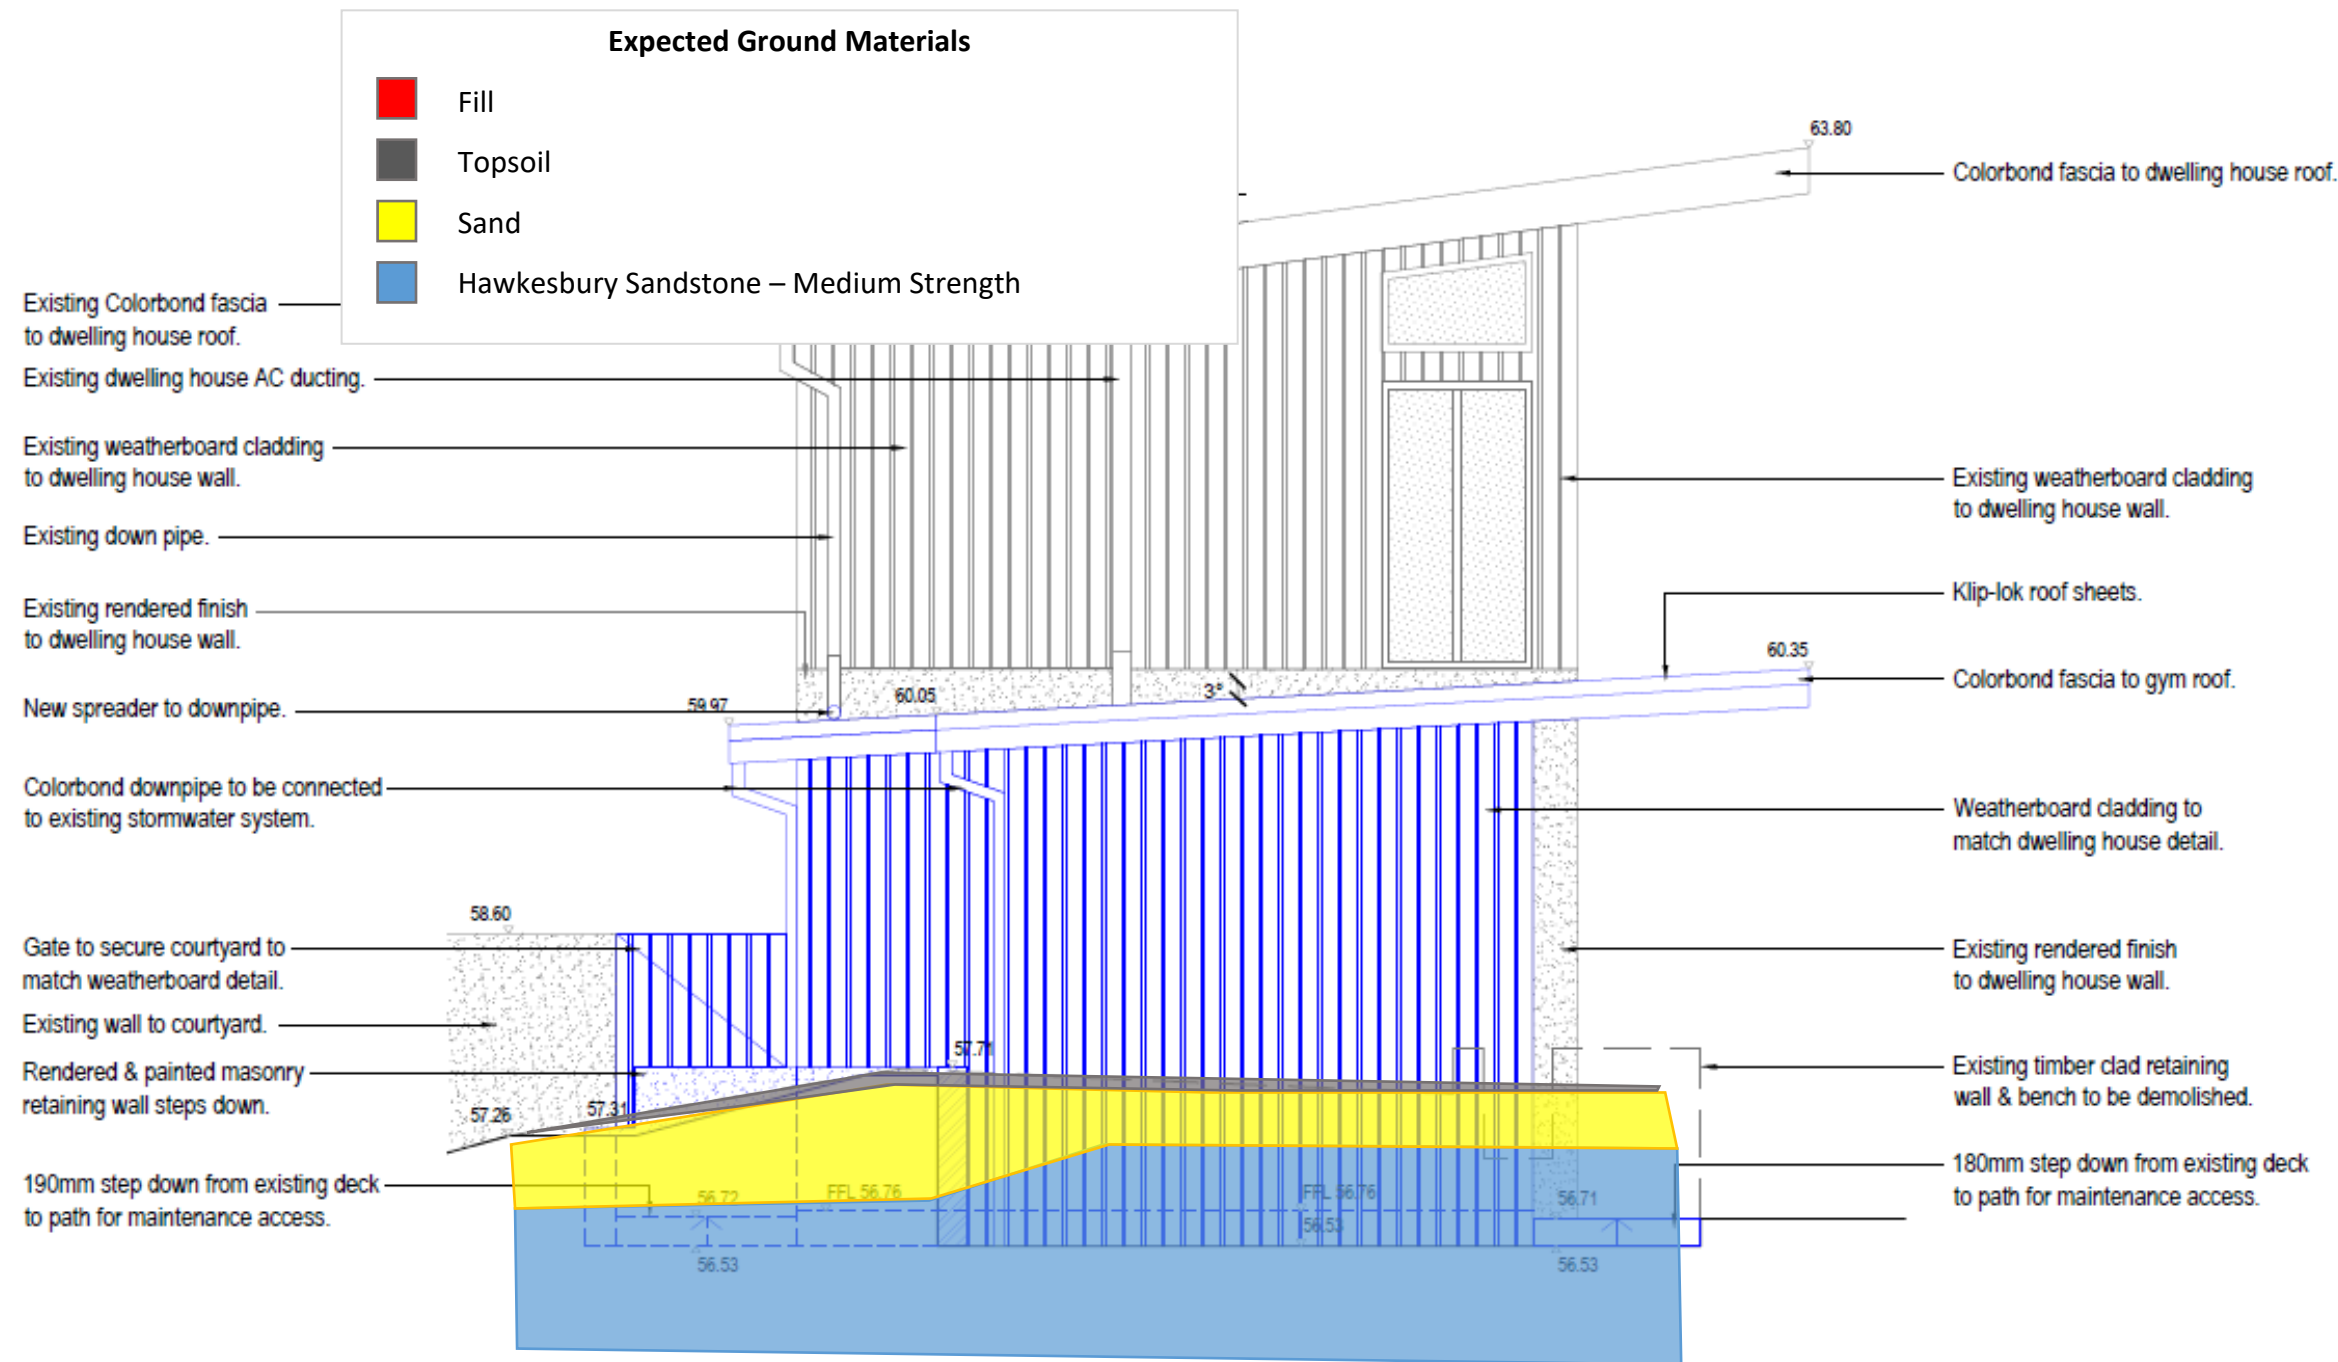
TYPE SECTION – Diagrammatical Interpretation of expected Ground Materials

sands that fill the bench step formation. In the test locations, where the rock is not exposed, the depth to rock ranged between 0.3 to 0.9m below the current surface, being slightly deeper due to the stepped nature of the underlying bedrock. The outcropping sandstone on the property is estimated to be medium strength or better and similar strength rock is expected to underlie the entire site. See Type Section attached for a diagrammatical representation of the expected ground materials.
