Scan Report

Date: 19/5/21

Client Name: McNally Management

Site Address: 21 Middleton Rd Cromer

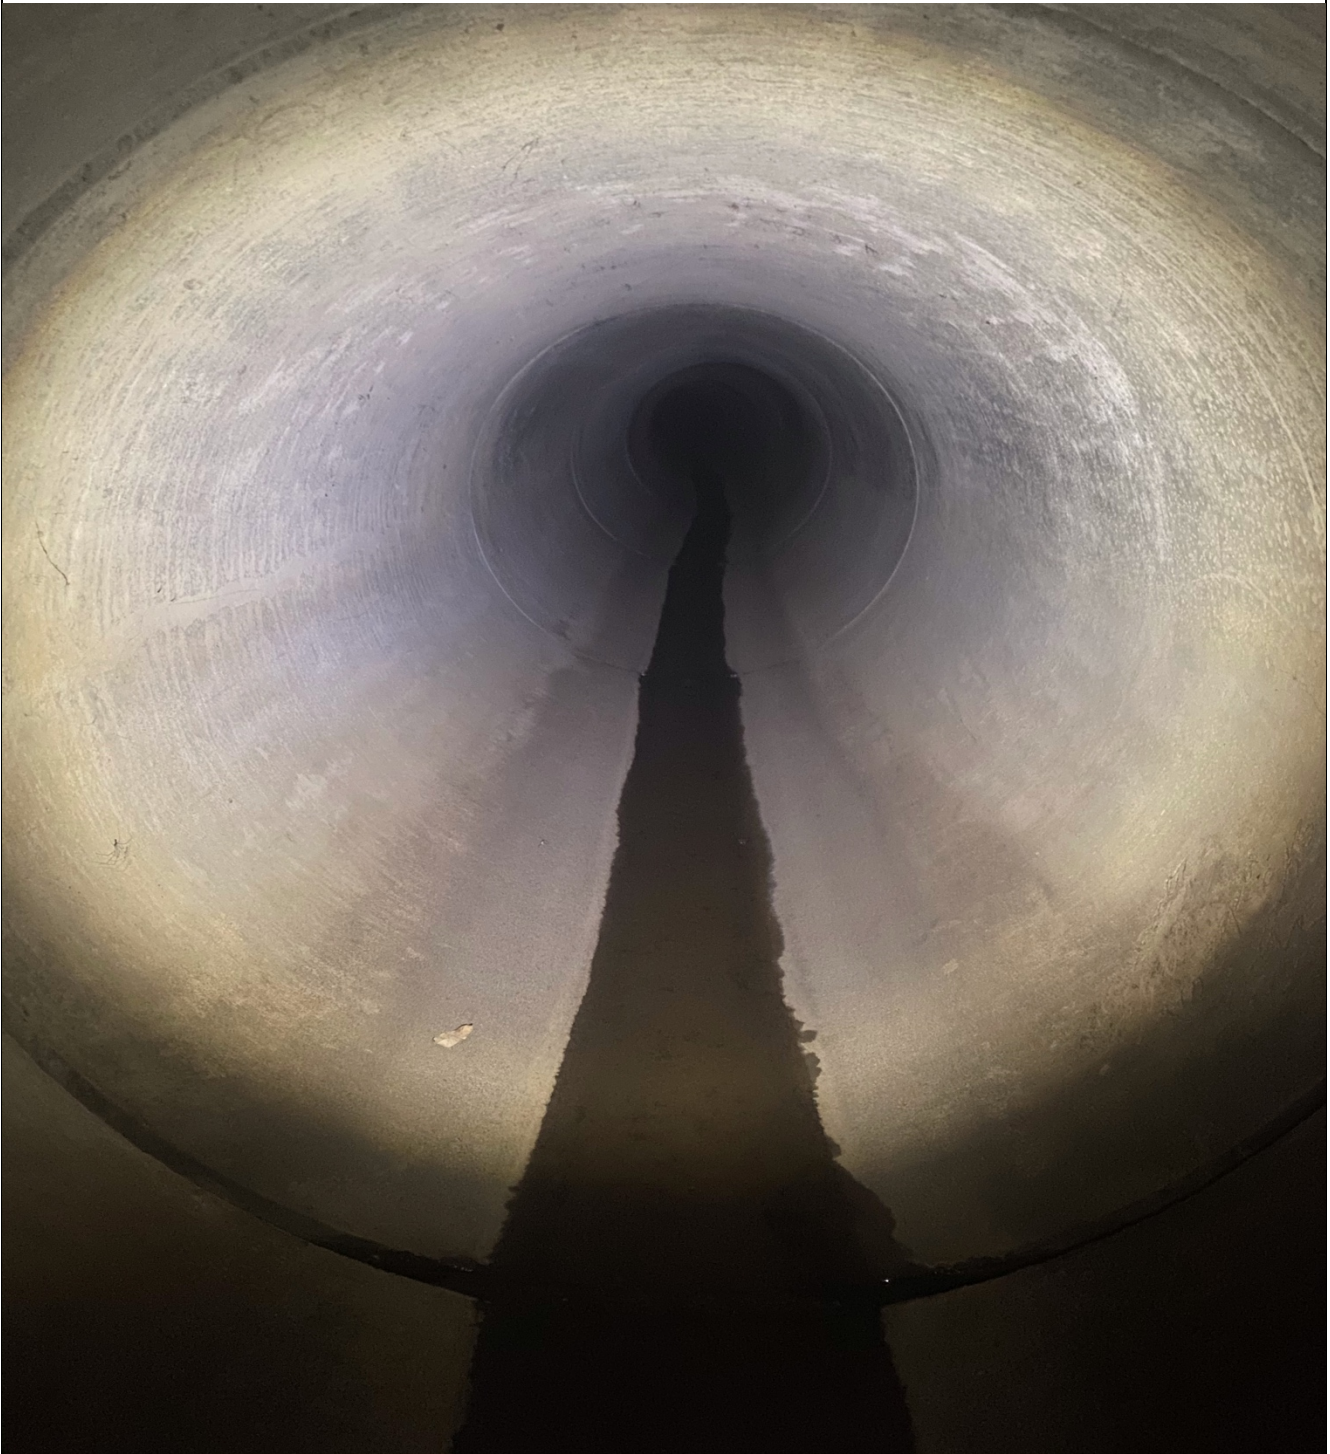
Pipe towards access “b”:

Continuing on from access “b” the condition of the pipe itself was in excellent condition without compression cracking, breaks, defects or miss joined segments. The transmitter was placed at points of visually noticeable turns or height changes in the stormwater pipe and the pinpointed on the surface and recorded by the surveyor.

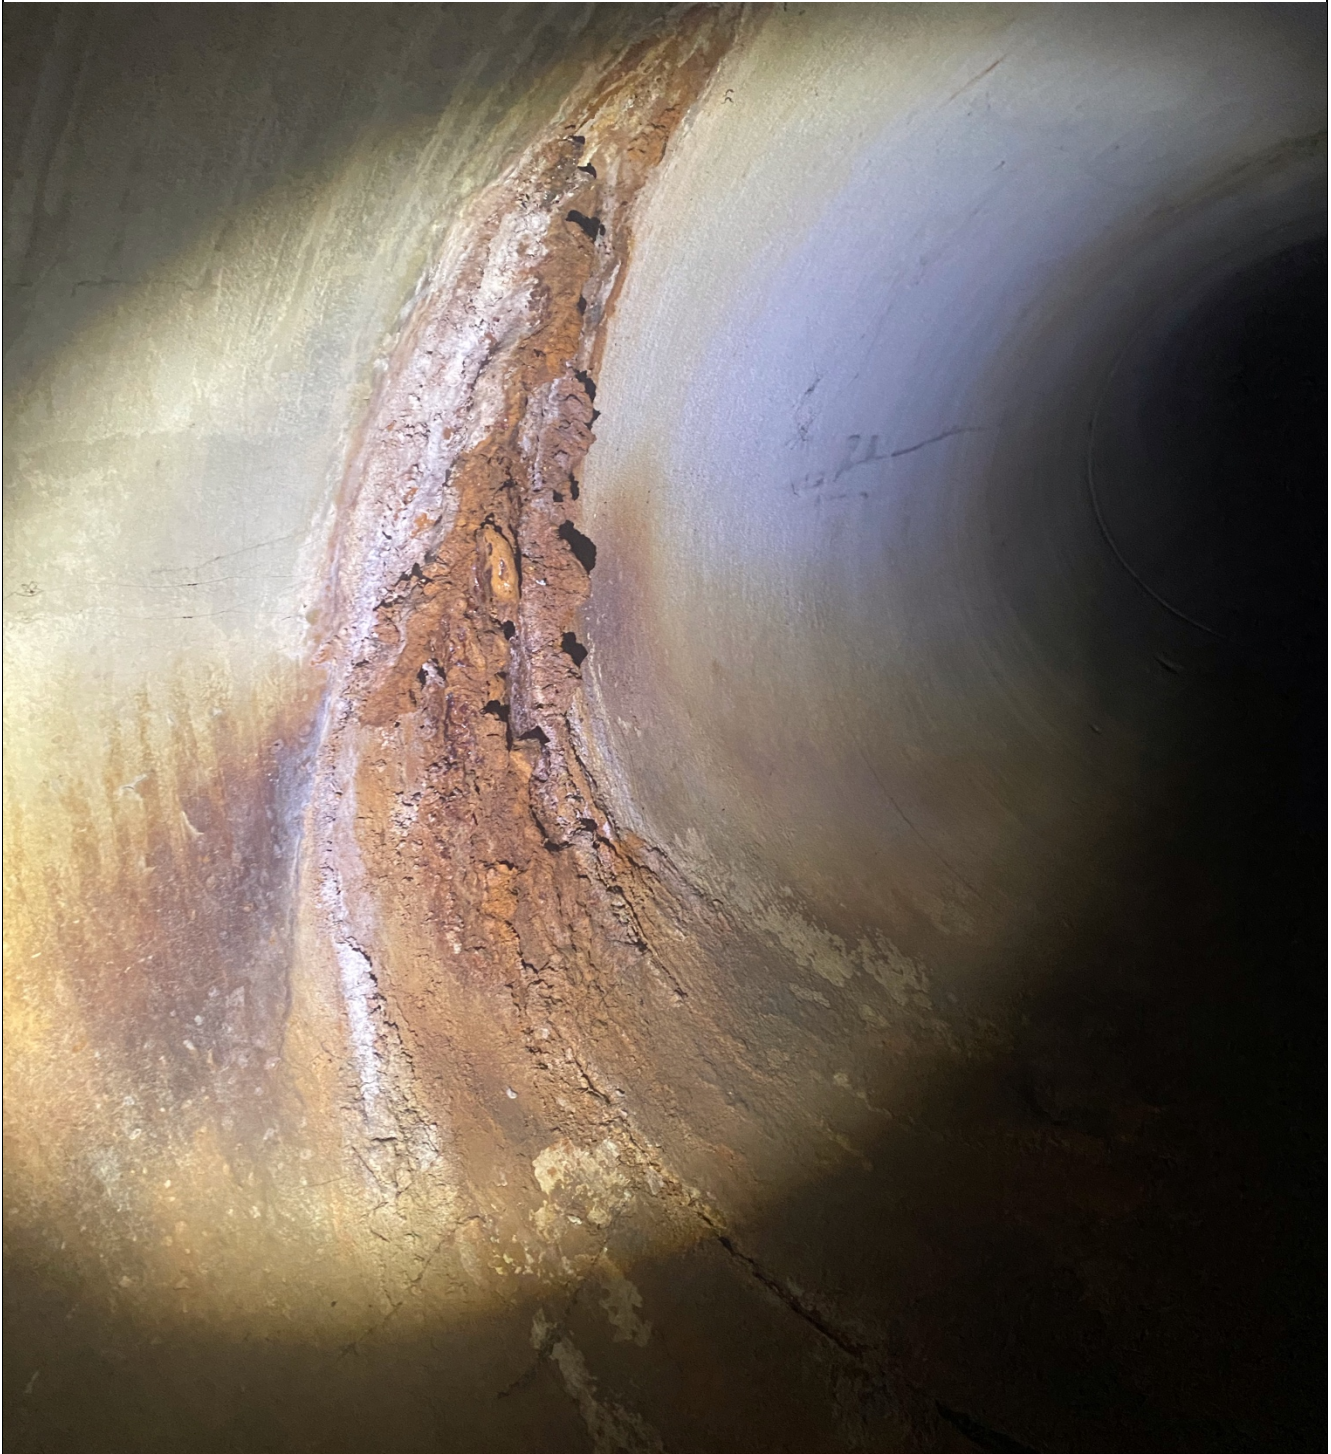
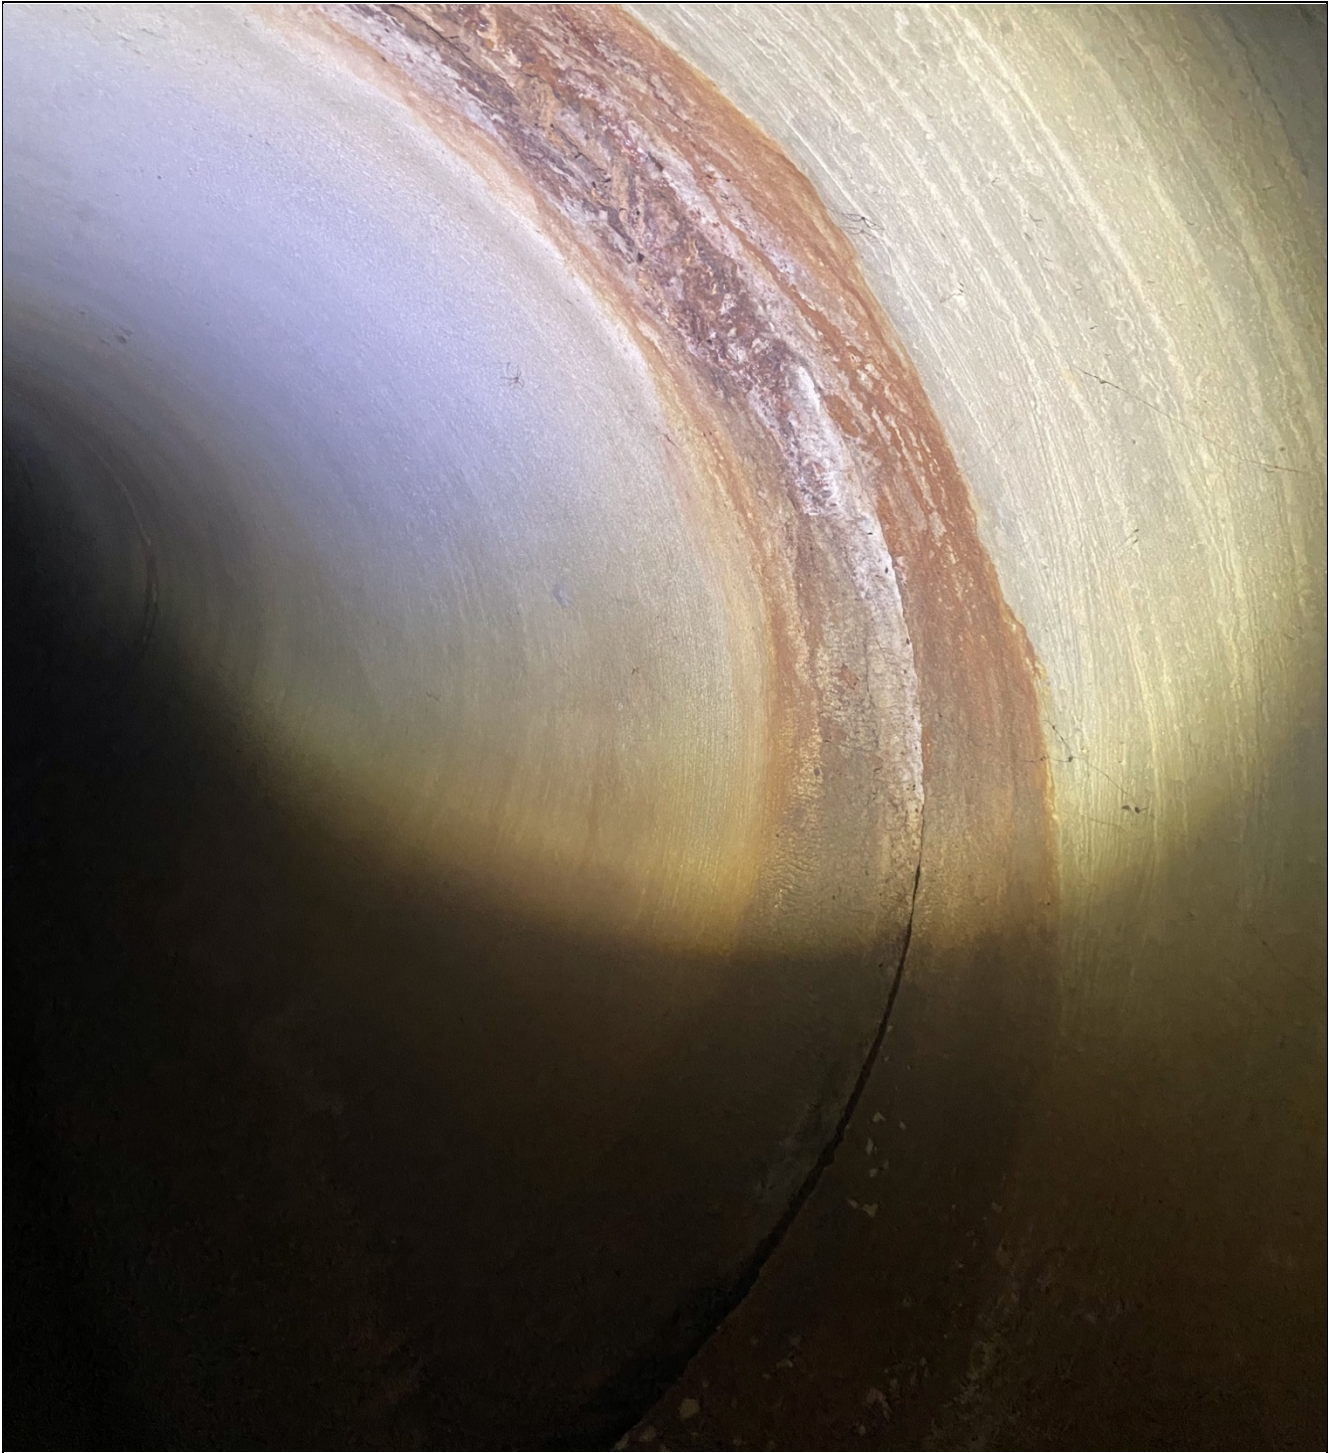
During the entire length of the stormwater pipe there was only one area of noticeable degradation which has been documented below which included surface rust and calcium and/or lime buildup.

Degradation between access “b” and pit “c”:

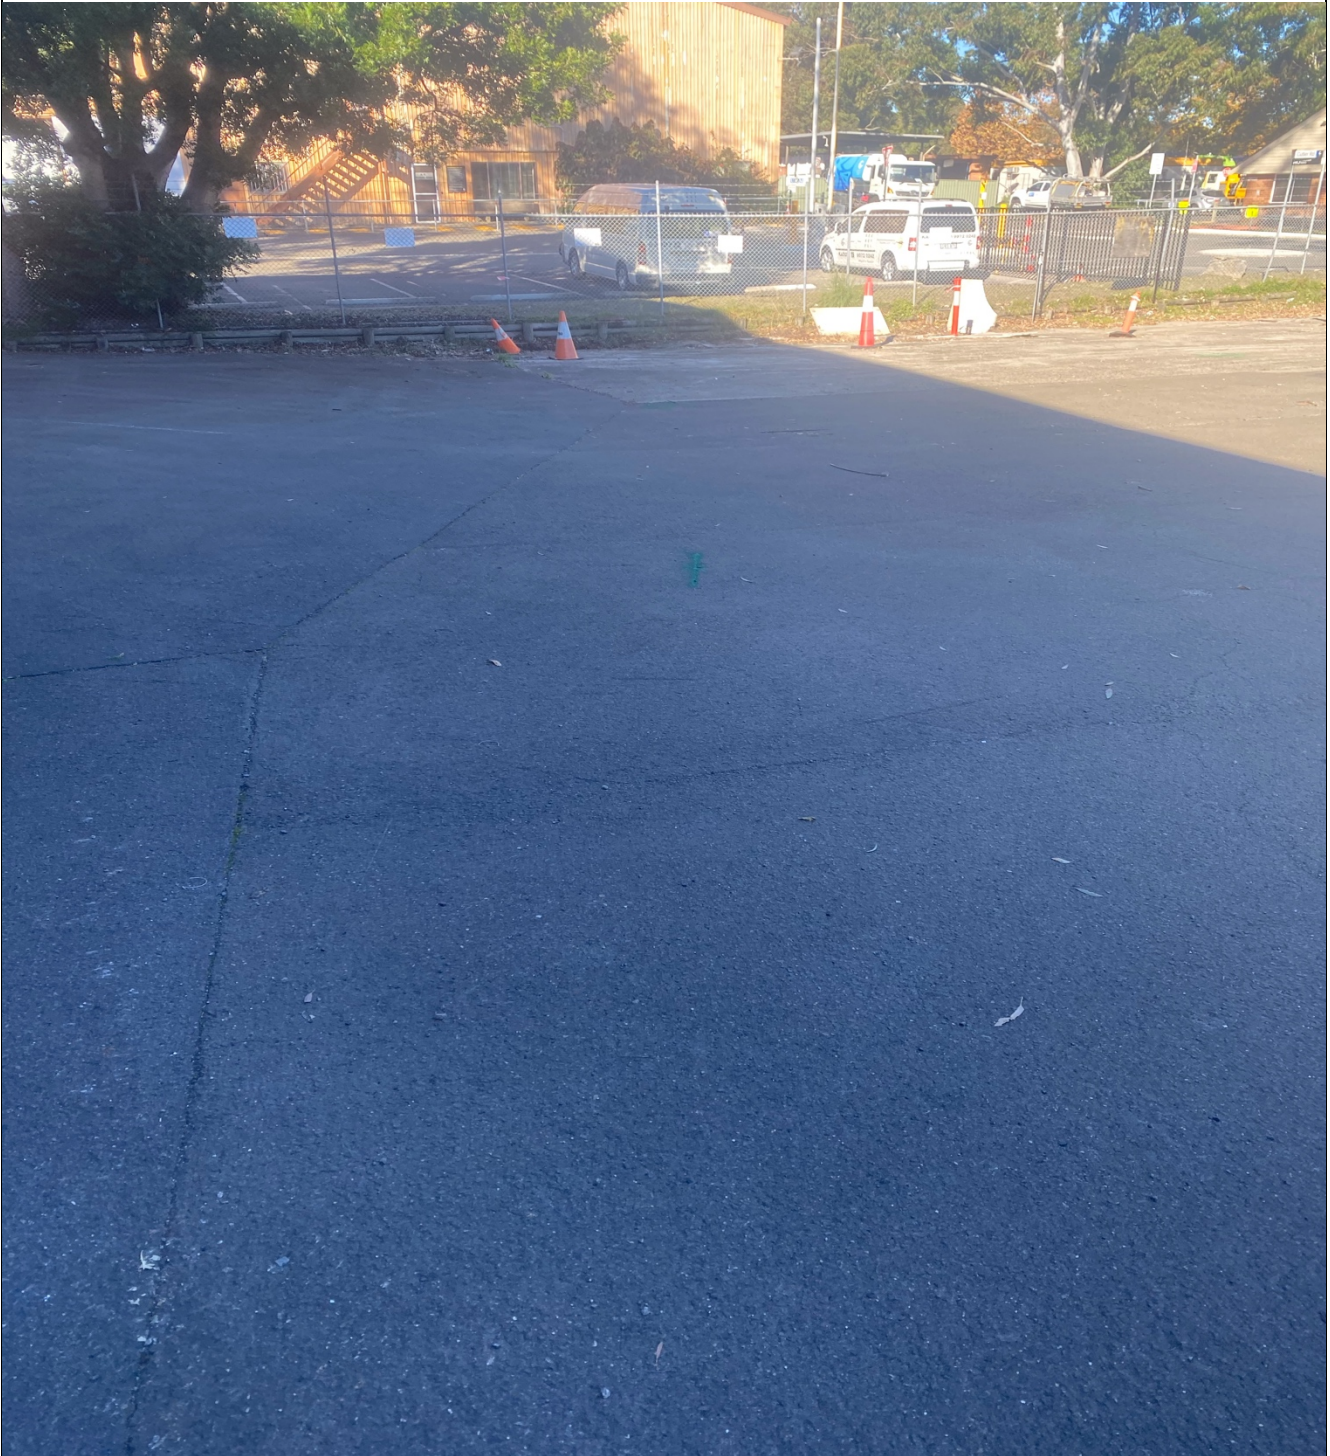
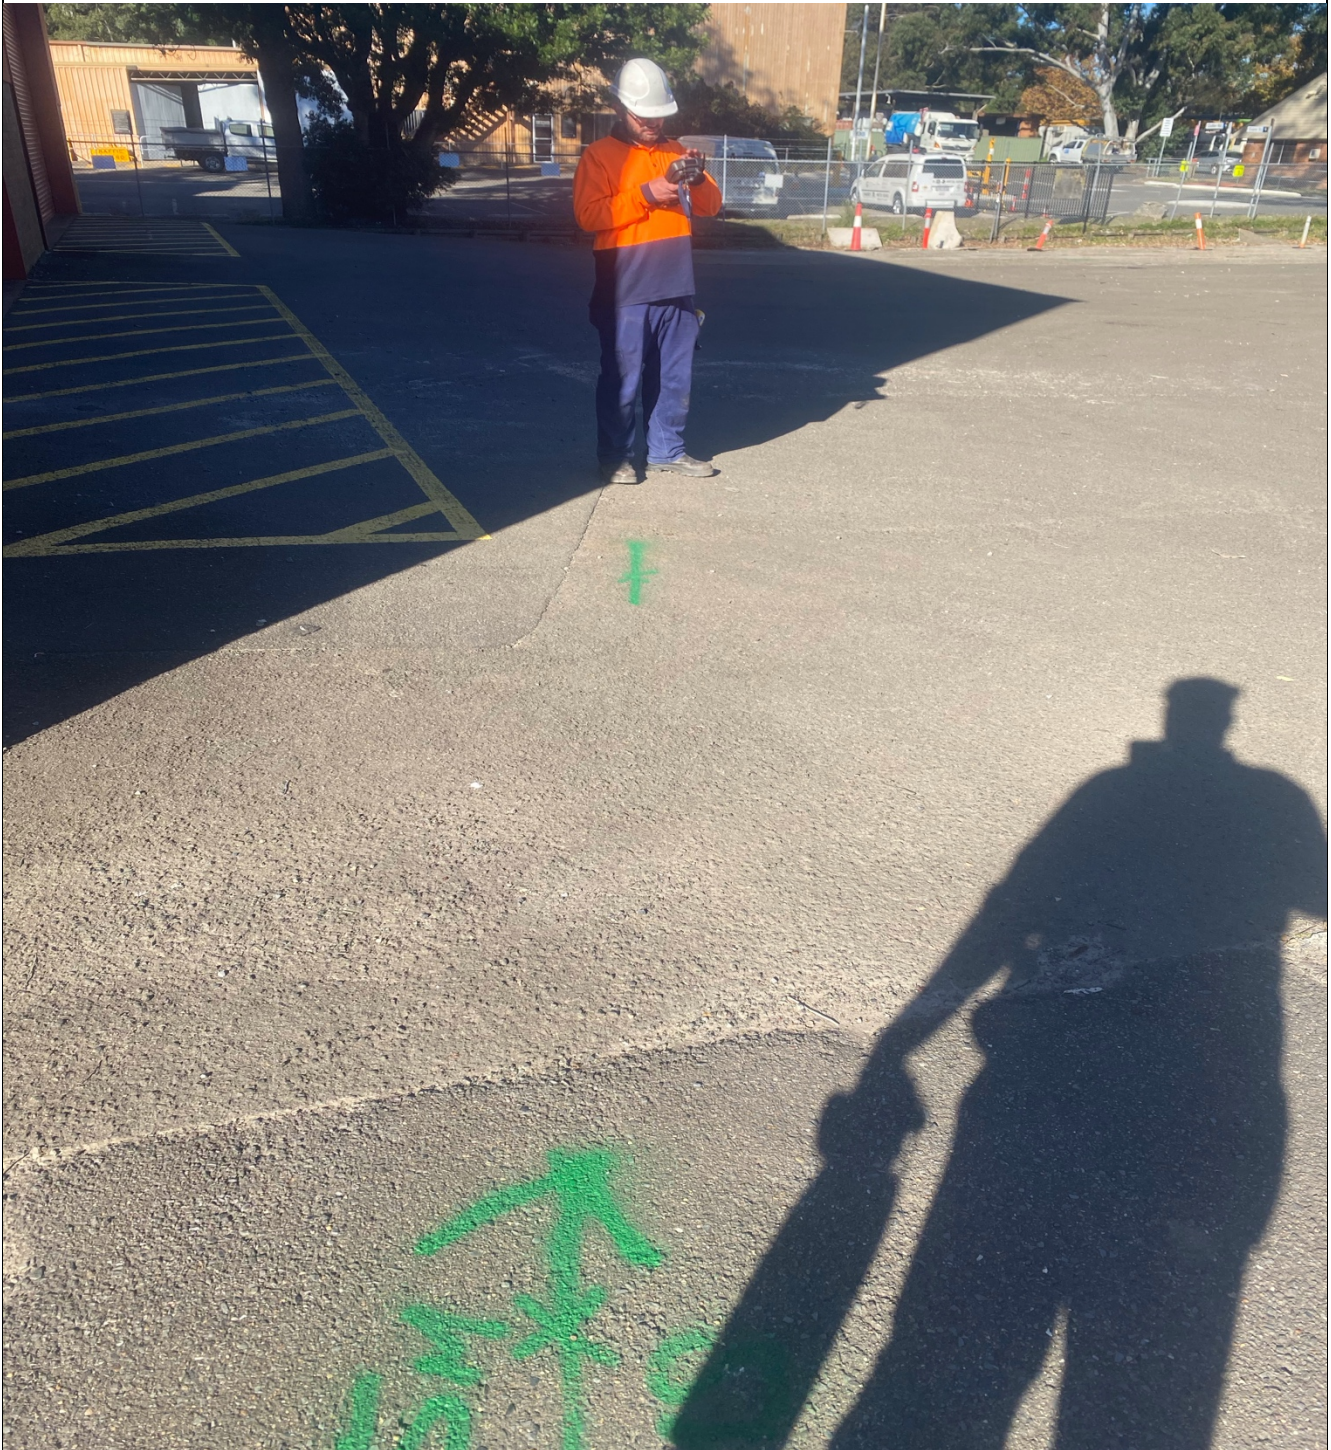
Pit "c" to corner of large shed:

Once the pit “c” was reached there were multiple inlets noted, of interest was the 700mm diameter pipe which was leading back to the corner of the large shed approximately 40m and on a 45° horizontal plane from the main stormwater line. This pipeline was traced back to the retention pit next to the large shed.
