Scan Report

Date: 19/5/21

Client Name: McNally Management

Site Address: 21 Middleton Rd Cromer

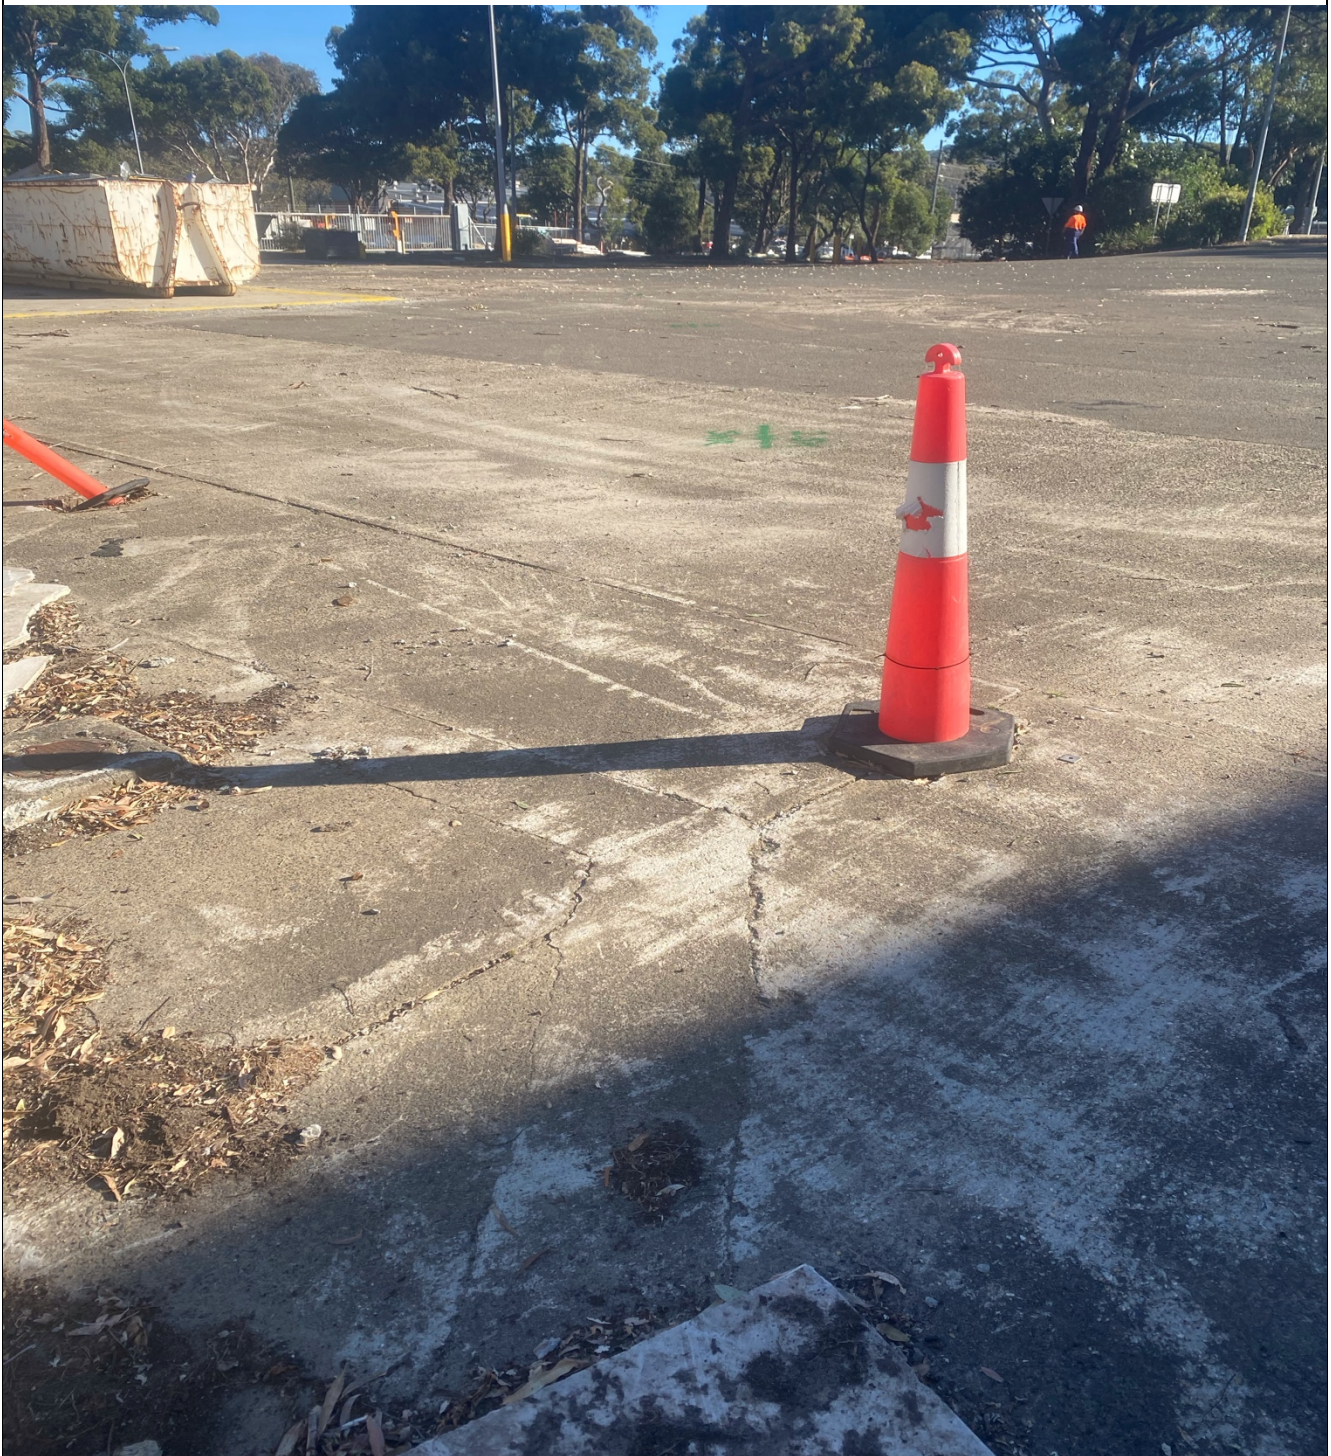
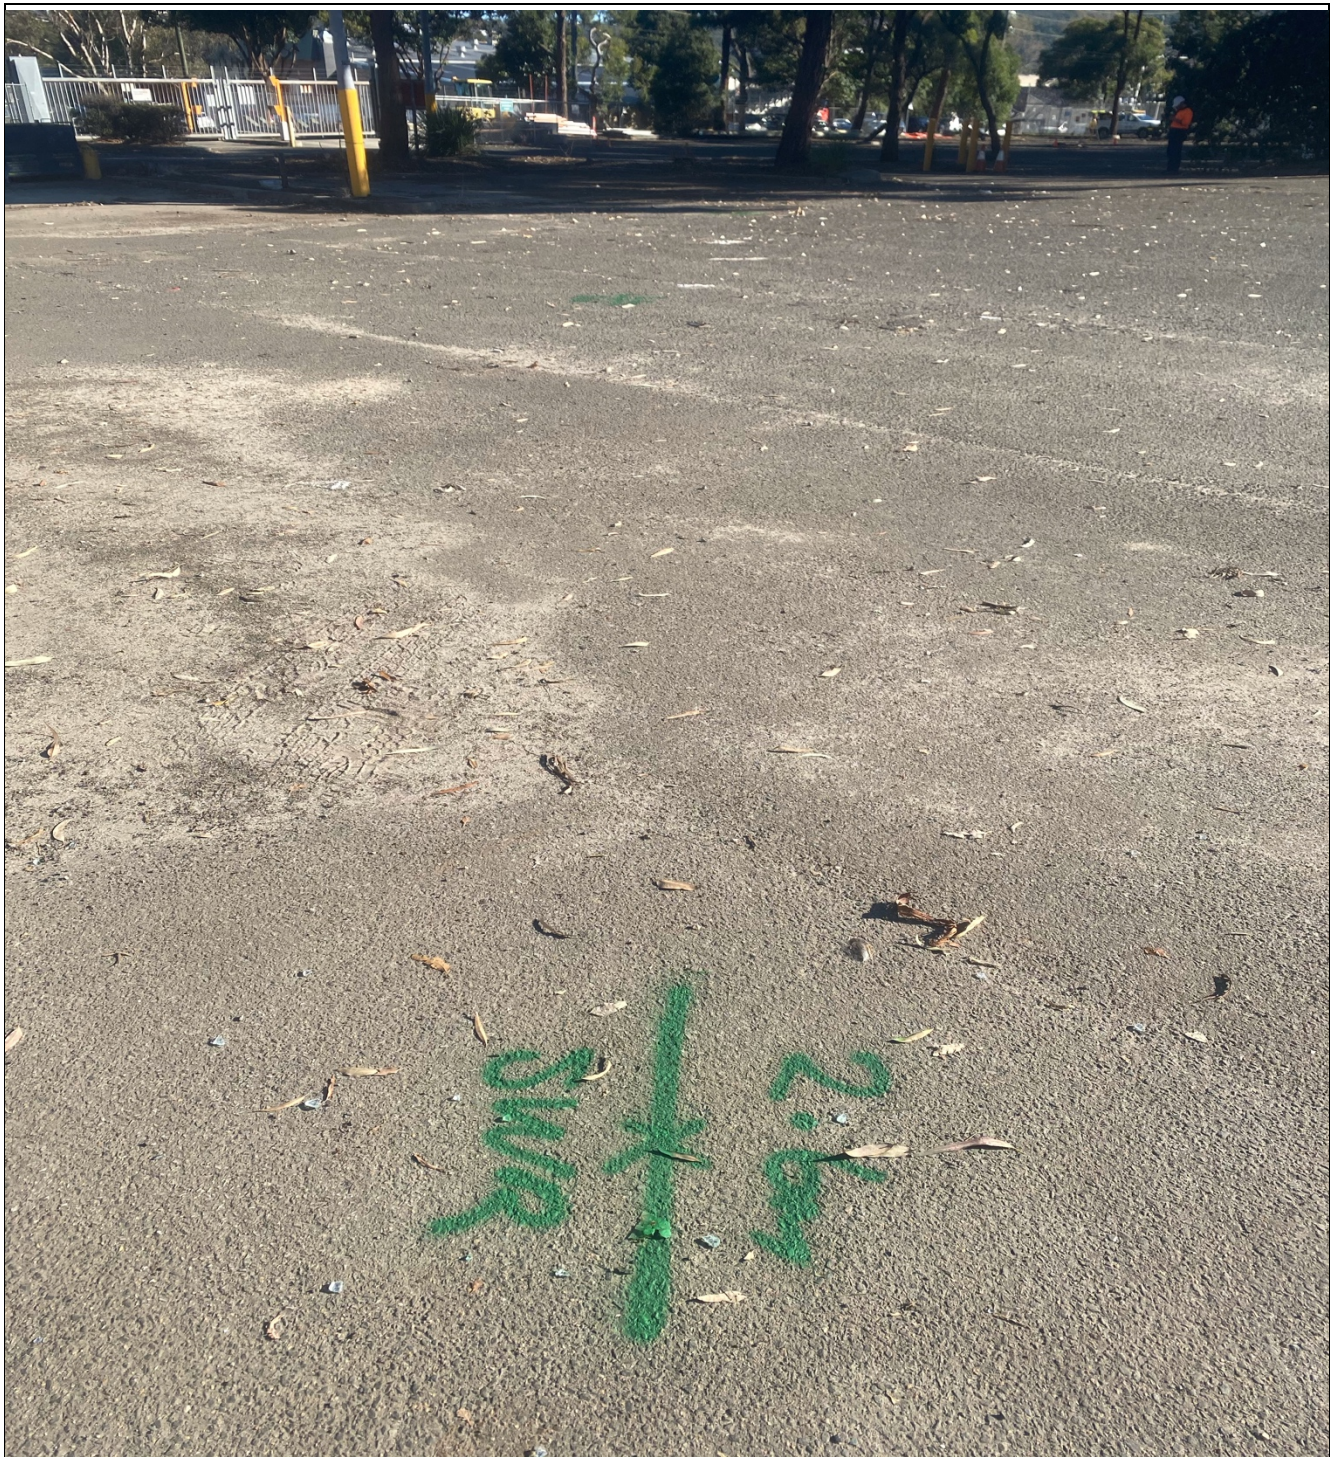
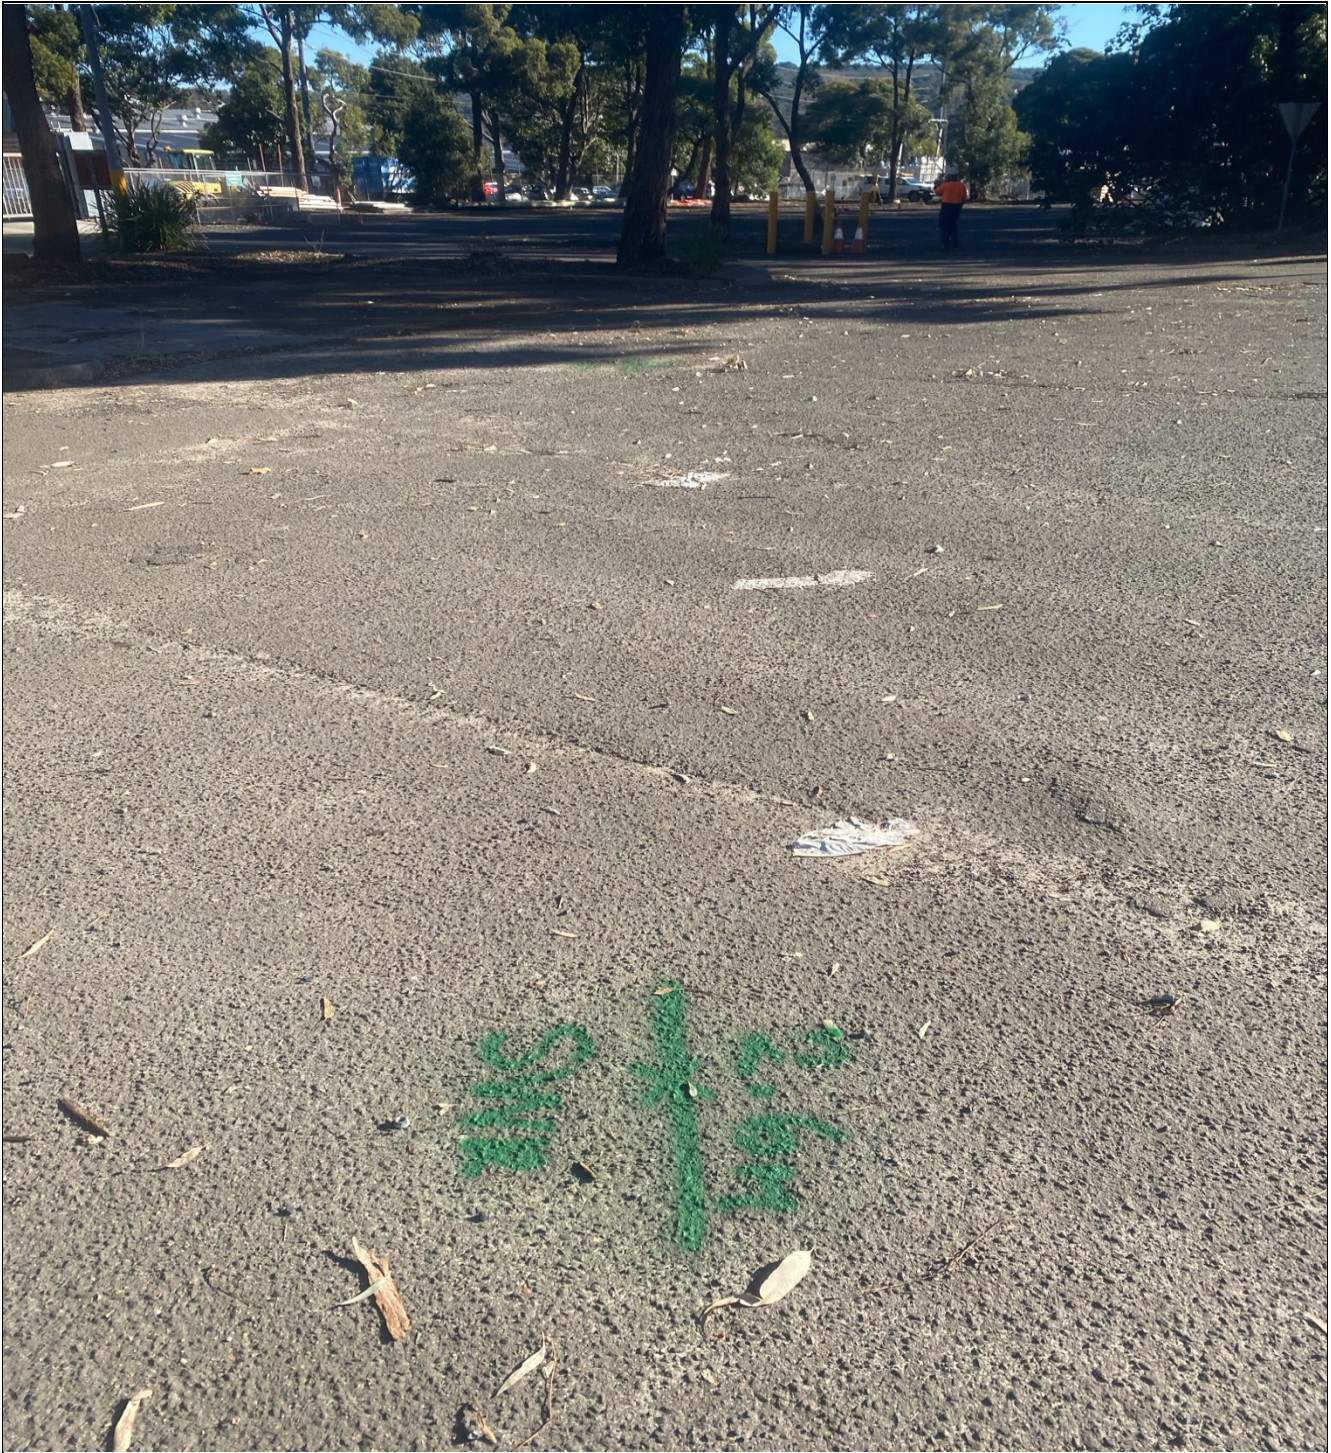
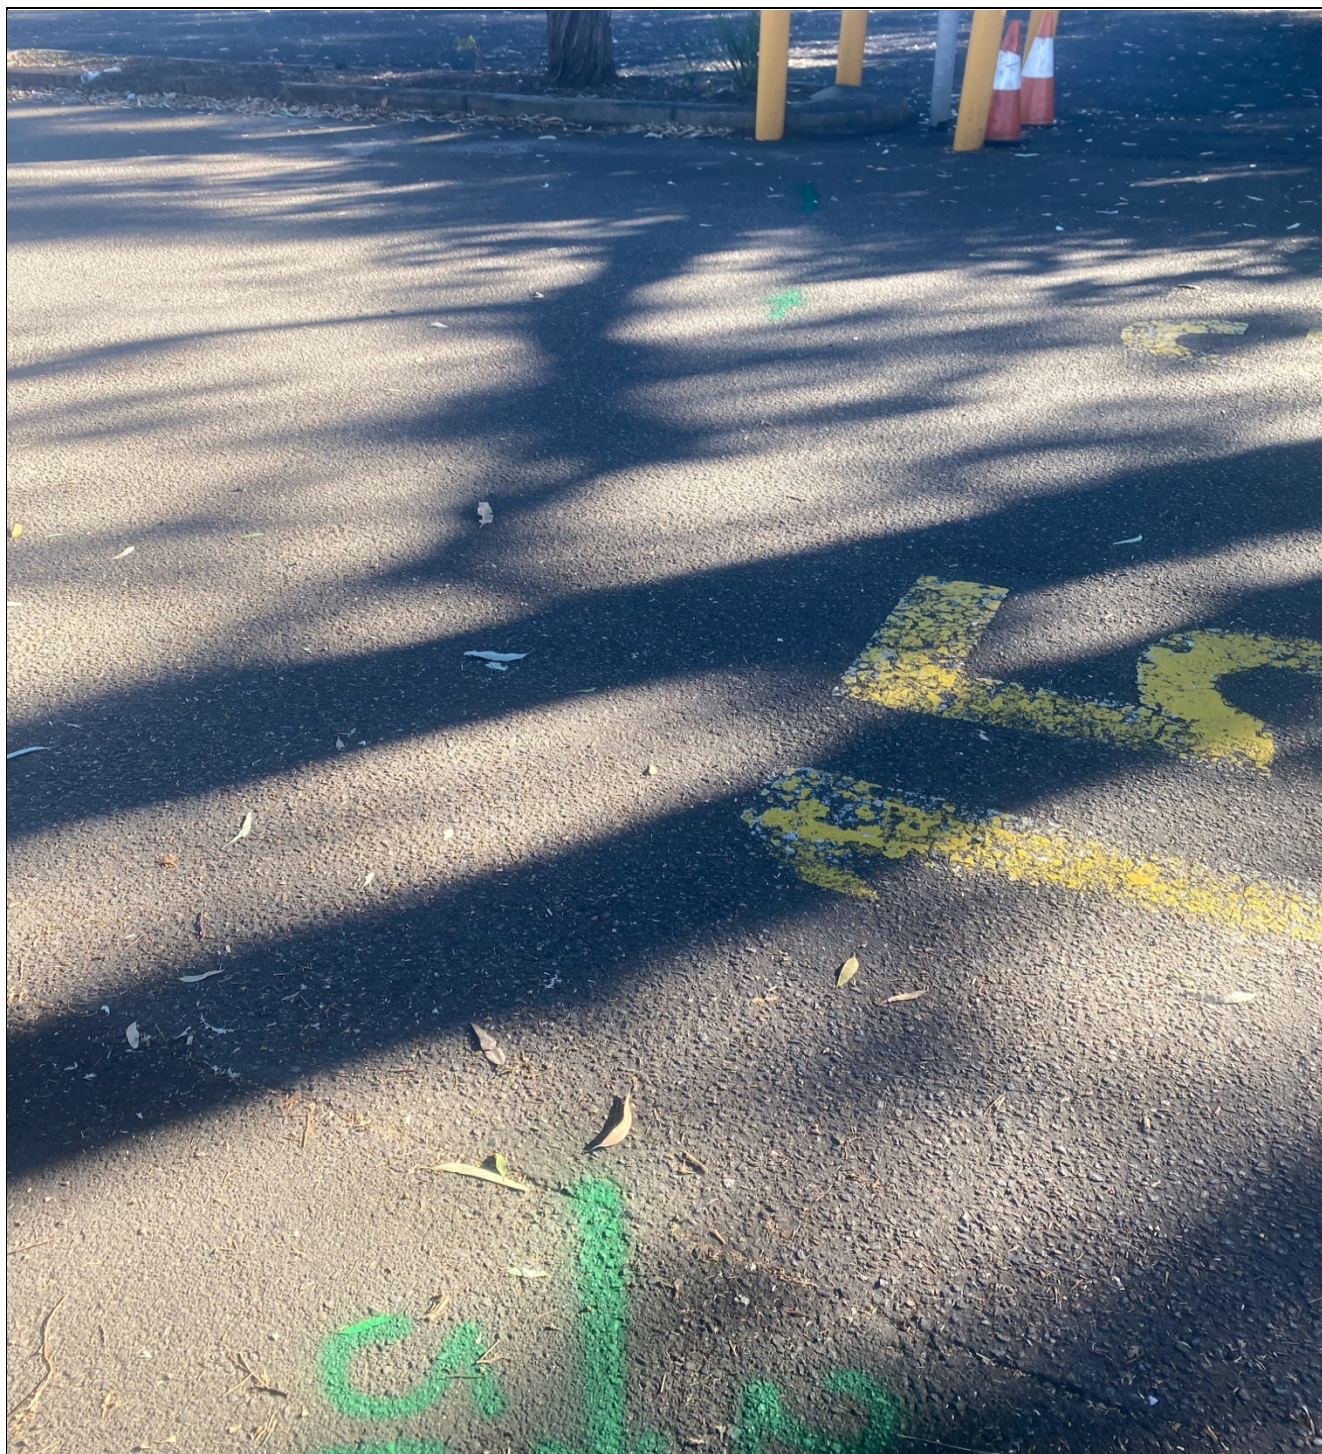
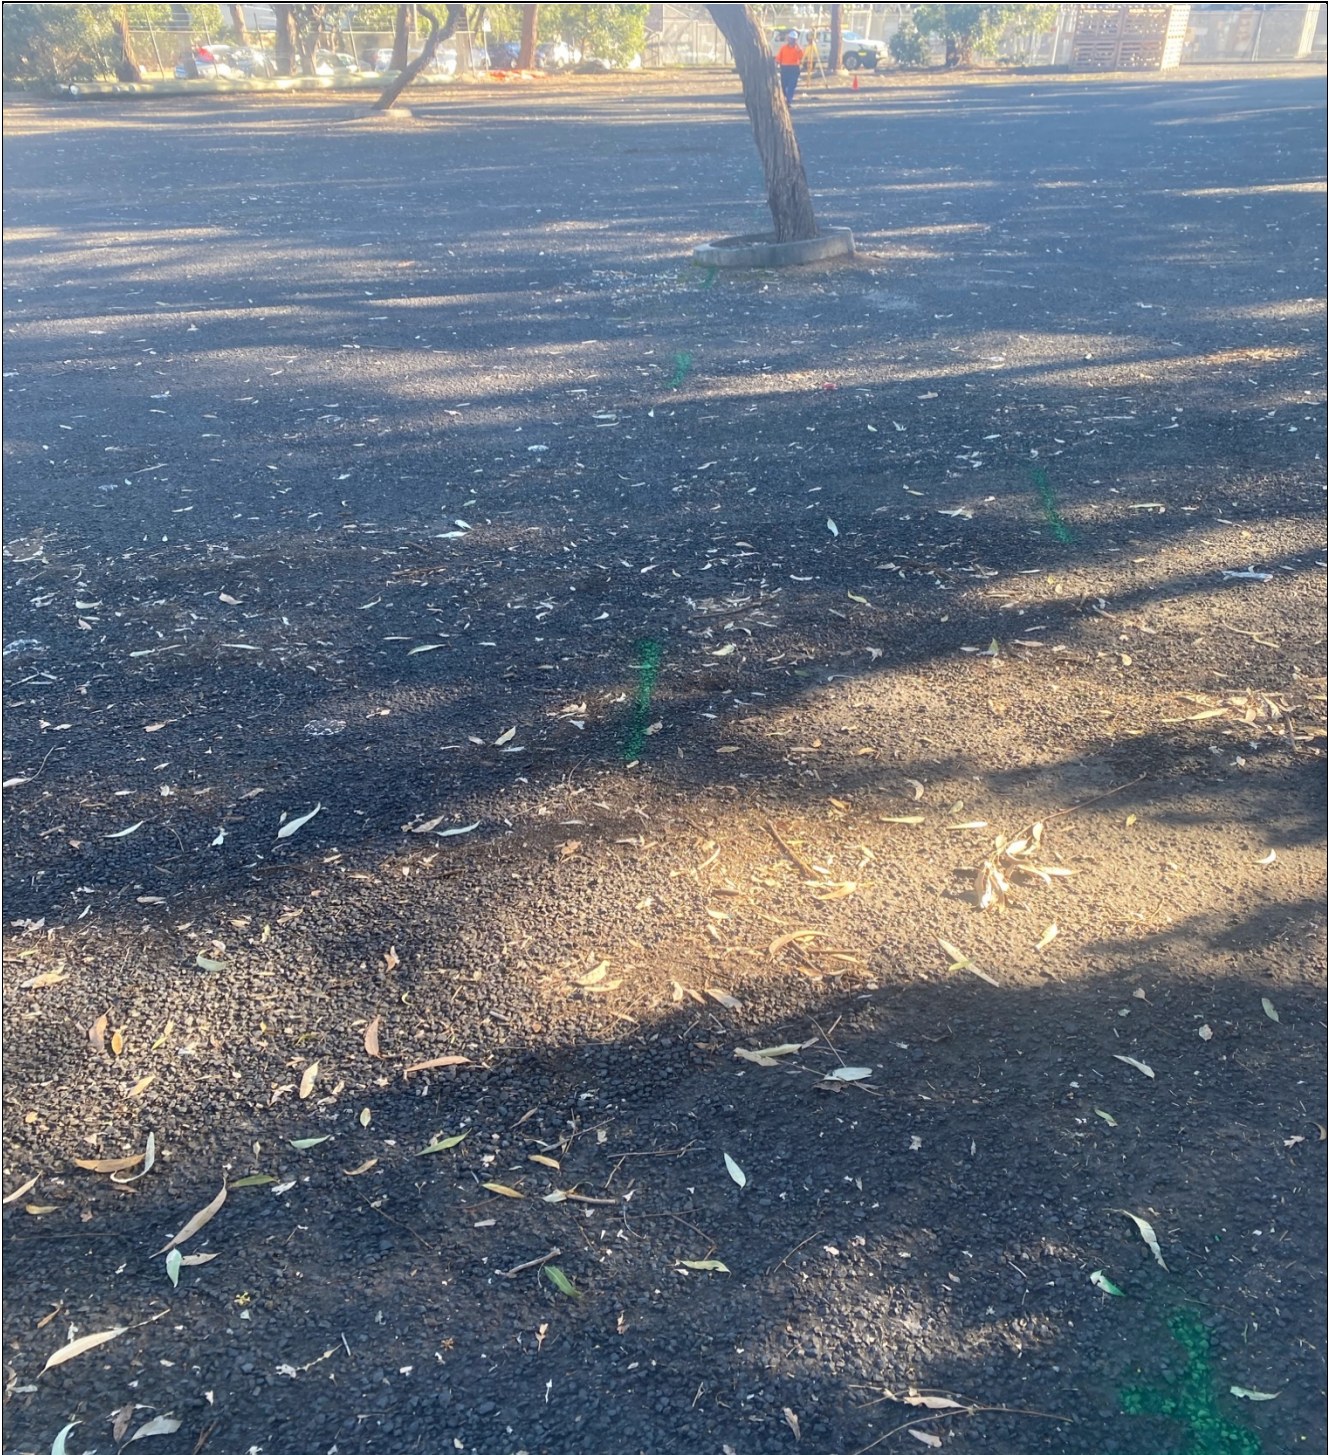
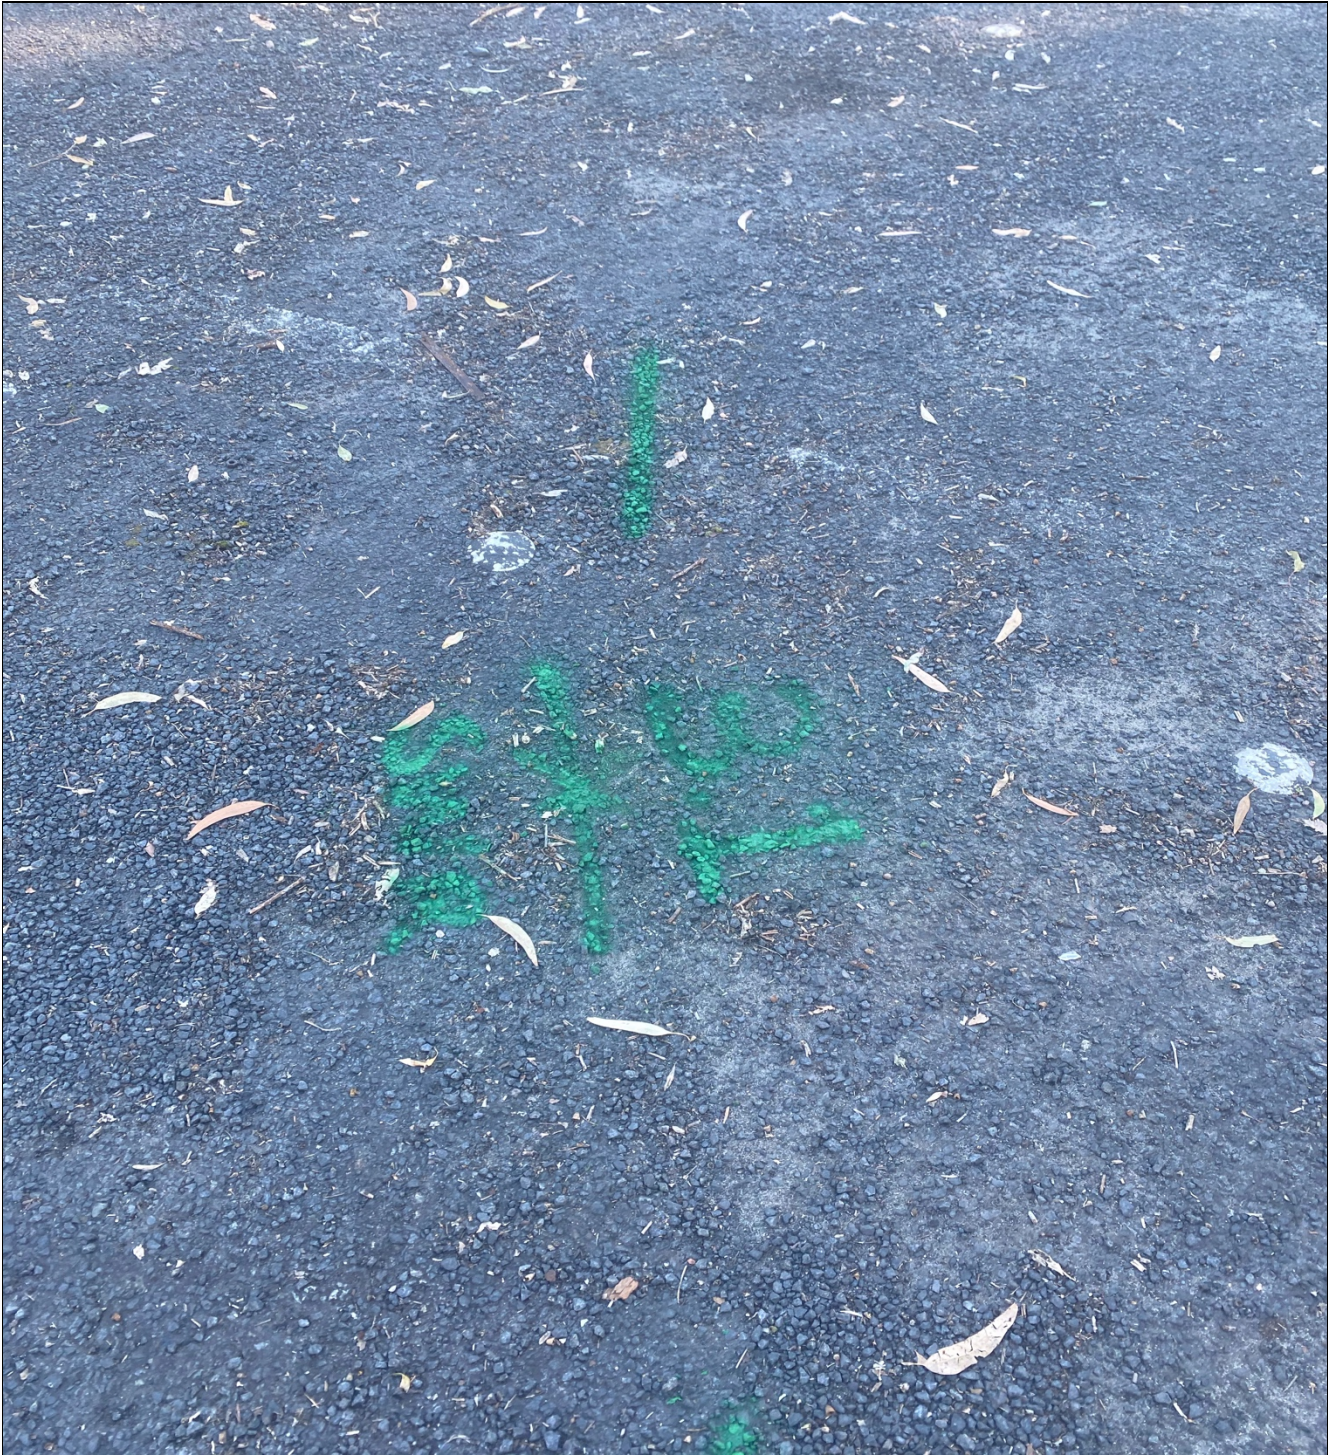
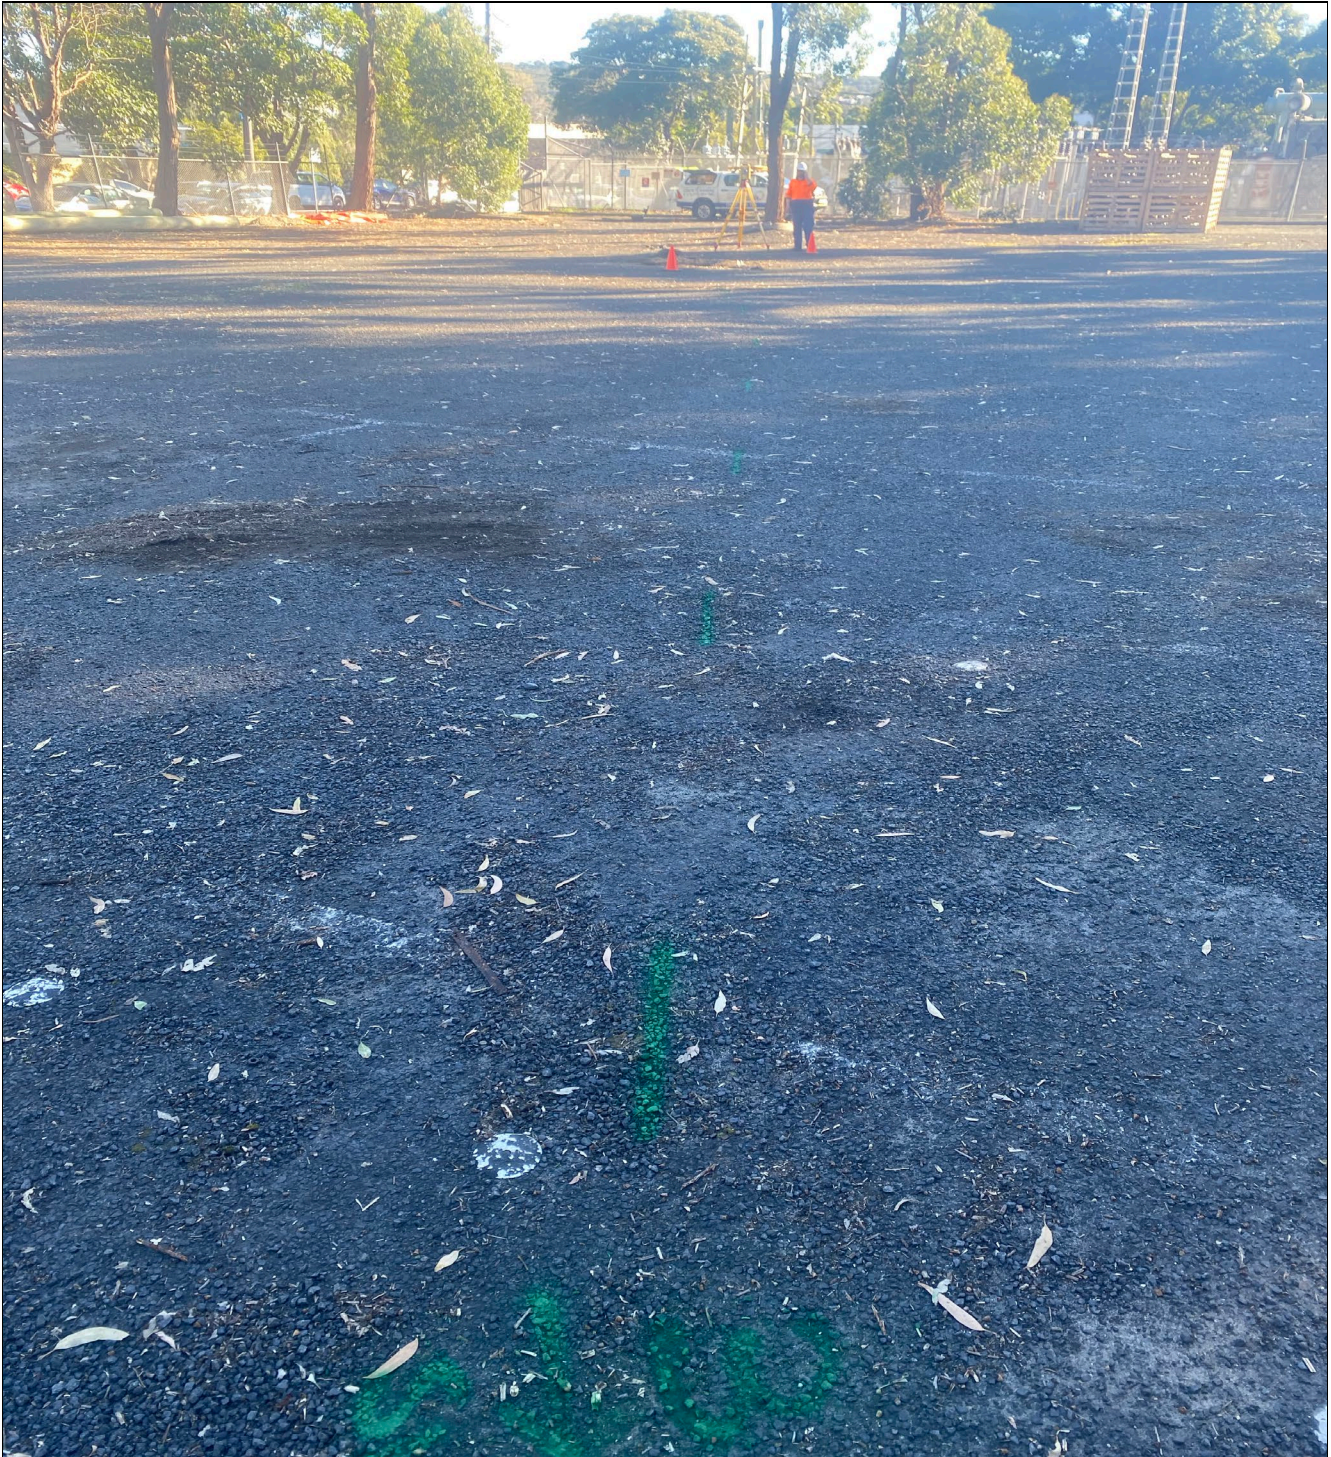
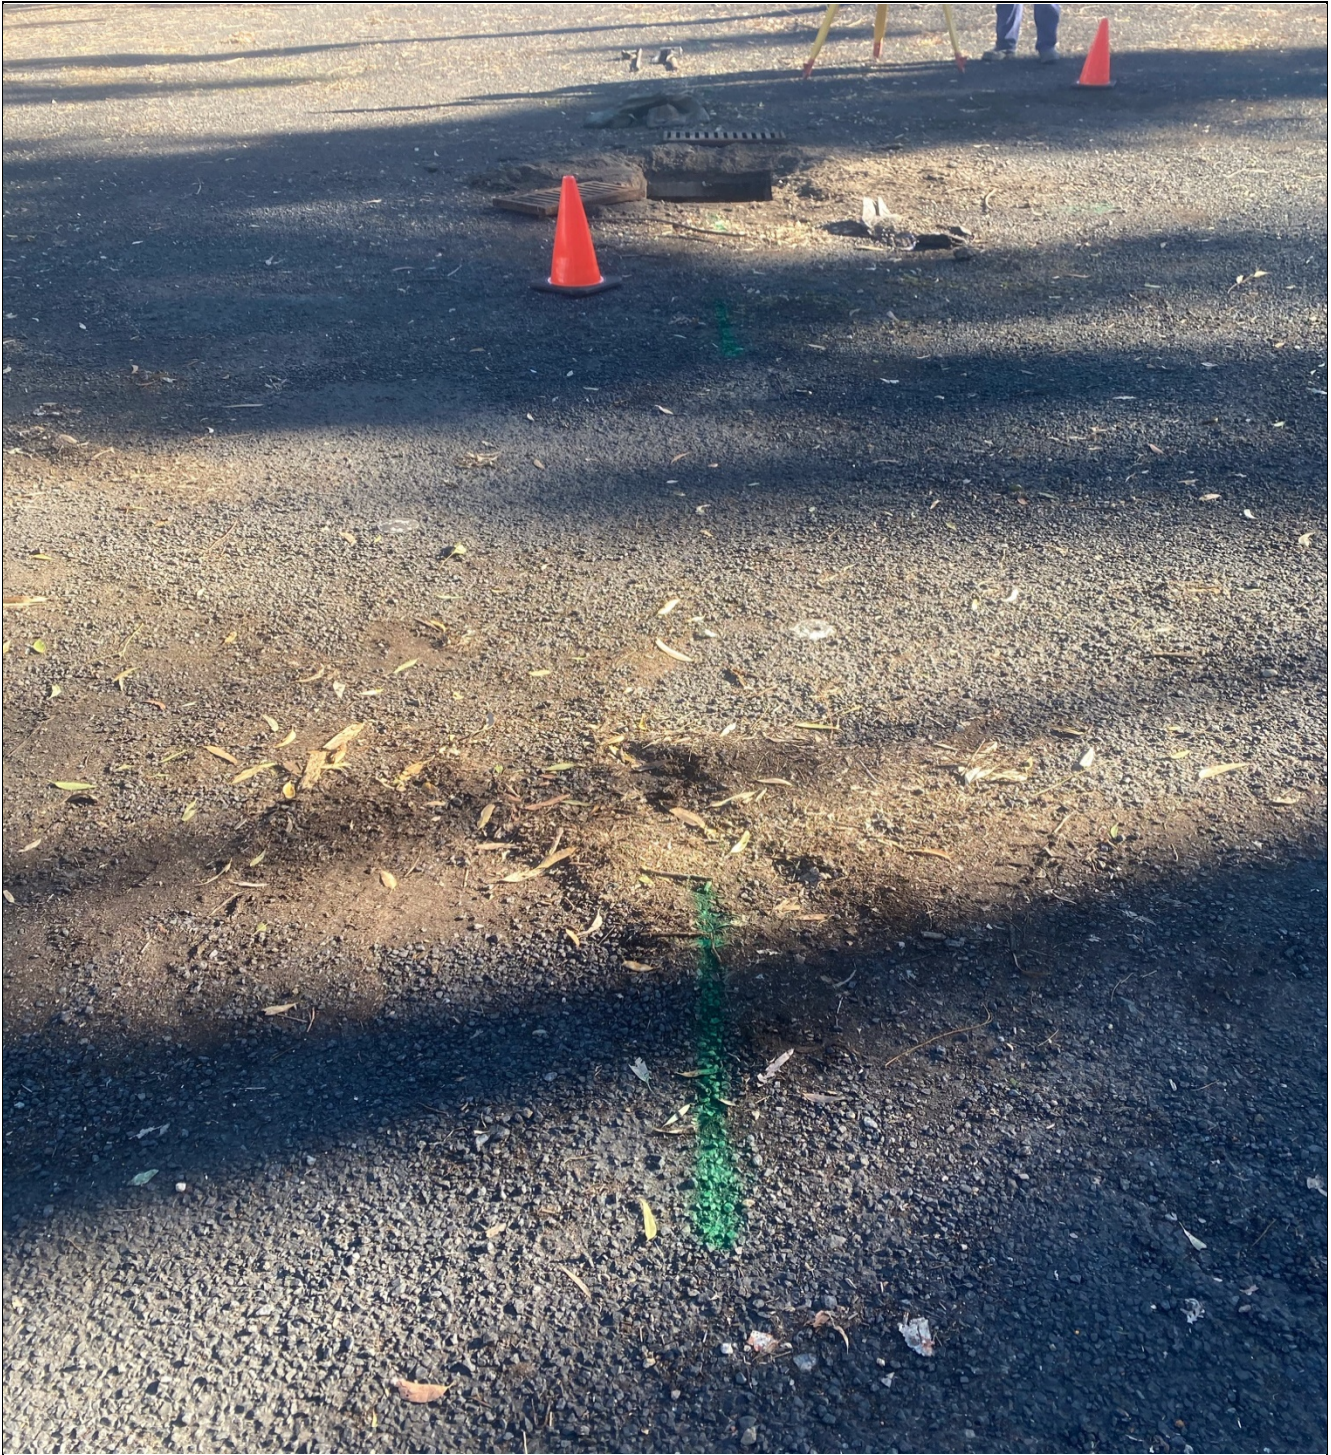
Pit "c" back to access "b":

From access “b” to pit “c” there are no further access points over the approximate 100m distance. Other than the previously mentioned degradation the pipeline presents in almost new condition.

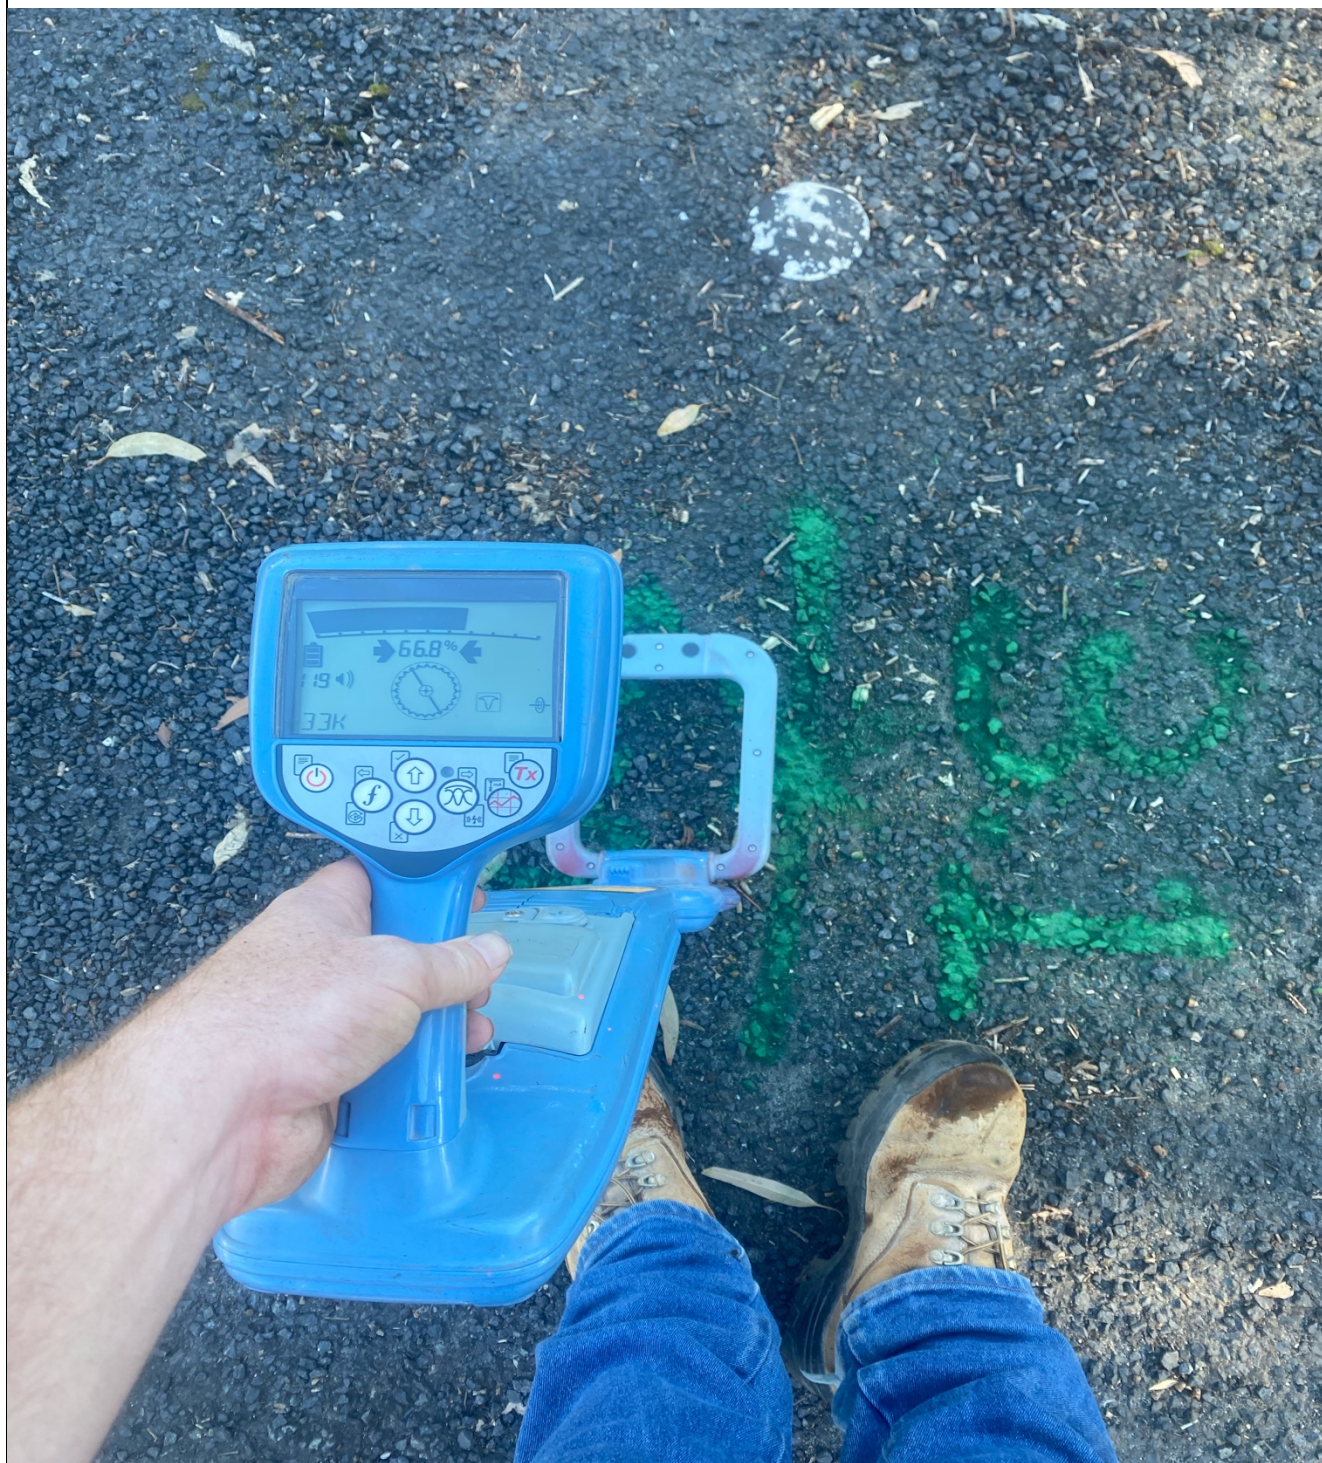
Emf locating of transmitter:

Upon entering access “a” and travelling towards pit “c” a vertical access point was noted a 33khz transmitter was placed in this access point and then the emf was traced from the surface to give exact depth and location of the transmitter. Once marked and recorded by the on-site surveyor the asphalt was breached and removed to use the access point for the confined space. There was a 700mm diameter pipe noted and discussed with the surveyor who informed me he was already familiar with the location and end point of above mentioned branch.
