Report on
Geotechnical Investigation

Proposed Development
46 Prince Alfred Parade, Newport

Prepared for
Adams Consulting Engineers Pty Ltd

Project 212173.00
July 2023

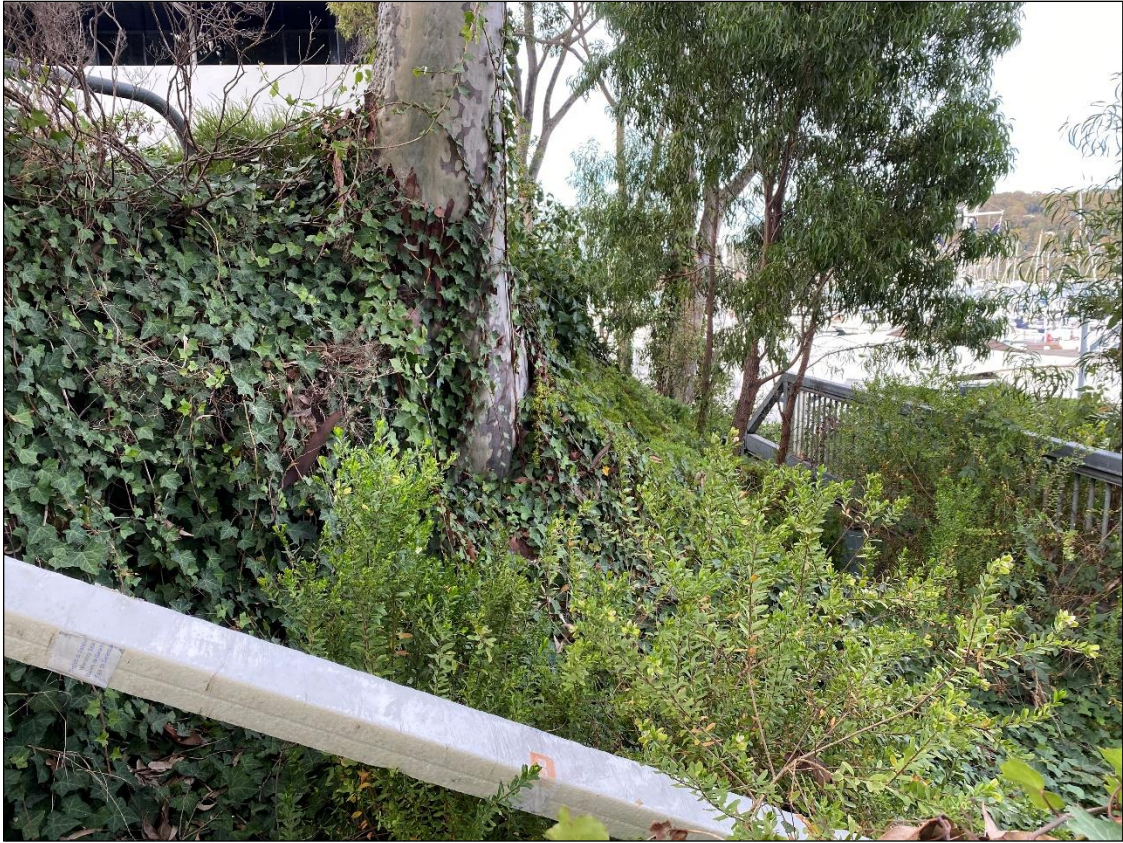
Photo 1: Existing Batter, looking south-west. Heavily vegetated. No leaning trees observed.

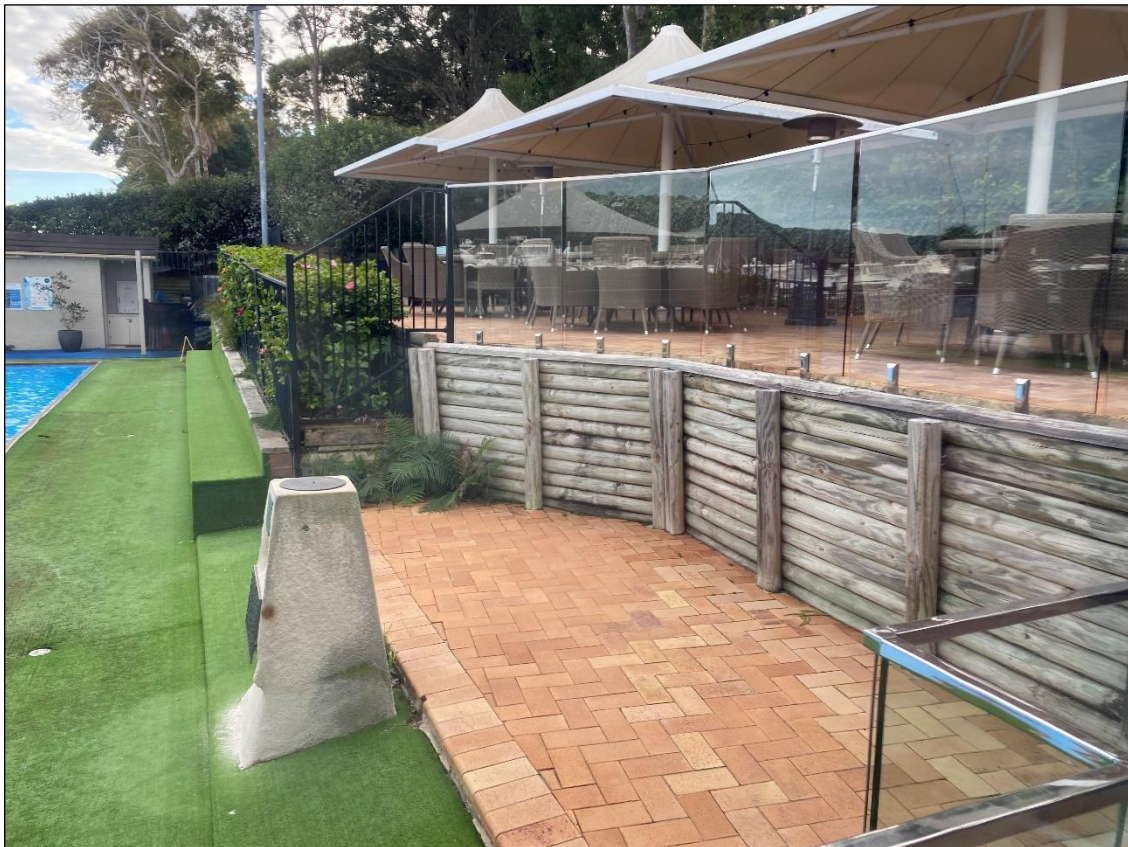
Photo 2: Terrace area, looking north-east.

- Some shallow timber retaining walls form the upper terrace area (Photo 2) showed some signs of bulging;
- Some weathered rock exposures were observed under the existing building, south of the vegetated slope within the proposed walkway area (Photo 5 and 6). The cut exposure showed light brown sandy clays, over yellow-orange colluvial sandy clays, over extremely weathered sandstone.

Timber retaining wall, showing some evidence of bulging

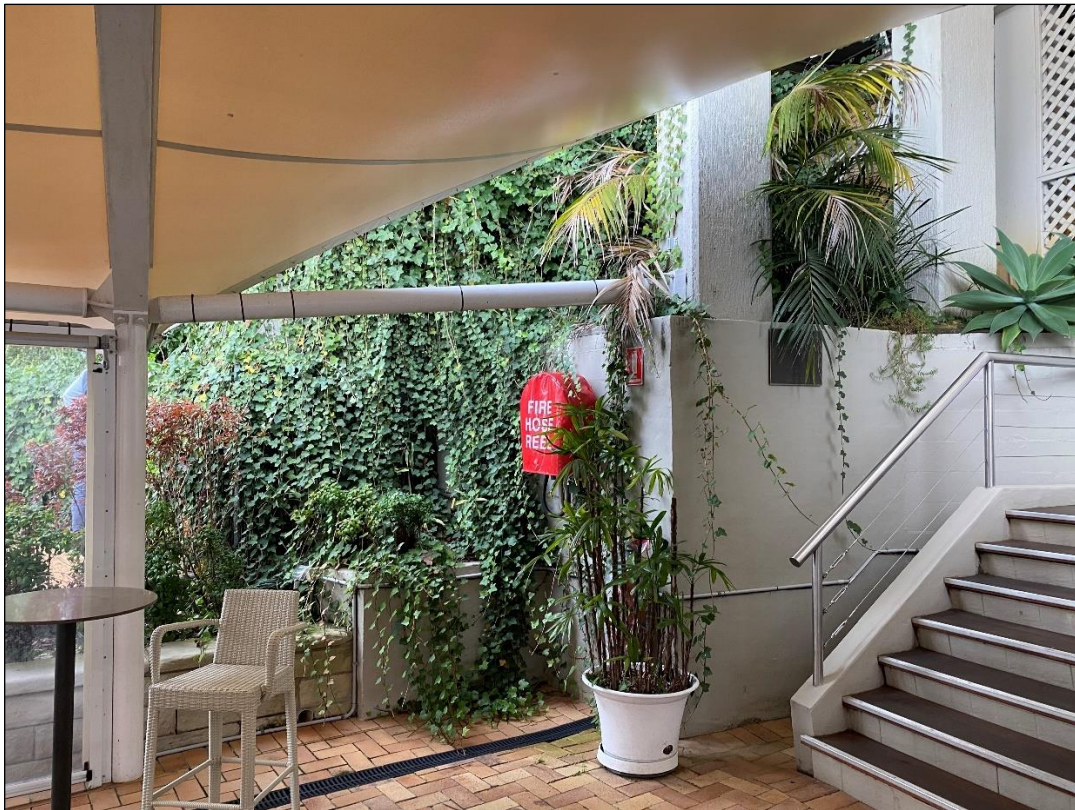
Photo 3: View of the proposed lift area, looking north-east.

Showing the existing retaining wall and vegetated batter.

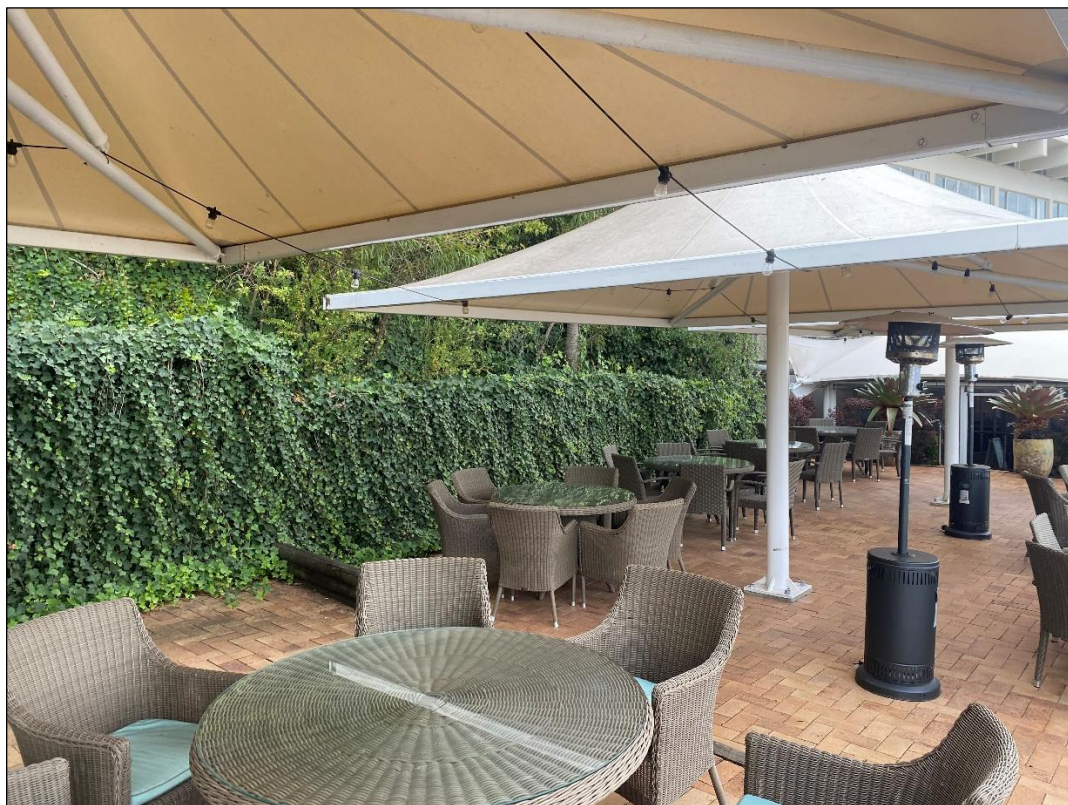
**Photo 4: View of terraced area, looking south-east toward the vegetated batter,
behind the brush fence.**

For the existing batter, careful consideration should be given to the long term stability of the existing batter. Consideration should be given to permanent stabilisation of the existing embankment. Support measures could include construction of a retaining wall, or anchors and shotcrete, where the above batter slopes cannot be achieved. Sub-surface geotechnical conditions will need to be confirmed within the batter by a geotechnical investigation, prior to the final design. The factor of safety for the current and remediated slope (if required) should also be determined using a program such as SLOPE/W.

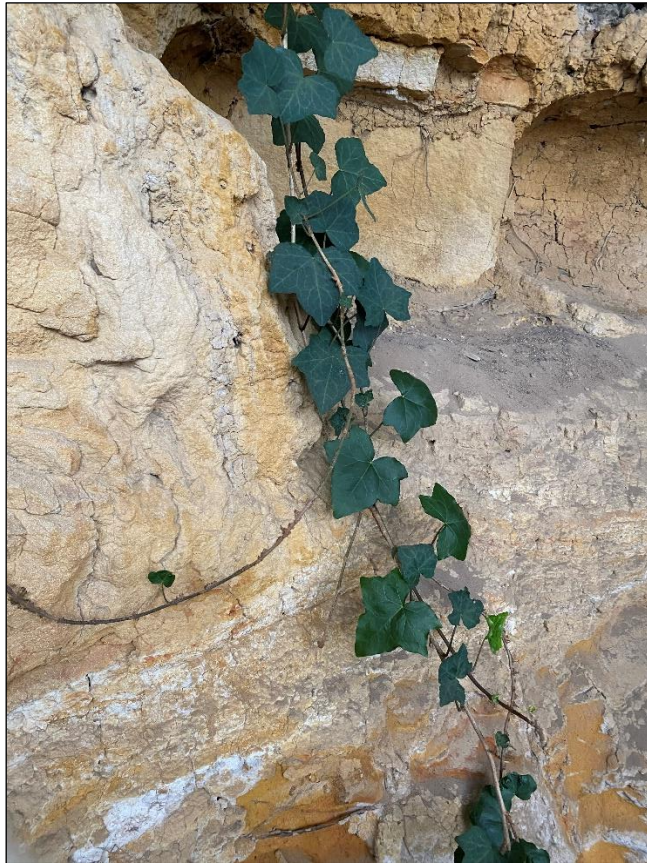
Photo 5: View of weathered rock beneath the existing building

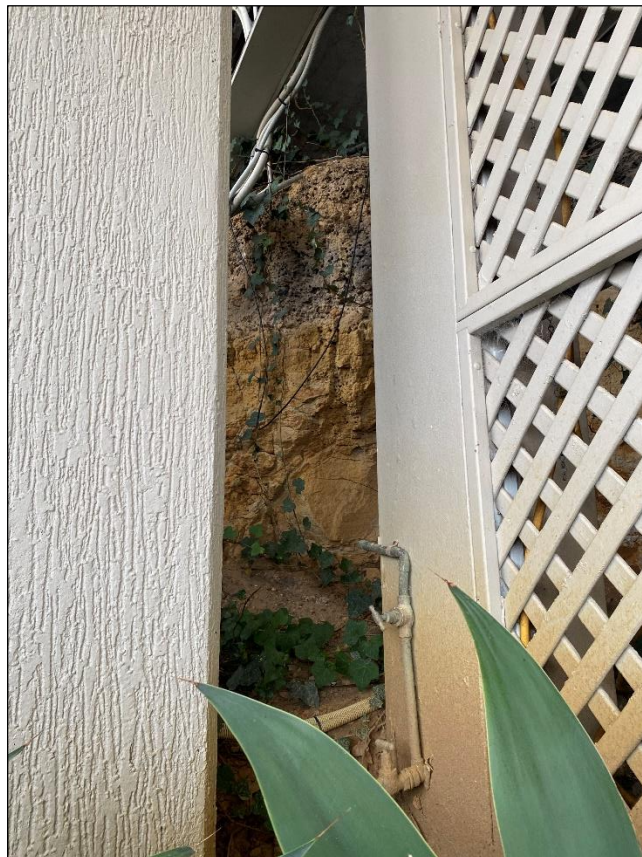
Photo 6: View of exposed cut beneath the existing building, looking north-east.
