Report Title: Geotechnical Report 14 Cheryl Crescent, Newport

Report Date: 30/06/20

GEOTECHNICAL INVESTIGATION:

Additions and Alterations at **14 Cheryl Crescent, Newport.**

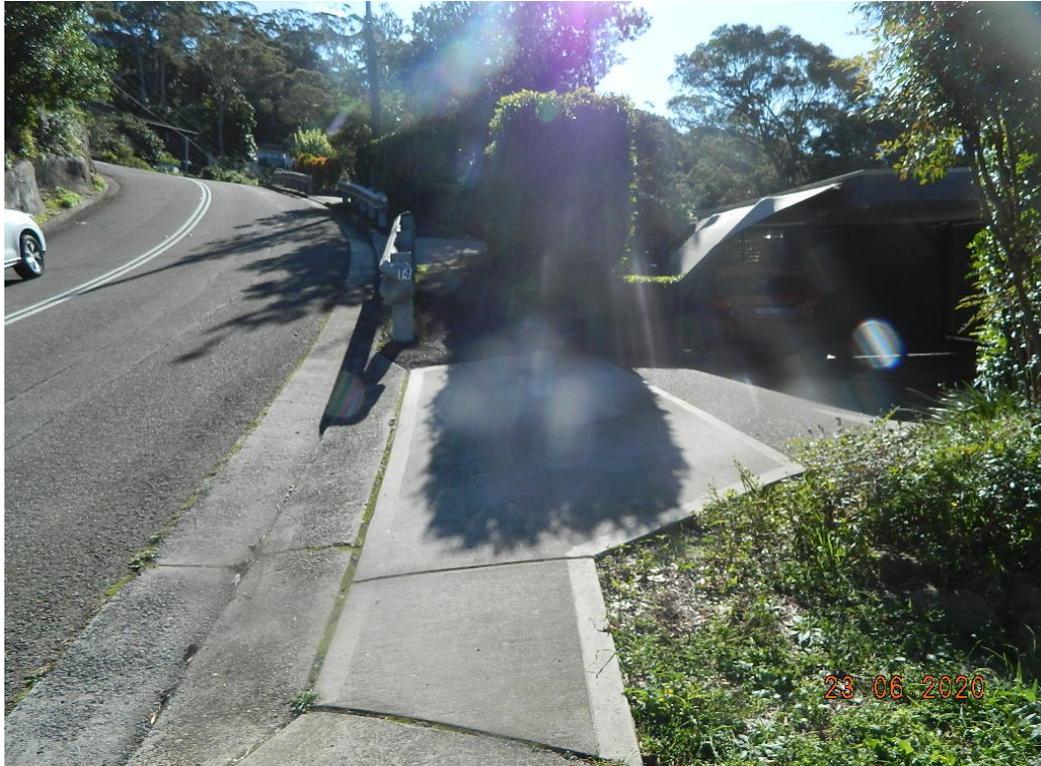
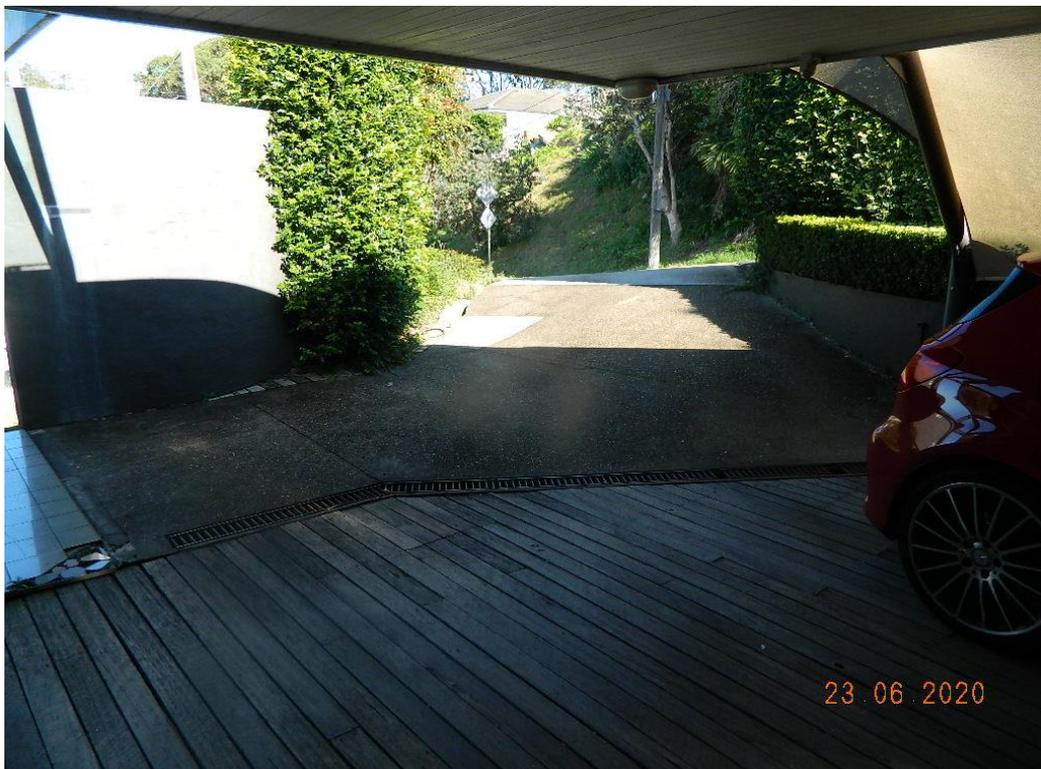
- 2.3** At the road frontage a concrete driveway runs to the existing carport (Photos 1 & 2). The natural slope on the uphill side of the house has been altered with filling to provide a more level platform for the existing driveway/carport area. The fill beside the driveway is supported by a stable but old ~ 3.2 m high formed concrete retaining wall (Photos 3 & 4). The upper portion of the wall has been recently constructed on the old concrete retaining wall. The fill under the carport is supported by brick and concrete retaining walls (Photo 5). A portion of the lower concrete retaining wall displays horizontal cracking but is considered currently stable (Photo 6). The two storey rendered masonry and timber clad house is supported by masonry walls (Photos 7 & 8). The external walls show no significant signs of movement. Fill has been placed below the deck on the downhill side of the house. The fill is supported by

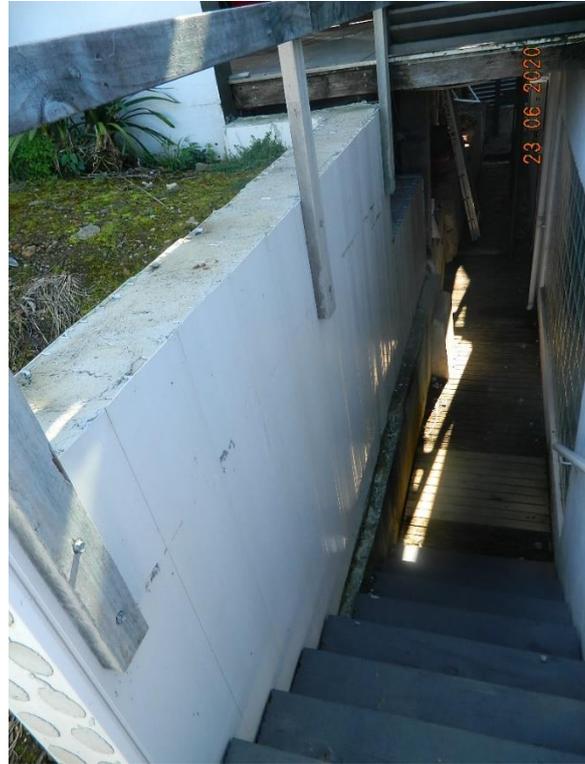
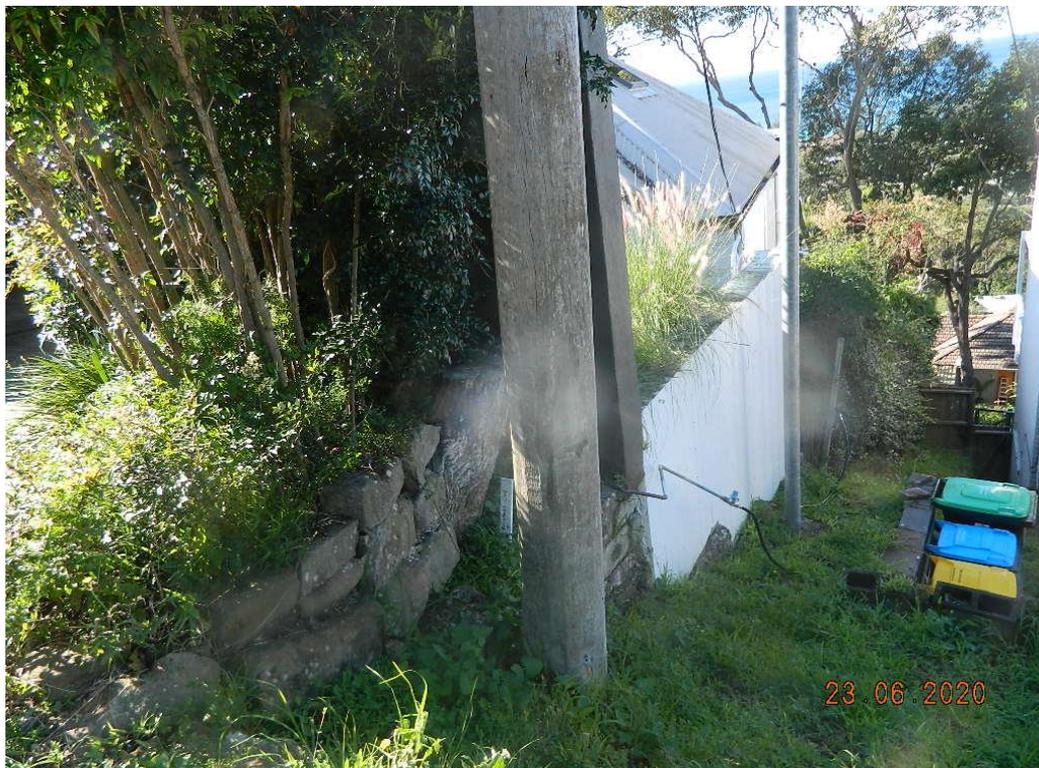
Observation of the concrete retaining wall (Photos 3 & 4) from the neighbouring property to the south indicates the natural surface approximates the slope along the base of the wall. We have inspected piercing work two houses to the south along the road fill batter. Although it is lower in elevation the natural surface was not far below the surface. The DCP testing correlates with the wall height as viewed from the south and also suggests the natural surface approximates the base of the wall. DCP 1 & 2 indicate the fill is ~1.2m deep. Both these tests hit a hard obstruction at ~1.8m. It is unclear what the hard surface was but given DCP 3 was

HAZARDS	Hazard One	Hazard Two
TYPE	The steep slope that falls across the property and continues above and below failing and impacting on the property.	Lateral loads from the proposed turning area slab acting on the existing retaining wall causing it to collapse (Photos 3 & 4).
LIKELIHOOD	'Unlikely' (10^{-4})	'Possible' (10^{-3})
CONSEQUENCES TO PROPERTY	'Medium' (12%)	'Medium' (12%)
RISK TO PROPERTY	'Low' (2×10^{-5})	'Moderate' (2×10^{-4})
RISK TO LIFE	8.3×10^{-7} /annum	5.0×10^{-5} /annum
COMMENTS	This level of risk is 'ACCEPTABLE'.	This level of risk to life and property is 'UNACCEPTABLE'. To move the risk to 'ACCEPTABLE' levels, the recommendations in Section 13 are to be followed.

If the proposed turning area is designed as a suspended slab supported off the existing retaining walls no foundations will be required. If the slab is supported by foundations they are to be taken beyond the zone of influence of the existing retaining walls and below the

backfill behind the walls into the Extremely Low Strength Shale. At DCP3 this is expected at a depth of ~2.1m. A maximum allowable bearing pressure of 600kPa can be assumed for piered footings on Extremely Low Strength Shale.

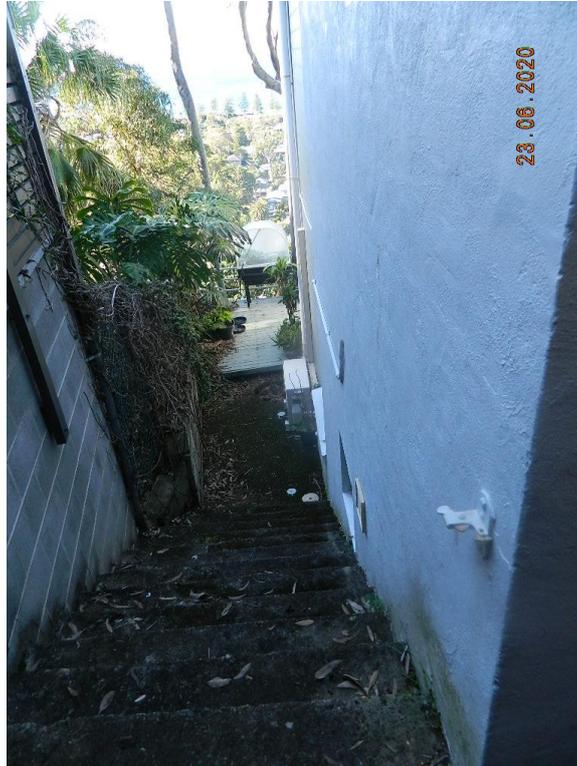
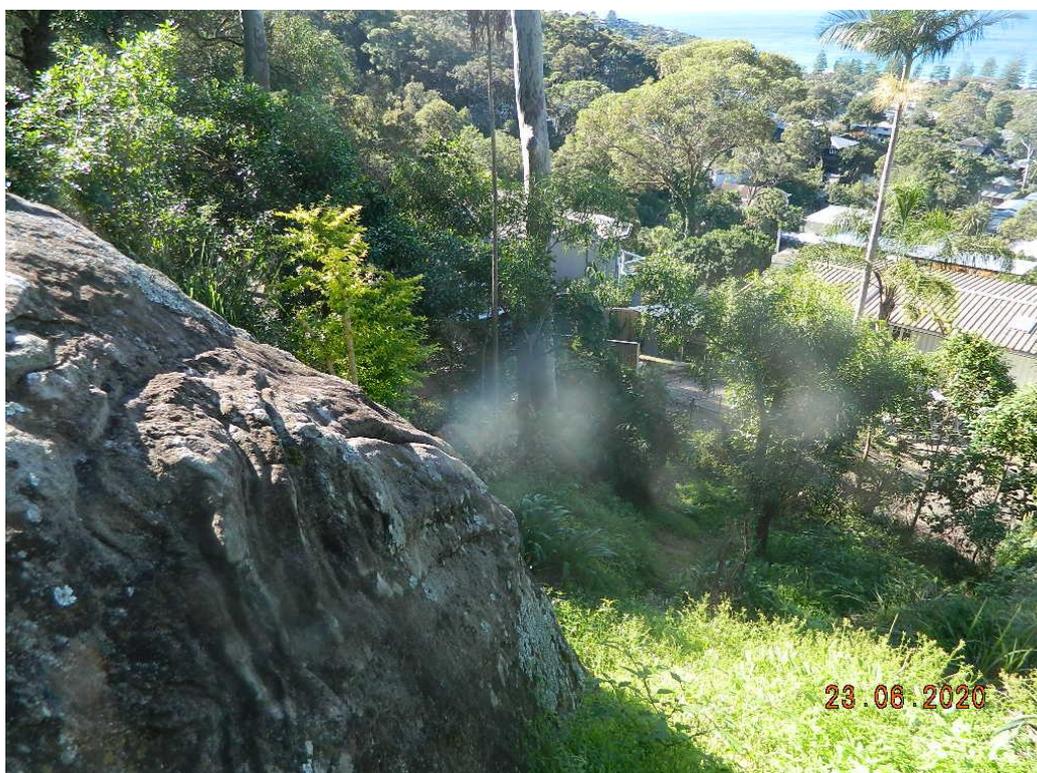
a ~2.4m high concrete block retaining wall. The wall displays minor stepped cracking through the mortar but is considered stable (Photo 9). Medium Strength Sandstone is outcropping on the downhill side of the house (Photos 7 & 10). No signs of slope instability were observed on the property. The adjoining neighbouring properties were observed to be in good order as seen from the street and subject property.
