## **Geotechnical Assessment**

**Project:** New Residence  
189 Riverview Road, Avalon Beach NSW.

**REF: AG 20235**  
23 September, 2020

For New Dwelling at  
**189 Riverview Road, Avalon Beach NSW**

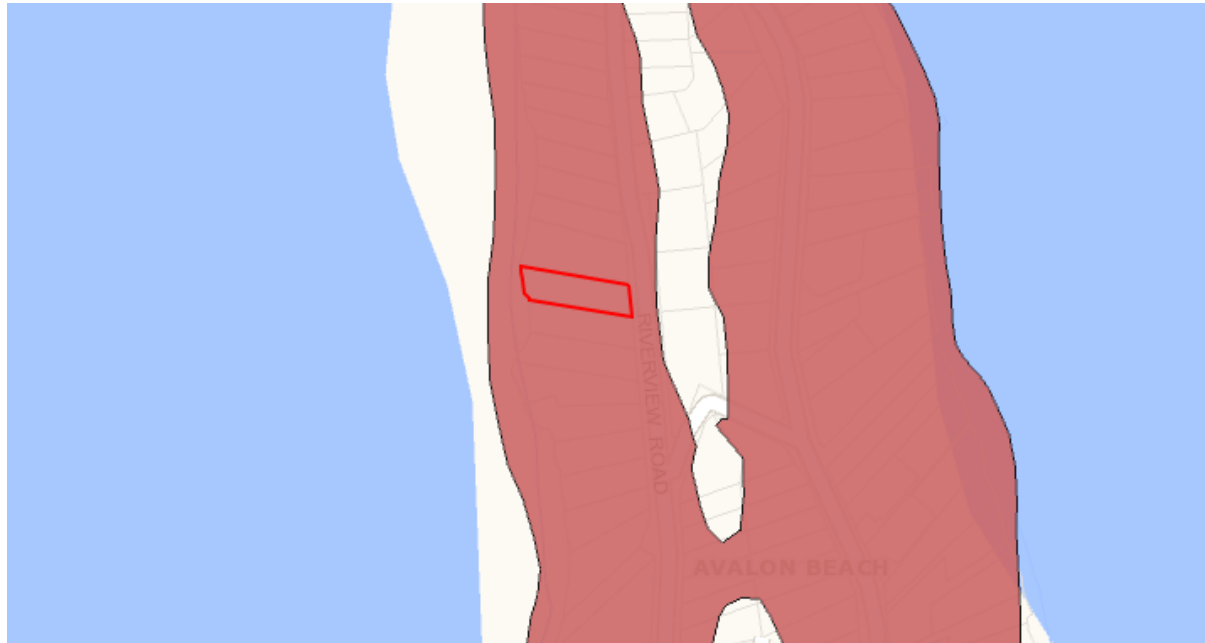
**Image 2:** PLEP Geotechnical Hazard Map – 189 Riverview Road, Avalon Beach NSW

- The property is classified as **Geotechnical Hazard H1** with reference to Northern Beaches Council PLEP Landslip Risk Map Sheet (PLEP Geotechnical Hazard Map **Image 2** below).
