18 August 2020

Our Ref: 20-0226lsc1

Re: 91 Lauderdale Avenue, Fairlight—Initial Heritage Assessment

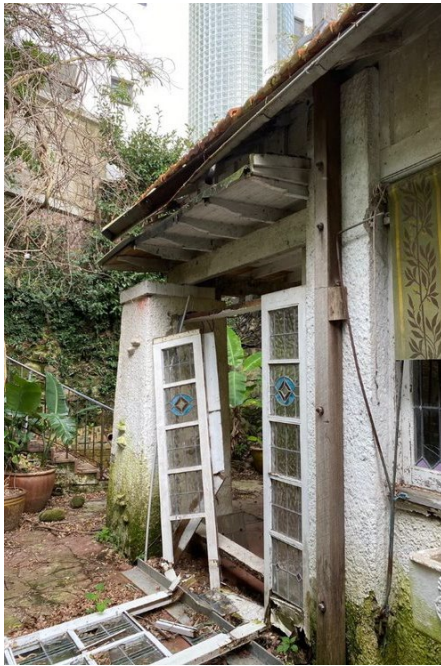
Figure A.2 Northeast corner. (Source: Skerrett, 2020)

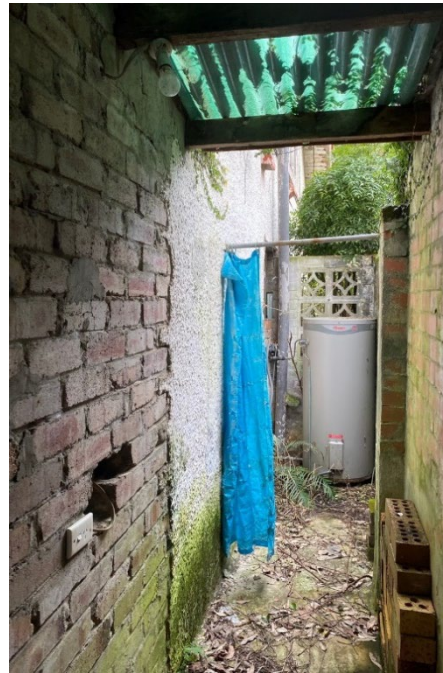
Alterations to change the layout and/or increase the size of the building's accommodation appear to have been carried out throughout its life, the works generally being of poor-quality design and construction. A key example is the addition to the northwest corner of the building—visible at the north end of the west elevation—and associated rearrangement of the internal layout and fittings of the kitchen, bathroom and associated spaces in this area. Key changes include the removal and addition of walls, changes to the location, layout and fittings of kitchen and bathroom facilities as well as alterations to original finishes (ceilings, walls and floors). Alterations to extend the roof over this are in very dilapidated condition, resulting in significant water damage and decay affecting the roof, interior finishes and floors.

Figure A.3 West elevation addition. (Source: Skerrett, 2020)

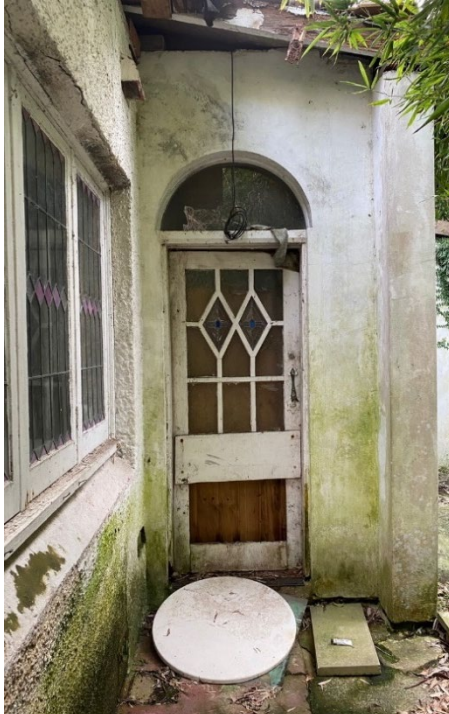
Figure A.4 Northwest corner with damaged and reused door to altered kitchen area. Rising damp throughout. (Source: Skerrett, 2020)

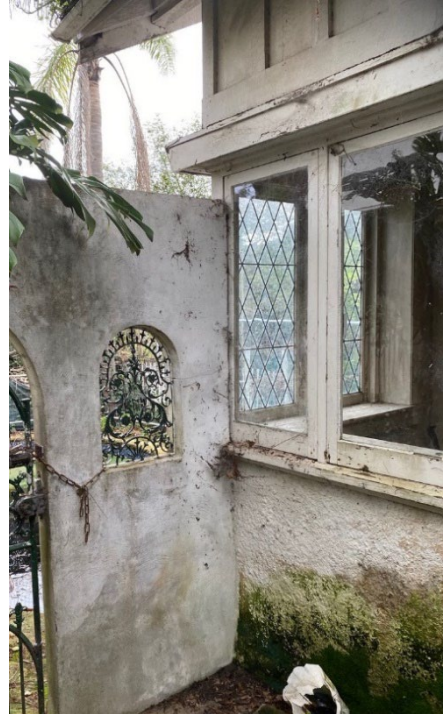
Figure A.5 Southeast corner with leadlight and replacement windows. Rising damp typical of all walls. (Source: Skerrett, 2020)

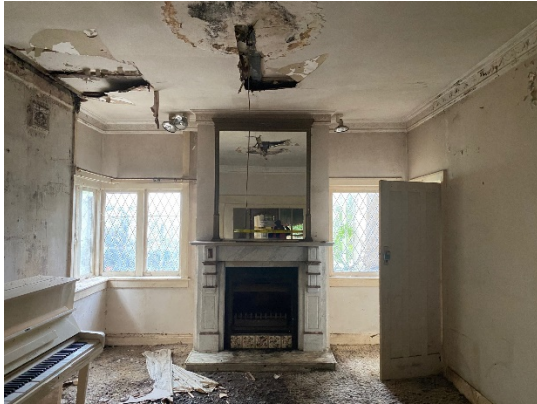
Figure A.6 Living room with reproduction chimney piece and fallen rose (not original). Unsafe floor and ceiling. (Source: Skerrett, 2020)

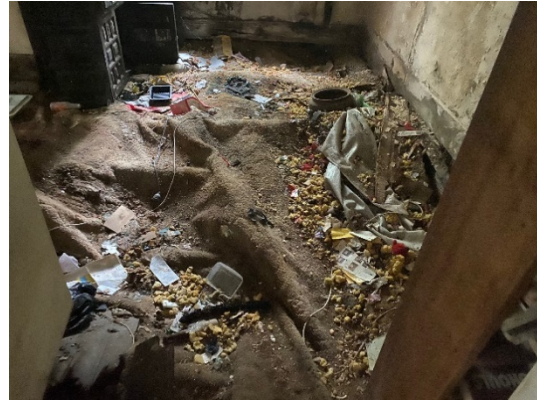
Figure A.7 Structural collapse and possible vandalism in north (breakfast?) room. (Source: Skerrett, 2020)

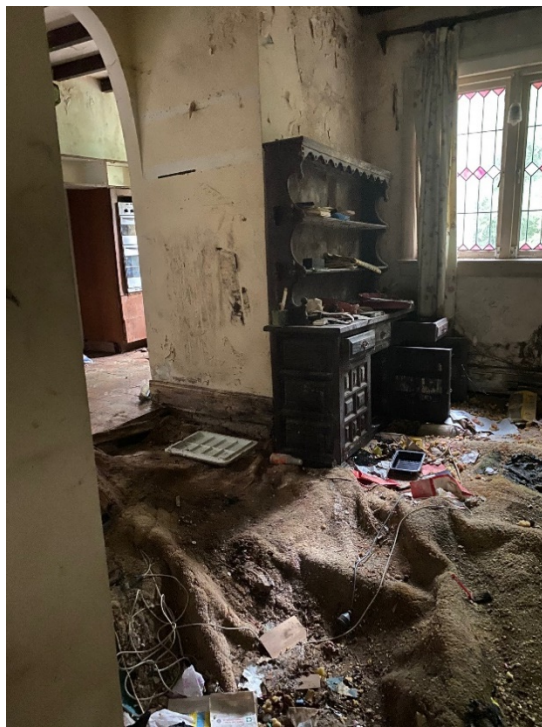
Figure A.8 Former kitchen and breakfast (?) room in northwest corner with later additions and alterations. (Source: GML Heritage, 2020)

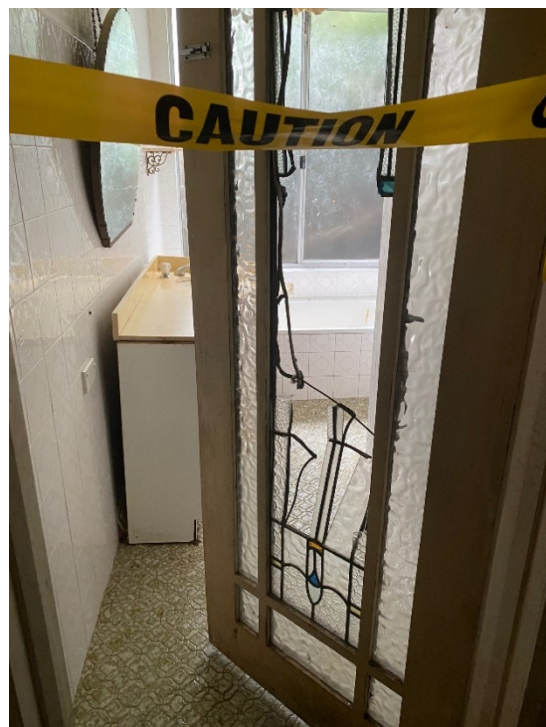
Figure A.9 Modern refurbished bathroom inserted as part of alterations and additions at north end of west elevation. Damage to original door is typical of vandalism throughout. (Source: Skerrett, 2020)
