ON  
**GEOTECHNICAL SLOPE STABILITY RISK  
ASSESSMENT**

FOR  
**PROPOSED ALTERATIONS AND ADDITIONS**

AT  
**NORTH HARBOUR MARINA, GOURLAY AVENUE,  
BALGOWLAH, NSW**

Ref: 36597Srpt

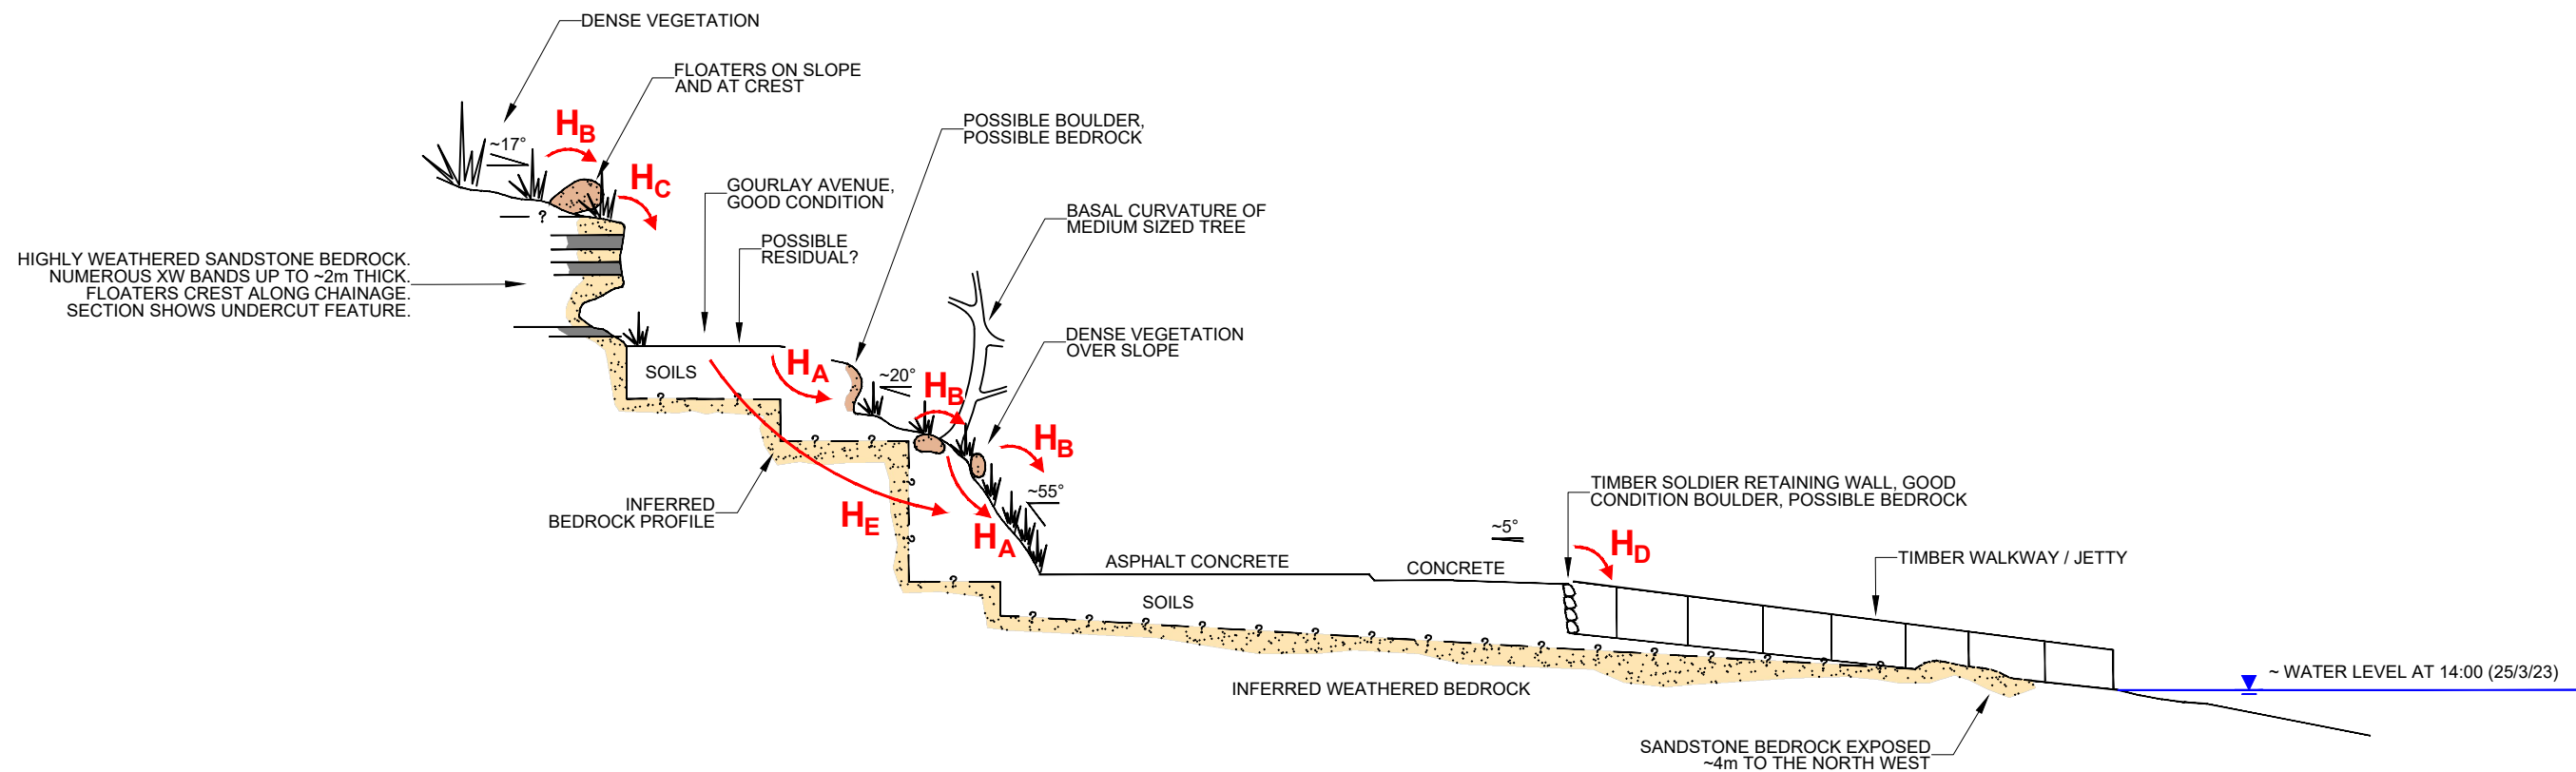
Based on our walkover inspection, we consider that the potential landslide hazards associated with the site and the proposed development are as follows:

| POTENTIAL<br>LANDSLIDE<br>HAZARD | A1 | A2 | B | C | D | E |
|---|---|---|---|---|---|---|
| Comments | Embankment appears steep, but sandstone bedrock is likely to be shallow so global failure through the bedrock is highly unlikely. Impact to entire site. | Embankment appears steep, though the depth of soils above the bedrock is expected to be limited which would result in limited material activated. Deepest soil cover likely adjacent to Gourley Avenue which support roadway. Possible high traffic loads (garbage trucks) along road. Impact to carpark area only. | Floaters generally appear to be embedded in the soil profile and therefore stable. Failure would result in impact to boathouse. Very large boulders on the high side of Gourley Avenue are not expected to travel over roadway and therefore will not impact site. | No signs of instability observed. Sandstone bedrock quality is poor, and may result in failure. Impact to Gourley Avenue only. | Walls are generally in good condition. Failure would result in minor remediation of pathways and wall itself. | Batters are considered to be oversteep and are likely to have a low Factor of Safety against failure. Oversteep batters are generally of minimal height. Slumping likely, although minimal impact to occur to site besides some remediation to the carpark and pathway. |

Any new footings that are required must be founded on the sandstone bedrock. New footings must be founded below the base of the timber sleeper retaining wall (or any other wall within the area) so that additional surcharge loads are not placed on the existing wall. Footings for the new deck may comprise of shallow pad or strip footings, where the depth of the overlying sands are expected to be thin and would not be an issue. Within the area of the proposed deck extension, extending footings/piles through the water charged sands above the sandstone bedrock may pose as a constructability issue. In this regard, steel tube piles may be driven/screwed to the surface of the sandstone bedrock and then the material within the tube drilled out.
