GEOTECHNICAL INVESTIGATION REPORT

PROPOSED NEW DEVELOPMENT

32 GOLF AVENUE, MONA VALE, NSW

Project No.: 2024-004.1

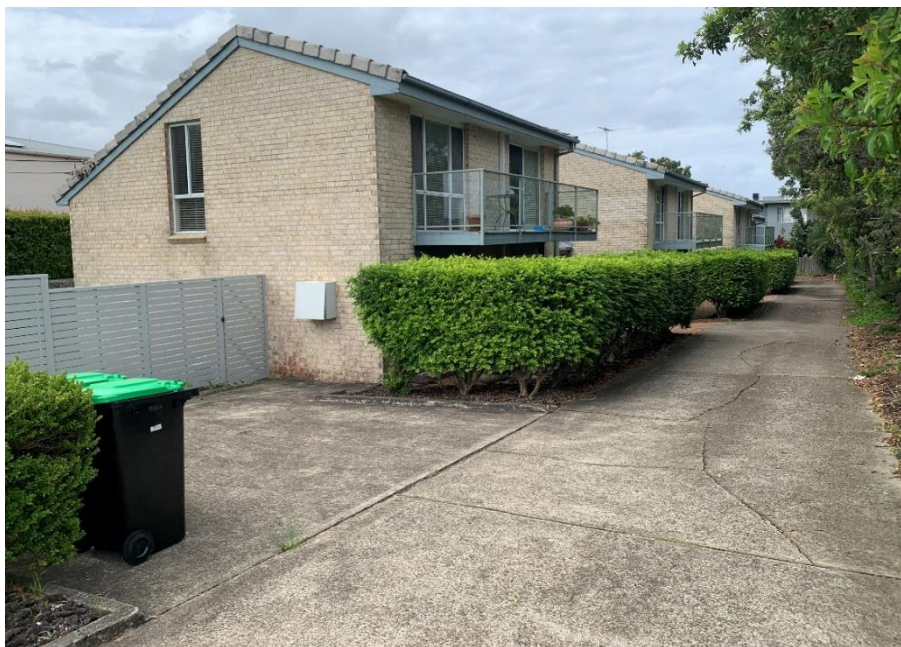
Photograph 2: View of the site, facing broadly north from the front south-east corner

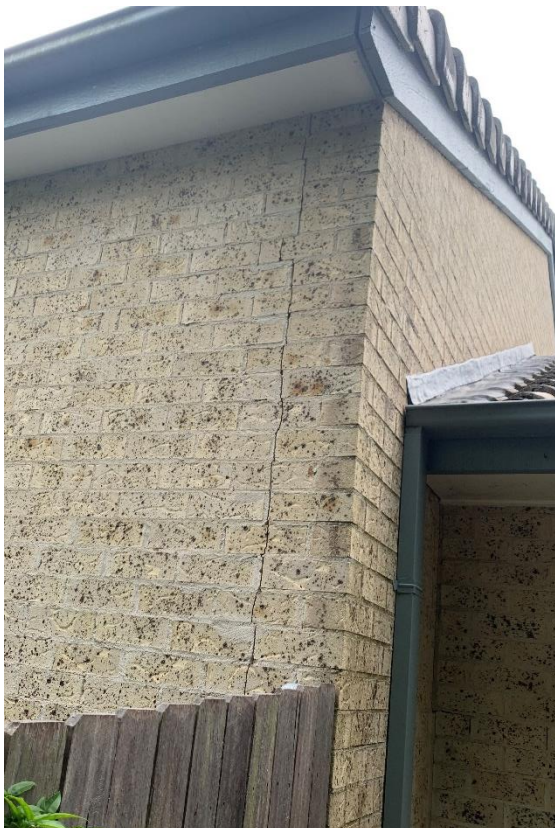
The main structures appeared in reasonable condition with several large vertical cracks observed on all-townhouse exterior walls presumed to be a result of thermal expansion and deterioration over time, shown in Photograph 3. Cracking and settlement was observed on the concrete driveway and concrete floor slab of the

Photograph 3: Vertical crack within rear external wall

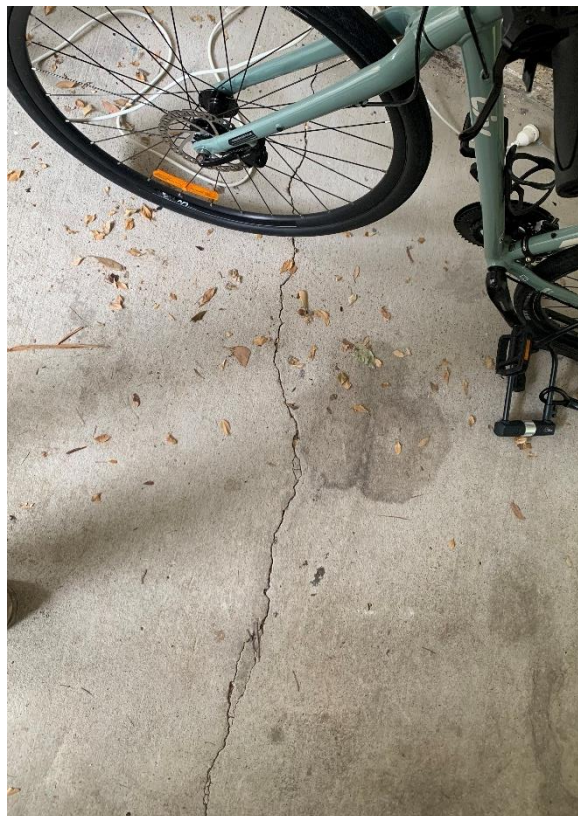
garage, shown in Photograph 4. These cracks are presumed to be a result of differential settlement and deterioration over time.

Photograph 4: Crack within concrete floor slab of garage
