1 March 2021
E24685.G02_REV1

Preliminary Landslip Risk Assessment Report 532 Pittwater Road, North Manly, NSW

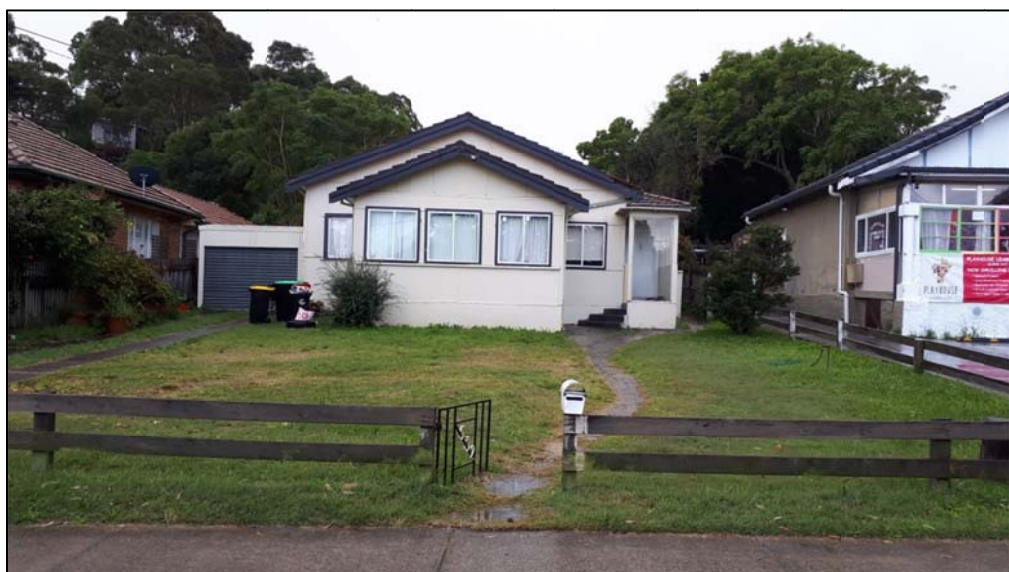
- The front of the site consists of a near level grassy lawn with a concrete strip driveway along the western site boundary that provides access to a single lock up garage located adjacent to the western side of the existing site house. A narrow concrete pathway through the front lawn provides access to the front entrance while a slightly uneven concrete pathway along the eastern site boundary leads to the rear of the property. A front view of the existing site house is shown below in **Plate 2**.

Plate 2: Front view of the site house, looking north
