## **PRELIMINARY GEOTECHNICAL ASSESSMENT:**

### **71 Quirk Street, Dee Why**

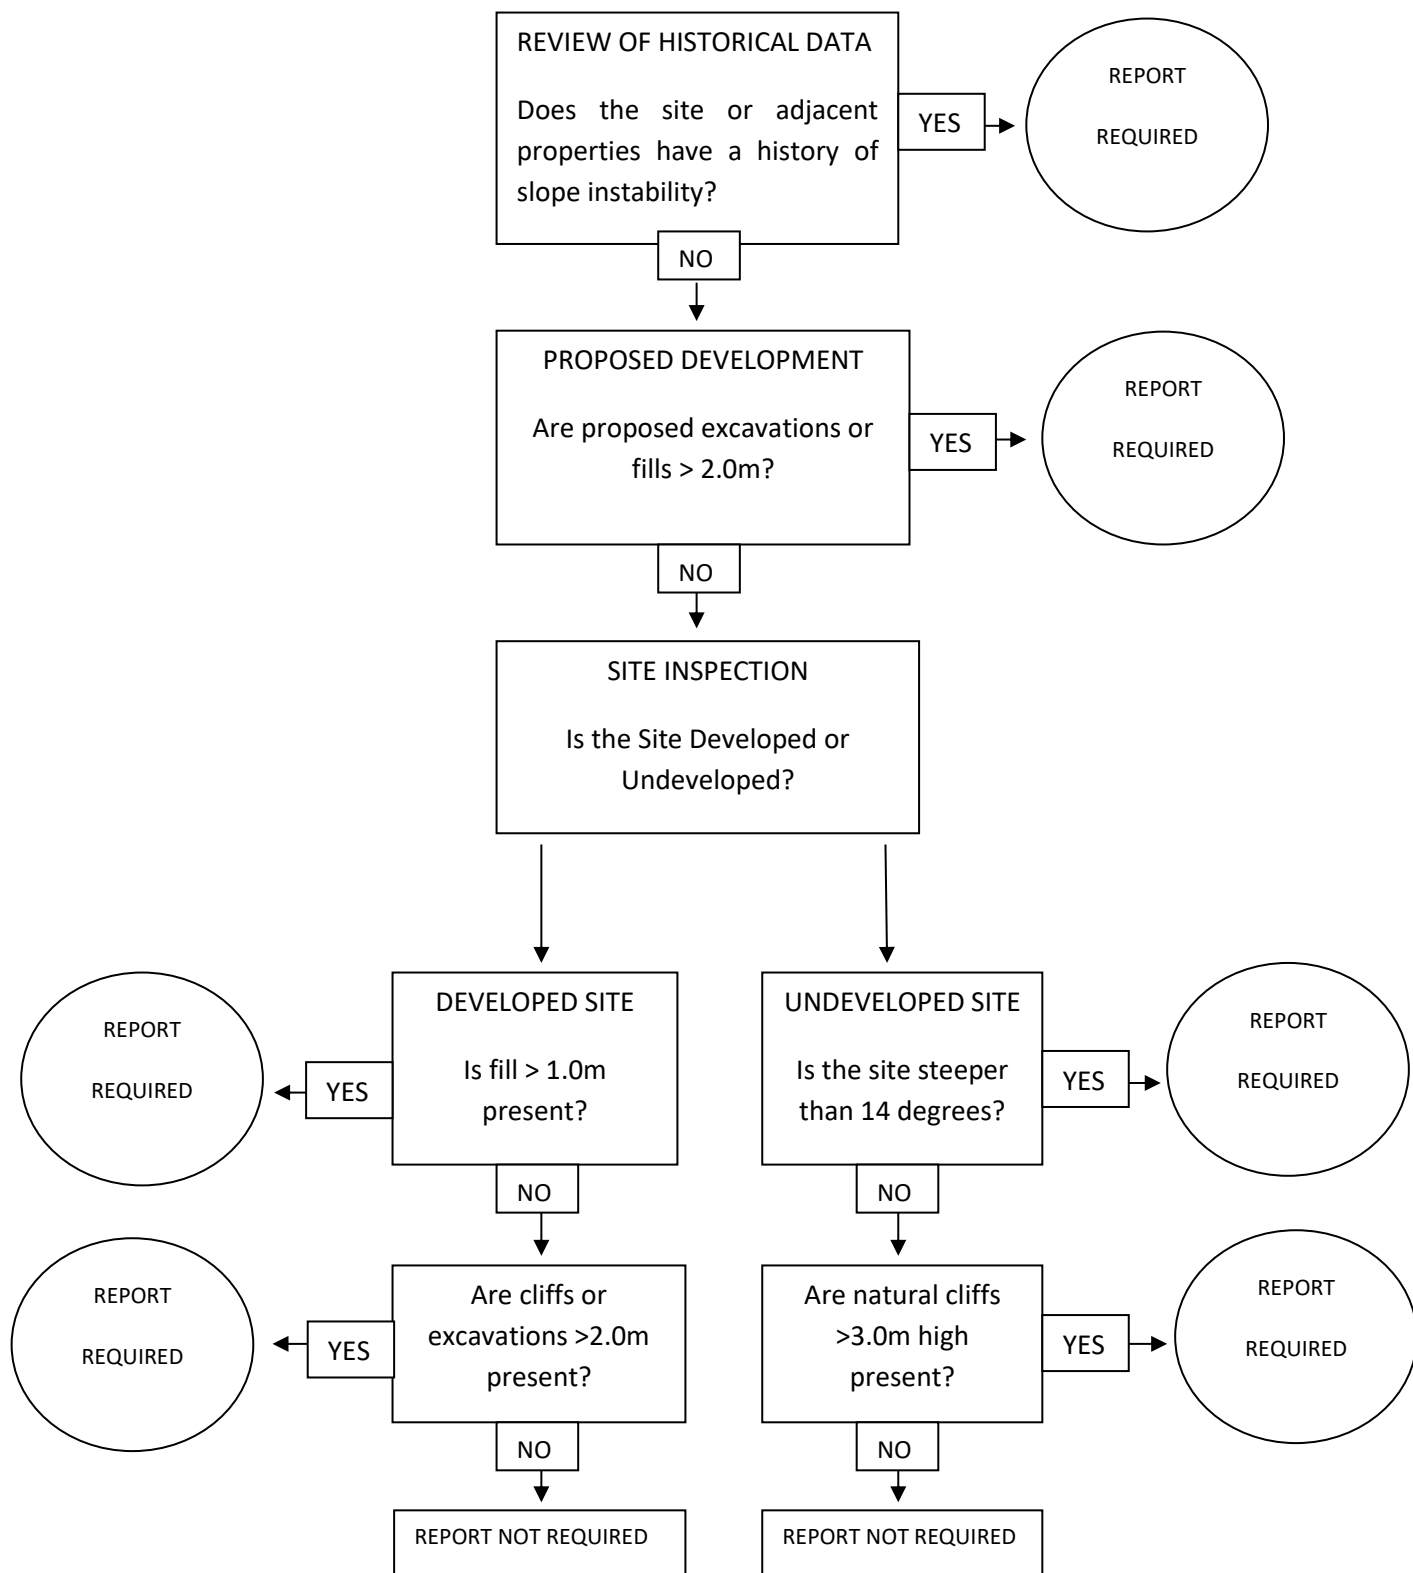
**Preliminary Assessment Flow Chart – Northern Beaches Council (Warringah)**

The proposed development and site conditions were considered and applied to the Council Flow Chart.

Provided good engineering and building practice are followed, no further Geotechnical assessment is recommended for the proposed development.
