# BUILDING CODE OF AUSTRALIA SECTION C, D & E COMPLIANCE AUDIT REPORT

Residential Flat Building

97 Queenscliff Road, Queenscliff

REPORT NO. ► 14094 Rev.00

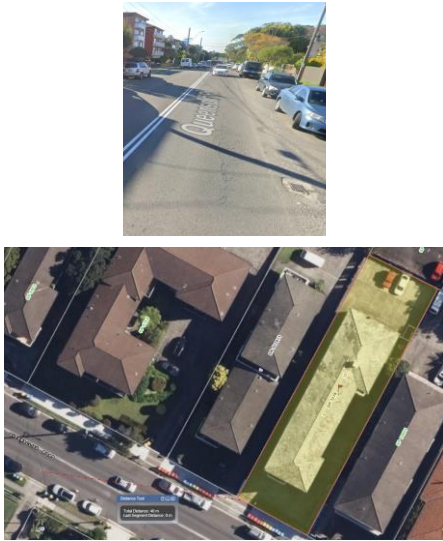
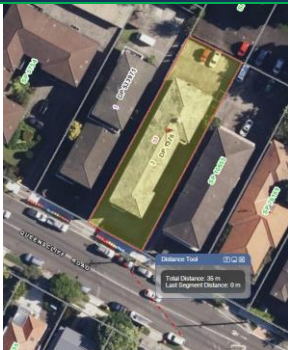
<p>BCA clause E1D2</p> <p>The street hydrant located to the west is approximately 40m from the footpath at the front of the site.</p> <p>The street hydrant located to the east of the building is approximately 35m from the footpath at the front of the site</p> <p>Compliant hydrant coverage was not able to be confirmed.</p>	<p>A hydraulic engineer is required to review the existing street hydrants to assess if they provide compliant coverage to the building in accordance with AS 2419.1 – 2021.</p> <p>Where a street hydrant does not achieve compliant coverage, it is also to be reviewed for coverage with the three lengths of hose concession relative to Fire and Rescue NSW Hydrant technical information guide for hydrants for existing buildings – reference D16/62522.</p> <p>If compliant with Fire and Rescue NSW Hydrant technical information guide for existing buildings, the hydraulic engineer is to specify what additional works are required to achieve compliance with the Fire and</p>

Rescue NSW Hydrant technical information guide D16/62522.
2.	TYPICAL ALL UNITS Front Door

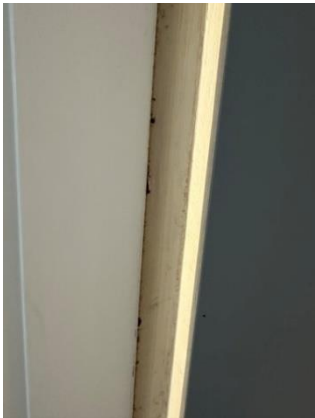
BCA clause C4D12. No tags to doors or door frames, the doors and frames are not fire doors.	A new fire door and fire door frame to be installed as per BCA clause C4D12 and AS 1905.1 – 2015 for all unit entry doors.

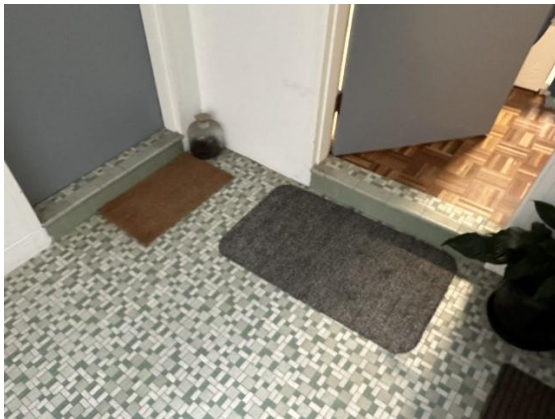
Item	Location	Photo	Details of Defect & Nominated Breach	Recommended Remedial Works
3.	TYPICAL ALL UNITS Front Door

BCA clause D3D16 This clause does not allow a step closer to a door than the width of the door leaf.	A performance-based solution to address the step at the doors would be required.
4.	Common area Stairs for Whole Building ground to top floor

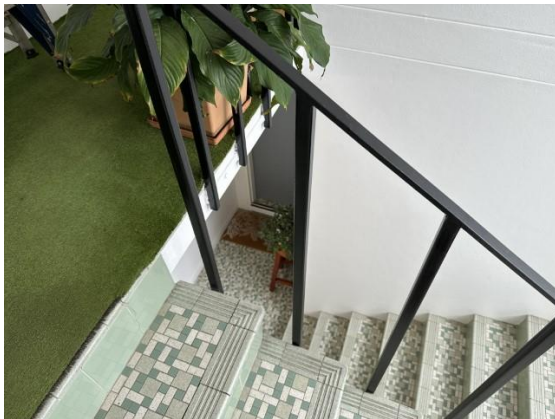
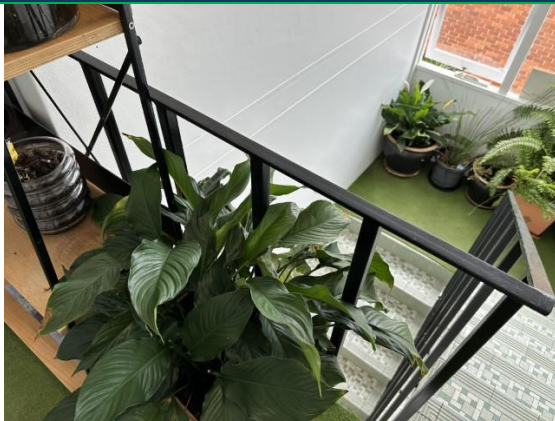
BCA clause D3D19 All the balustrading in the stairs has gaps greater than 125mm.	The balustrade should be upgraded so that it has no gaps greater than 125mm, where the fall exceeds 1-m, in accordance with BCA clause D3D19.

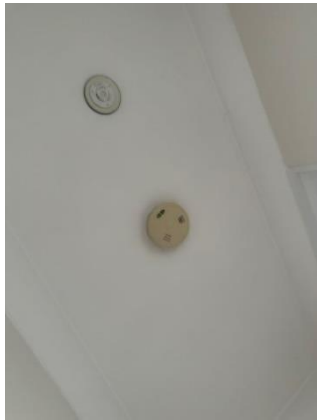
5.	TYPICAL ISSUE Within the residential units

BCA Specification 20 Smoke alarms are not hardwired in all units other than units 8, 9 and 10 which are hardwired.	Hard wired smoke alarms should be installed within all residential units in accordance with BCA specification 20 and AS3786 - 2014 other than units 8, 9 and 10.

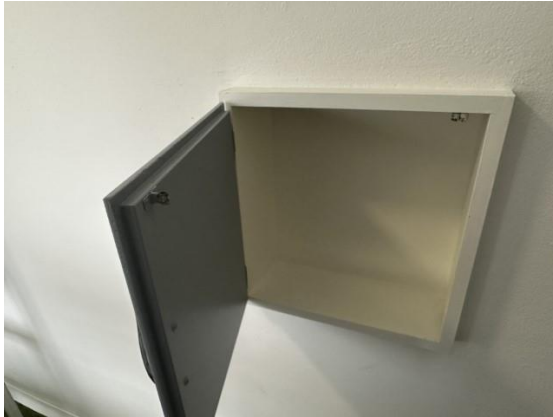
Item	Location	Photo	Details of Defect & Nominated Breach	Recommended Remedial Works
6.	TYPICAL ISSUE Common Area – bounding walls of units Milk Boxes

<p>BCA Specification 5.</p> <p>The milk boxes are cut into the bounding walls between the units and the common areas. This compromises the fire rating of the bounding walls.</p>	<p>Further invasive inspection is required to identify the level of non-compliance with respect to these opening into the bounding walls of the units.</p> <p>Once this has been completed and the method of construction and separation verified, fire separation will be required to ensure that the fire rating of the bounding walls is compliant with BCA Specification 5 for type A construction. This could be via bricking in the boxes area once the boxes are removed.</p>

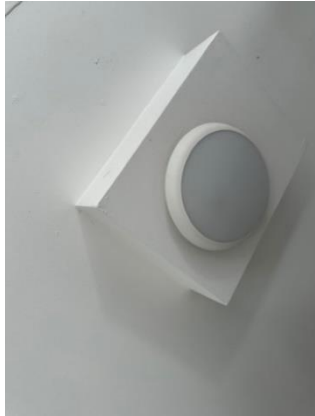
7.	TYPICAL ISSUE Units

<p>BCA clause C4D15</p> <p>There was limited access to inspect services penetrations throughout the building to check the building for compliance. Set ceilings did not contain any access panels.</p>	<p>An invasive audit of the building will be required by a suitably qualified fire contractor to determine what service penetrations are not fire rated that penetrate fire rated building elements and provide a report detailing what fire upgrading is required in accordance with BCA clause C4D15.</p> <p>All non-fire sealed service penetrations are to be fire rated in accordance with this invasive inspection report to achieve compliance with BCA clause C4D15.</p>

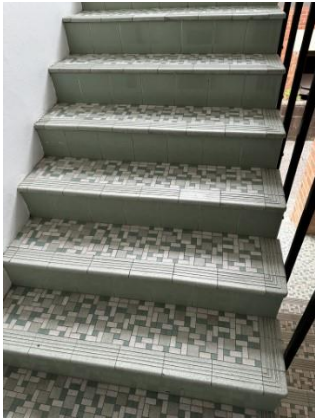
Item	Location	Photo	Details of Defect & Nominated Breach	Recommended Remedial Works
8.	TYPICAL ISSUE Stairs

<p>BCA clauses D3D14 and D3D15</p> <p>There are no non-slip nosings to the stairs and the stair landings.</p>	Non slip nosing should be installed in accordance with BCA clauses D3D14 and D3D15.
9.	Unit 1 Ground

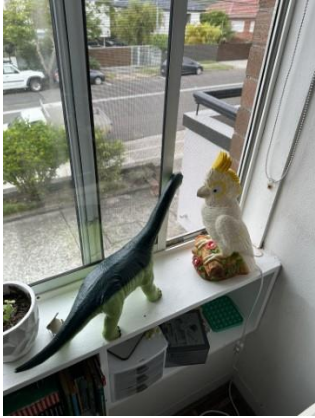
<p>BCA clause D3D29</p> <p>The bedroom window has not been fitted with a window restrictor in accordance with this clause.</p>	A window restrictor should be installed to the bedroom window as required by clause D3D29.

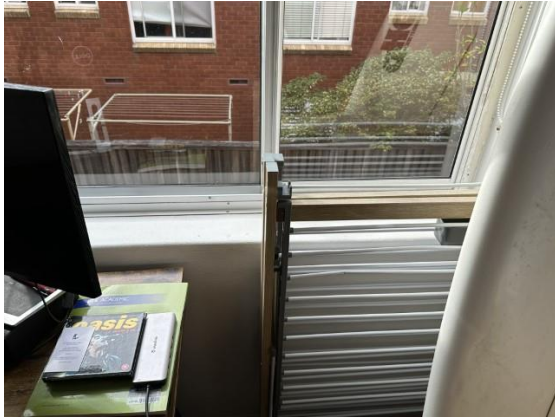
Item	Location	Photo	Details of Defect & Nominated Breach	Recommended Remedial Works
10.	Unit 2 2 <sup>nd</sup> Bedroom

BCA clause D3D29 The bedroom window has not been fitted with a window restrictor in accordance with this clause.	A window restrictor should be installed to the bedroom window as required by clause D3D29.
11.	Unit 2 Main Bedroom

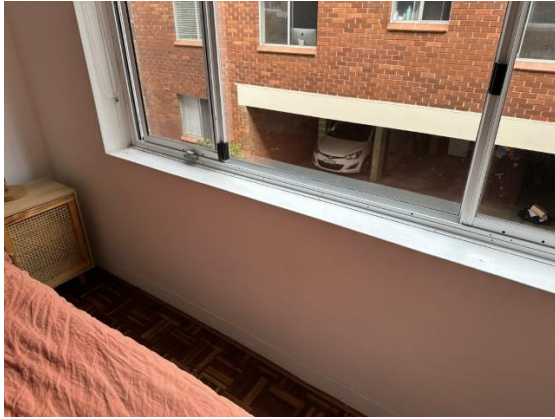
BCA clause D3D29 The bedroom window has not been fitted with a window restrictor in accordance with this clause.	A window restrictor should be installed to the bedroom window as required by clause D3D29.

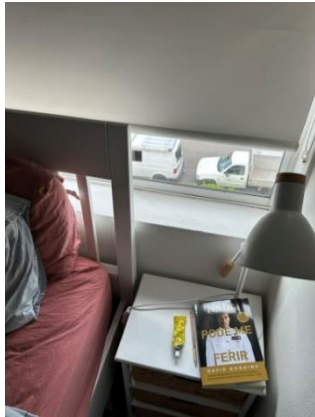
Item	Location	Photo	Details of Defect & Nominated Breach	Recommended Remedial Works
12.	Unit 6 Main Bedroom

<p>BCA clause D3D29</p> <p>The bedroom window has not been fitted with a window restrictor in accordance with this clause.</p>	A window restrictor should be installed to the bedroom window as required by clause D3D29.
13.	Unit 7 Bedroom

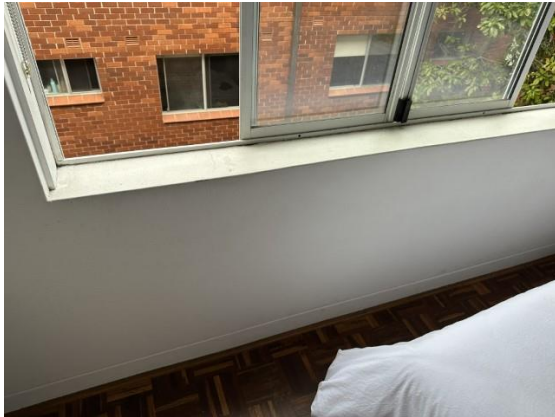
<p>BCA clause D3D29</p> <p>The bedroom window has not been fitted with a window restrictor in accordance with this clause.</p>	A window restrictor should be installed to the bedroom window as required by clause D3D29.

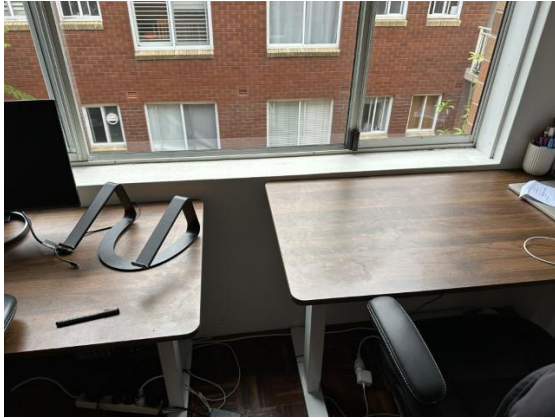
Item	Location	Photo	Details of Defect & Nominated Breach	Recommended Remedial Works
14.	Unit 7 2 <sup>nd</sup> Bedroom

<p>BCA clause D3D29</p> <p>The bedroom window has not been fitted with a window restrictor in accordance with this clause.</p>	A window restrictor should be installed to the bedroom window as required by clause D3D29.
15.	Unit 8

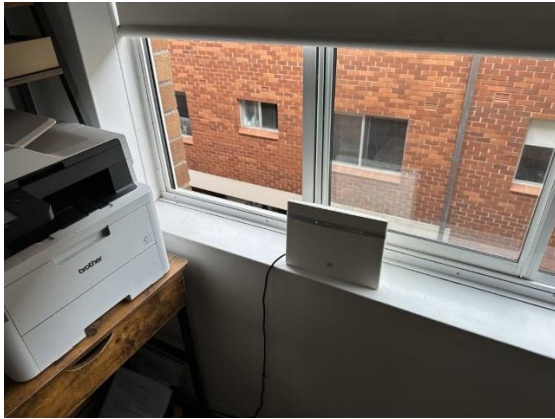
<p>BCA clause D3D29</p> <p>The bedroom window has not been fitted with a window restrictor in accordance with this clause.</p>	A window restrictor should be installed to the bedroom window as required by clause D3D29.
16.	Unit 9 Bedroom	NO PHOTO	<p>BCA clause D3D29</p> <p>The bedroom windows have not been fitted with window restrictors in accordance with this clause.</p>	Window restrictors should be installed to all bedroom windows as required by clause D3D29.

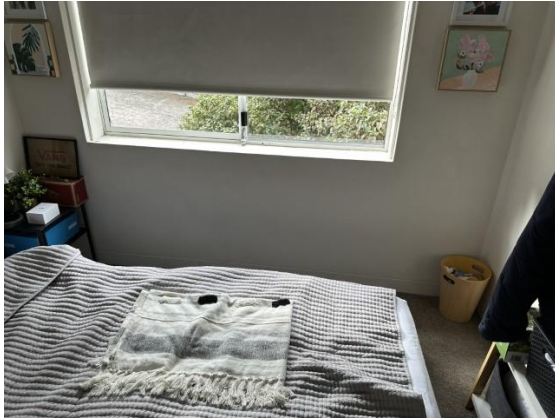
Item	Location	Photo	Details of Defect & Nominated Breach	Recommended Remedial Works
17.	Unit 10 Main Bedroom Level 2

<p>BCA clause D3D29</p> <p>The bedroom window has not been fitted with a window restrictor in accordance with this clause.</p>	A window restrictor should be installed to the bedroom window as required by clause D3D29.
18.	Unit 10 2nd Bedroom Level 2

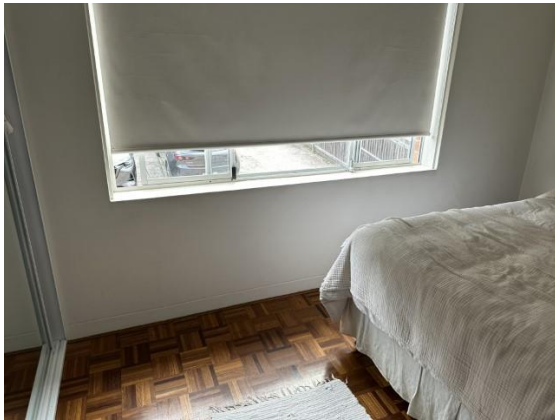
<p>BCA clause D3D29</p> <p>The bedroom window has not been fitted with a window restrictor in accordance with this clause.</p>	A window restrictor should be installed to the bedroom window as required by clause D3D29.

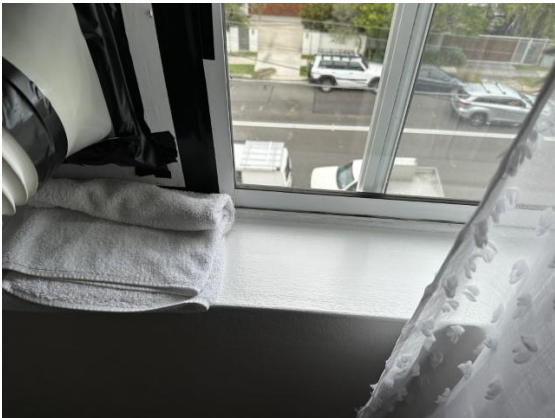
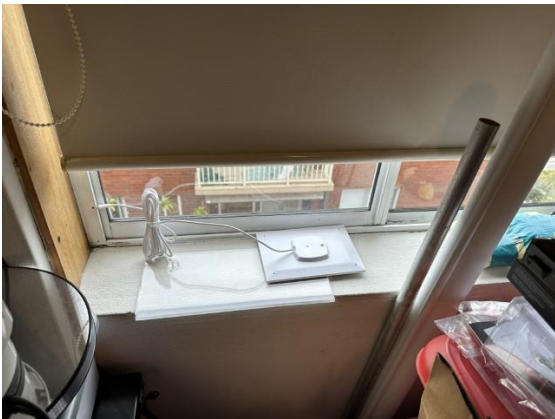
Item	Location	Photo	Details of Defect & Nominated Breach	Recommended Remedial Works
19.	Unit 11 Both Bedrooms

<p>BCA clause D3D29</p> <p>The bedroom windows have not been fitted with window restrictors in accordance with this clause.</p>	<p>Window restrictors should be installed to all bedroom windows as required by clause D3D29.</p>

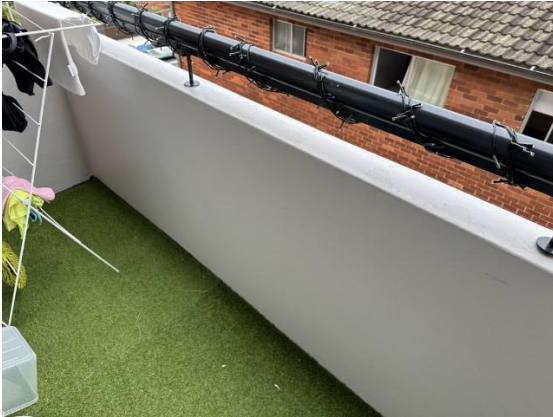
Item	Location	Photo	Details of Defect & Nominated Breach	Recommended Remedial Works
20.	Unit 12 Balcony

<p>BCA clause D3D18</p> <p>The balustrade is less than 1m in height above the floor, as the owner has added artificial grass on the floor.</p>	<p>The artificial grass should be removed and the balustrade rechecked for compliance with this clause, where still non-compliant the balustrade should be upgraded to be compliant with BCA clause D3D218 relative to being 1m minimum height.</p>
21.	Unit 12 Bedrooms x 2

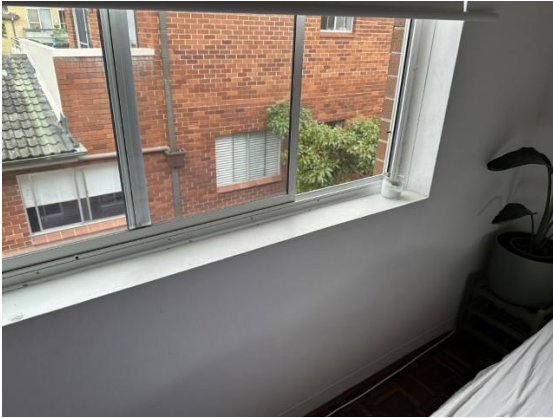
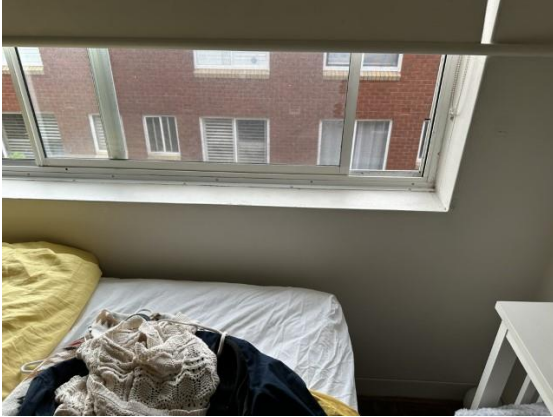
<p>BCA clause D3D29</p> <p>The bedroom window has not been fitted with a window restrictor in accordance with this clause.</p>	<p>A window restrictor should be installed to the bedroom window as required by clause D3D29.</p>

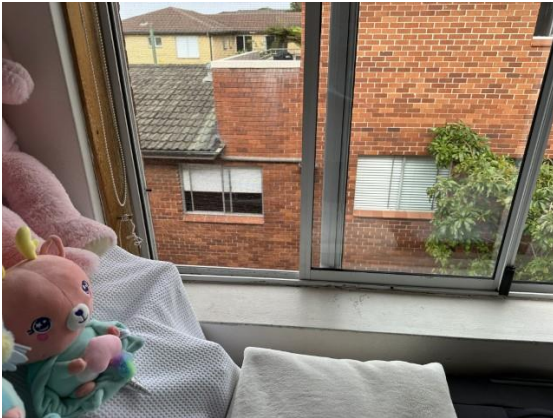
22.	Unit 13 Bedroom

<p>BCA clause D3D29</p> <p>The bedroom window has not been fitted with a window restrictor in accordance with this clause.</p>	<p>A window restrictor should be installed to the bedroom window as required by clause D3D29.</p>

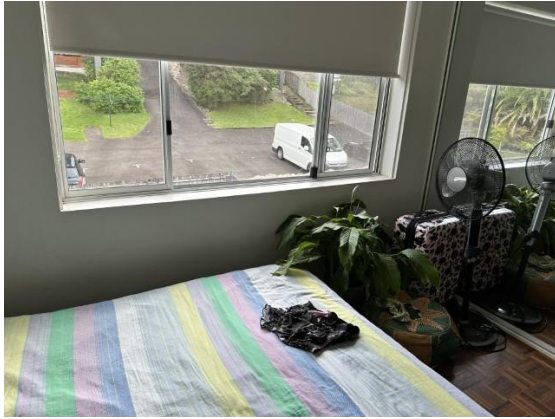
Item	Location	Photo	Details of Defect & Nominated Breach	Recommended Remedial Works
23.	Unit 15 Both bedrooms

<p>BCA clause D3D29</p> <p>The bedroom window has not been fitted with a window restrictor in accordance with this clause.</p>	<p>A window restrictor should be installed to the bedroom window as required by clause D3D29.</p>
24.	Front Block Commons Third Floor (top)

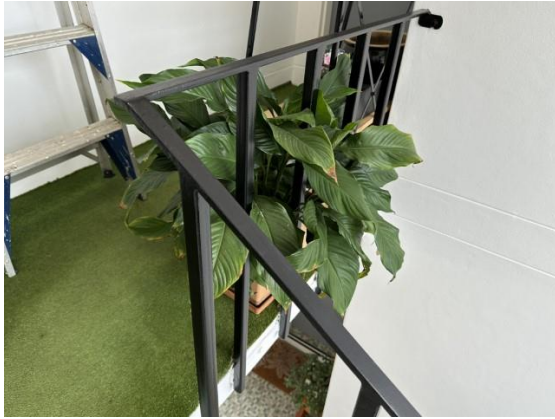
<p>BCA clause D3D18</p> <p>The balustrade at the landing was less than 1m high.</p>	<p>The balustrade should be upgraded to be a minimum 1 metre high to comply with BCA clause D3D18 and AS 1170.1 - 2022.</p>

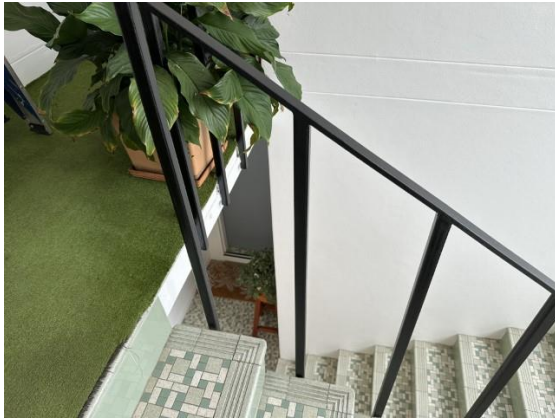
Item	Location	Photo	Details of Defect & Nominated Breach	Recommended Remedial Works
25.	Front Block Commons 3 <sup>rd</sup> Floor (top) L3 to L2

BCA clauses D3D18 and D3D22 The balustrade and handrail to the stair are less than 865mm high.	The balustrade and handrail should be upgraded to be compliant with BCA clauses D3D18 and D3D22 and AS 1170.1 - 2002.
26.	Front Block Commons 3 <sup>rd</sup> Floor (top) L3 to L2

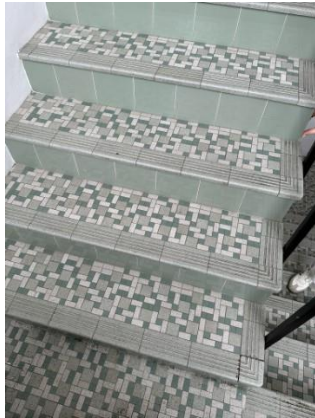
BCA clause D3D14 Risers variance is greater than 5mm riser to riser and greater than 10mm in the flight, circa 20mm.	The stair risers should be modified so as to be compliant with BCA clause D3D14.

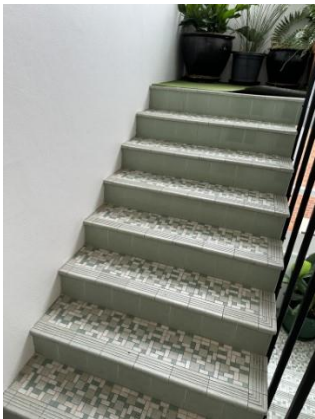
Item	Location	Photo	Details of Defect & Nominated Breach	Recommended Remedial Works
27.	Front Block Level 3 Mid Landing to Level 2

BCA clause D3D22 A handrail was not provided.	The stair should be upgraded to be compliant with BCA clause D3D22 - handrail.
28.	Both Blocks Common Area Smoke alarms

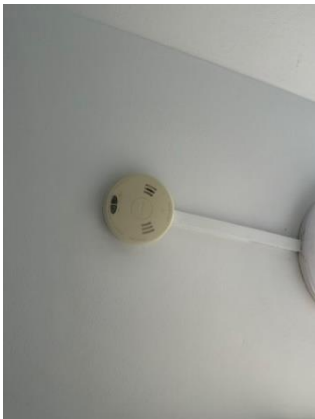
BCA Specification 20. The smoke alarms in the public corridors of the building are not interconnected.	The smoke alarms within the common areas of the building are to be upgraded so that they are interconnected in accordance with BCA Specification 20.

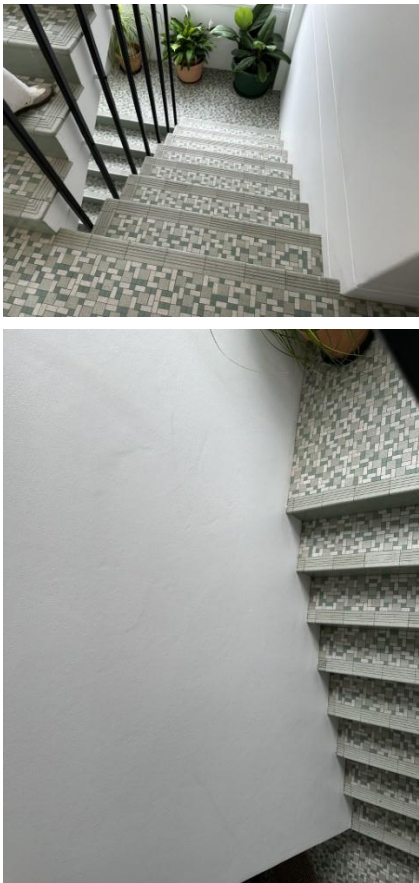
Item	Location	Photo	Details of Defect & Nominated Breach	Recommended Remedial Works
29.	Front Block Level 2 to level 1 Stair

BCA clause D3D22 A handrail was not provided.	The stair should be upgraded to be compliant with BCA clause D3D22 via providing a handrail.

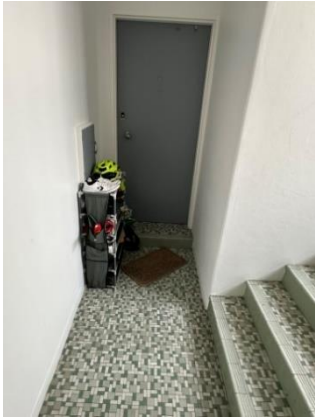
Item	Location	Photo	Details of Defect & Nominated Breach	Recommended Remedial Works
30.	Front Block Level 2

<p>BCA clause D3D8</p> <p>The path of travel from Unit 1 to the common stair is less than 1m, only 970mm.</p>	<p>Due to the minor nature of the non-compliance and the low occupant load of this area I do not consider that upgrade works are required as the minor reduced width would be compliant with the performance requirement D1P6.</p>
31.	Front Block Level 2

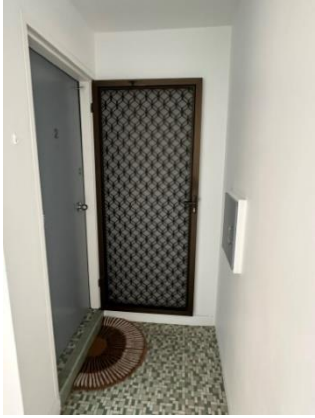
<p>BCA clause D3D8</p> <p>The path of travel from Unit 2 to the common stair is less than 1m, only 970mm.</p>	<p>Due to the minor nature of the non-compliance and the low occupant load of this area I do not consider that upgrade works are required as the minor reduced width would be compliant with the performance requirement D1P6.</p>

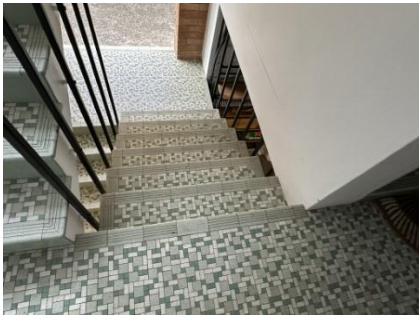
Item	Location	Photo	Details of Defect & Nominated Breach	Recommended Remedial Works
32.	Front Block Level 1 to Ground Stair

BCA clause D3D22 A handrail was not provided.	The stair should be upgraded to be compliant with BCA clause D3D22 via providing a handrail.
33.	Front Block Level 1 Ground

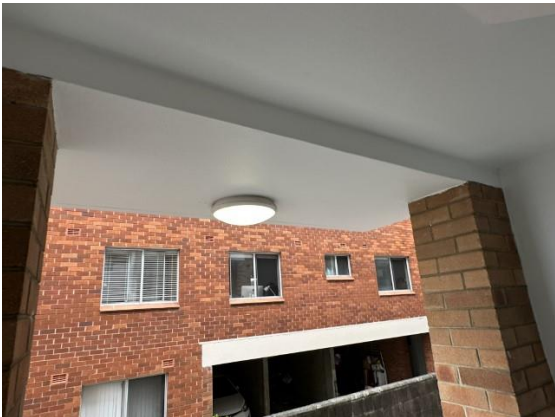
BCA Specification 20 A smoke alarm was not installed at the ground floor entry.	A smoke alarm should be installed at the ground floor entry in accordance with BCA specification 20 and be interlinked to the remaining smoke alarms in the common area.

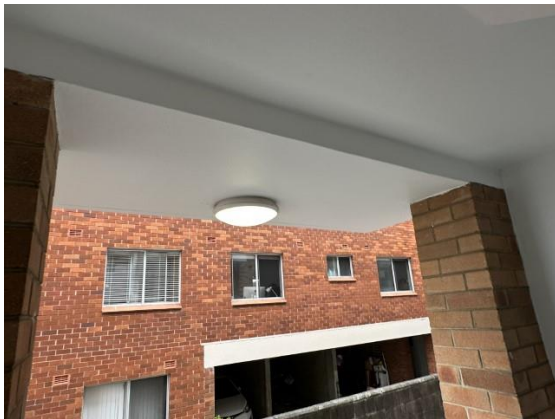
Item	Location	Photo	Details of Defect & Nominated Breach	Recommended Remedial Works
34.	Front Block Level 1 Ground

<p>BCA clause E4D5</p> <p>There was no exit sign installed at the exit location at ground floor.</p>	<p>An exit sign should be installed at the ground floor in accordance with BCA clause E4D5 and AS/NZS 2293.1 – 2018.</p>
35.	Front Block Common Area Two steps at residential unit egress level

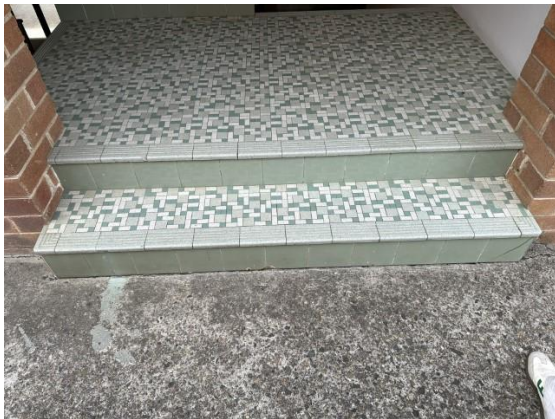
<p>BCA clause D3D22</p> <p>A handrail was not provided.</p>	<p>The stair should be upgraded to be compliant with BCA clause D3D22 via providing a handrail.</p>

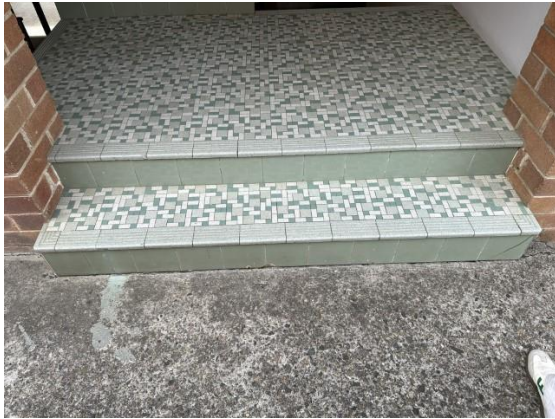
Item	Location	Photo	Details of Defect & Nominated Breach	Recommended Remedial Works
36.	Front Block Common Area Two steps at residential unit egress level

BCA clause D3D14  Riser variance is greater than 5mm riser-to-riser and the variance is greater than 10mm in flight (circa 13-mm).	Due to the minor non-compliance we would recommend a performance solution is provided to address this issue.
37.	Rear Block Level 3 Landing

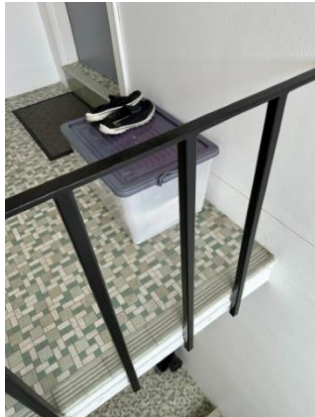
BCA clause D3D18  The balustrade at the landing was less than 1m high.	The balustrade should be upgraded to be a minimum 1 metre high to comply with BCA clause D3D18 and AS 1170.1 - 2022.

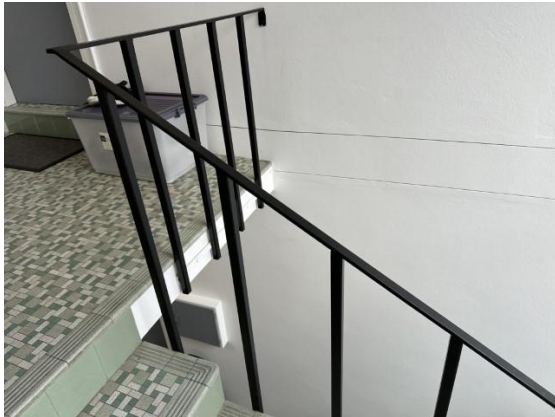
Item	Location	Photo	Details of Defect & Nominated Breach	Recommended Remedial Works
38.	Rear Block Level 3 Stair

BCA clauses D3D18 and D3D22 The balustrade and handrail to the stair are less than 865mm high.	The balustrade and handrail should be upgraded to be compliant with BCA clauses D3D18 and D3D22 and AS 1170.1 - 2002.
39.	Rear Block Level 3 Stair

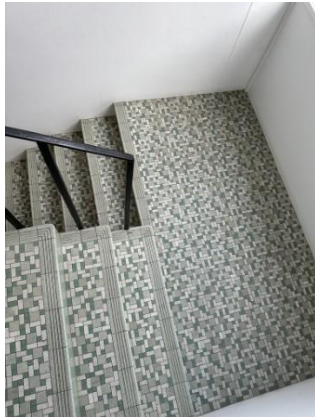
BCA clauses D3D22 The handrail at the mid-landing is not continuous vertically above the riser.	The handrail should be upgraded to be compliant with BCA clauses D3D22.

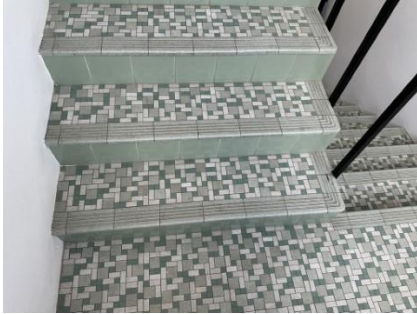
Item	Location	Photo	Details of Defect & Nominated Breach	Recommended Remedial Works
40.	Rear Block Level 3 Stair

BCA clause D3D14 Riser variance is greater than 5mm bottom riser to second bottom riser and the variance is greater than 10mm in flight (circa 12-mm).	Due to the minor non-compliance we would recommend a performance solution is provided to address this issue.
41.	Rear Block Stair L3 to Ground

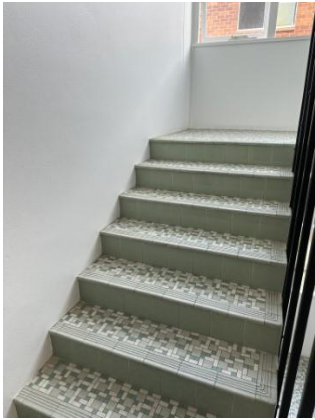
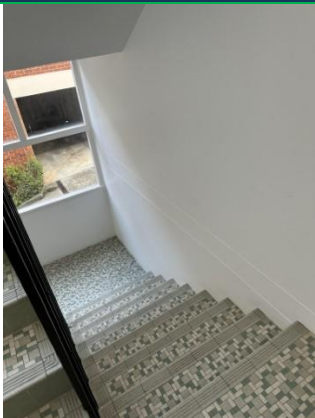
BCA clause D3D22 A handrail was not provided.	The stair should be upgraded to be compliant with BCA clause D3D22 via providing a handrail.

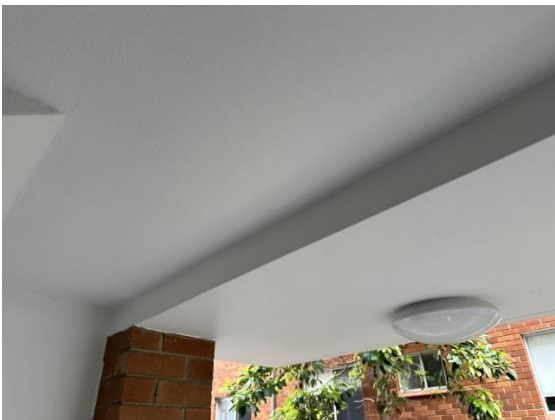
42.	Rear Block Level 1

<p>BCA clause E4D5</p> <p>There was no exit sign installed at the exit location at ground floor.</p>	<p>An exit sign should be installed at the ground floor in accordance with BCA clause E4D5 and AS/NZS 2293.1 – 2018.</p>

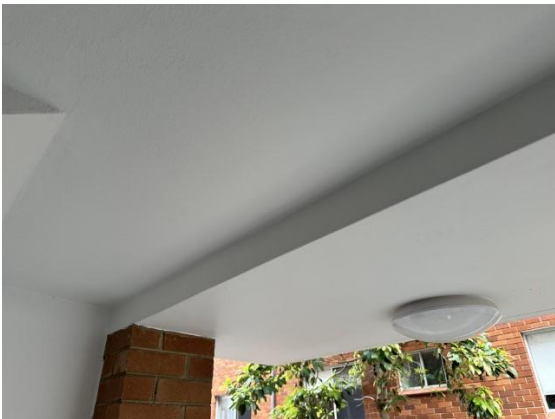
Item	Location	Photo	Details of Defect & Nominated Breach	Recommended Remedial Works
43.	Rear Block Level 1

BCA Specification 20 A smoke alarm was not installed at the ground floor entry.	A smoke alarm should be installed at the ground floor entry in accordance with BCA specification 20 and be interlinked to the remaining smoke alarms in the common area.
44.	Rear Block Stair Ground up to L1

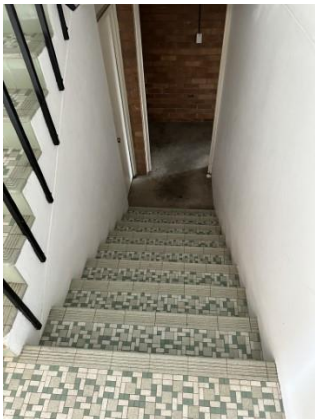
BCA clause D3D22 A handrail was not provided.	The stair should be upgraded to be compliant with BCA clause D3D22 via providing a handrail.

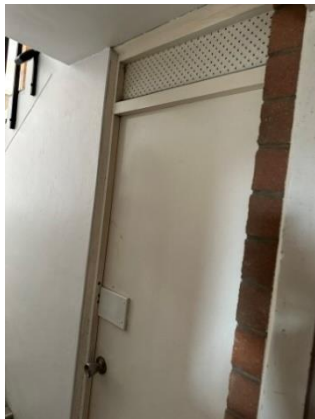
Item	Location	Photo	Details of Defect & Nominated Breach	Recommended Remedial Works
45.	Rear Block Ground Level Cupboard under Stair

BCA clause D3D9 No access was provided to check if this room under the stair is fire rated and whether penetrations are sealed.	Given the age of the building I consider it highly likely the room, the door and any services penetrations in the room will not be fire rated in accordance with BCA clause D3D9.  The room should be fire rated to a fire resistance level of one hour, the door be replaced with a one hour self-closing fire door and any service penetrations be fire rated to achieve a minimum 60 minute fire rating on both sides of the wall.
46.	Ground Level Electrical Board

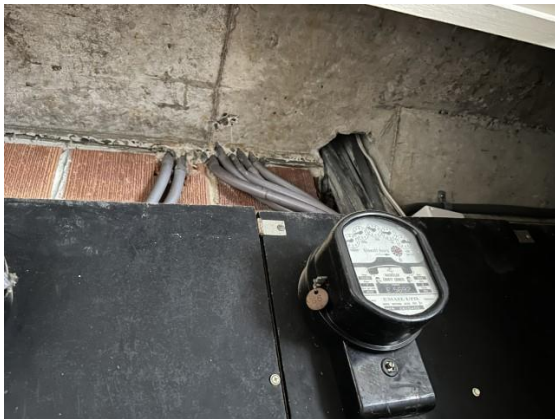
BCA clause C4D15. The cables and conduits in the soffit are not fire sealed.	The service penetration should be fire sealed in accordance with BCA clause C4D15.

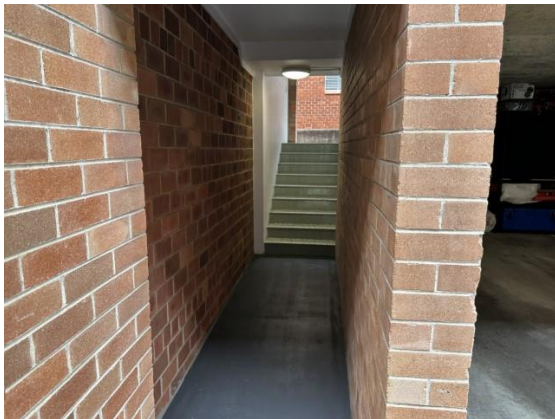
Item	Location	Photo	Details of Defect & Nominated Breach	Recommended Remedial Works
48.	Ground Level Path of Travel to Stair

<p>BCA clause D3D8</p> <p>The path of travel from the stair to external is less than 1m, only 940mm.</p>	<p>Due to the minor nature of the non-compliance and the low occupant load of this area I do not consider that upgrade works are required as the minor reduced width would be compliant with the performance requirement D1P6.</p>
49.	Ground Level Stair up to L1 Main Entry

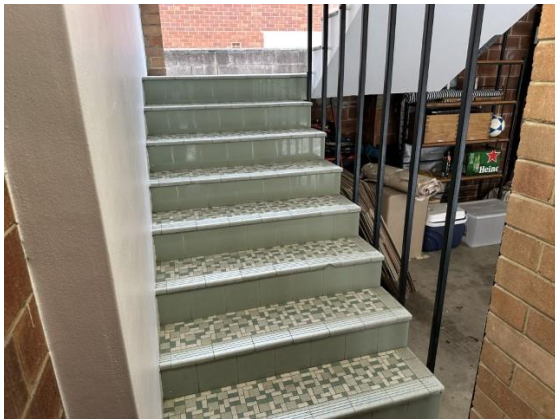
<p>BCA clause D3D8</p> <p>The path of travel on the stair is less than 1m, only 950mm.</p>	<p>Due to the minor nature of the non-compliance and the low occupant load of this area I do not consider that upgrade works are required as the minor reduced width would be compliant with the performance requirement D1P6.</p>

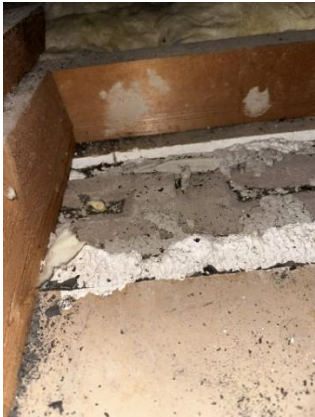
Item	Location	Photo	Details of Defect & Nominated Breach	Recommended Remedial Works
50.	Roof level

<p>BCA Specification 5</p> <p>The ceiling at roof level is not continuous throughout the whole of the top floor and stops and starts between the masonry divided walls within the top floor.</p>	<p>A performance-based solution is recommended to address this non-compliance.</p> <p>This would provide justification of the suitability of allowing for the fire rated ceiling to be non-continuous.</p> <p>Typically this requires that any penetrations into the walls below the fire rated ceiling are fire rated at the entry point to ensure that fire does not gain access into the wall and then spread up through the wall and into the roof space allowing fire to spread to an adjacent unit. Any ceiling/wall junctions would also be required to be fire sealed.</p> <p>A fire engineer should attend the site to inspect the non-compliance to then provide details of a suitable performance-based solution to address this non-compliance.</p>

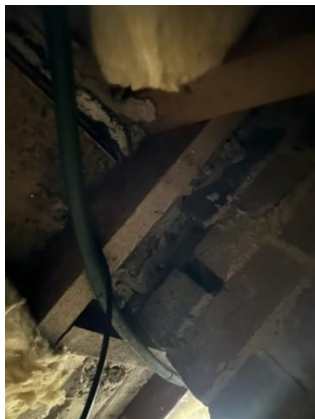
Item	Location	Photo	Details of Defect & Nominated Breach	Recommended Remedial Works
51.	Roof level

<p>BCA Specification 5.</p> <p>There was a hole in the wall of the riser that was not fire sealed.</p>	<p>The hole in the wall of the riser should be fire sealed to comply with BCA Specification 5.</p>
52.	Roof level

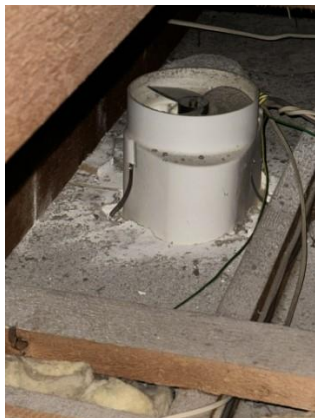
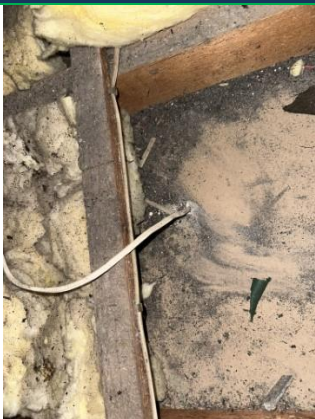
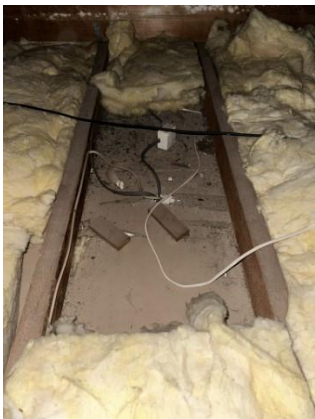
<p>BCA clause C4D15</p> <p>Within the roof area there were service penetrations that were not fire sealed where they came through the ceiling. The ceiling appears to be a fire rated ceiling as two layers of fire rated plasterboard have been provided.</p>	<p>A fire contractor specialising in fire rating of service penetration should gain access to the roof space and fire rate all service penetrations within the roof space that penetrate through the ceiling, so that the penetrations achieve a minimum 60 minute incipient spread fire rating.</p>

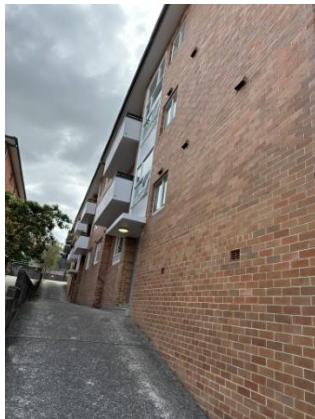
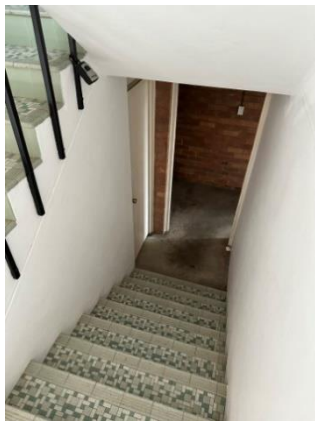
Item	Location	Photo	Details of Defect & Nominated Breach	Recommended Remedial Works
58.	Throughout

<p>Photo above shows the residentail units egress at the high side of the building.</p>

<p>BCA clause E1D6</p> <p>The building has a rise in storeys of four.</p> <p>Due to the rise in storeys of four, the building is required to be provided with a sprinkler system throughout. It is currently not sprinklered.</p>	<p>Whilst the building has a rise in storeys of only 4 storeys, it is noted that the occupants of the class 2 residential levels only need to travel a maximum of 3 storeys to egress the building as the class 2 occupants level of egress is on the high side of the site and their egress path does not require them to travel down to the carpark level below, due to the stepped nature of the site and of the building.</p> <p>Whilst it is acknowledged that the BCA requires the building to be sprinkler protected throughout where it is a new building, I am of the opinion that it is not necessary for this building to be sprinkler protected due to the rise in storeys only being four and that the class 2 residential component of the building is only three stores.</p> <p>In addition the building is to be heavily fire separated due to the fire upgrade works, with these works including fire rating of the service penetrations, installation of fire doors, upgrading of the bounding wall for the fire rating of the milk boxes, installation of hard wired smoke alarms in units and interconnection of smoke alarms in the common areas.</p> <p>As a further measure to assist with occupant evacuation the upgrade of the building should include hard wired thermal smoke alarms within 1.5-m of</p>
