35A Plateau Road, Avalon

J2928. 11th September, 2020. Page 1.

GEOTECHNICAL INVESTIGATION:

Alterations and Additions at 35A Plateau Road, Avalon

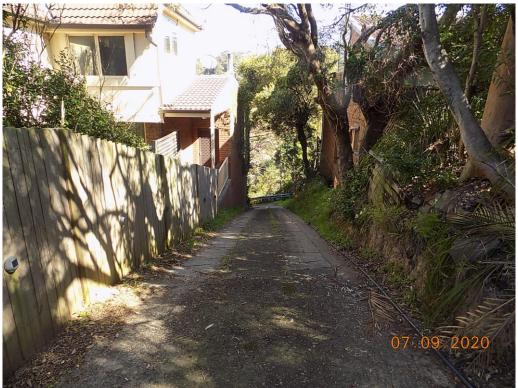
Photo 1

- **2.1** The site was inspected on the 7th September, 2020.
- 2.2 This residential property is on the low side of the road and has a S aspect. The block is located on the moderate to steeply graded upper middle reaches of a hillslope. From the upper boundary to the downhill side of the house, the natural slope falls at an average angle of ~19°. The slope between the downhill side of the house and the lower boundary falls at an average angle of ~30°. The slope below the property continues at steep angles. The slope above the property continues briefly before encountering crest of the slope.
- 2.3 At the road frontage, a long and steep concrete Right of Carriageway (ROW) runs down the slope (Photo 1). A brick-paved parking area diverts off the ROW on the

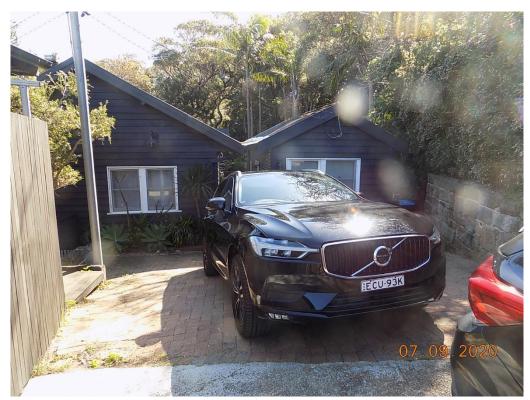
Photo 2

subject property (Photo 2). The cut for the parking area is supported by a stable sandstone block retaining wall reaching ~1.6m high (Photo 3). An excavation has been made in the slope to create a level platform for a stable outbuilding and deck on the uphill side of the house (Photo 4). The cut is supported by a stable ~0.9m high treated timber retaining wall (Photo 5). The single-storey sandstone block and timber framed and clad house is supported on sandstone block walls and piers (Photo 6). No significant signs of movement were observed in the supporting walls and the supporting piers stand vertical. A steep slope falls from the downhill side of the house to the lower common boundary (Photo 7). The slope has surface covering of unkept grass and is mostly vegetated with weeds. To improve the long-term stability of the slope we recommend it be planted out in native shrubs that have deep root systems that bind the soils to the rock below. Competent Medium Strength Sandstone outcrops through this slope below the house (Photo 8).
