## **83 Parkes Road, Collaroy Plateau**

### Geotechnical Comments for Section 4.55.

## **GEOTECHNICAL INVESTIGATION:**

### **New Houses at 83 Parkes Road, Collaroy Plateau**

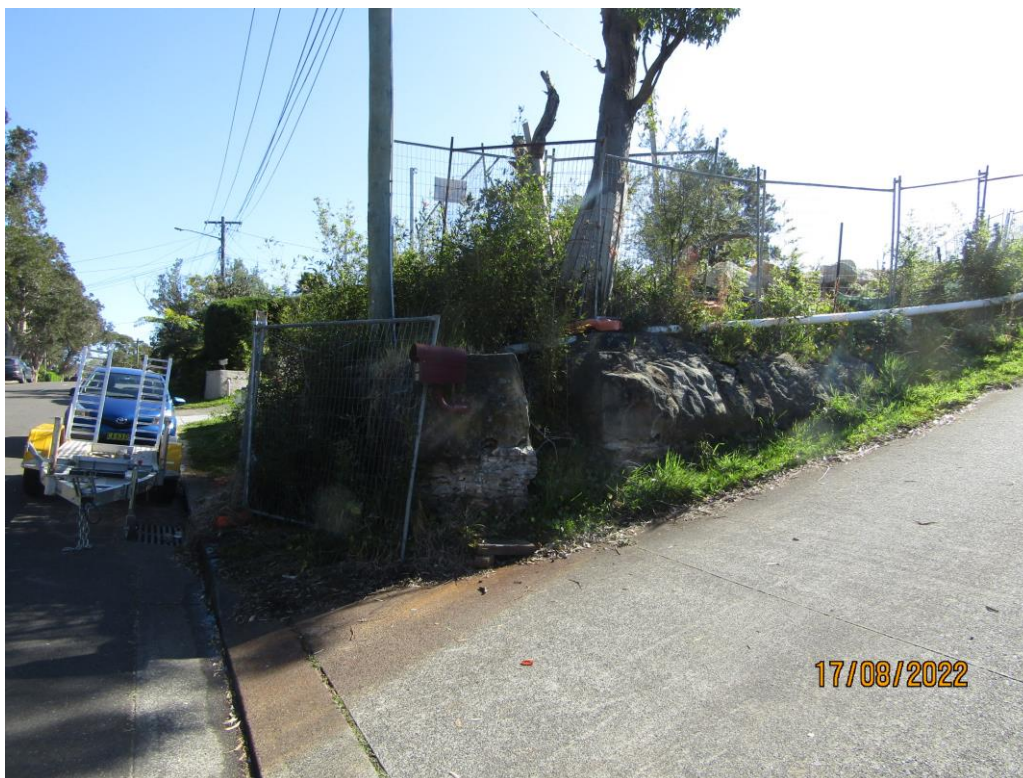
Photo 1

- 2.3** Medium Strength Hawkesbury Sandstone bedrock outcrops at the downhill property boundary (Photo 1). A ~1.4m high cut and fill provides a level platform for the road and reduces the grade of the downhill portion of the property (Photo 2). A formed plastic retaining wall mould has been placed against the lower portion of the cut as a temporary support measure. It is recommended an engineered retaining wall be built to support the cut as part of the proposed works. At the road frontage, a concrete driveway runs up the slope to each vacant lot (Photos 2 to 4). Apart from the
