## **GEOTECHNICAL INVESTIGATION REPORT**

### **PROPOSED NEW DEVELOPMENT**

**32 GOLF AVENUE, MONA VALE, NSW**

**Project No.: 2024-004**

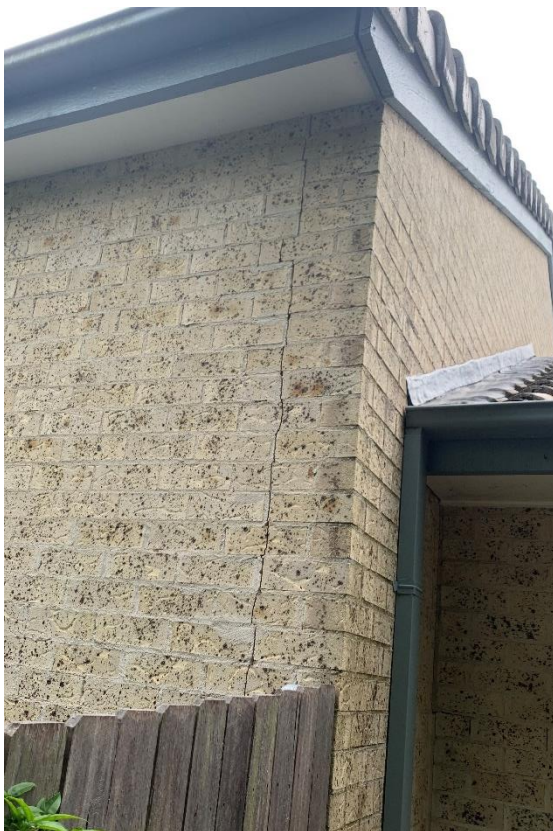
The main structures appeared in reasonable condition with several large vertical cracks observed on all-townhouse exterior walls presumed to be a result of thermal expansion and deterioration over time, shown in Photograph 3. Cracking and settlement was observed on the concrete driveway and concrete floor slab of the

*Photograph 3: Vertical crack within rear external wall*

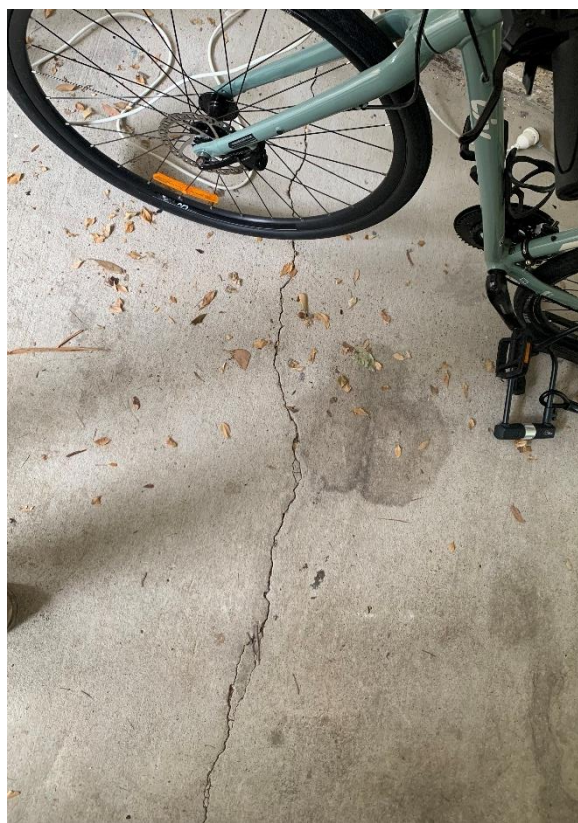
garage, shown in Photograph 4. These cracks are presumed to be a result of differential settlement and deterioration over time.

*Photograph 4: Crack within concrete floor slab of garage*
