Geotechnical Assessment

Project: Alterations & Additions 2 Warekila Road, Beacon Hill NSW

REF: AG 21356 25 October 2021

Preliminary Geotechnical Assessment

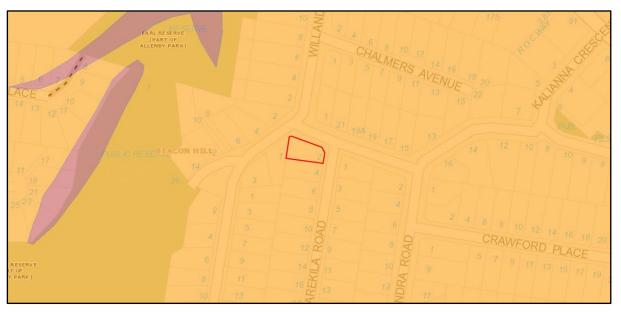
The site is mapped as **Area B** subject to specific landslip risk/geotechnical hazard mapping with reference to the Warringah Landslip Risk Map (**Image 1**).

Image 1. Warringah Landslip Risk Map: 2 Warekila Road, Beacon Hill NSW (© NBC Maps)
