Geotechnical Assessment

Project: New Dwelling

190 McCarrs Creek Road, Church Point NSW

11 February 2021

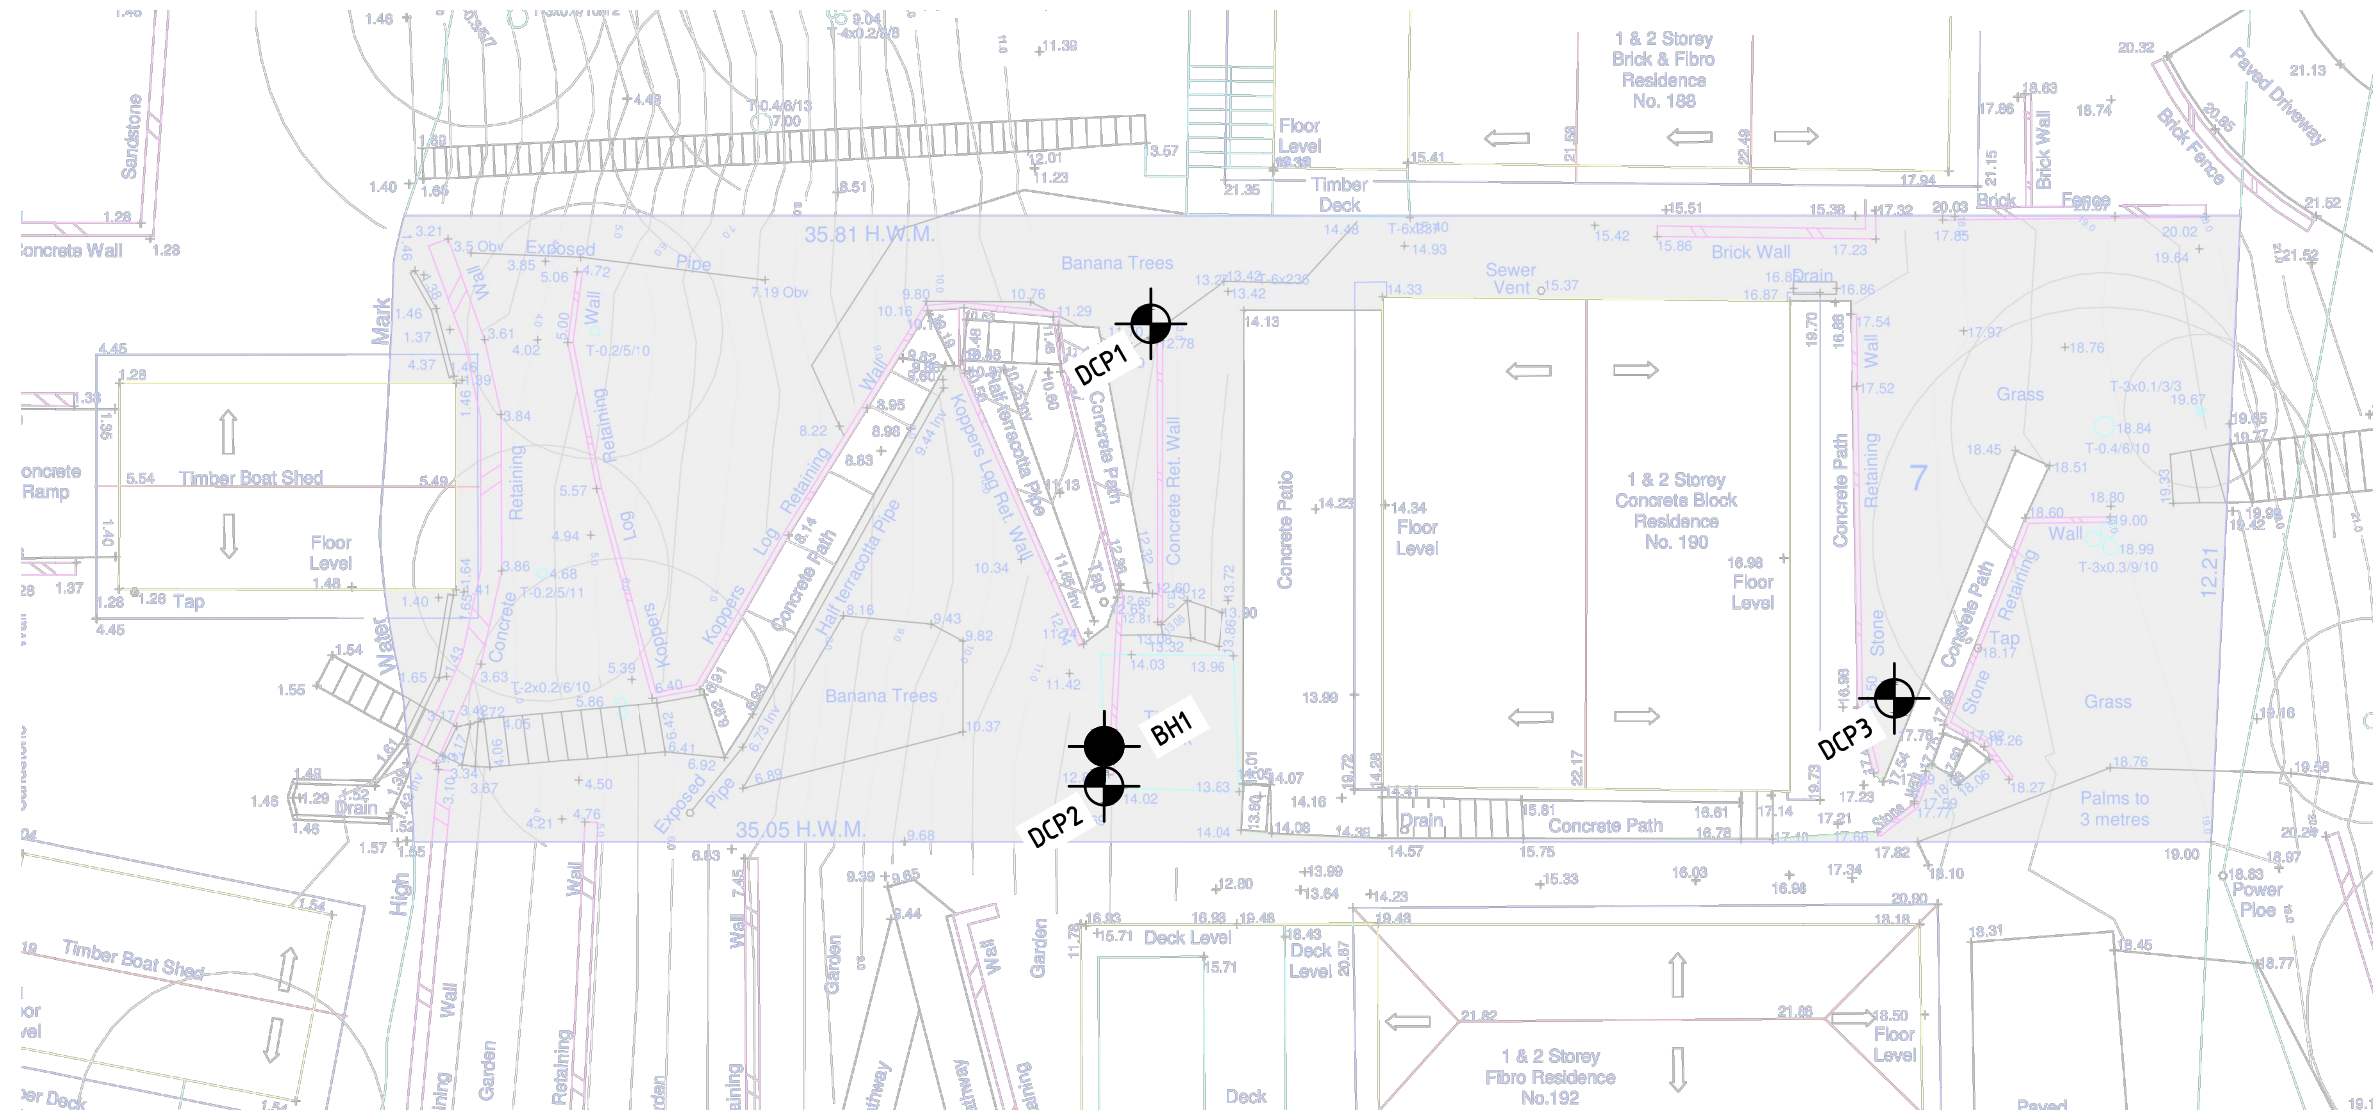
SITE PLAN/GROUND TEST LOCATIONS SCALE NTS

NOTE: SURVEY PROVIDED FROM 2003,
DOES NOT SHOW RECENTLY CONSTRUCTED
CARPORT STRUCTURE.

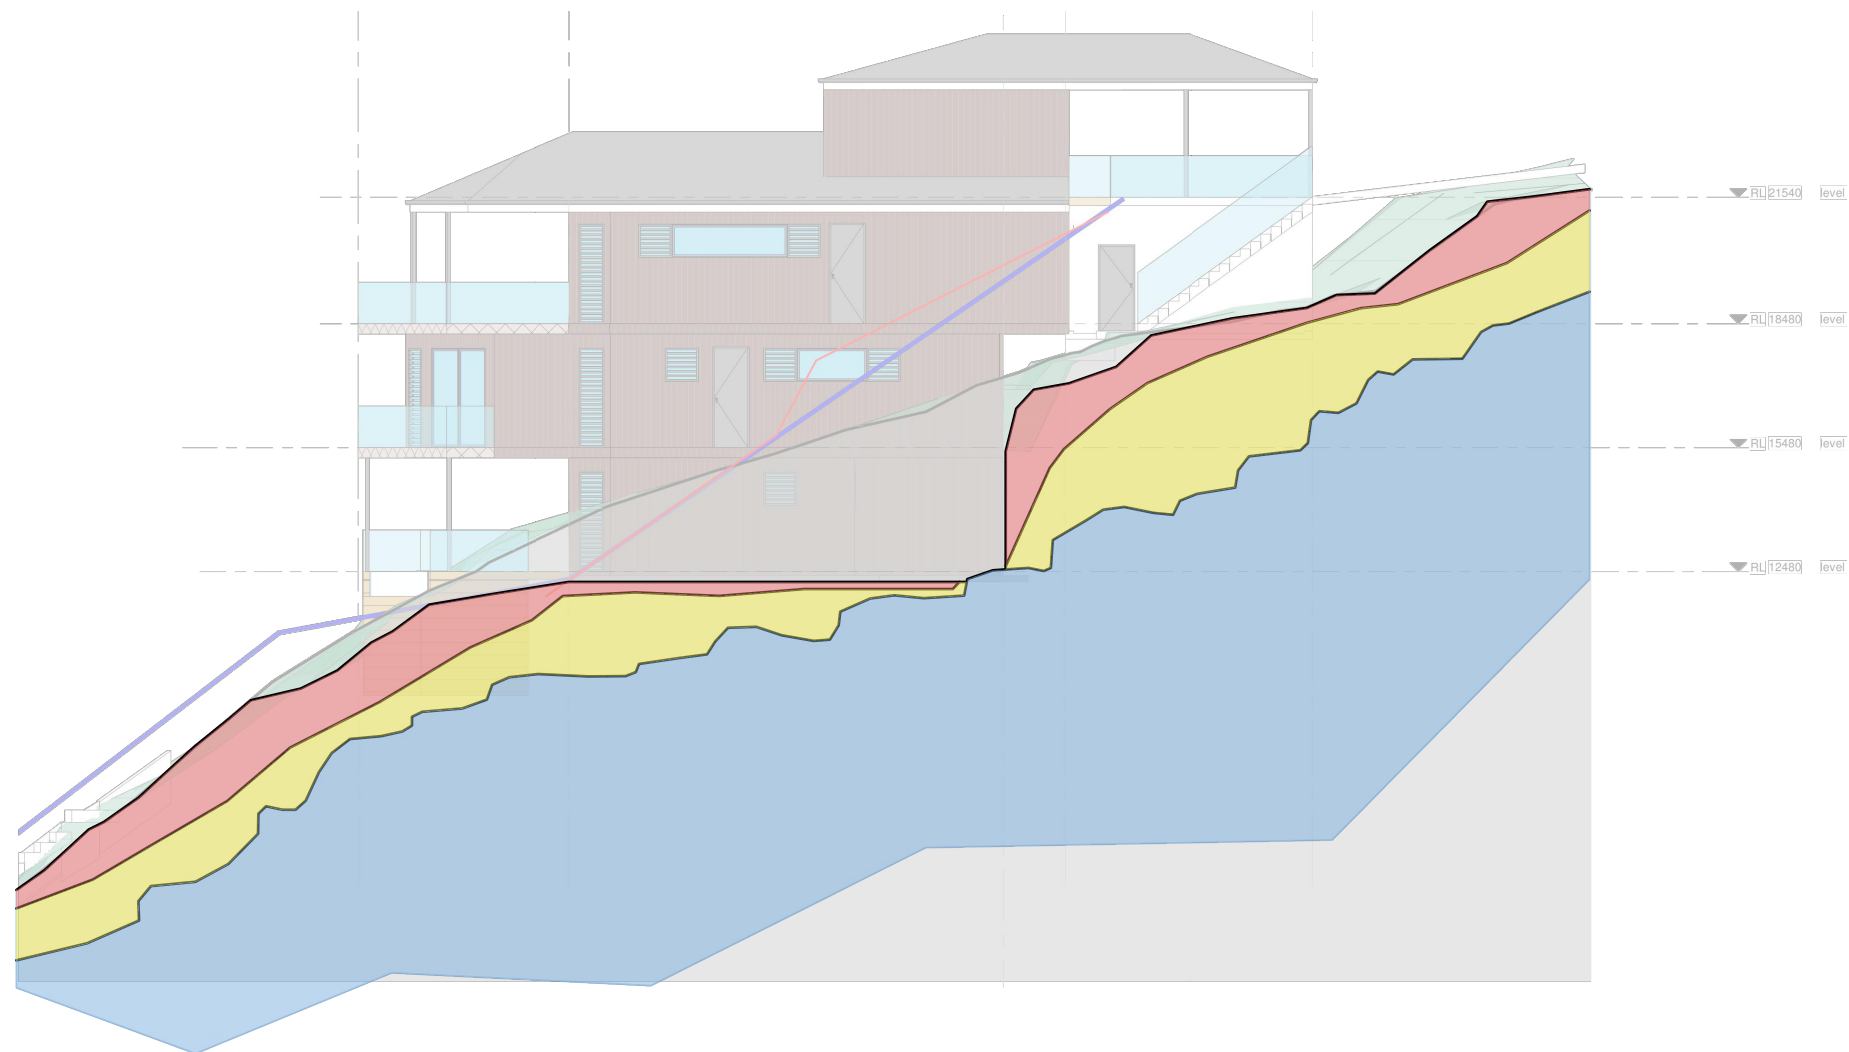
INFERRED GEOLOGICAL SECTION
SCALE NTS

INTERPRETED SUBSURFACE SECTION ONLY.
ACTUAL GROUND CONDITIONS MAY VARY.
