**GEOTECHNICAL RISK MANAGEMENT POLICY FOR PITTWATER**  
**FORM NO. 1 – To be submitted with Development Application**

## **1178 Barrenjoey Road, Palm Beach**

### **Minor Works Assessment**

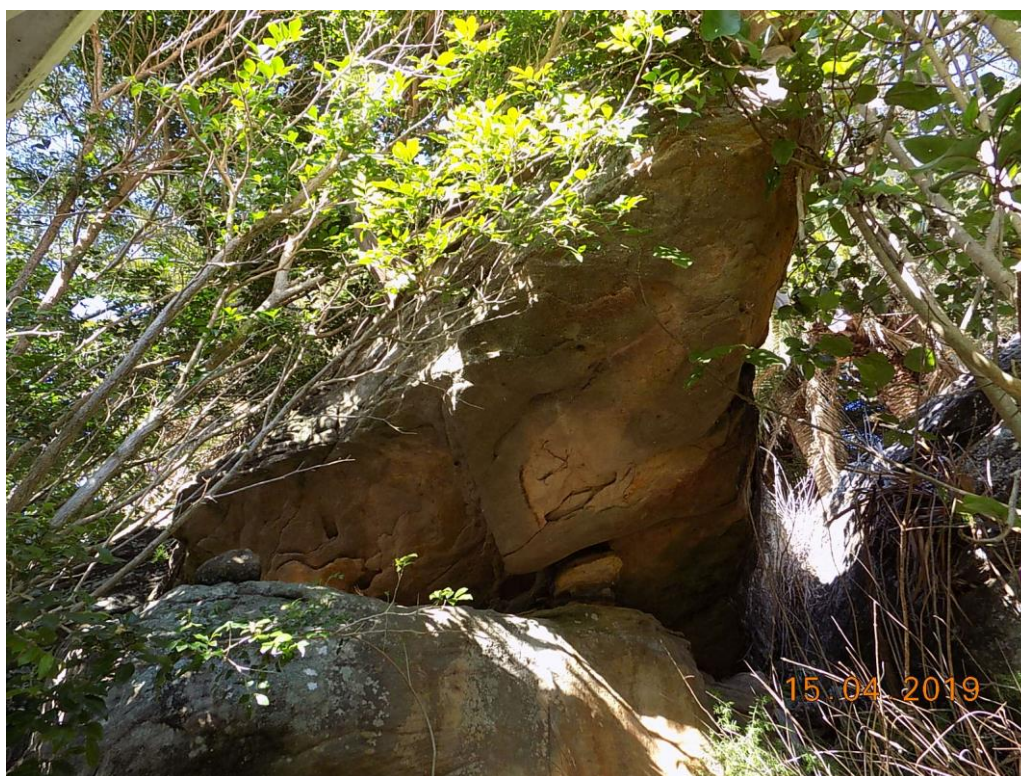
Photo 8

| HAZARDS | Hazard One | Hazard Two |
|---|---|---|
| TYPE | The moderate to steep slope that rises across the property and continues above failing and impacting on the proposed works. | The undercut rock face failing and impacting on the house (Photo 8). |
| LIKELIHOOD | 'Unlikely' ( $10^{-4}$ ) | 'Rare' ( $10^{-5}$ ) |
| CONSEQUENCES TO PROPERTY | 'Medium' (20%) | 'Major' (60%) |
| RISK TO PROPERTY | 'Low' ( $2 \times 10^{-5}$ ) | 'Low' ( $6 \times 10^{-5}$ ) |
| RISK TO LIFE | $8.3 \times 10^{-7}$ /annum | $8.3 \times 10^{-7}$ /annum |
| COMMENTS | 'ACCEPTABLE' level of risk to life & property. | 'ACCEPTABLE' level of risk to life & property. |
