## Preliminary Geotechnical Assessment

For Alterations & Additions at

**5 Forest Glen Crescent, Belrose NSW**

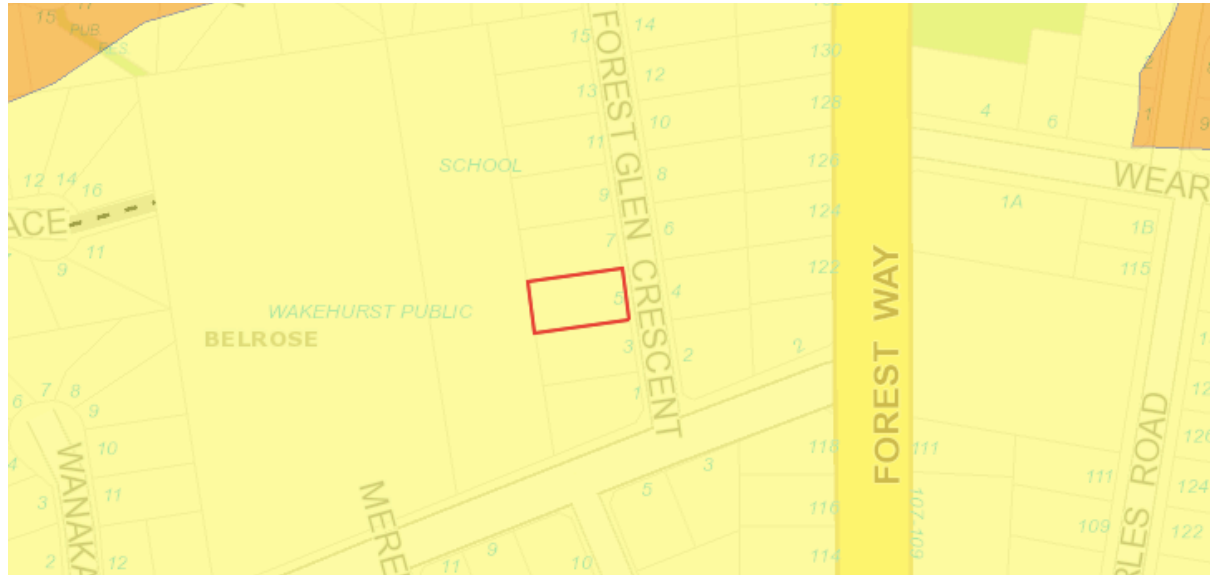
**WARRINGAH LANDSLIP RISK MAP**

The site is mapped as **Area A** on the Landslip Risk Map WLEP 2011 (**Image 1**, below).
