REPORT ON GEOTECHNICAL SITE INVESTIGATION

PROPOSED DEMOLITION OF EXISTING SITE HOUSE AND CONSTRUCTION OF TWO STOREY RESIDENCE

15 BURRENDONG PLACE, AVALON, NSW

Project No.: 2020-142

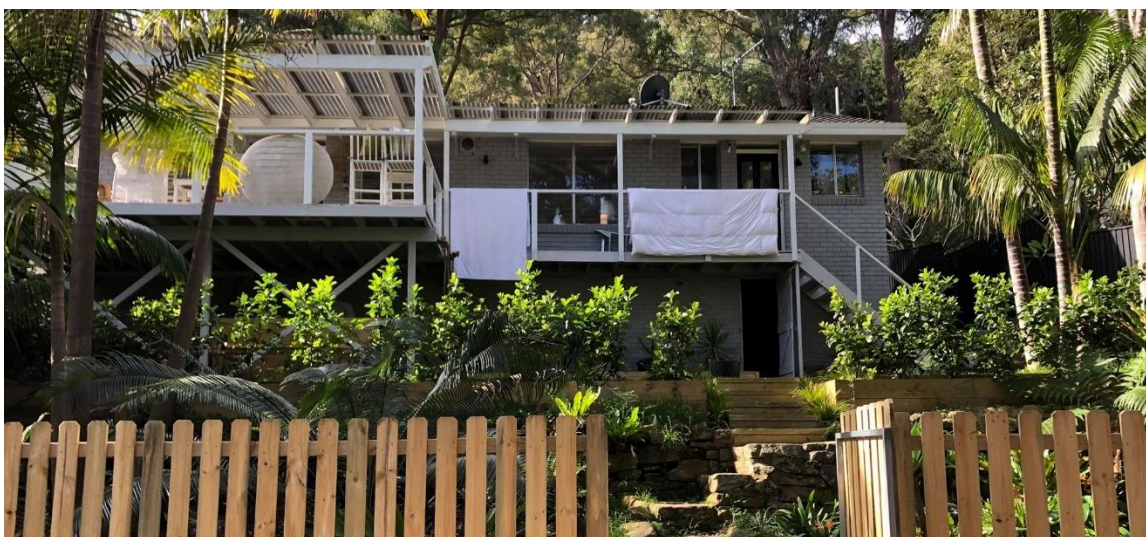
Photograph 2: View of the rear of the site and main structure, looking north east

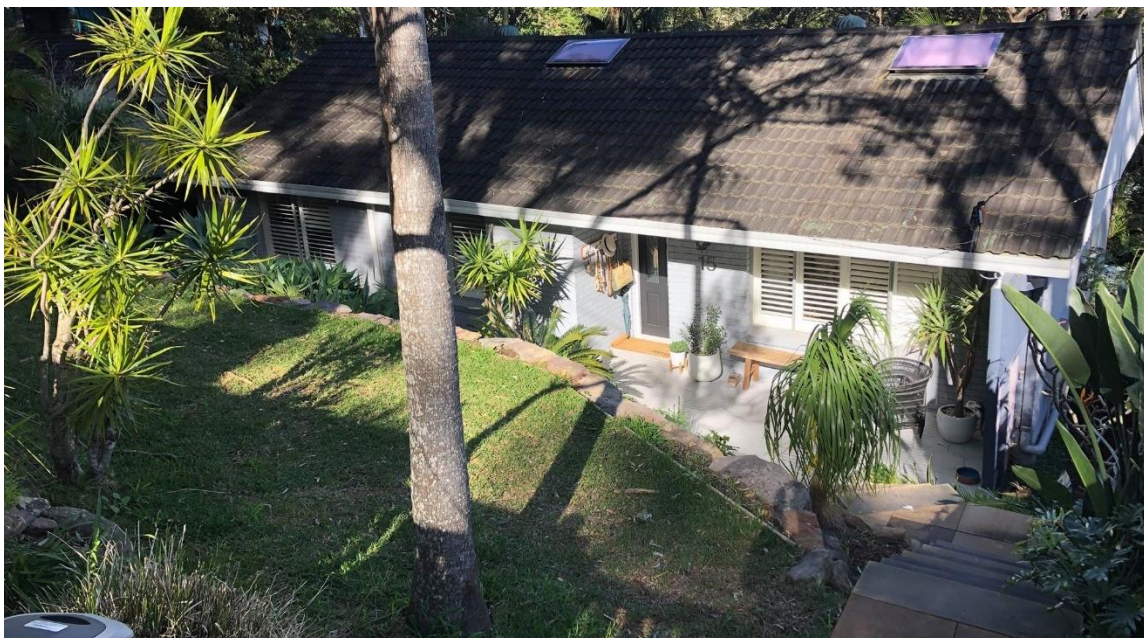
Photograph 3: View of the front of the site and main structure, looking south

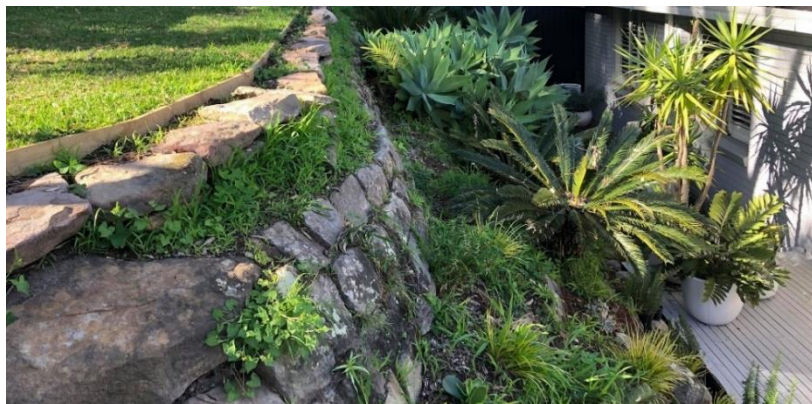
Retaining walls and grassed terrace lawns occupy the front of the site. The top dry stack stone retaining wall is $\leq 1.2\text{m}$ high with the lower retaining wall within the front of the site extending to a height $\leq 3.0\text{m}$. The base of the lower retaining wall is level with the front decking area and concrete side access walkway. The sub vertical retaining walls within the front of the site appear to be in good condition, the lower retaining wall is shown in Photograph 5. Large gum trees are positioned within the front of the site and along the front boundary.

Photograph 5: Lower front retaining wall, facing south east

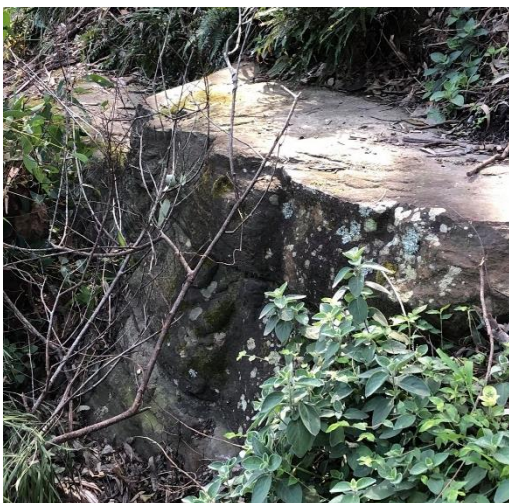
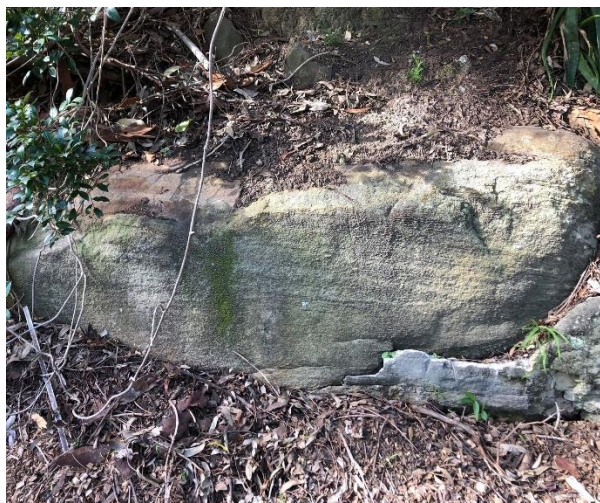
Sandstone rock outcrops were observed on the high side of Burrendong Place within No.2 Burrendong Place. The interpreted outcropping bedrock is formed with tabular blocks, consisting of medium to coarse grained sandstone. Approximately ten individual outcrops were noted across the front portion of the adjacent property, some of these outcrops are shown in Photograph 6, 7 and 8.

Photograph 6 & 7: Rock outcrops within No. 2 Burrendong Place.

The bedrock profile appears to step down the moderate south west to west dipping slope. Exposed planar sandstone bedrock is evident on the high side of the street, as shown in Photograph 6, it is anticipated that these cliff drops continue throughout the site though weaker and more deeply weathered siltstone units may also be encountered. No seepage or groundwater was encountered during the investigation however, it is likely that minor seepage will be intersected at the soil - rock interface and on defects in the bedrock during excavation. A freestanding water table was not encountered and is not expected within the site due to the topography of the site and surrounds.

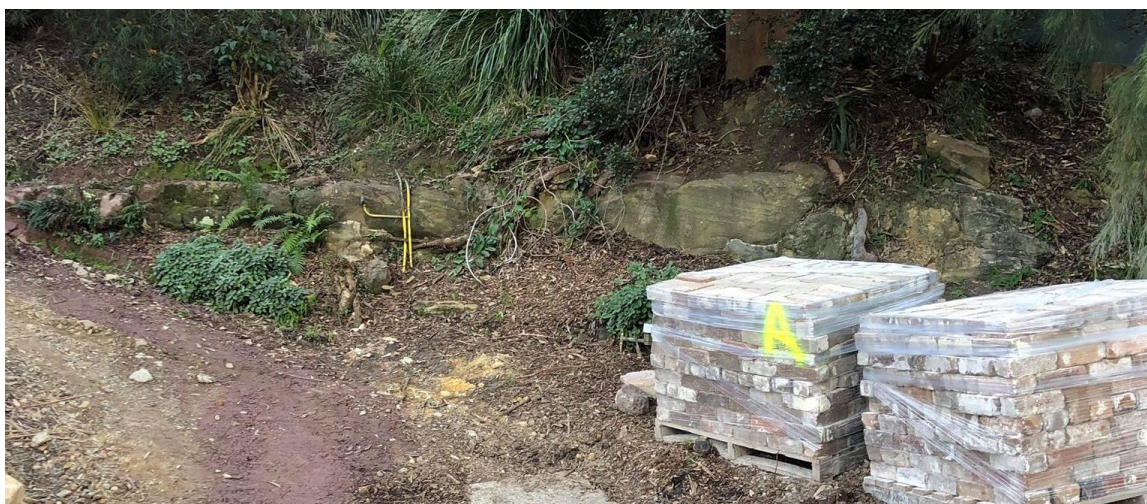
Photograph 8: Rock outcrops within eastern portion of the front of No. 2 Burrendong Place.

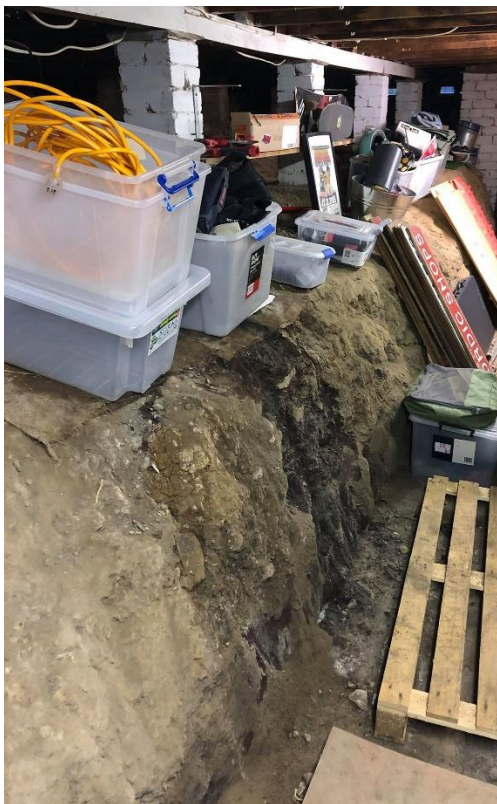
Photograph 9: Stepped soil profile in basement sub floor level, facing south east

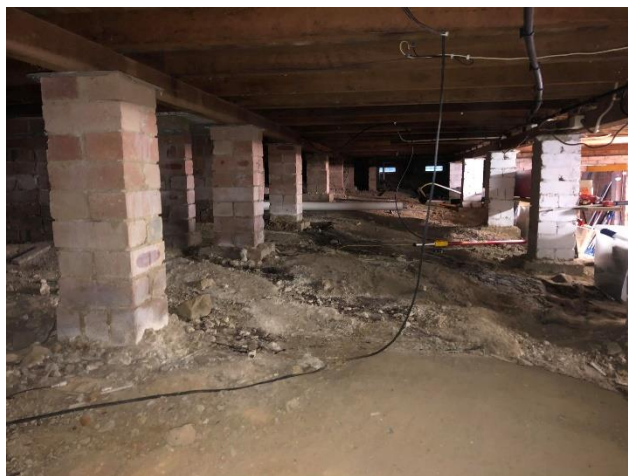
Photograph 10: Exposed footings in basement sub floor level, facing south east
