REPORT ON GEOTECHNICAL INVESTIGATION

PROPOSED NEW DEVELOPMENT

1010-1014 PITTWATER ROAD, COLLAROY, NSW

Project No.: 2023-150

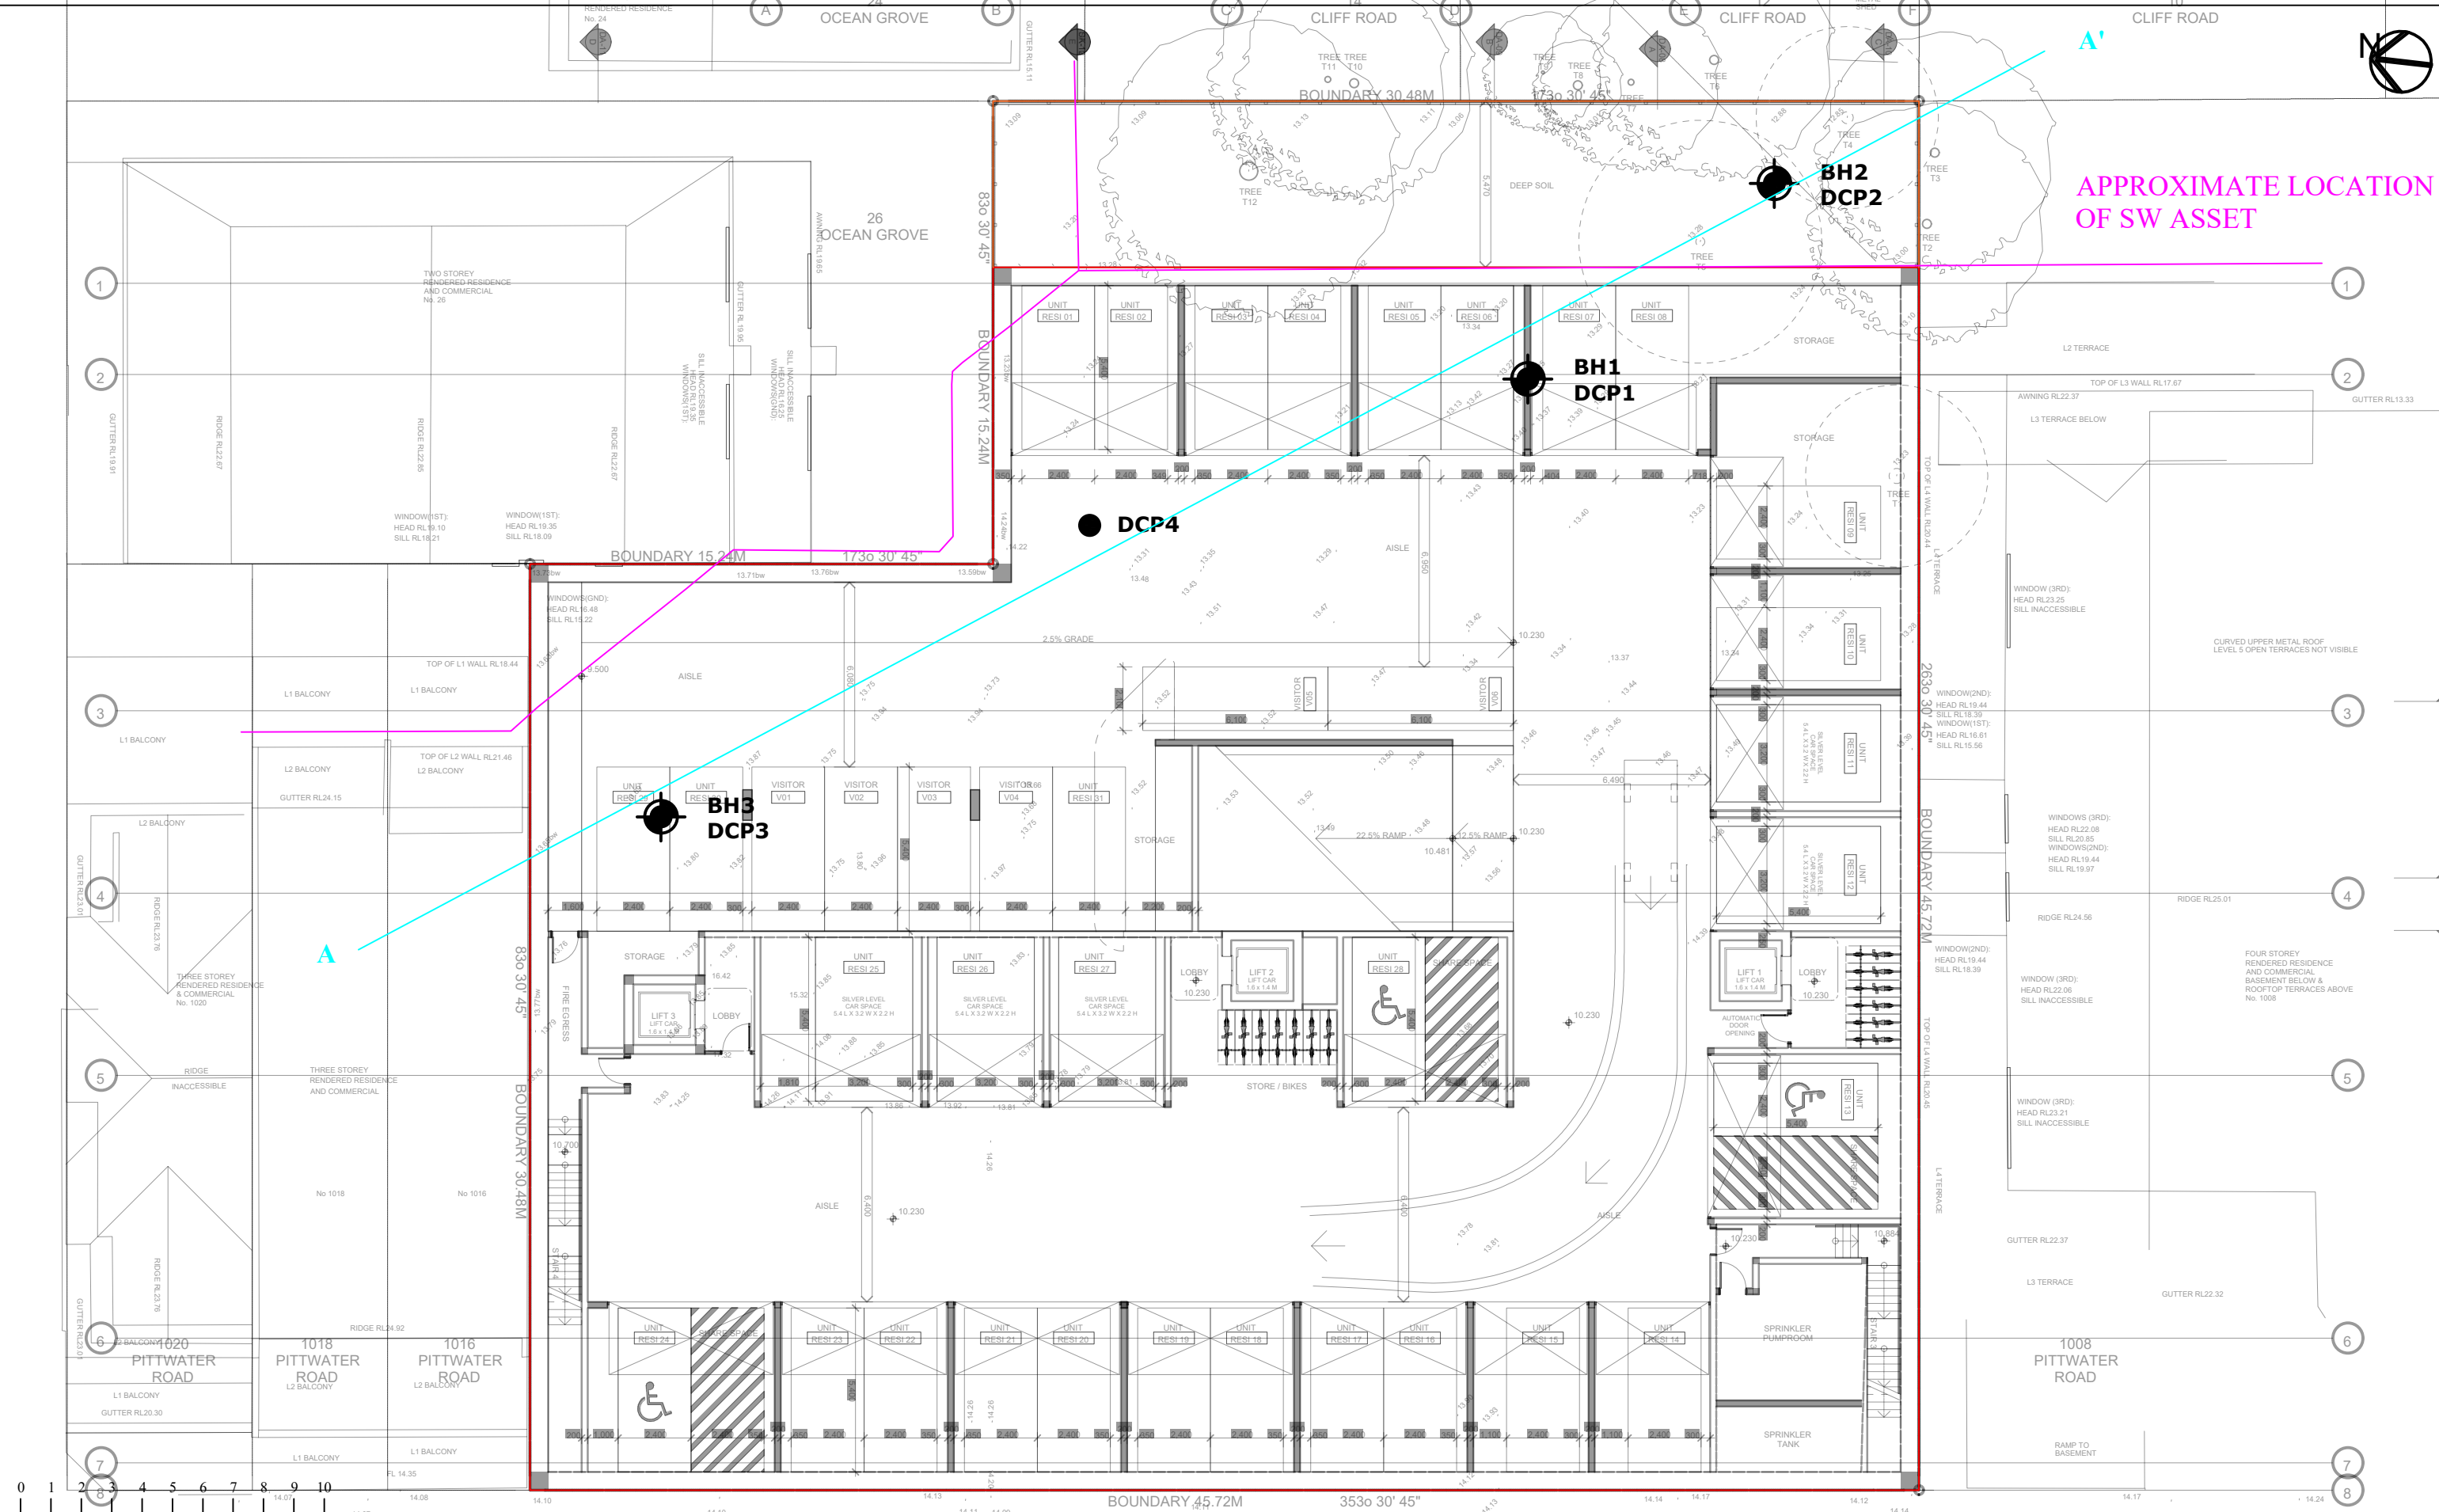
SITE PLAN & TEST LOCATIONS **FIGURE 1.**

- **TOPSOIL/FILL** – This layer was encountered in the test locations and extended to a maximum depth of 0.50m. It generally comprised a loose, dark brown, moist silty sand with building refuse and roots.
- **NATURAL SANDY SOILS** – Natural sandy soils were intersected underlying the topsoil/fill in all boreholes and extended to the maximum investigation depth of 4.00m. These soils varied in composition both with depth and between points with zones of increased clay, silt, quartz gravels and iron content encountered with negligible correlation between test points. Despite the varied composition, the soils graded fairly uniformly in density/stiffness with depth. With effective DCP refusal in very dense/hard natural soils intersected at depths varying between 1.90m (DCP3 & DCP4) and 2.70 (DCP1).
