GEOTECHNICAL INVESTIGATION:

New Carport, Storeroom and Lift at **103 Narrabeen Park Parade, Mona Vale**

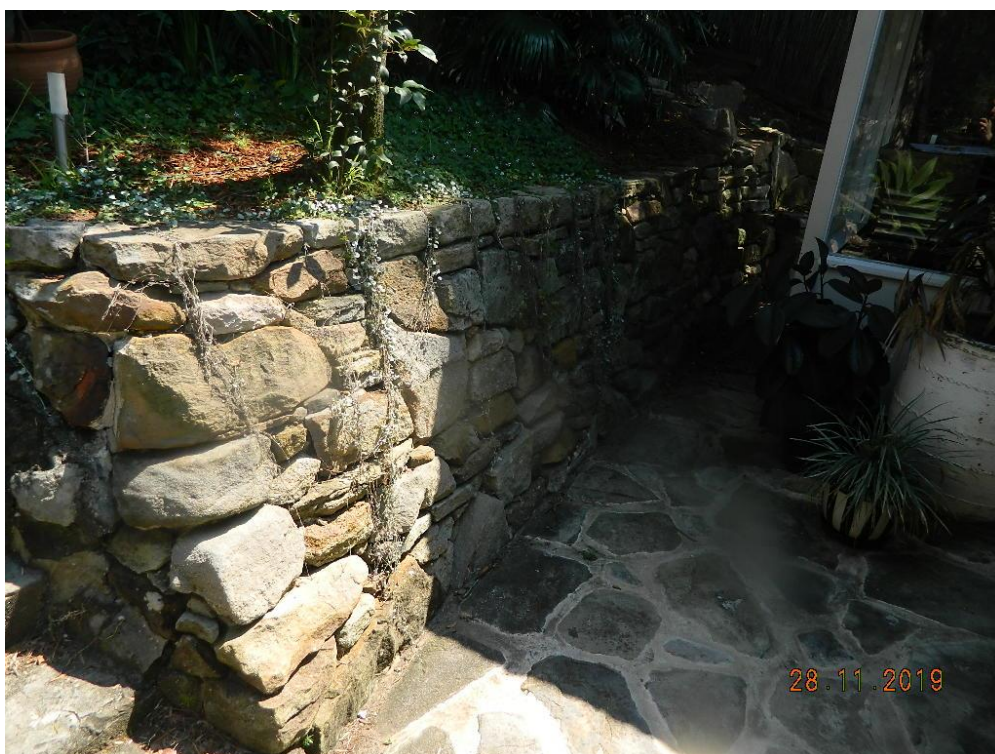
Photo 8

garden is supported by a stable stack rock retaining wall ~1.0m high (photo 8). The cut below the lawn is supported by a stable sandstone retaining wall ~1.0m high (photo 9). The two storey timber and weatherboard clad house is supported on brick walls, brick piers and concrete piers (photos 10 to 14). The supporting walls and piers show no significant signs of movement. A stable timber retaining wall supports a cut batter located underneath the downhill side of the house (photo 13). A suspended timber deck supported on timber posts extends off the downhill side of the house. (photo 15). A fill that provides a level platform for a stone pavement is supported by a stable timber retaining wall (photos 12, 16 & 17). A moderately sloping lawn descends downhill to the SE boundary of the property (photo 18). Below the boundary the surface is covered in coastal shrub and continues to Warriewood Beach (photos 19 & 20).

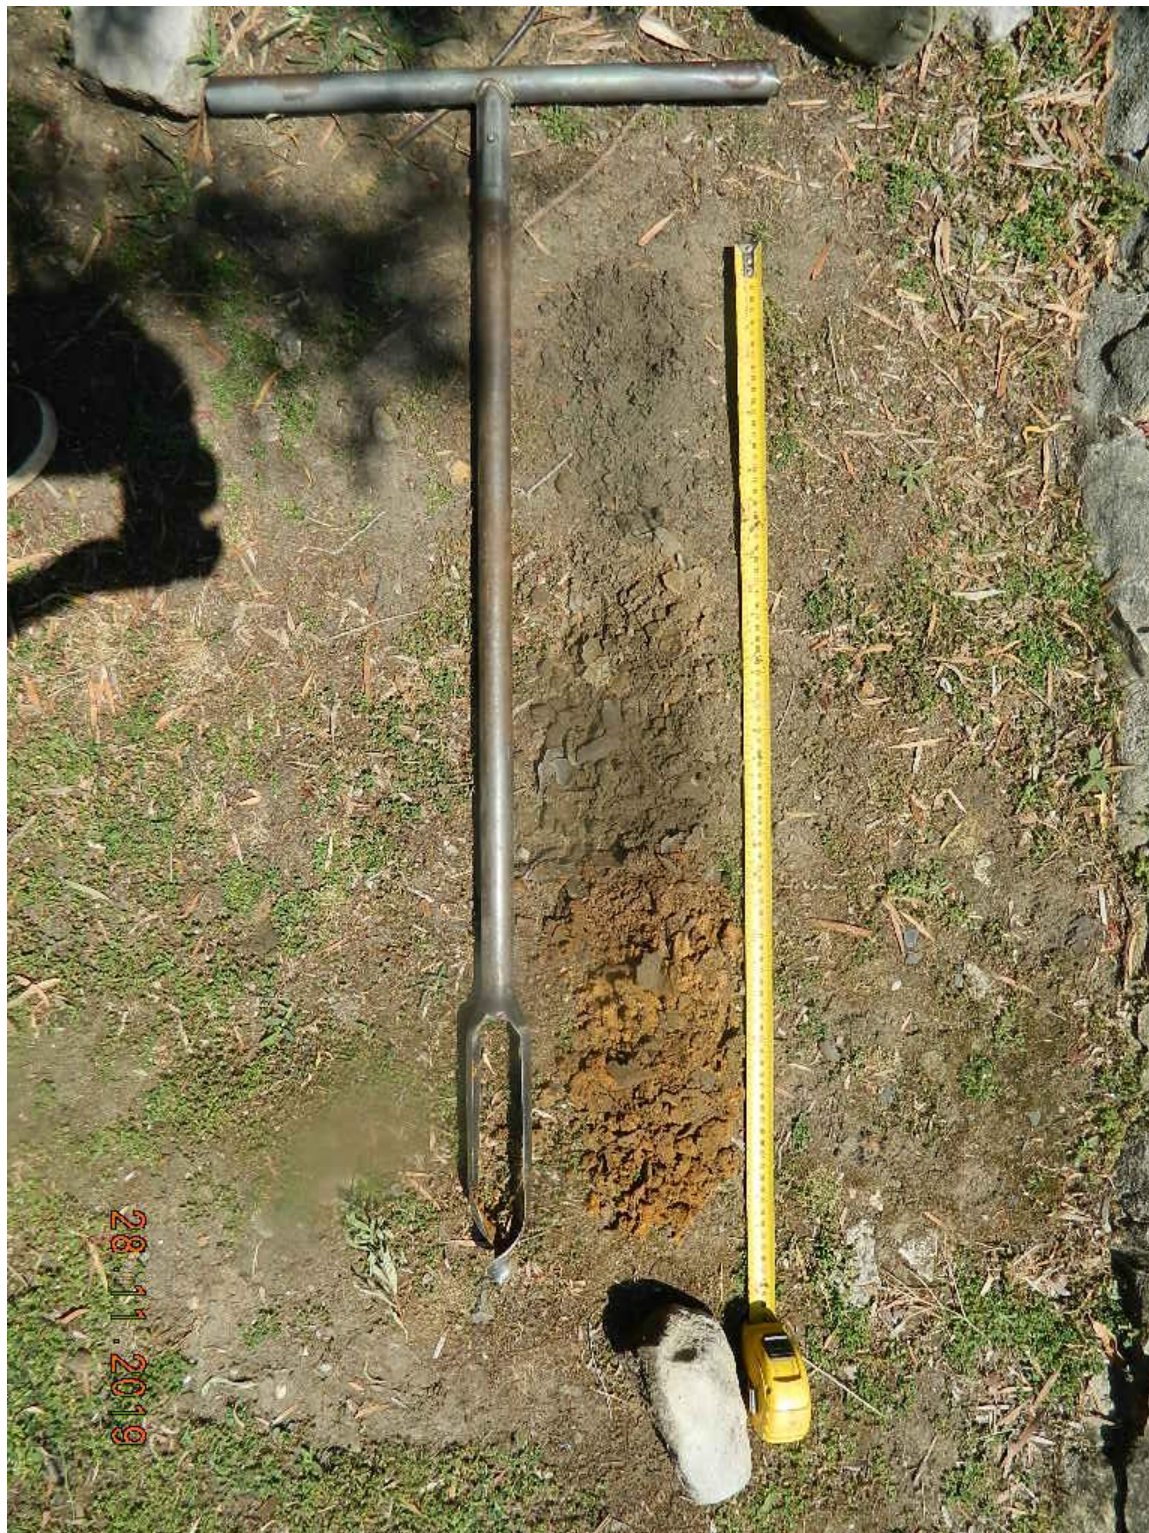
Photo 21: AH1 – Downhole is from top to bottom

AUGER HOLE 1 (~RL34.5) – AH1 (photo 21)

Depth (m)	Material Encountered
0.0 to 0.2	SANDY SOIL , grey, fine to medium grained.
0.2 to 0.5	SANDY CLAY , grey-brown, mottled with red, course grained, firm to stiff, dry.
0.5 to 0.8	SANDY CLAY , orange brown, firm to stiff, moist.

End of hole @ 0.8m in firm to stiff sandy clay. No watertable encountered.

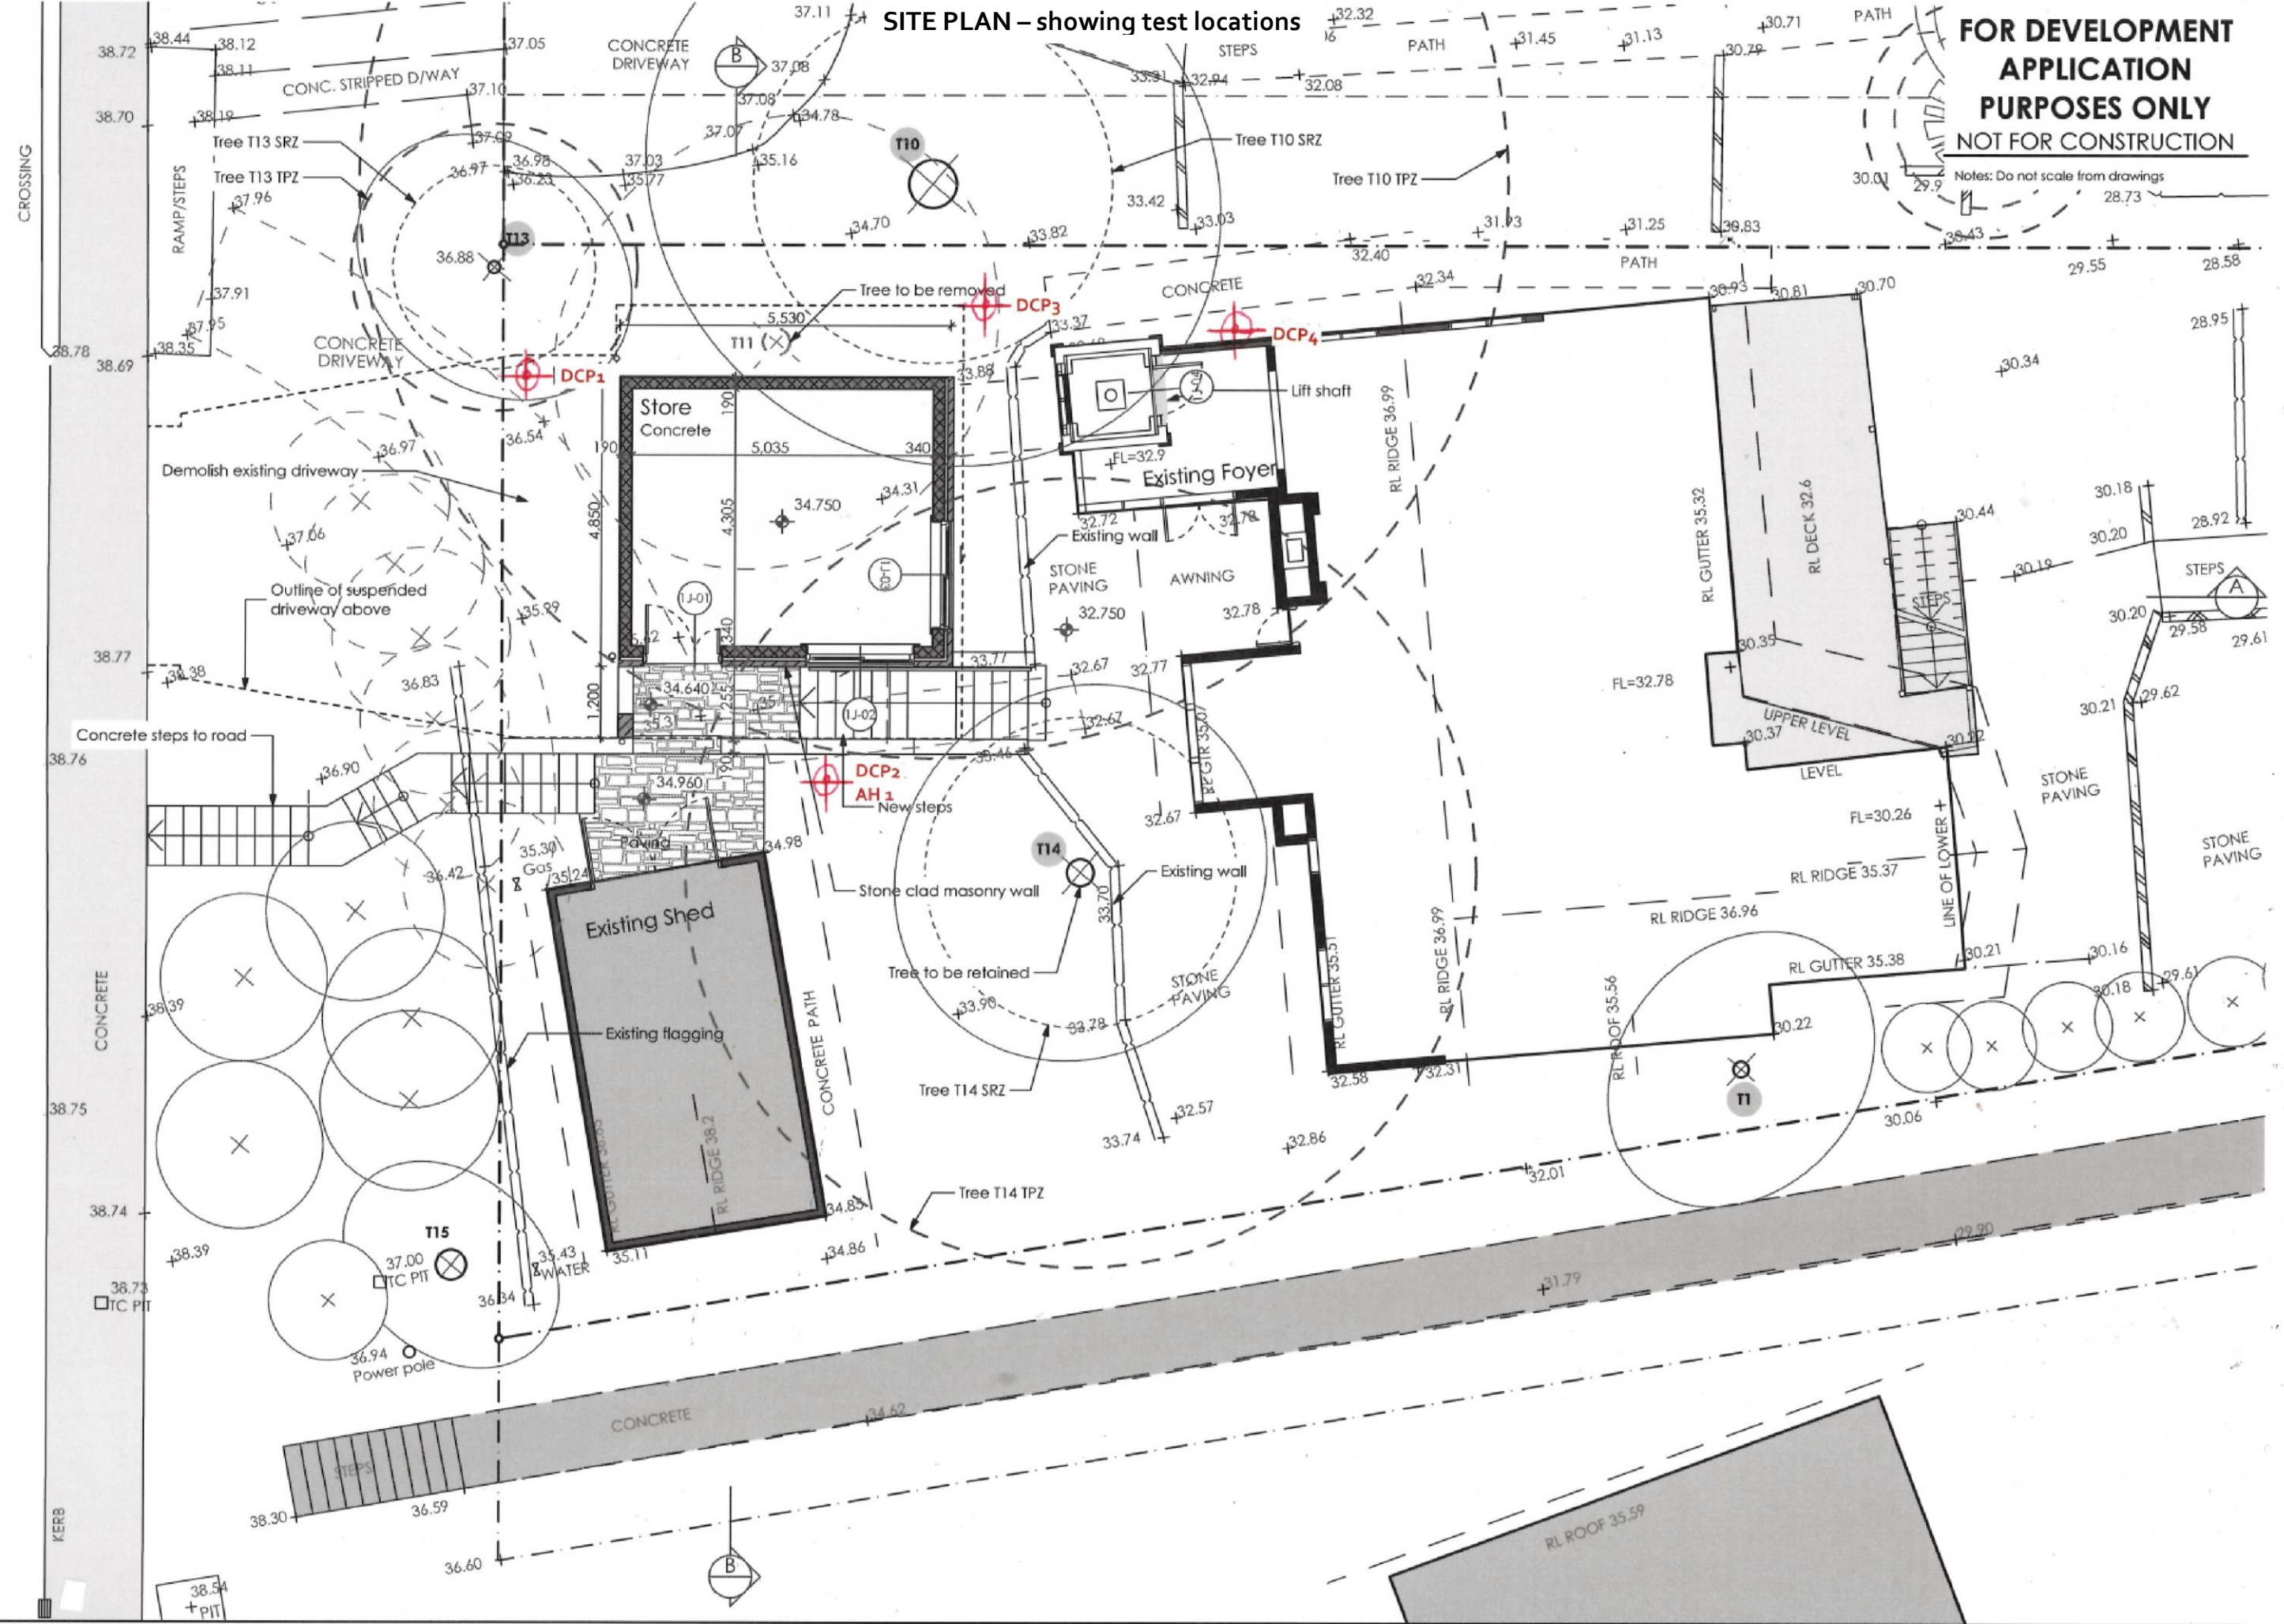
SITE PLAN - showing test locations

One auger hole was put down to identify the soil materials. Four Dynamic Cone Penetrometer (DCP) tests were put down to determine the relative density of the overlying soil and the depth to weathered rock. The locations of the tests are shown on the site plan. It should be noted that a level of caution should be applied when interpreting DCP test results. The test will not pass through hard buried objects so in some instances it can be difficult to determine whether refusal has occurred on an obstruction in the profile or on the natural rock surface. This is not expected to be an issue for the testing on this site and the results are as follows:

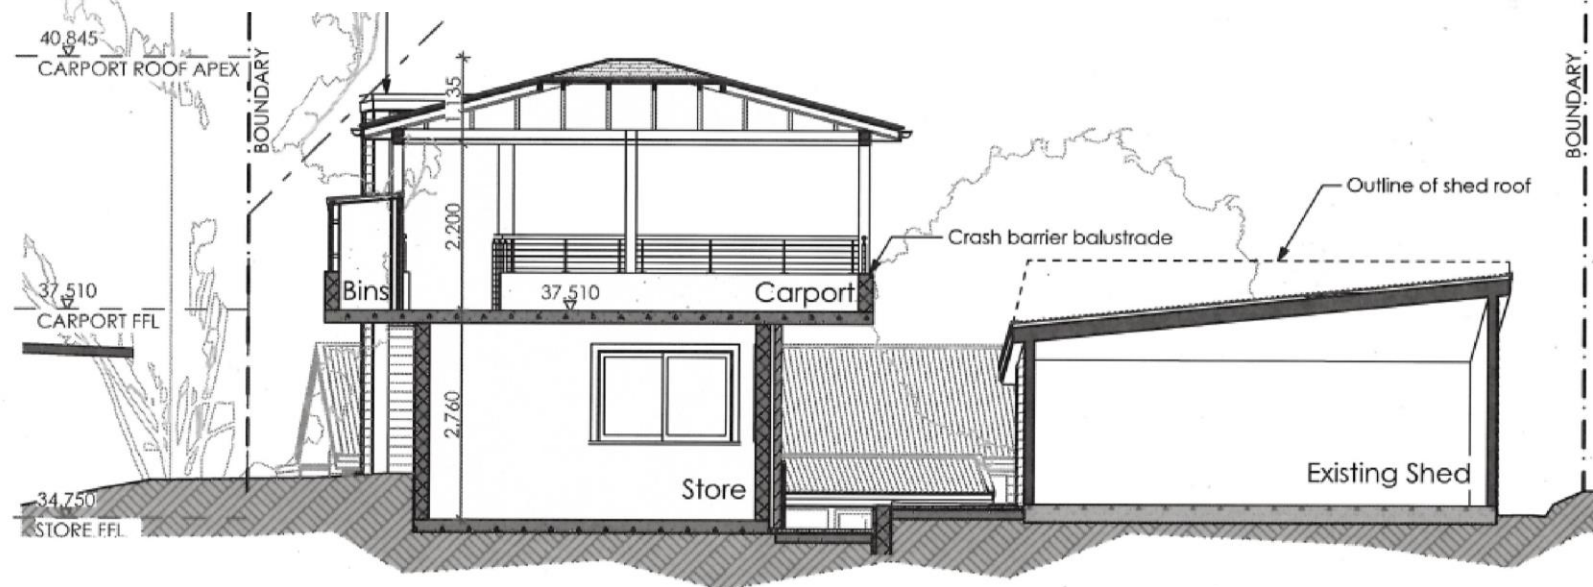
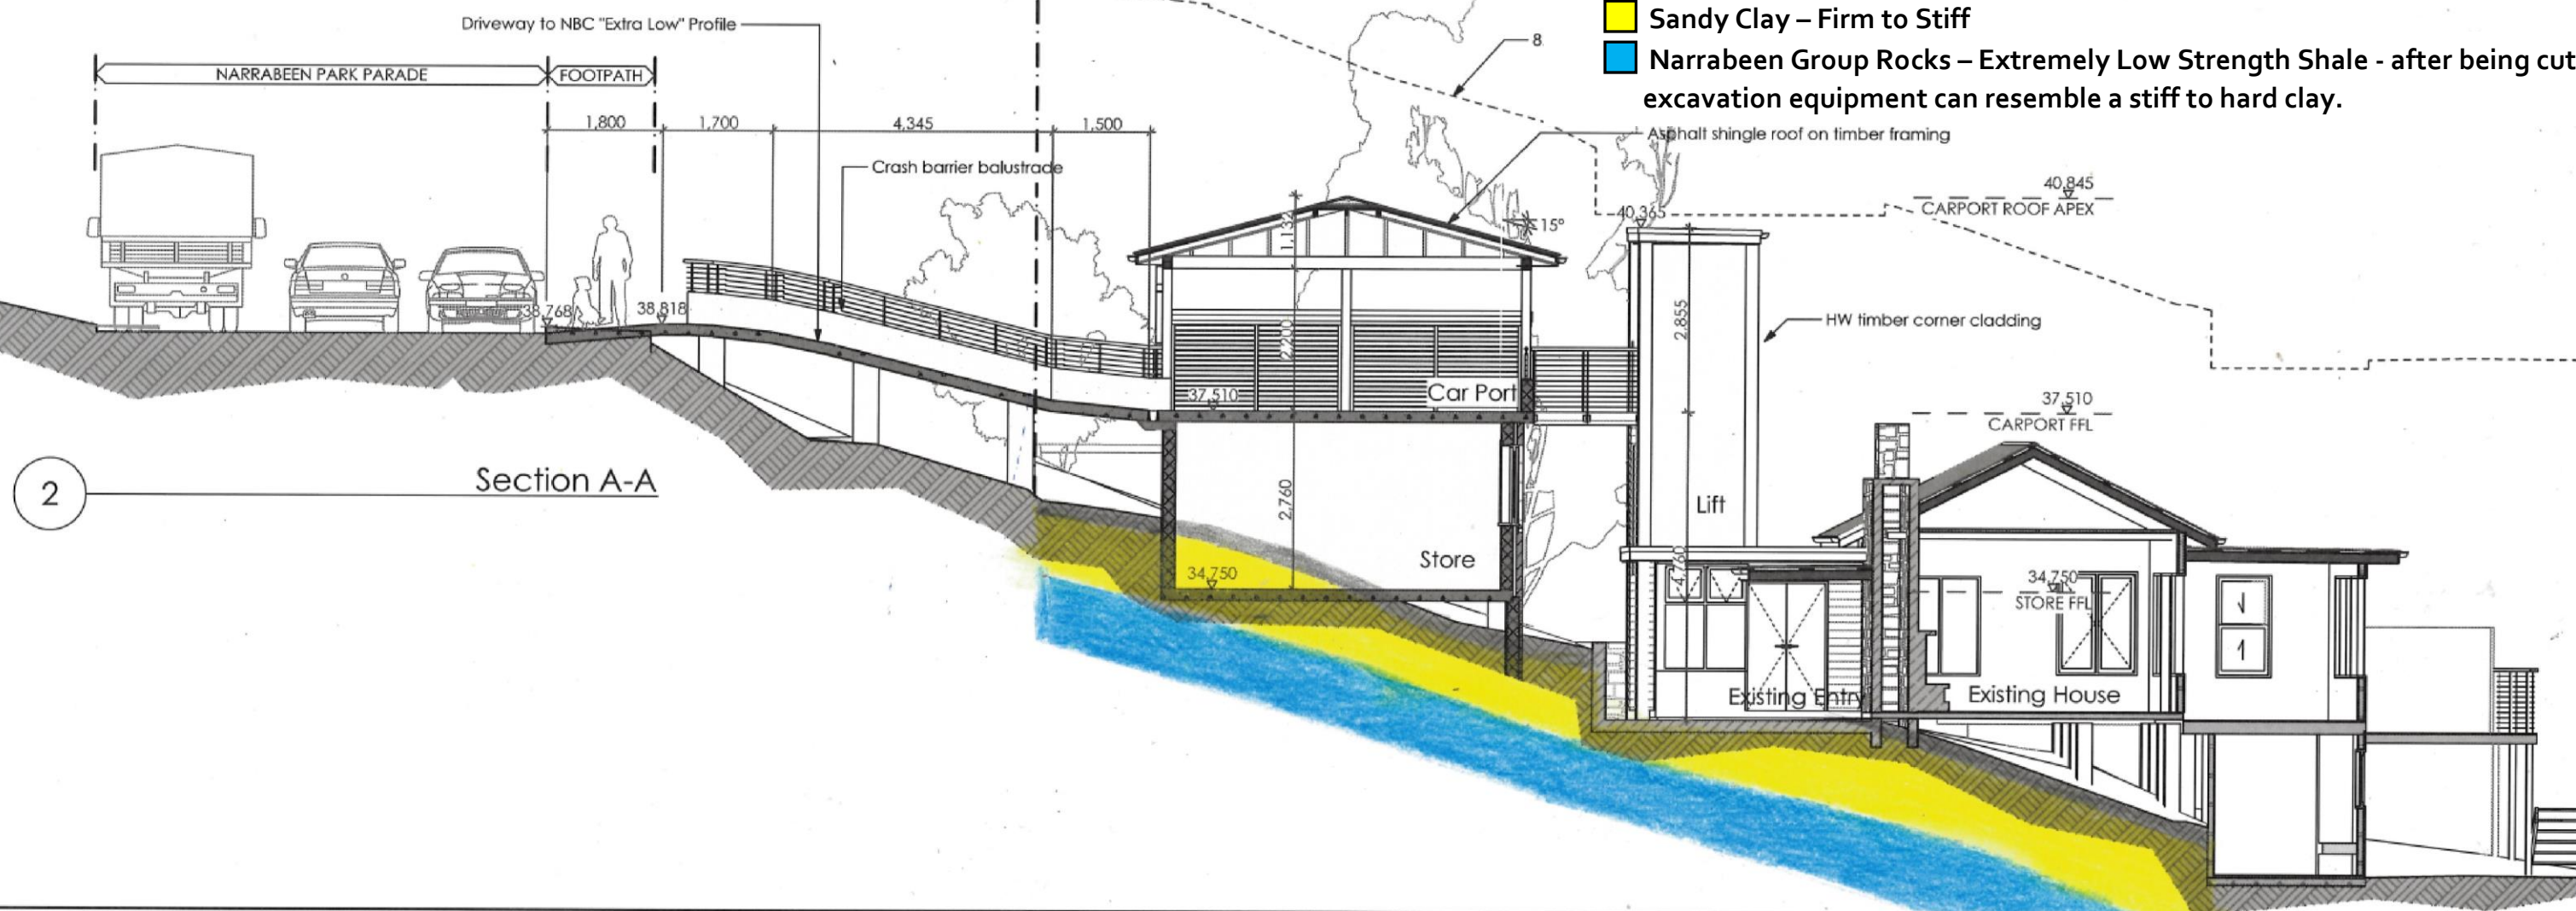
TYPE SECTION – Diagrammatical Interpretation of expected Ground Materials

The slope materials are colluvial at the near surface and residual at depth. They consist of a sandy topsoil over sandy clays. In the test locations, the clays merge into the weathered zone of the underlying rocks at an average depth of ~1.5m below the current surface. The weathered zone of the underlying rock is interpreted as Extremely Low Strength Shale. It is to be noted that this material is a soft rock and can appear as a mottled stiff clay when it is cut up by excavation equipment.

- Sandy Soil
- Sandy Clay – Firm to Stiff
- Narrabeen Group Rocks – Extremely Low Strength Shale - after being cut by excavation equipment can resemble a stiff to hard clay.
