87 Alexandra Crescent, Bayview

Comments on Updates to Plans

GEOTECHNICAL INVESTIGATION:

Alterations and Additions at **87 Alexandra Crescent, Bayview.**

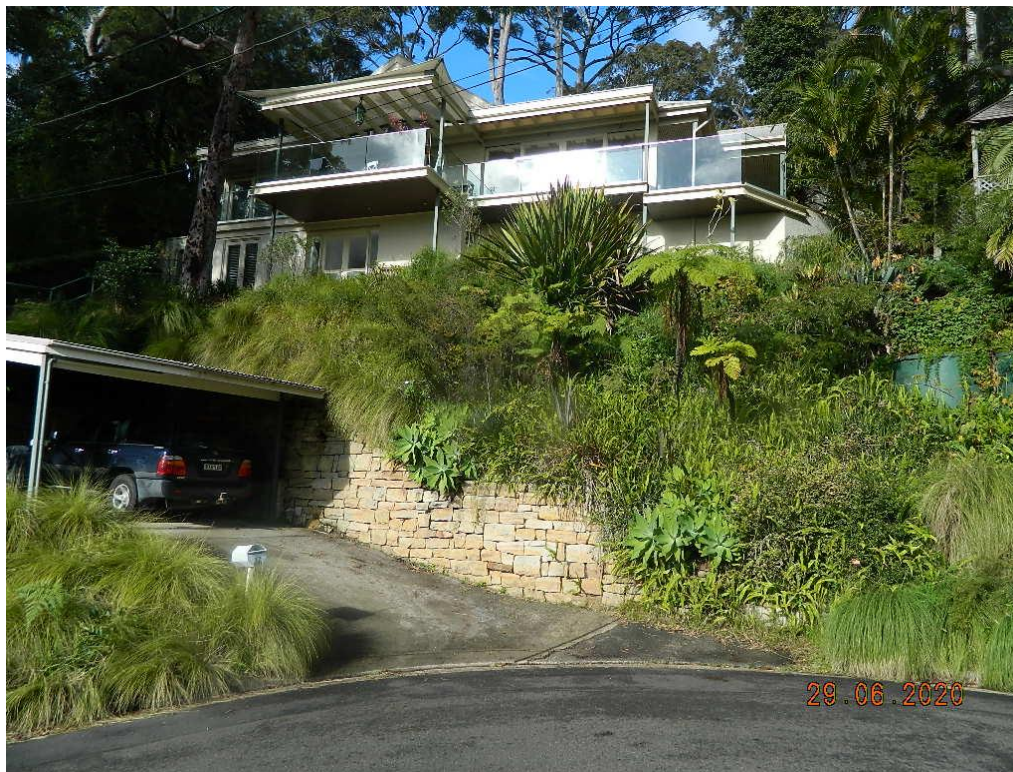
Photo 1

2.3 At the road frontage a concrete driveway runs to a carport cut into the slope (Photo 1). The cut is supported by sandstone block, brick and concrete block retaining walls up to ~3.4m high (Photos 1 to 3). The highest portion of the sandstone block wall is supported by a brick wall in front of the base of the retaining wall (Photo 2). The retaining walls are considered to be stable. Between the carport and the house is a steep and thickly vegetated slope (Photo 1). The part three storey rendered brick and weatherboard clad house is supported by brick walls and brick piers Photos (1 & 4). The supporting walls and piers stand vertical and show no significant signs of movement (Photo 5). Uphill of the house a cut in the slope provides a level platform for the house. The cut is supported by concrete block and sandstone flagging retaining walls up to ~2.7m high. (Photos 6 & 7). The W portion of the concrete block retaining wall is tilting at up to ~4° from vertical. See 'Section 16 Ongoing Maintenance'. A Medium Strength Sandstone bedrock cliff face up to ~7m outcrops above the cut for the house (Photo 8). A portion of the cliff face is undercut by up to ~4.4m (Photo 9). The undercut is considered stable. No geotechnical hazards were observed on the neighbouring properties that could impact on the subject property as seen from the street and subject property.

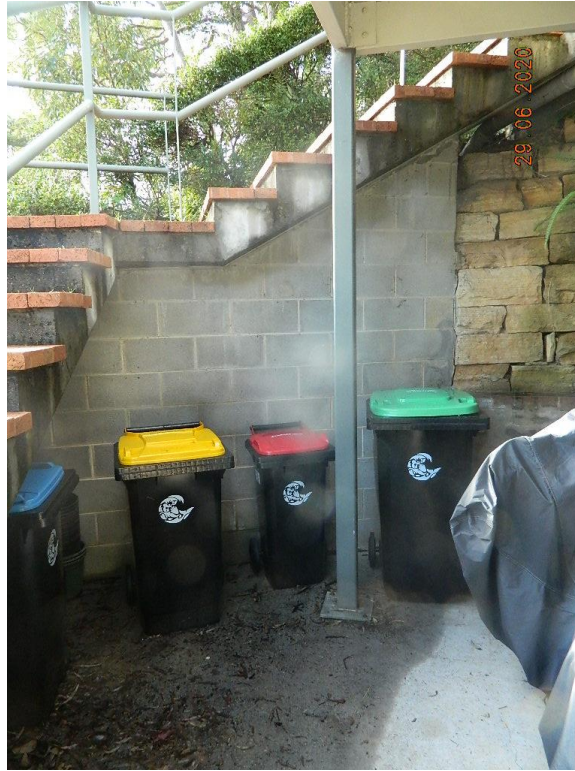
Photo 3

The excavation requires the demolition of part of the existing sandstone block, brick and concrete block retaining walls (Photo 3).

The existing retaining walls (Photo 3) are to be demolished from the top down as the excavation is progressed.

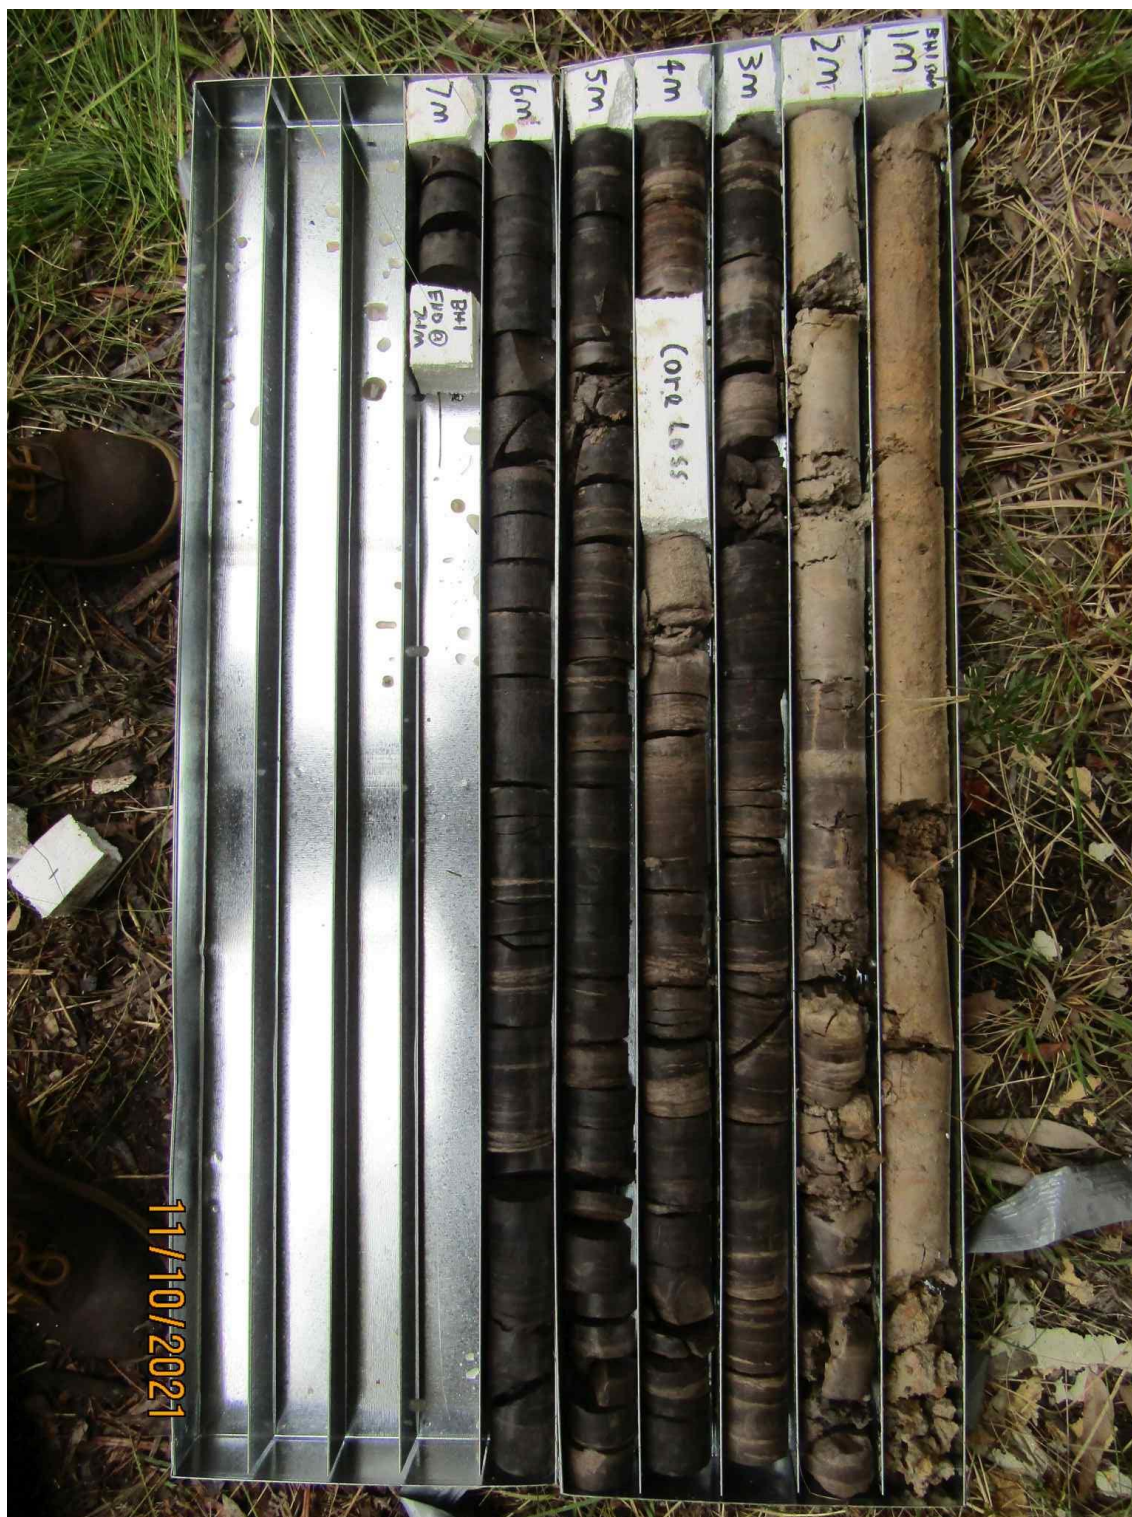
Photo 11: BH1

BORE HOLE 1 (~RL72.9) – BH1 (Photo 11)

1.0 to 2.2	CLAY , brown orange and grey, stiff.
2.2 to 2.4	EXTREMELY LOW STRENGTH SHALE , grey.
2.4 to 3.0	VERY LOW STRENGTH SHALE , grey and black/dark brown.
3.0 to 4.14	LOW STRENGTH SHALE , black/dark brown, grey and orange, parting at variable intervals of between 2cm to 13cm.
4.14 to 4.31	CORE LOSS.
4.31 to 7.1	LOW STRENGTH SHALE , black/dark brown and grey, with grey sandstone laminite, parting at variable intervals of between 2cm to 12cm.

End of hole @ 7.1m in Low Strength Shale. No watertable encountered.

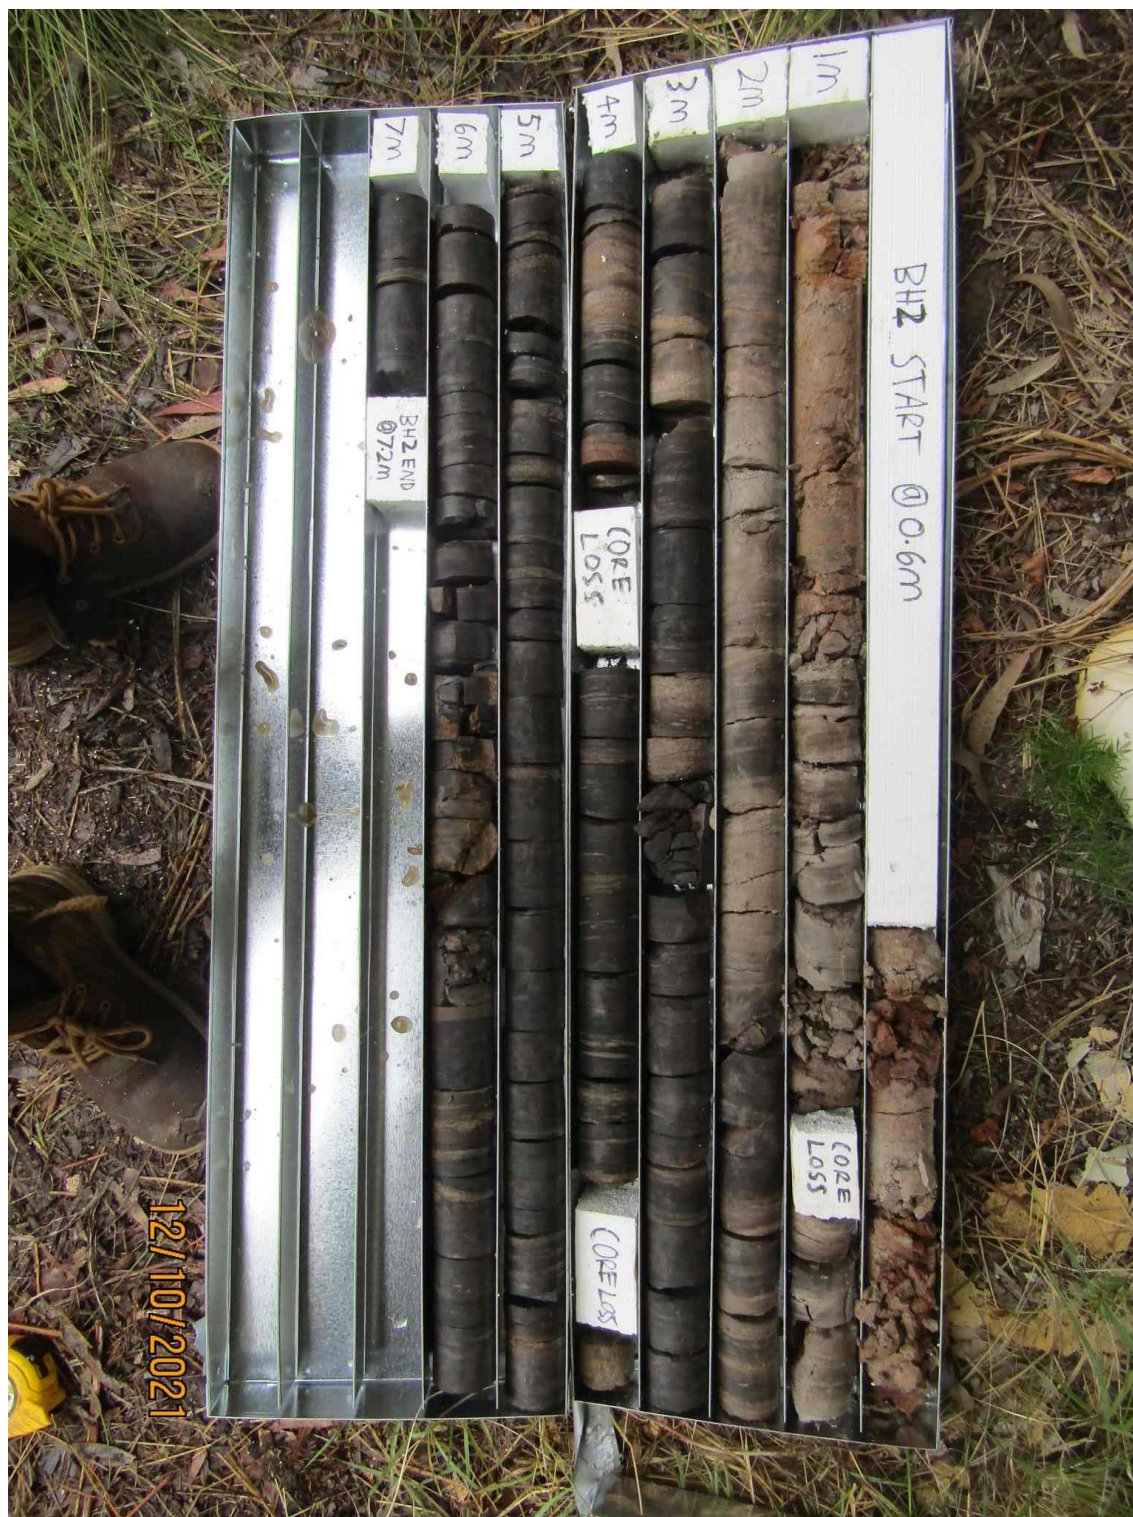
Photo 12: BH2

BORE HOLE 2 (~RL73.0) – BH2 (Photo 12)

0.6 to 1.3	EXTREMELY LOW STRENGTH SHALE , grey, brown and orange.
1.3 to 1.76	VERY LOW STRENGTH SHALE , grey and black/dark brown.
1.76 to 1.83	CORE LOSS.
1.83 to 2.7	VERY LOW STRENGTH SHALE , grey, black/dark brown and orange, with thin grey sandstone laminite, parting at variable intervals of between 4cm to 12cm.
2.7 to 4.28	LOW STRENGTH SHALE , black/dark brown, grey and orange, parting at variable intervals of between 4cm to 12cm.
4.28 to 4.39	CORE LOSS.
4.39 to 4.84	LOW STRENGTH SHALE , black/dark brown and grey, parting at variable intervals of between 2cm to 8cm.
4.84 to 4.94	CORE LOSS.
4.94 to 7.2	LOW STRENGTH SHALE , black/dark brown, grey and orange, with thin grey sandstone laminite, parting at variable intervals of between 2cm to 8cm.

End of hole @ 7.2m in Low Strength Shale. No watertable encountered.

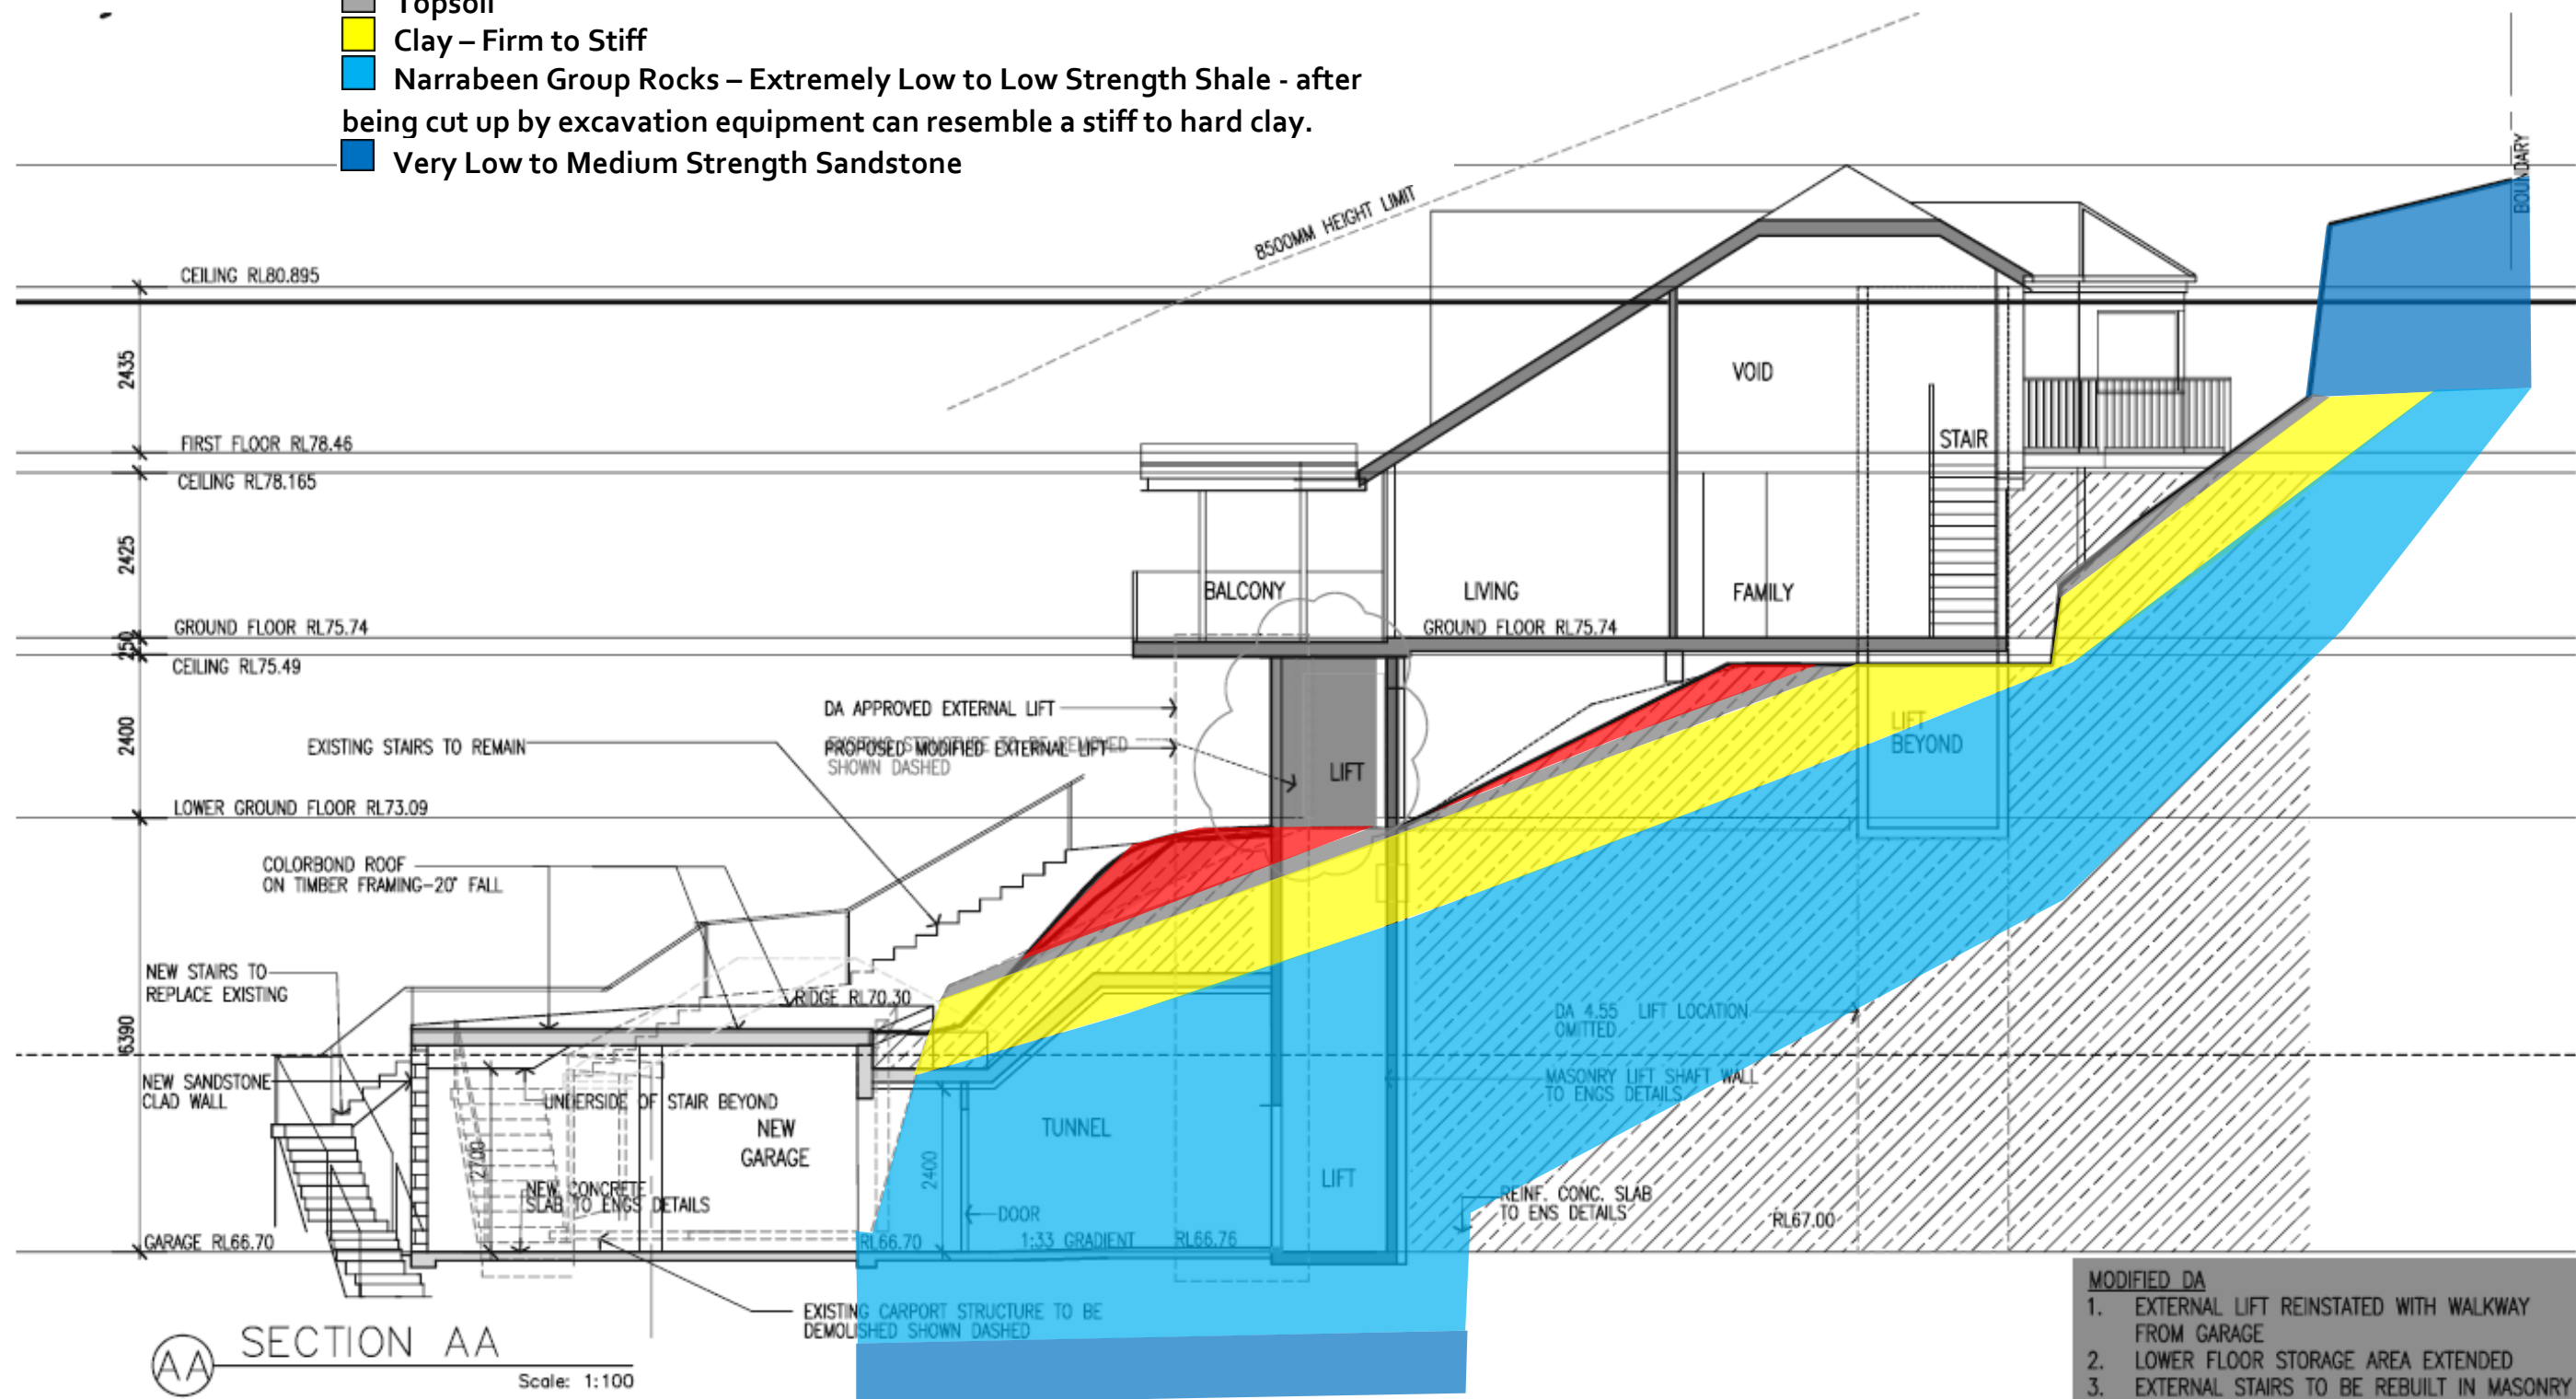
TYPE SECTION – Diagrammatical Interpretation of expected Ground Materials

- Fill
- Topsoil
- Clay – Firm to Stiff
- Narrabeen Group Rocks – Extremely Low to Low Strength Shale - after being cut up by excavation equipment can resemble a stiff to hard clay.
- Very Low to Medium Strength Sandstone
