## **Geotechnical Assessment**

**Project:** New Residence  
13 Iluka Road, Palm Beach NSW.

**REF: AG 20223**  
9<sup>th</sup> September, 2020

**13 Iluka Road, Palm Beach NSW**

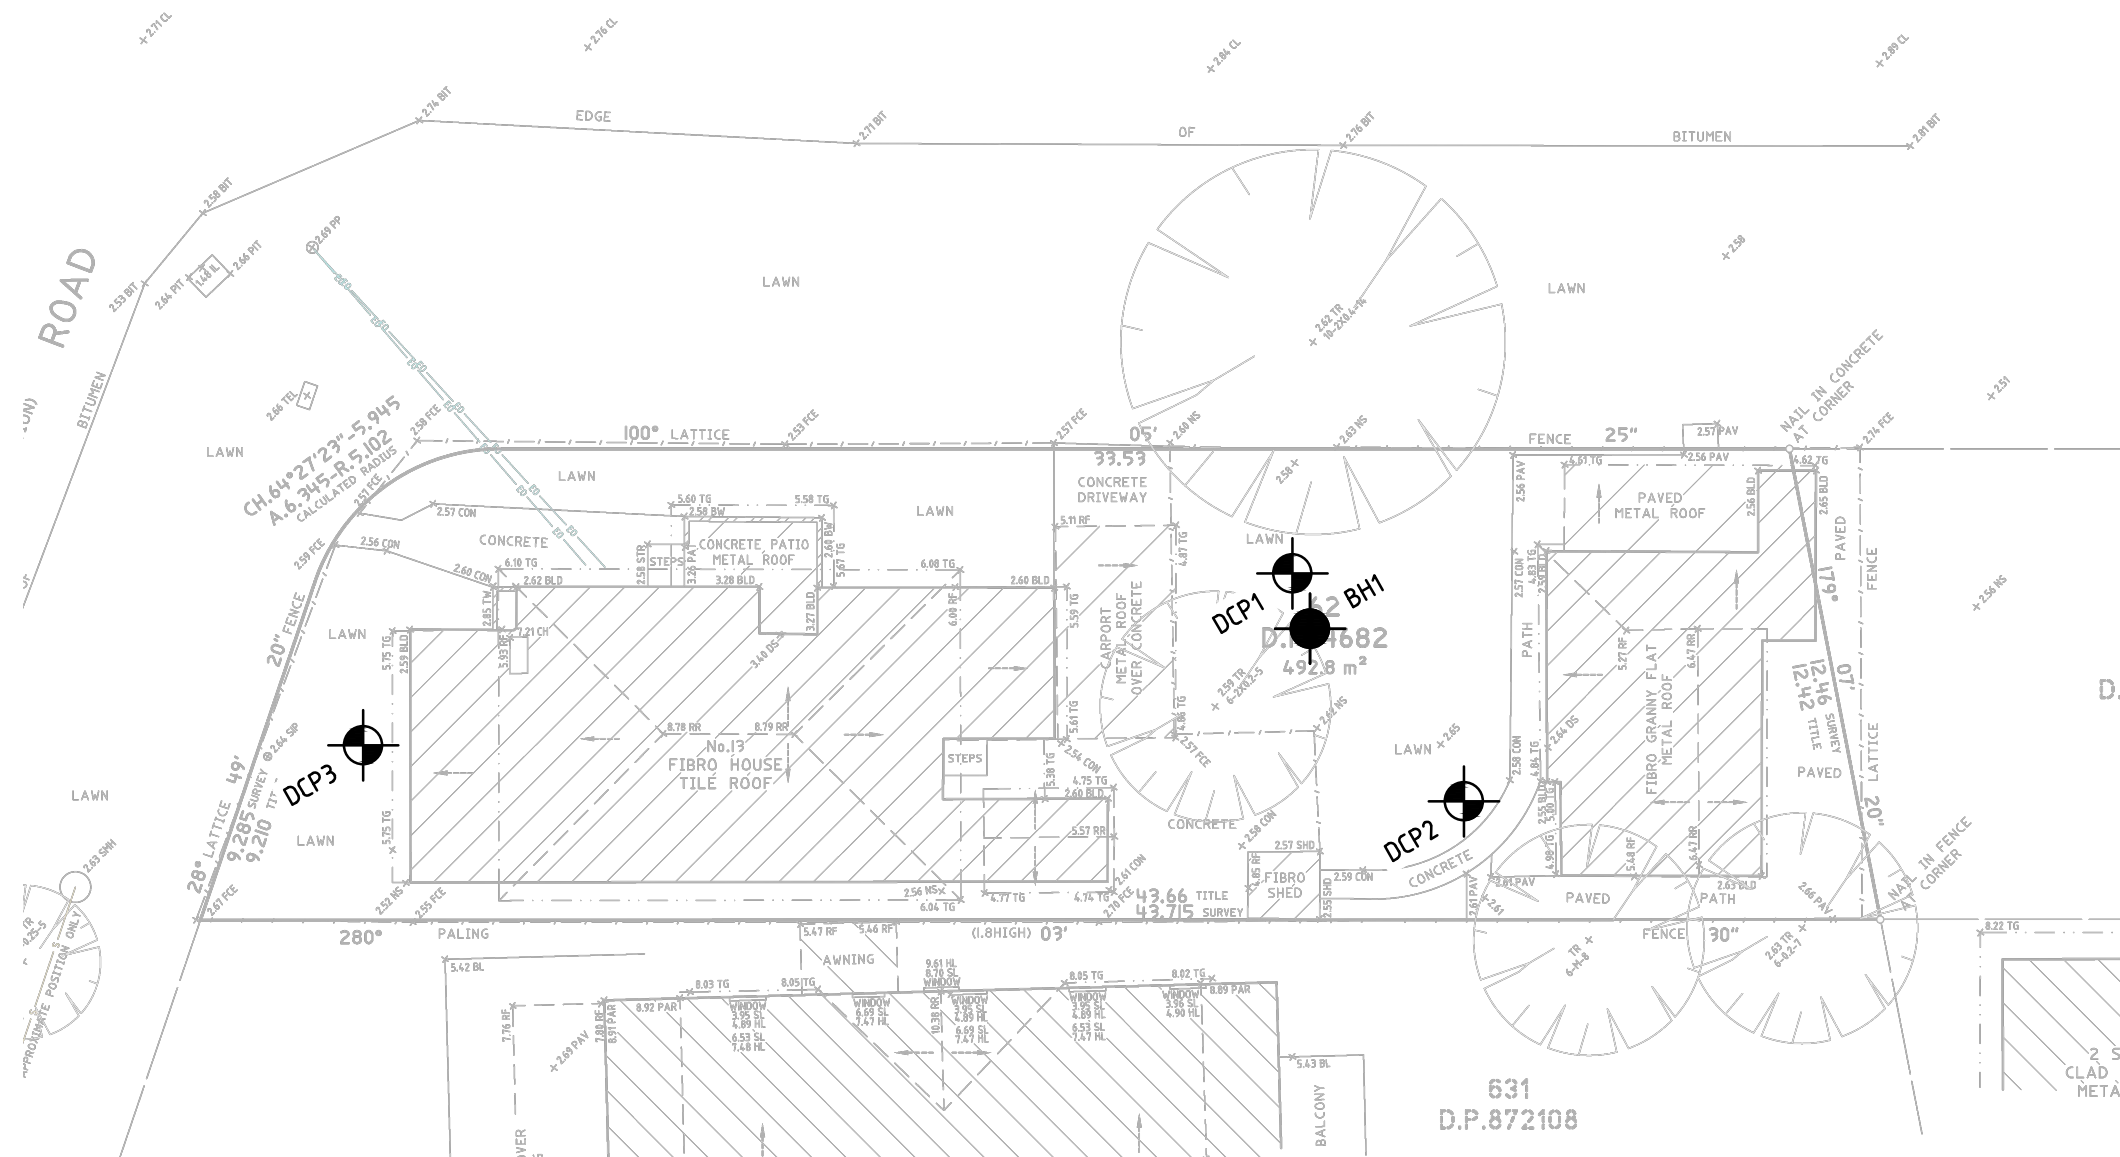
SITE PLAN/GROUND TEST LOCATIONS  
SCALE NTS

One Hand Auger borehole (BH01) test was drilled at the approximate location shown on the site plan to visually identify the subsurface material. The soil profile consists of shallow uncontrolled fill and silty sand top soils and loose marine sand. An engineering log of the borehole is presented in the appendix of this report.

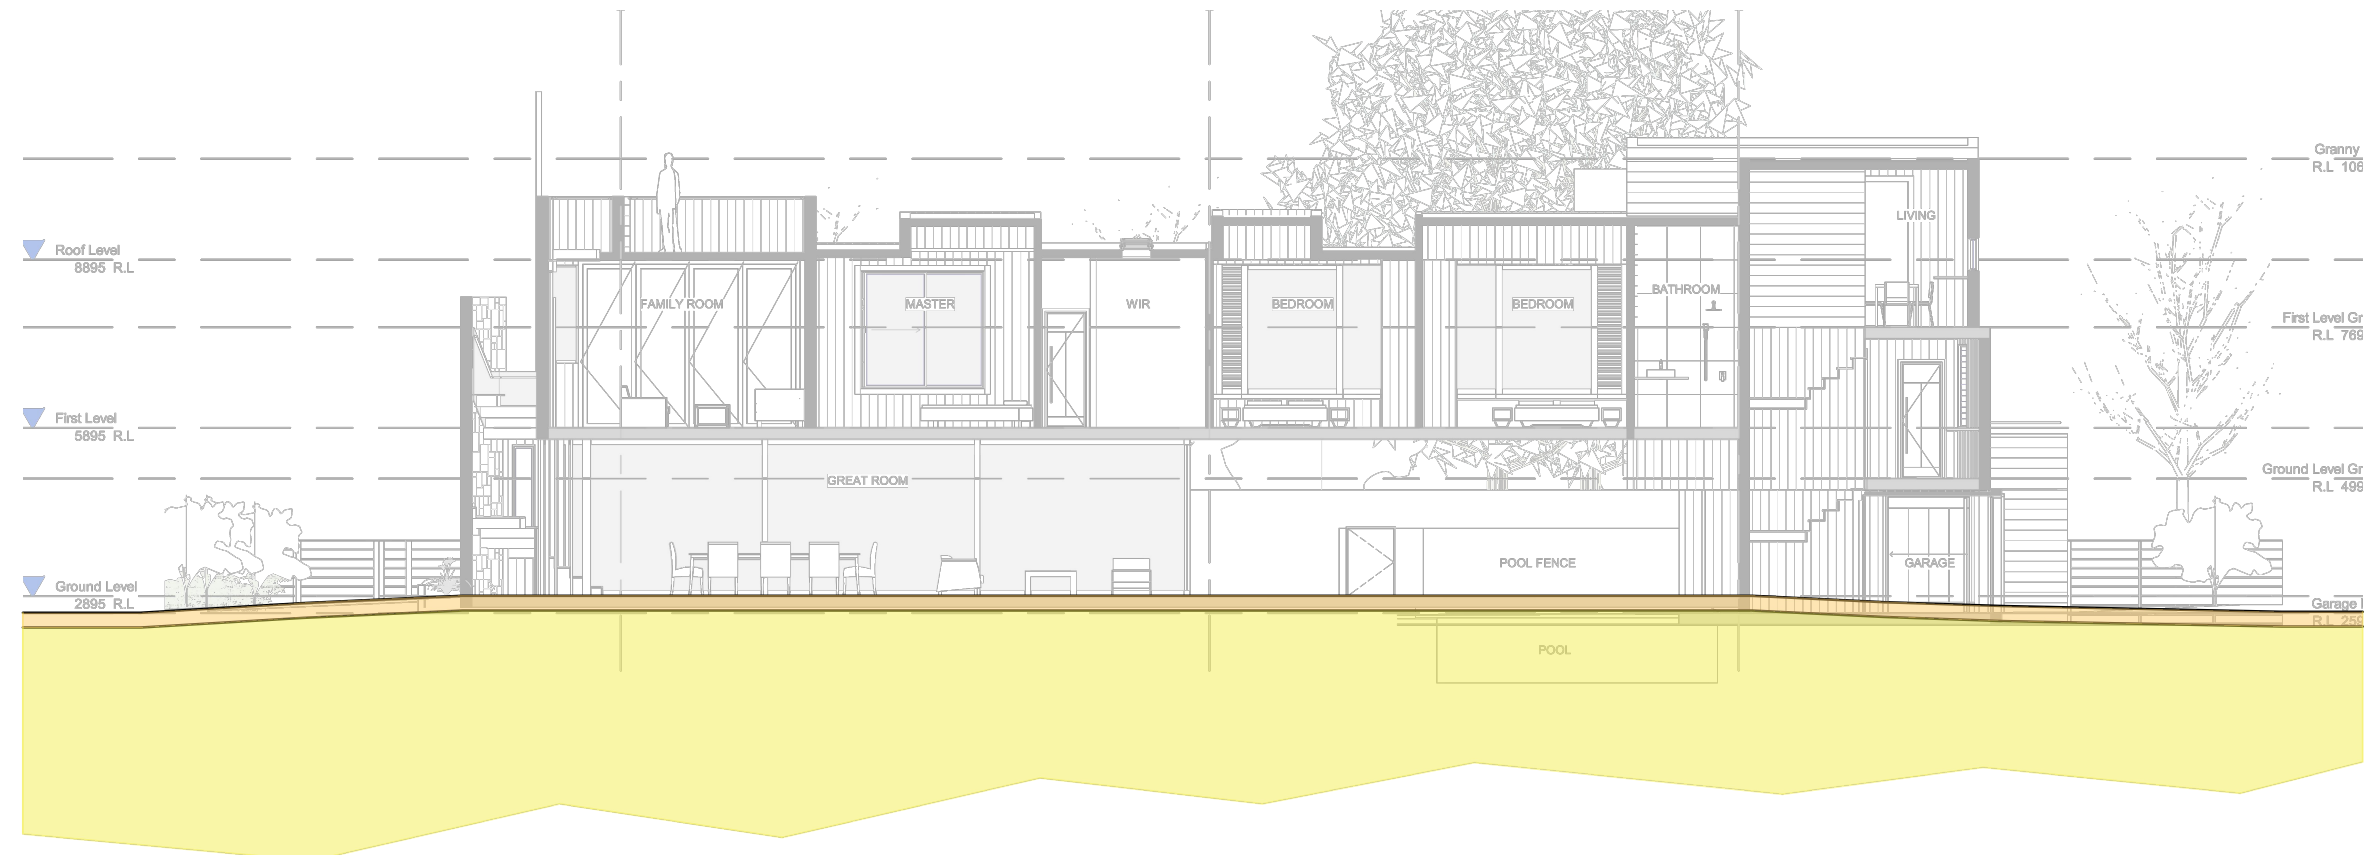
**INFERRED GEOLOGICAL SECTION**  
SCALE NTS

INTERPRETED SUBSURFACE SECTION ONLY.  
ACTUAL GROUND CONDITIONS MAY VARY.
