VT 25577A 16th July, 2008 Page 1

62 HERBERT AVENUE, NEWPORT Order No NOT0092/08 and FINALISATION OF APPROVAL P0523/97

RISK ANALYSIS & MANAGEMENT FOR BUILDING CERTIFICATE AT 62 HERBERT AVENUE, NEWPORT

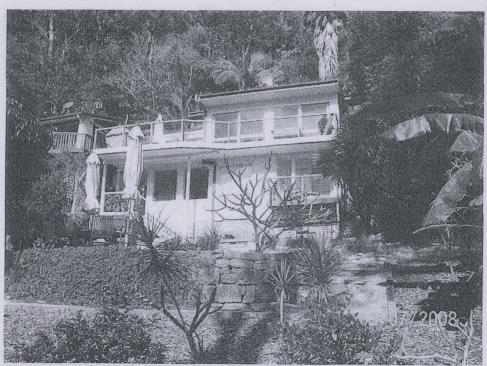
- 2 1 The site was inspected on the 9th July 2008
- The property is on the low side of the road and has a northerly aspect (Photo 1) The road is supported by a sandstone block retaining wall in good condition (Photo 2). A second block wall is located immediately down slope and the path to the house runs along the trop of this wall (Photo 3). The wall has had some remedial work carried out in the recent past and Gabion Baskets have been installed in front of the wall to support it (Photo 4). The boundary of the road reserve is just below the Gabion Baskets. From the toe of this wall the surface slopes down steeply to the house at angles of some 20 degrees where a low cut is supported by a stable stack rock wall (Photo 5). The grade reduces at the house footprint and the surface continues to slope down to the rear boundary at angle of some 10 degrees. Some landscaping has been carried out below the house (Photo 6) and a Gabion Basket supports a fill just above the lower boundary (Photo 7 & 8).

- 71 The steep slope that rises to the road across the site is a potential hazard (Photo 1 8, IIAZARD ONE)
- 72 The steep slope that rises above the site is a potential hazard (Photo 10 & 11 HAZARD TWO)

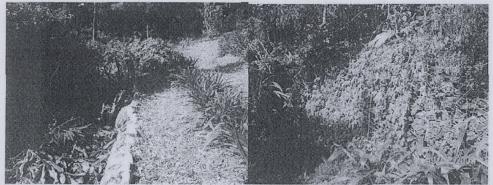
Photo 7 Photo 8

HAZARD ONE Qualitative Risk Assessment on Property The steep slope from the road down to the house is supported with a series of two sandstone block walls that appear stable. The lower wall has recently had Gabion Baskets installed in front of it as part of remedial works to stabilise the wall. At the footprint to the house the grade reduces significantly. Near the lower boundary a low Gabion basket supports a fill. Above the site on the slope shale bedrock outcrops indicating the overlying unconsolidated materials are relatively shallow. No evidence of movement related to landslides was observed on the site. The likelihood of the slope failing is assessed as 'Rare' (>10.5). The consequences to property of such a failure are assessed as 'Medium' (>20%). The risk to property is 'Low'(2 x 10.5).

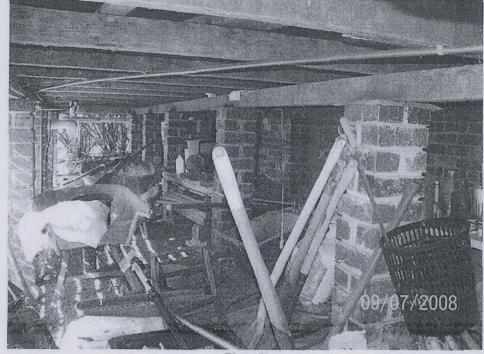
Photo 9

The two storey brick veneer and timber house is in good condition. The supporting brick walls, piers and timber posts show no evidence of ground movement (Photo 9)

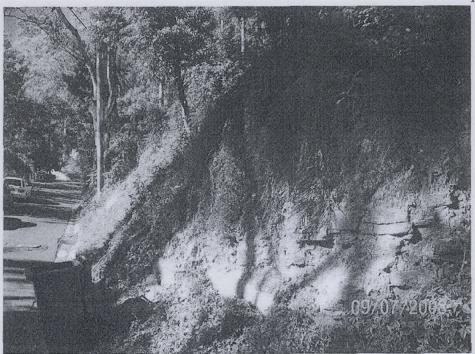
Photo 10

- The site is underlain by interbedded sandstones, siltstones and shales of the Narrabeen Group that outcrop on the high side of the road (Photo 10) The Narrabeen Group Rocks are Late Permian to Middle Triassic in age with the early rocks not outcropping in the area under discussion. The materials from which the rocks were formed consist of gravels, coaise to fine sands, silts and clays. They were deposited in a riverine type environment with larger floods causing fans of finer materials. The direction of deposition changed during the period of formation. The lower beds are very variable with the variations decreasing as the junction with the Hawkesbury Sandstones is approached This is marked by the highest of persistent shale beds over thicker sandstone beds which are similar in composition to the Hawkesbury Sandstones

HAZARD TWO Qualitative Risk Assessment on Property The steep slope above the site is separated by the road. Shale bedrock outcrops in the cut batter for the road indicating the overlying unconsolidated materials are relatively shallow (Photo 10) The slope is vegetated with a ground cover of exotic weeds and some large gum trees that stand vertical. The site is developed and the concrete block retaining wall and house show no evidence of movement as observed from the road (Photo 11) The likelihood of the slope failing and impacting on the property is assessed as Rate (>105) The consequences to property of such a failure are assessed as Medium' (>20%) The risk to property is 'Low'(2 x 10%)
