## **GEOTECHNICAL INVESTIGATION:**

Subdivision and New Houses at **12-14 Gladys Avenue, Frenchs Forest**

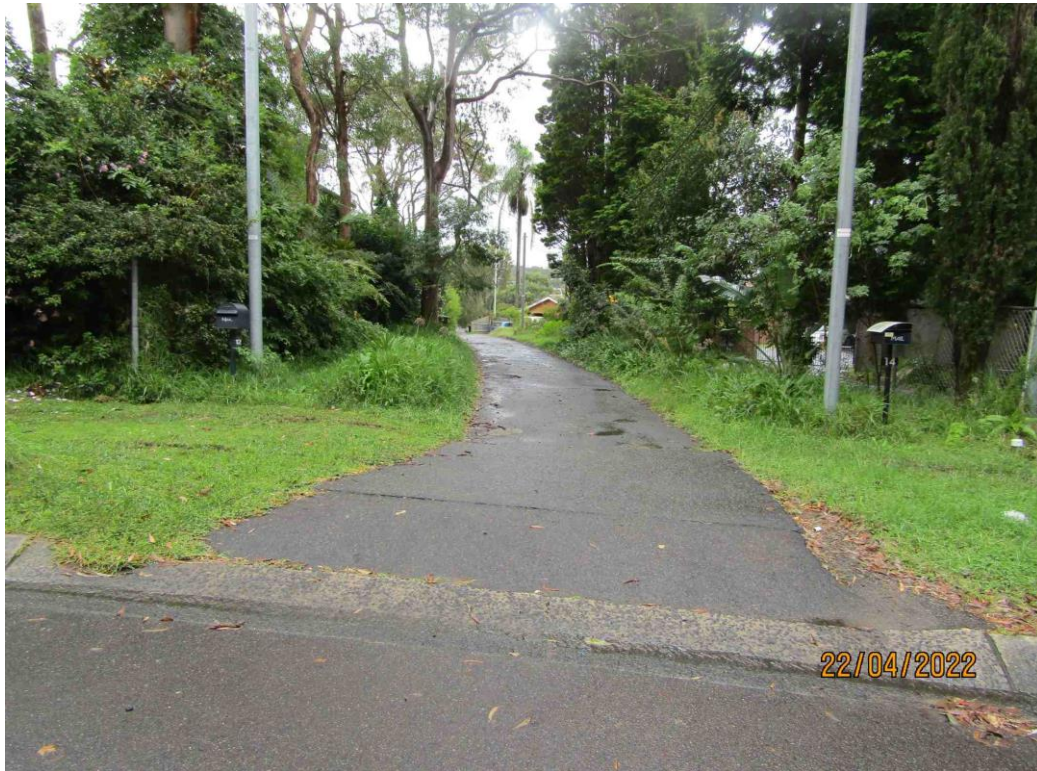
Photo 1

**2.3** At the road frontage, a shared bitumen driveway (Photo 1) runs to a concrete carport at 14 Gladys Ave and a concrete driveway at 12 Gladys Ave.

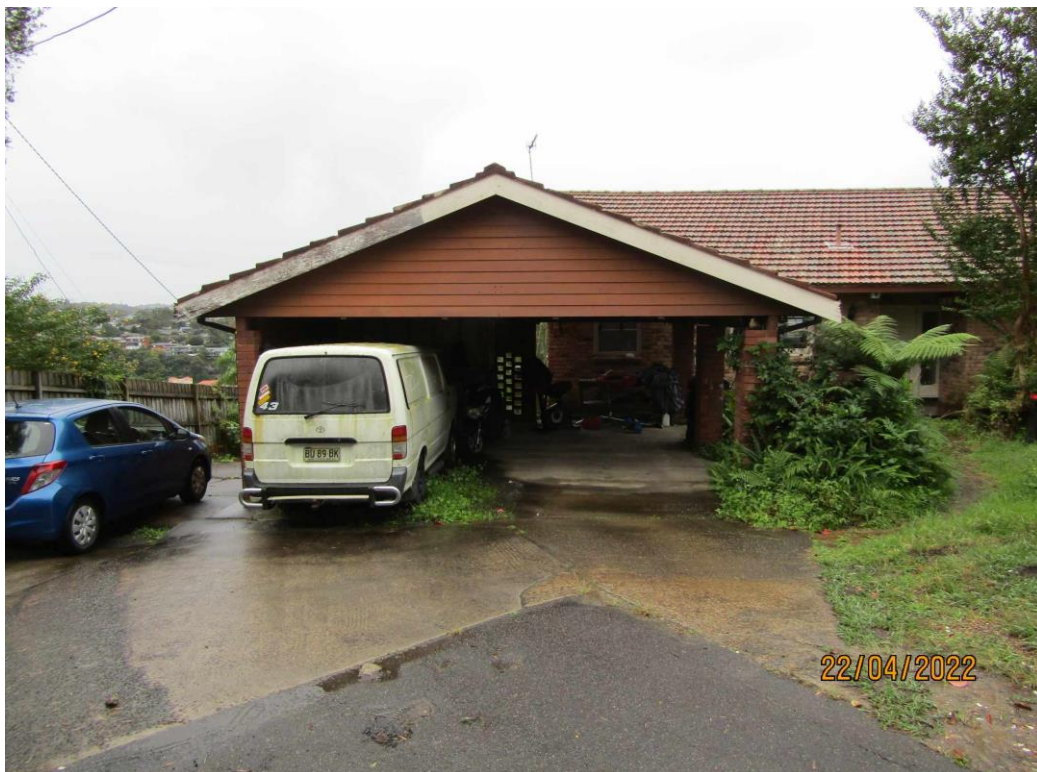
Photo 2

The carport roof is supported by brick columns that stand vertical. The part two storey brick and timber clad house is supported by brick walls (Photos 2 & 3). The external supporting walls show no significant signs of movement. A pool that shows no significant signs of movement is located on the downhill side of the house (Photo 4). The pool was partially empty at the time of inspection. A gently sloping lawn and timber clad shed is located on the downhill side of the pool. Fill reduces the grade of the lawn.

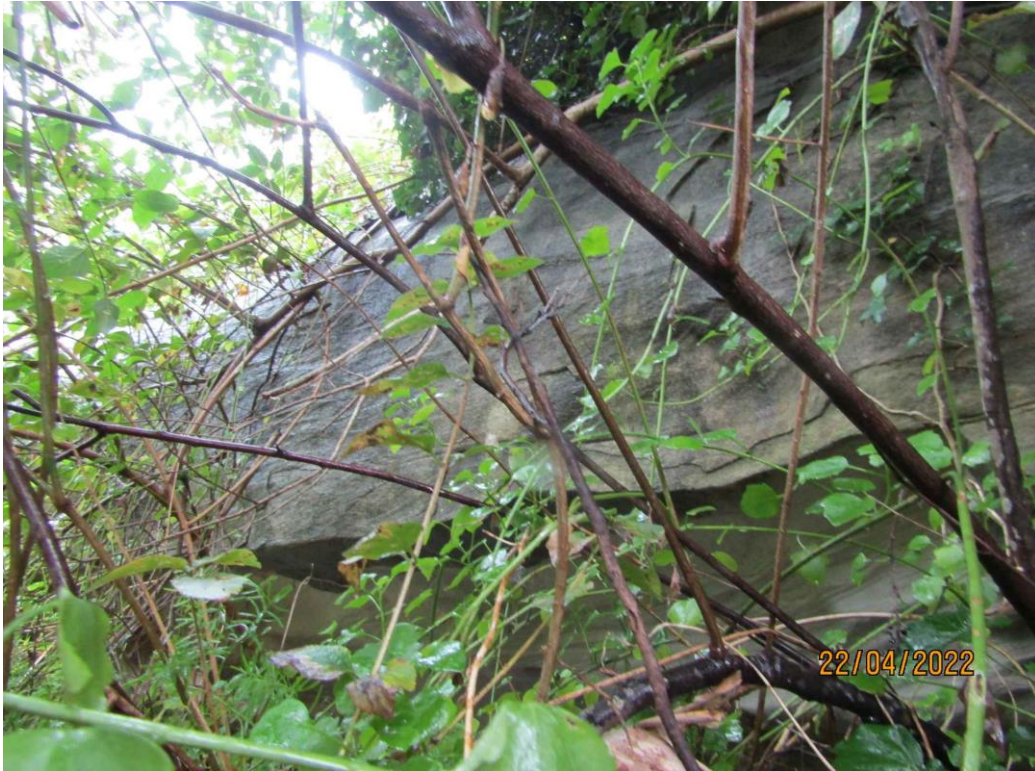
Photo 5

is estimated to be undercut by up to ~1.5m (Photo 5). The visible undercut has a relatively thick cantilever arm in relation to its overhang length and is currently considered to be stable. The slope below the rock face is densely vegetated (Photo 6). Sandstone bedrock outcrops in places on the slope. Sandstone joint blocks are embedded in stable positions in the slope.

No footings are to be supported on undercut rock. If during the markout footings are over undercut rock, they are to be moved back upslope beyond the undercut.

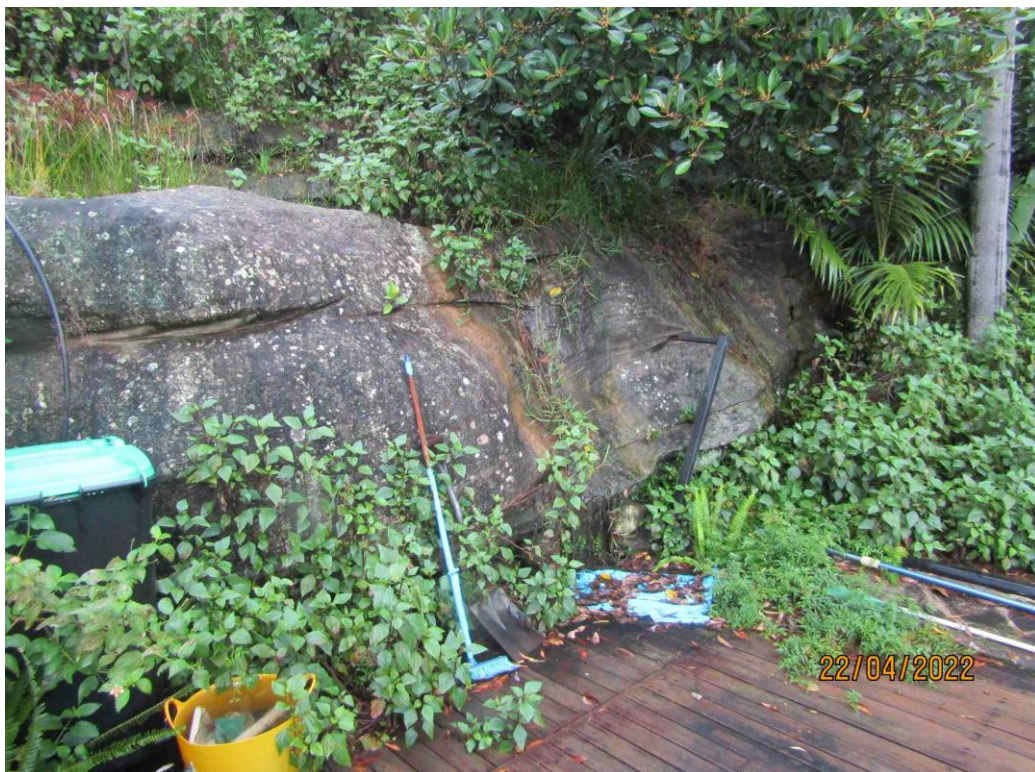
Photo 12

A near level lawn area extends off the downhill side of the house. Sandstone bedrock steps down the slope on the downhill side of the lawn (Photo 12). The outcropping rock is estimated to be up to ~4m high. The upper portion of the rock is obscured by vegetation. The rock face is undercut at the base slightly, but has a thick cantilever arm in relation to its overhang length and is currently considered to be stable. A pool that shows no significant signs of movement is located on the downhill side of the rock

Evidence of recent surface flows were observed on the outcropping sandstone bedrock on the uphill side of the proposed new house on Lot 2 (Photo 12). It is recommended that drainage measures be installed on the uphill sides of the proposed houses to capture and divert any surface water that flows over the rock face.

All footings supported on Medium Strength Sandstone are to be set back at least 0.6m from any steps in the rock and are to be set back at least 1.0m from the top edge of any large rock faces on site (Photo 12).

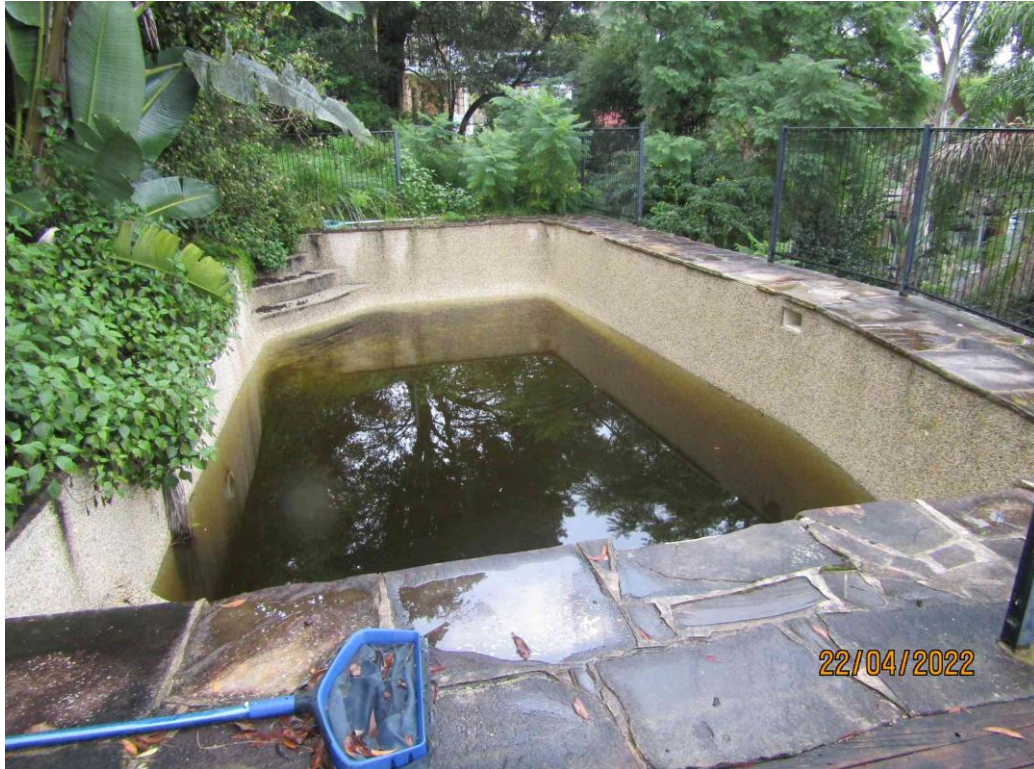
Photo 13

face (Photo 13). The pool was partially empty at the time of inspection. The slope below the pool is thickly vegetated (Photo 14). Sandstone bedrock outcrops in places on the slope. Sandstone joint blocks are embedded in stable positions in the slope.
