### **18 Alexander Street, Collaroy**

J2125. 4<sup>th</sup> April, 2019. Page 1.

# **GEOTECHNICAL INVESTIGATION:**

New House and Pool at **18 Alexander Street, Collaroy**

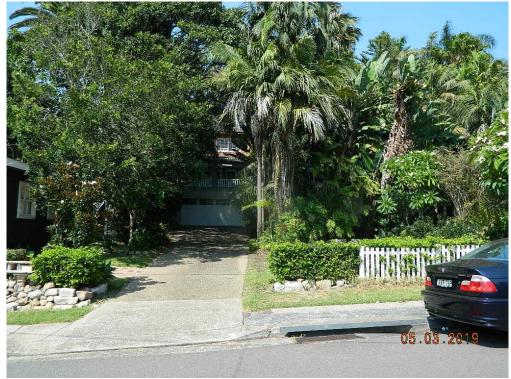
Photo 1

**2.3** At the road frontage, a concrete driveway runs to a garage beneath the house (Photo 1). A free standing studio is located beside the driveway (Photo 2). A gravel driveway runs up the slope to a car parking space on the E side of the studio (Photo 3). The area between the road frontage and the house is otherwise densely vegetated (Photo 4). The majority of the part three storey brick house will be demolished as part of the proposed works (Photo 5). A stable timber retaining wall reaching a maximum height of ~1.0m terraces the

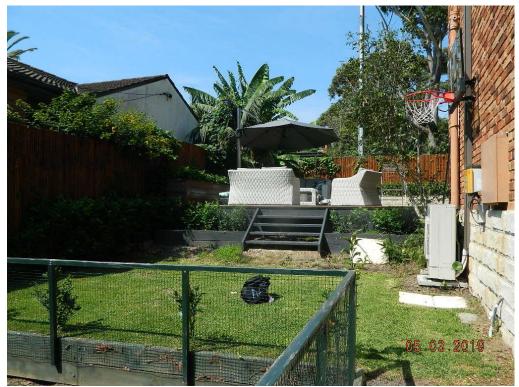
Photo 6

slope on the E side of the house. The wall retains a fill that levels a lawn area above (Photo 6). A near level lawn area rises from the uphill side of the house to a stable ~0.5m high sandstone block retaining wall along the uphill boundary (Photo 7). A recently constructed pool in the SW corner of the property is in good condition with no signs of cracking or movement in the pool shell (Photo 8). No signs of movement were observed on the grounds. The adjoining neighbouring properties were observed to be in good order as seen from the road and the subject property. No geotechnical hazards were observed on these properties that could impact on the subject property.

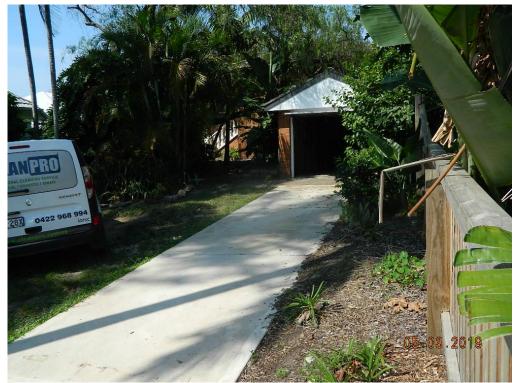
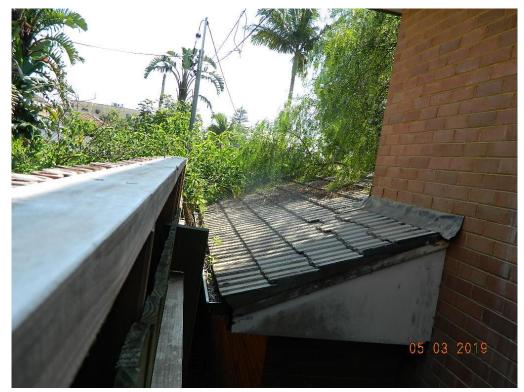
No geotechnical hazards were observed above, below, or beside the property. The proposed excavation undercutting the E neighbouring house walls is a potential hazard (**Hazard One**). The proposed excavation collapsing onto the worksite before retaining walls are in place is a potential hazard (**Hazard Two**).

HAZARDS	Hazard One	Hazard Two	
ТҮРЕ	The proposed excavation undercutting the neighbouring house to the E, causing failure in the supporting walls of the neighbouring house (Photos 9 & 10).	The proposed excavation collapsing onto the worksite and impacting on the E neighbouring property before retaining walls are in place.	
LIKELIHOOD	'Possible' (10 <sup>-3</sup> )	'Possible' (10 <sup>-3</sup> )	
CONSEQUENCES TO PROPERTY	'Minor' (15%)	'Medium' (20%)	
RISK TO PROPERTY	'Moderate' (2 x 10 <sup>-5</sup> )	'Moderate' (2 x 10 <sup>-4</sup> )	
RISK TO LIFE	6.6 x 10 <sup>-7</sup> /annum	6.8 x 10 <sup>-4</sup> /annum	
COMMENTS	This level of risk to property is ' <b>UNACCEPTABLE'</b> . To move the risk levels to acceptable levels the recommendations in <b>Section</b> <b>13</b> are to be followed.	This level of risk to life and property is ' <b>UNACCEPTABLE'</b> . To move the risk levels to acceptable levels the recommendations in <b>Section 13</b> are to be followed.

Due to the depth of the excavation and its close proximity to the boundary, the portion of the excavation that runs parallel with the E neighbouring house is to be supported before any excavations commence with secant or contiguous piers or similar. Secant piers are the preferred option but, if contiguous piers are used, the gaps between the piers are to be grouted closed as the excavation is lowered, so no fill, sandy soil, or sand moves through the wall. The piers can be temporarily supported by embedment below the base of the excavation. For ease of design and construction, piers may be installed around the entire perimeter of the excavation for the proposed driveway exceeds 0.5m deep the piling will need to extend to the N end of the neighbouring garage. To drill the pier holes for the wall, a powerful excavator or small pilling rig that can excavate through medium strength rock will be required. If a machine of this type is not available, we recommend carrying out core drilling before the construction commences to confirm the strength of the rock, and to ensure the excavation equipment is capable of reaching the required depths. The retaining wall is to be tied into the concrete floor and ceiling slabs of the garage to permanently brace the retaining wall.

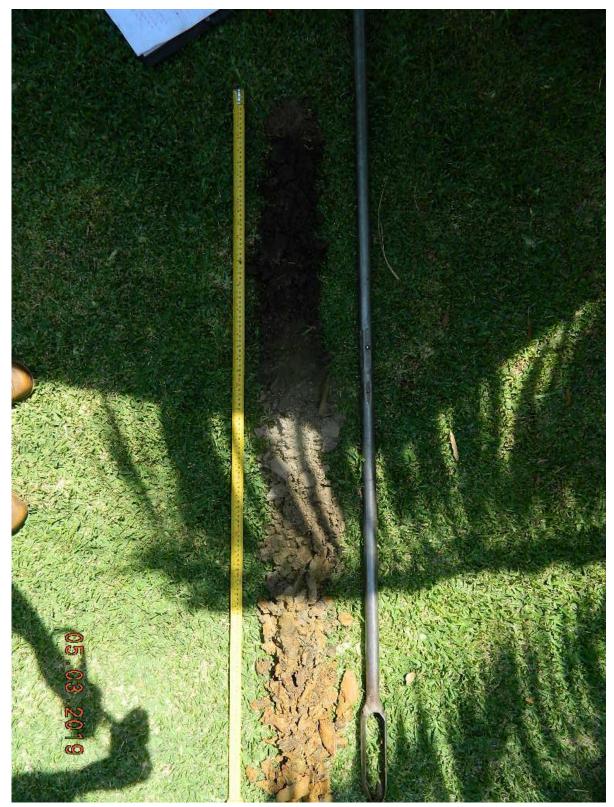
#### AUGER HOLE 1 (~RL12.4) - AH1 (Photo 11)

Depth (m)	Material Encountered
0.0 to 0.1	FILL, disturbed sandy soil, light brown, loose, fine to medium grained,
	organic matter, dry.
0.1 to 0.6	SANDY SOIL, dark brown, rock fragments, fine to medium grained,
	loose, dry.
0.6 to 0.8	SAND, light grey, loose, fine to medium grained, dry.
0.8 to 0.9	SAND, light tan, loose, fine to medium grained, dry.
0.9 to 1.3	SANDY CLAY, orange with yellow and grey mottling, firm to stiff, fine
	to medium grained, dry.
1.3 to 1.4	SANDY CLAY, orange with yellow and grey mottling, stiff, fine to
	medium grained, dry.

End of test @ 1.4m in sandy clay. No watertable encountered.

Photo 11: Auger Hoe 1: The base of auger hole is at the base of the image.
