GEOTECHNICAL ASSESSMENT REPORT

PROPOSED NEW HOUSE

95 GURNEY CRESCENT, SEAFORTH

Project No.: 2019-203

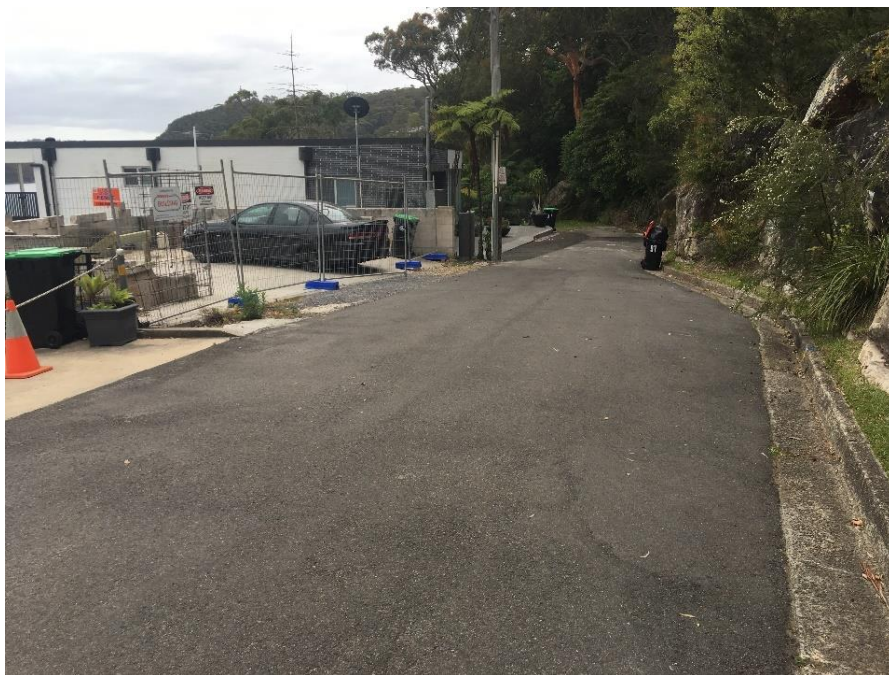
Photograph-2: Gurney Crescent road reserve, view looking north.

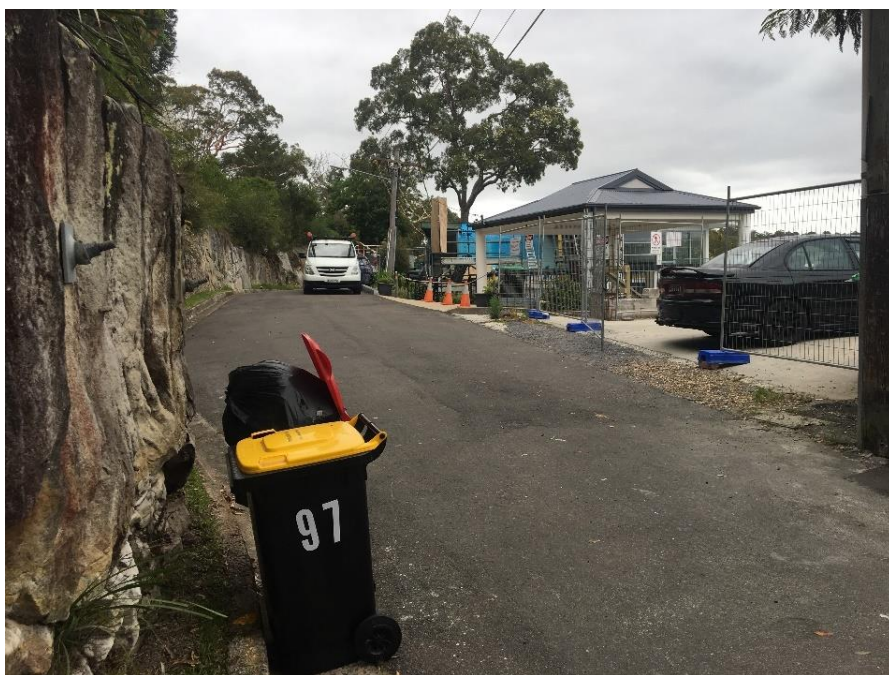
Photograph-3: Gurney Crescent road reserve, view looking south.

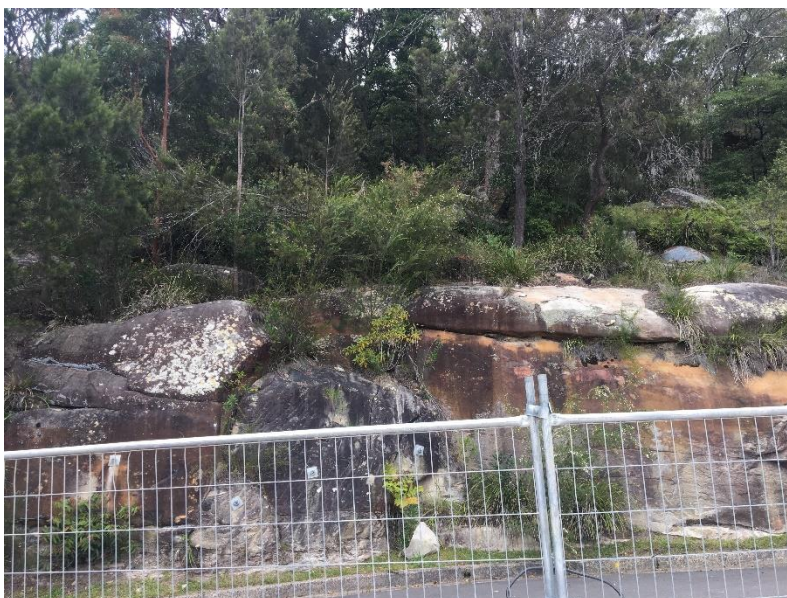
Outside of the site, to the front of the eastern boundary, the bedrock cliff-face comprises of sandstone of at least medium strength and displayed an apparent gently dipping bedding plane at the top of the cliff. The cliff-face also contained apparent joints, these joints were supported by hazard reduction measures such as rock bolts/anchors and shotcrete. The sandstone cliff-face appears to be stable with no sign of rock instability, in the portion in front of the site.

Photograph-4: Sandstone cliff-face, view looking east.

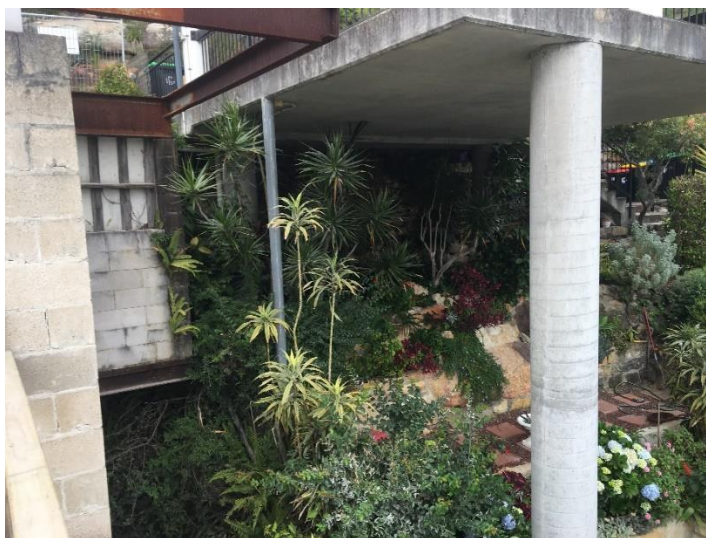
Photograph-5: Concrete block retaining wall, view looking east into No.93.

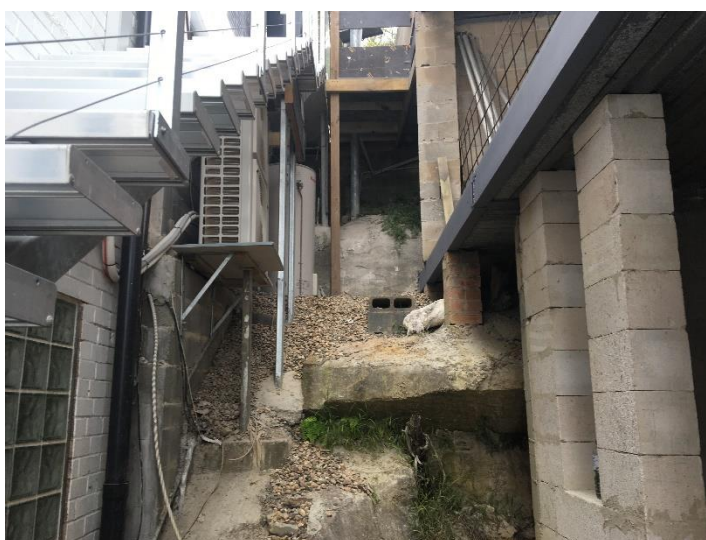
The provided original architectural drawings (dated:25/05/2000), indicate that Level 3 and Level 4 were to be founded onto an unexcavated rock surface, whilst rock excavation was required for Level 2 to Level 1, to accommodate construction. This was confirmed in the site investigation, it appears that Level 3 and Level 4 are formed on brick and concrete columns, which are founded directly onto unexcavated bedrock (Photograph 6) to the east of an excavation into the bedrock. The bedrock comprises of sandstone of at least medium strength containing horizontal bedding planes with minor defects and no destabilizing defects were observed. There were no signs of underlying geotechnical issues within the supporting columns of the existing structure.

Photograph-6: Level four supported in brick columns directly on to rock, view looking east.

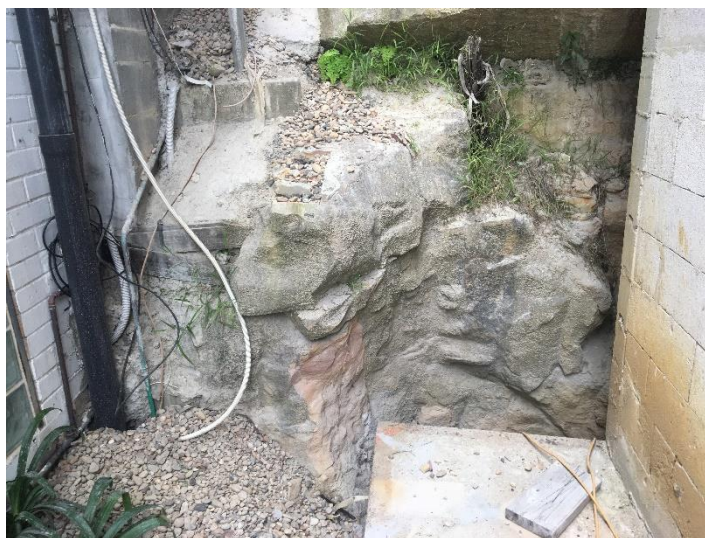
Level 2 comprises of a concrete floor, concrete block walls and steel beam. Signs of rock excavation were found in the north east corner of the slab (Photograph-7). The bedrock outcrop comprises of sandstone of at least medium strength, it presented an irregular outcrop face due to the excavation, however it did not contain destabilizing defects, where visible. There were no signs of underlying geotechnical issues/destabilization within the bearing walls, slab and columns. Vertical cracks (approximately 2.5m height and 5mm width) were observed within the internal walls (Photograph 8&9), however no evidence indicated they were due to a geotechnical issue. Photograph 10 shows a timber framed door, which appeared to be in good condition, the frame is vertically straight with no sign of tilting/dislocation.

Photograph-7: Rock excavation in the north east corner. View looking east.

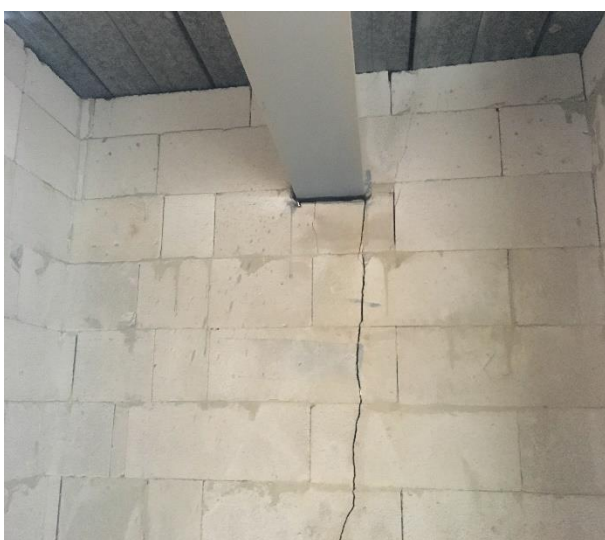
Photograph-8: Vertical crack. View looking south south

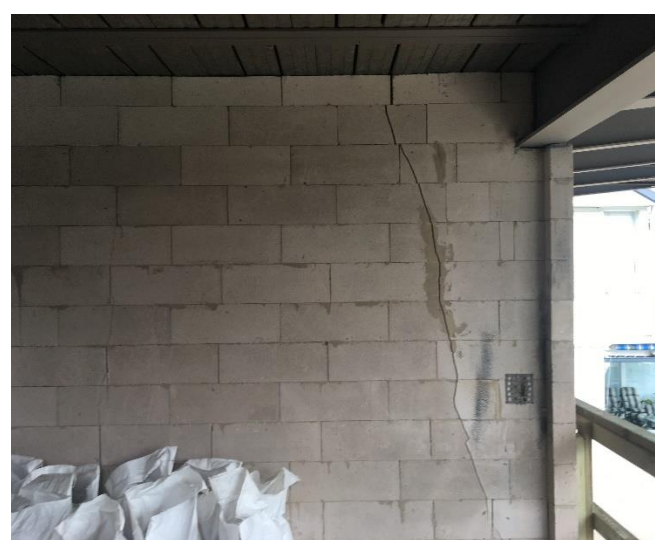
Photograph-9: Vertical crack. View looking

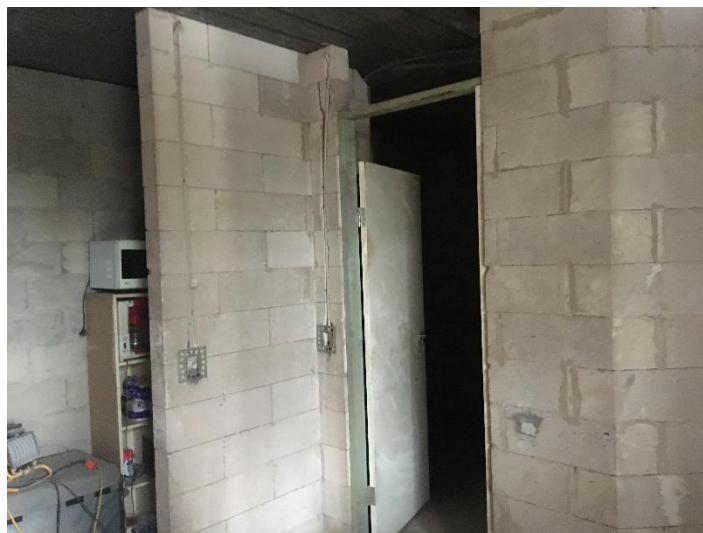
Photograph-10: Straight timber framed door. View looking south.

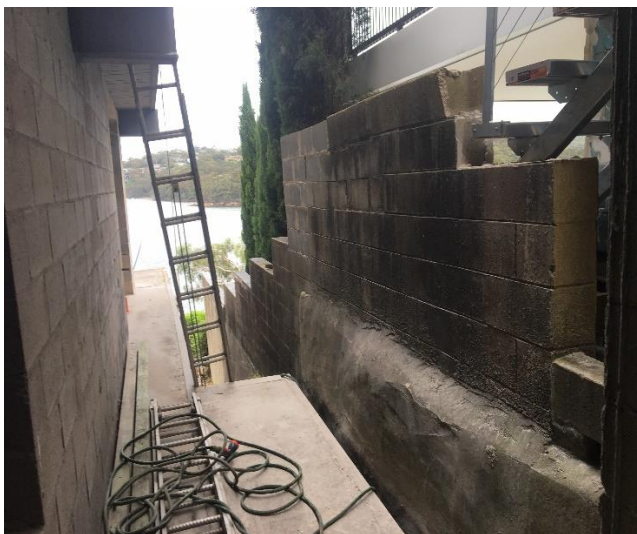
The northern boundary contains a concrete block boundary/retaining wall which is covered or underlain by a shotcrete wall/face from Level 2 (Photograph-11) down to Level 1 (Photograph-12). The wall appears to be in good condition with no sign of cracking, tilting or deformation. Similarly, the southern boundary contains a shotcrete boundary/retaining wall. The wall also appears to be in good condition with no sign of cracking, tilting or deformation.

Photograph-11: Retaining wall. View looking east.

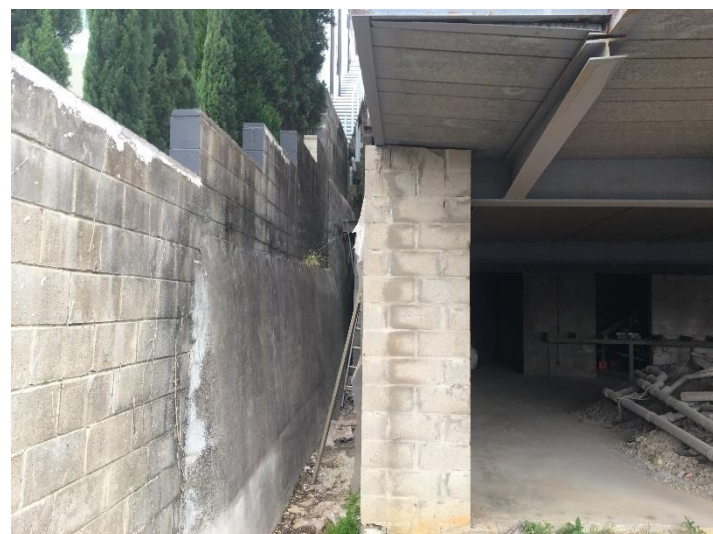
Photograph-12: Retaining wall. View looking east.

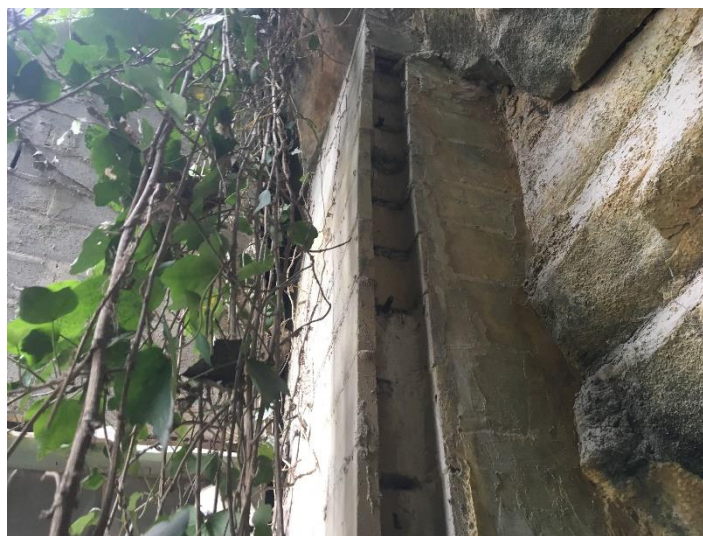
Photograph-13: Reinforced concrete/brick retaining wall.

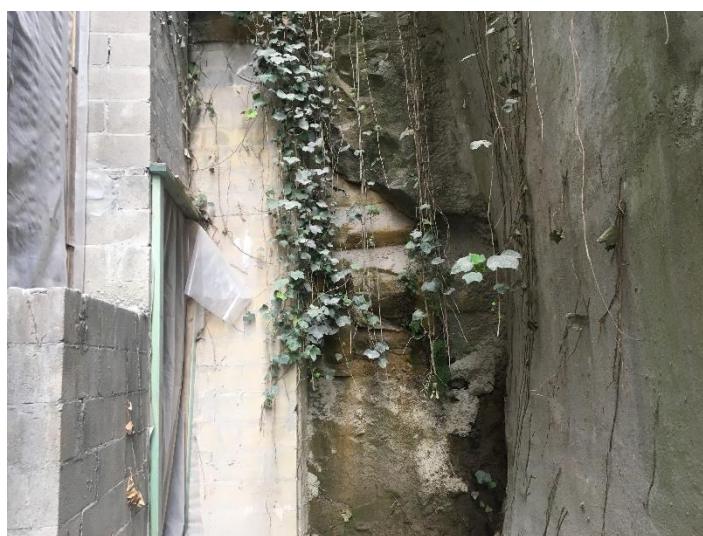
Photograph-14: Reinforced concrete/brick retaining wall. View looking east.

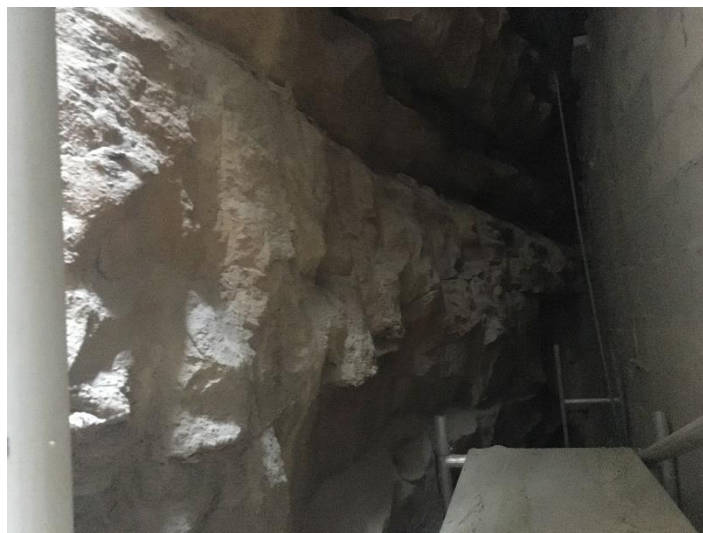
Photograph-15: Steeply defect joints from behind the wall. View looking east.

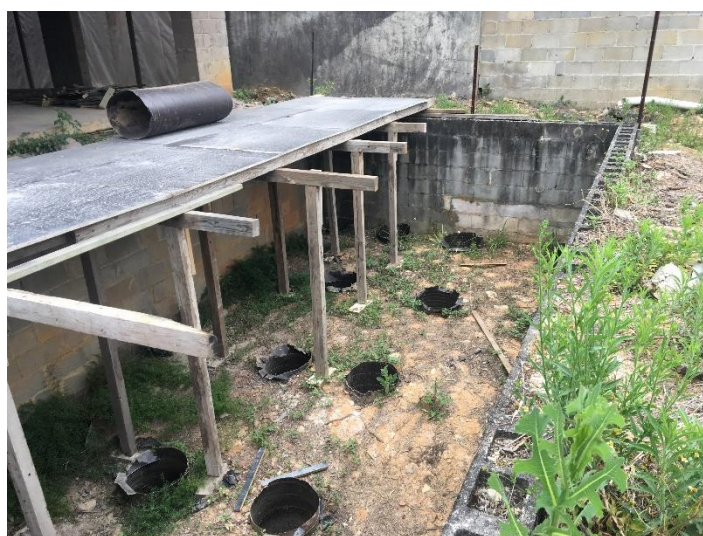
To the west of Level 1 is an excavation for the existing incomplete pool (that was to be founded on piers) (Photograph 16). To the west of the pool is a terrace with concrete floor that extends west approximately 5m. This terrace is supported by a concrete block retaining wall (approximately 5m height) around its western edge. The concrete block retaining wall (Photograph-17) appears to be founded on bedrock (Photograph-18), the bedrock extends approximately 2m west. The concrete block retaining wall appeared to be in good condition with no sign of cracks, deformation or rotation. The same bedrock composition was observed to the north, in the northern boundary line and in the neighbour's property (No.97). It comprises of sandstone of at least medium strength and no destabilizing defects were observed. To the west of the sandstone outcrop is a dense vegetated slope and further inspection was not possible in this part of the site.

Photograph-16: Proposed pool location

5.1.2. Retaining Structures:	
Required	The new pool shell will permanently support the required excavation for the pool extension. It is recommended that the pool extension and any new footings extend to found on sandstone bedrock of at least low strength.

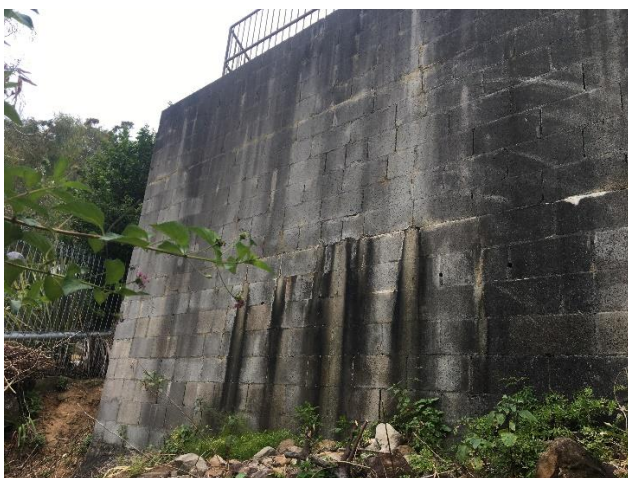
Photograph-17: Concrete block retaining wall. View looking east

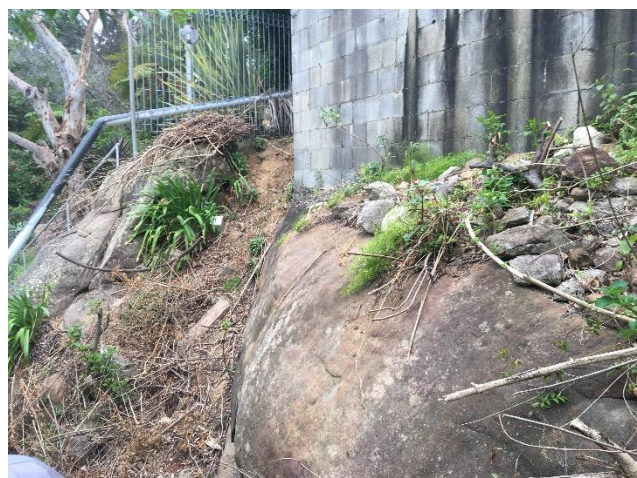
*Photograph-18: Sandstone bedrock
View looking east*
