GEOTECHNICAL INVESTIGATION:

New House (Alts & Adds) & Pool at 23 Hay Street, Collaroy Plateau

For Proposed Infiltration Trench at **23 Hay Street, Collaroy**

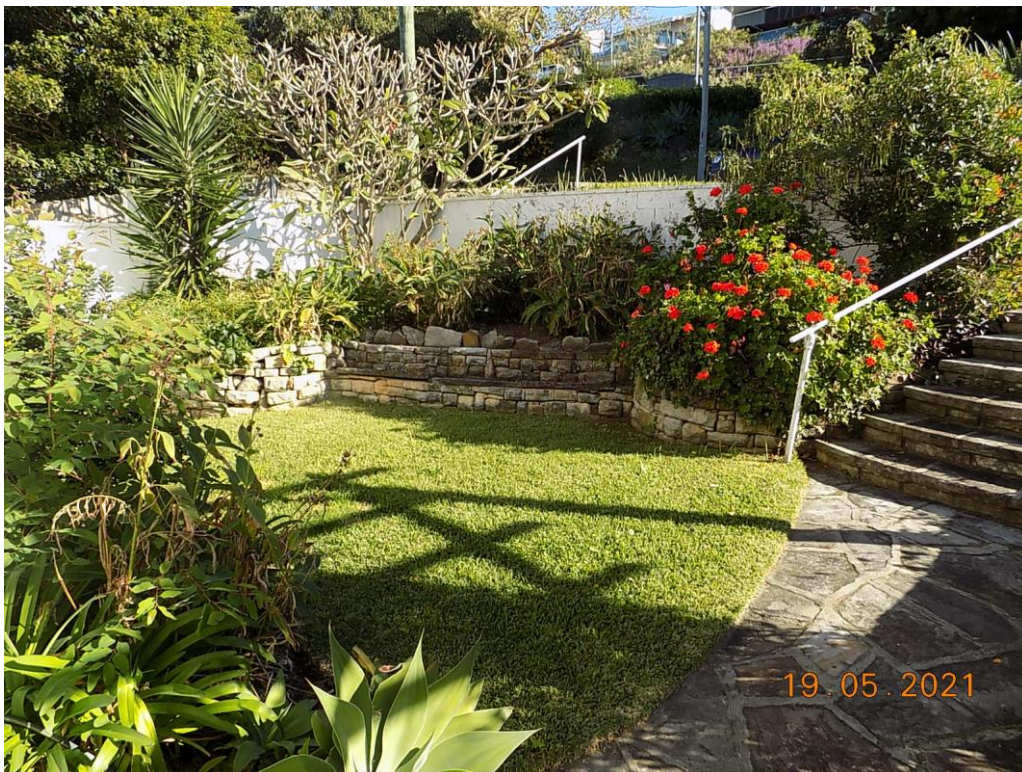
Photo 2

between the road frontage and the house for a gently sloping lawn and garden area (Photo 2). The cut is supported by a concrete block retaining wall that displays stepped cracking and will also be demolished as part of the proposed works (Photo 3). The part three-storey rendered brick house is supported on brick walls and brick piers (Photo 4). The majority of these walls and piers will be demolished as part of the proposed works. The S supporting wall that is to remain displays significant cracking in multiple locations (Photos 5 & 6). We recommend this wall be rebuilt as part of the proposed works. A stone-paved fill extends off the NE corner of the house (Photo 7). The fill and its supporting sandstone block retaining wall (Photo 8) will both be removed as part of the proposed works. A gently sloping lawn falls from the downhill side of the house to the lower common boundary (Photo 9). Portions of the lawn have been filled and are battered to stable angles.

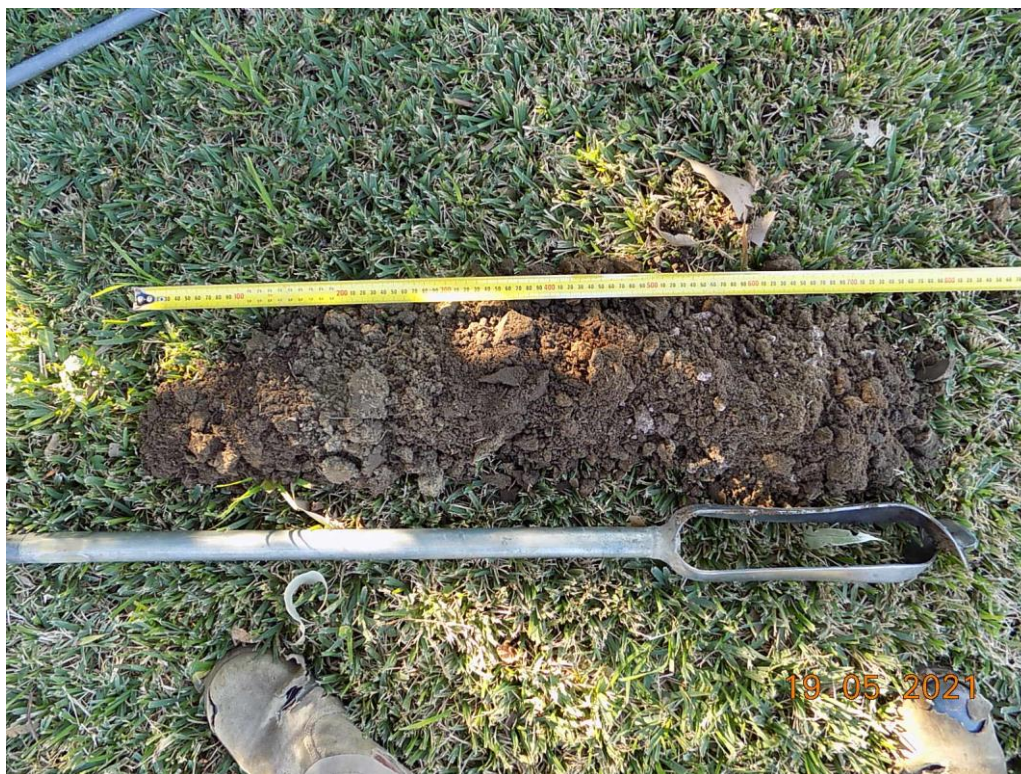
Photo 10 – AH1: Downhole is from left to right

AUGER HOLE 1 (~RL27.4) – AH1 (Photo 10)

Depth (m)	Material Encountered
0.0 to 0.8	FILL , disturbed clayey soil, dark brown, medium dense to dense, dry, fine to coarse grained with fine trace organic matter and rock fragments.

End of test @ 0.8m in fill. No water table encountered.

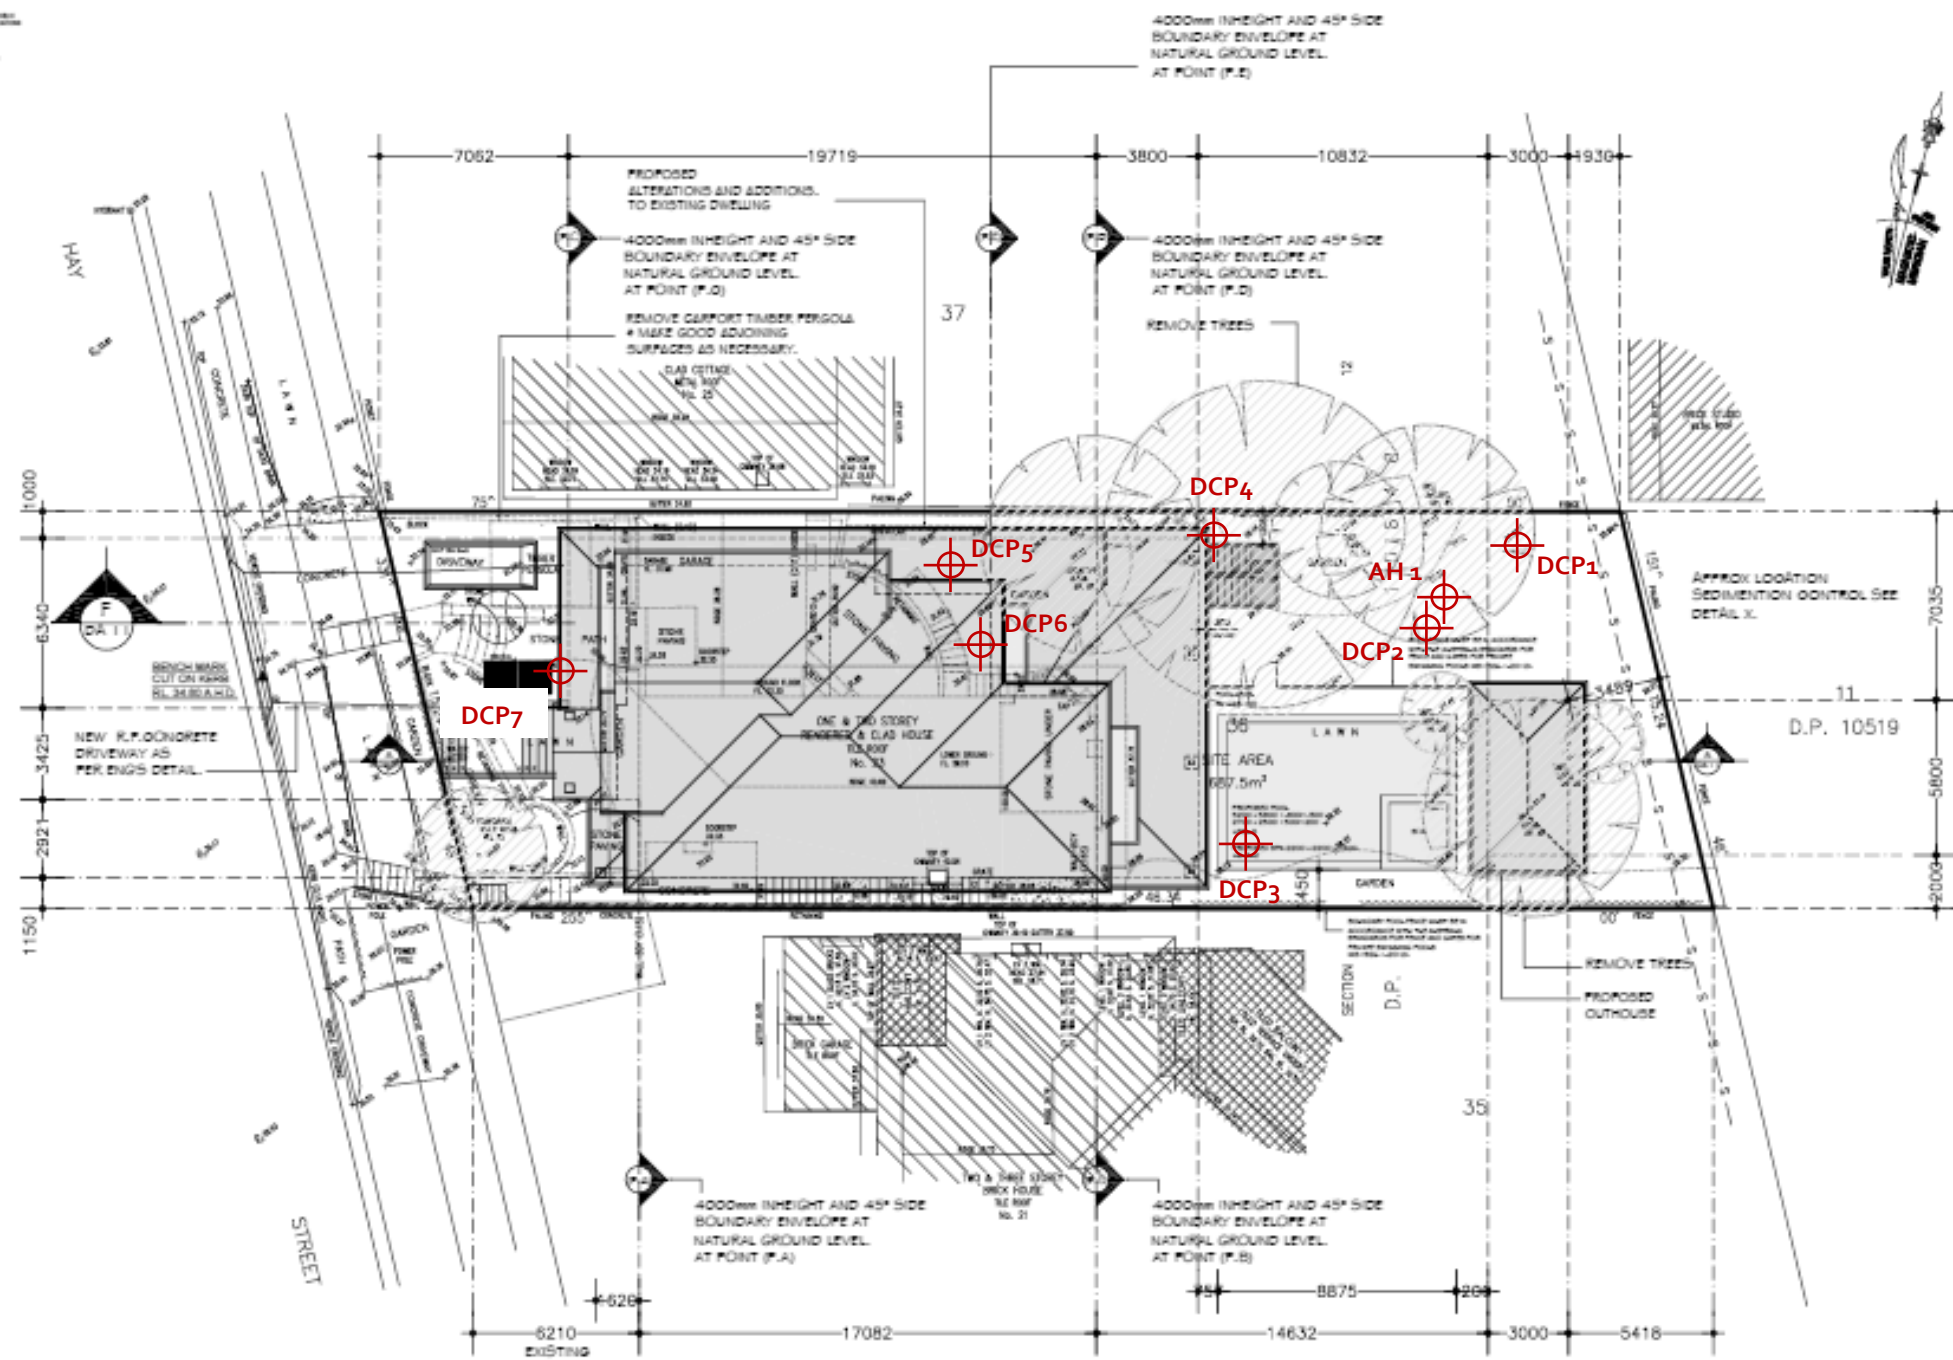
LOWER GROUND FLOOR PLAN – showing minimum required extents of shoring

Minimum extent of required shoring shown in blue

Minimum extent of temporary shoring shown in red

Due to the depth of the proposed excavation and to ensure the integrity of the subject and neighbouring houses and properties, ground support will need to be installed along all sides of the excavation with the support installed before, or as the excavation commences. See the site plan attached for the minimum extent of the required shoring. Following the removal of the fill off the NE corner of the existing house, a spaced piled retaining wall is one of the suitable methods of support. Pier spacing is typically ~2.0m but can vary between 1.6 to 2.4m depending on the design. The piers can be supported by embedment or propping installed as the excavation is lowered.

To ensure the integrity of the S neighbouring property, we recommend the S side of the excavation be temporarily supported with typical pool shoring such as sacrificial form ply,

until the pool structure is in place. See the minimum extent of temporary shoring shown on the site plan attached.

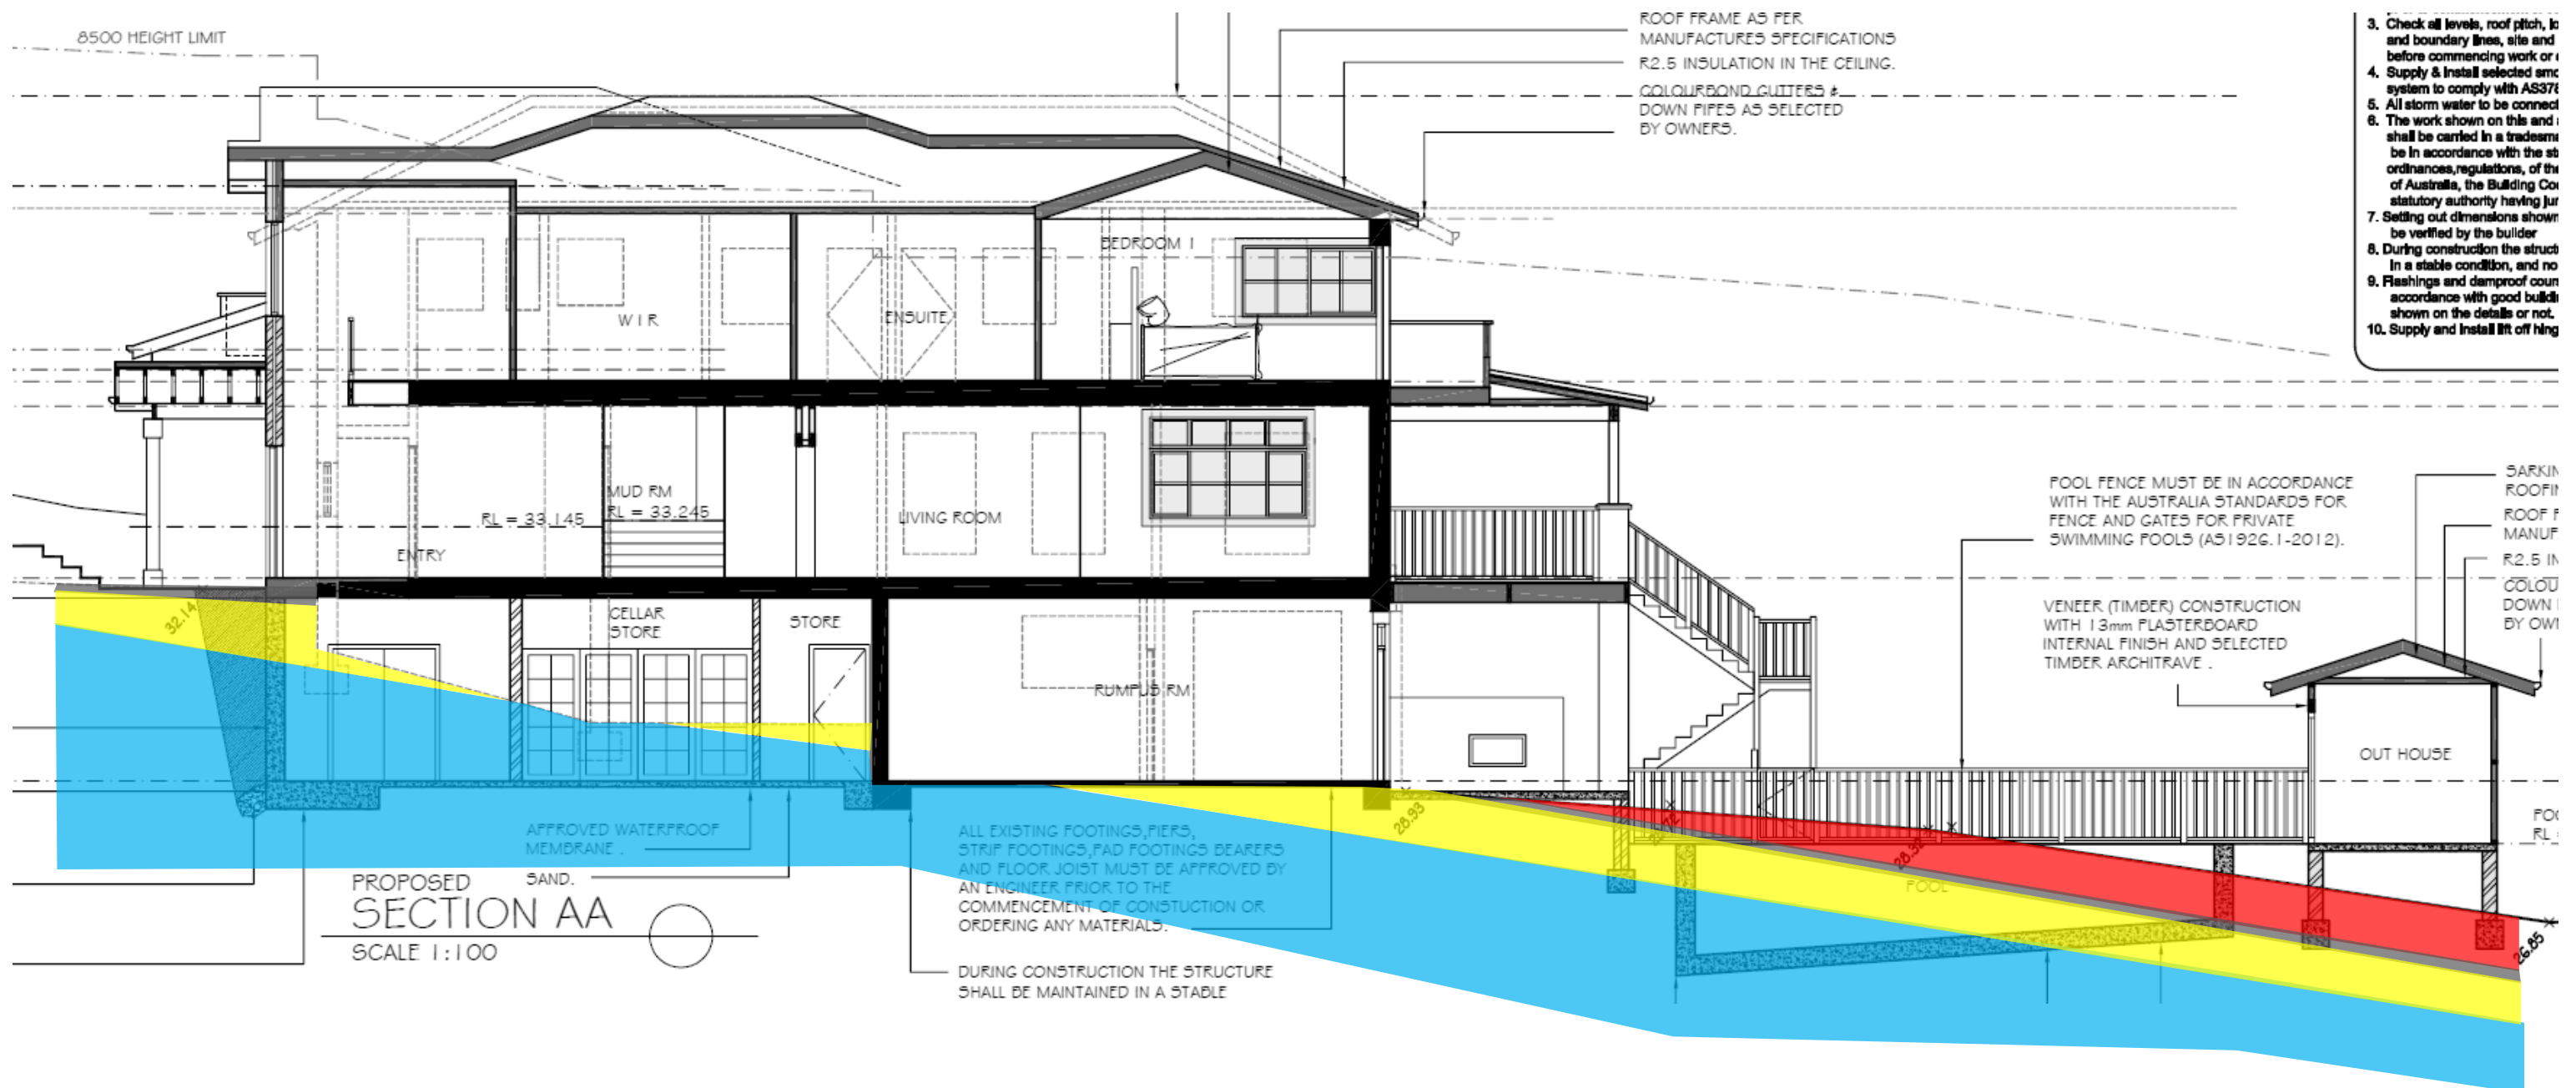
TYPE SECTION – Diagrammatical Interpretation of expected Ground Materials

The slope materials are colluvial at the near surface and residual at depth. In the location of the proposed works, they consist of a topsoil over silty clays. Filling has been placed across the downhill side of the property for landscaping. In the test locations, the clays merge into the weathered zone of the underlying shale at depths of between 0.9 to 2.1m below the current surface, being deeper due to the presence of filling and a variable weathering profile. The weathered zone is interpreted as Extremely Low Strength Shale. It is to be noted that this material can appear as a mottled stiff clay when it is cut up by excavation equipment. See Type Section attached for a diagrammatical representation of the expected ground materials.

- Fill
- Topsoil
- Silty Clay – Firm to Stiff
- Narrabeen Group Rocks – Extremely Low Strength Shale - after being cut up by excavation equipment can resemble a stiff to hard clay.

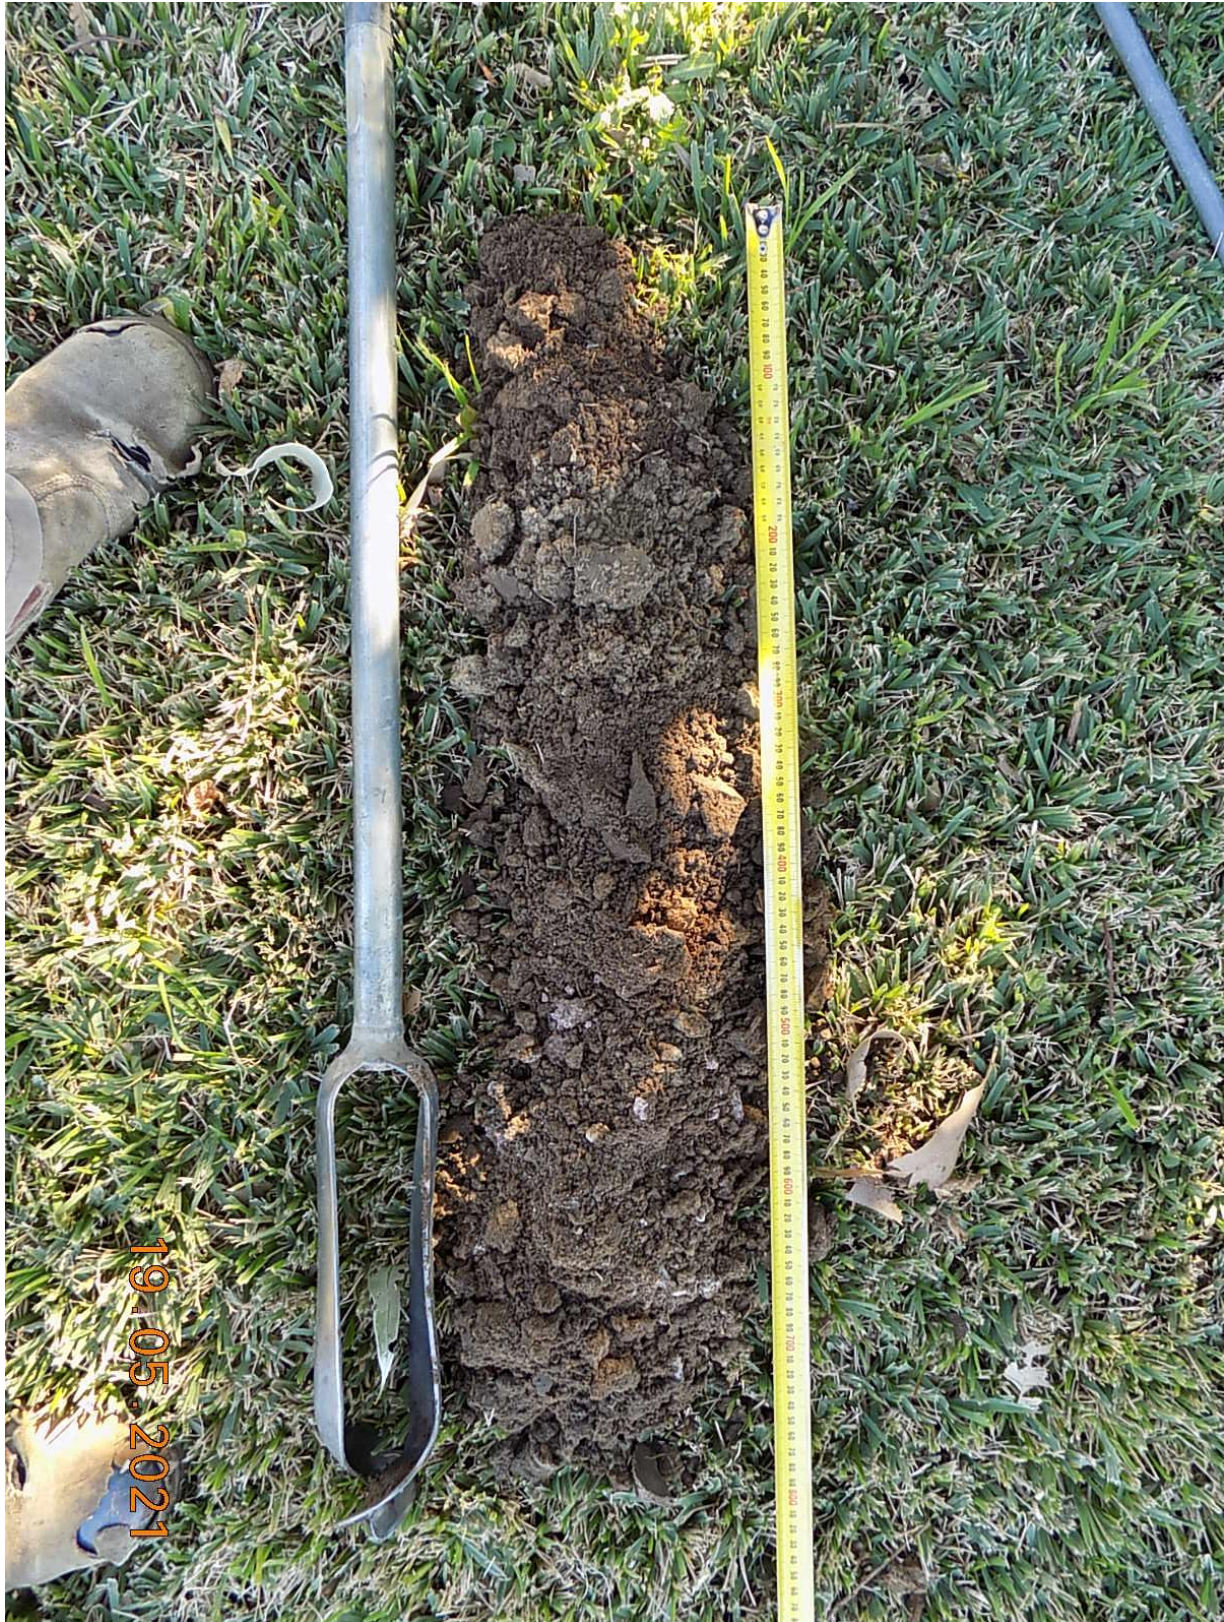
Photo 1: AH1 – Downhole is from top to bottom

AUGER HOLE 1 (~RL27.4) – AH1 (Photo 1)

Depth (m)	Material Encountered
0.0 to 0.8	FILL , disturbed clayey soil, dark brown, medium dense to dense, dry, fine to coarse grained with fine trace organic matter and rock fragments.

End of test @ 0.8m in fill. No water table encountered.
