## FINAL OCCUPATION CERTIFICATE

# INSPECTION REPORT

## INSPECTION CERTIFICATE FOR STRUCTURAL COMPONENT

Alterations and Additions at  
193 Whale Beach Road,  
Whale Beach, NSW, 2107

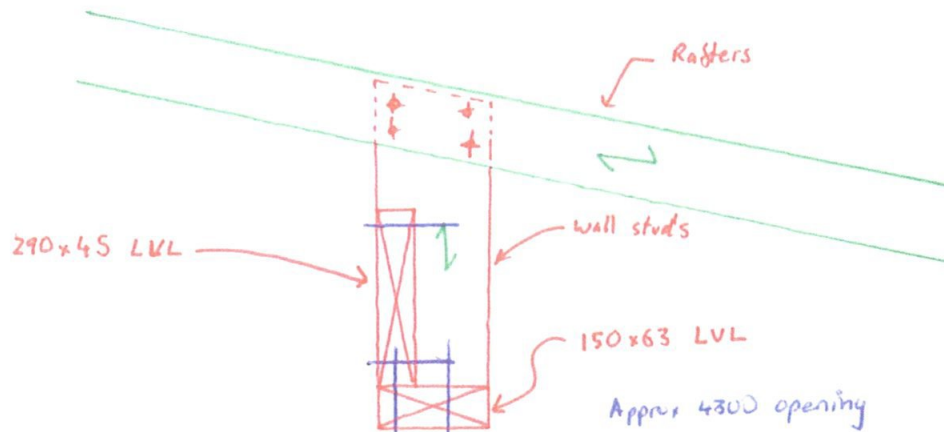
- f. The intermediate walls on each side of the entrance space require lintels which may be constructed as follows.
