REPORT ON GEOTECHNICAL SITE INVESTIGATION

PROPOSED RESIDENTIAL DEVELOPMENT

45 LANTANA AVENUE, WHEELER HEIGHTS

Project No.: 2020-242

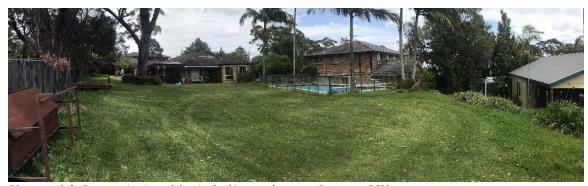
Photograph 2: Panoramic view of the site looking south to west from near BH1.

The site contains one large (see Photograph 2 and 3) mature tree and the roots of this tree were observed breaking through the lawn surface.

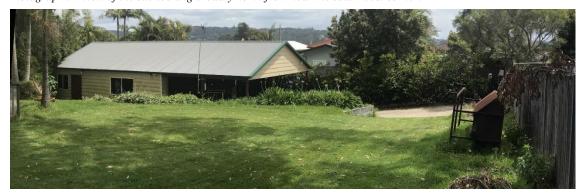
Photograph 4: View of the site looking broadly north from near BH1.
