## **Geotechnical Assessment**

**Project:** Alterations and Additions  
89 Cutler Road, Clontarf NSW.

**REF: AG 19158**

23<sup>rd</sup> September, 2019

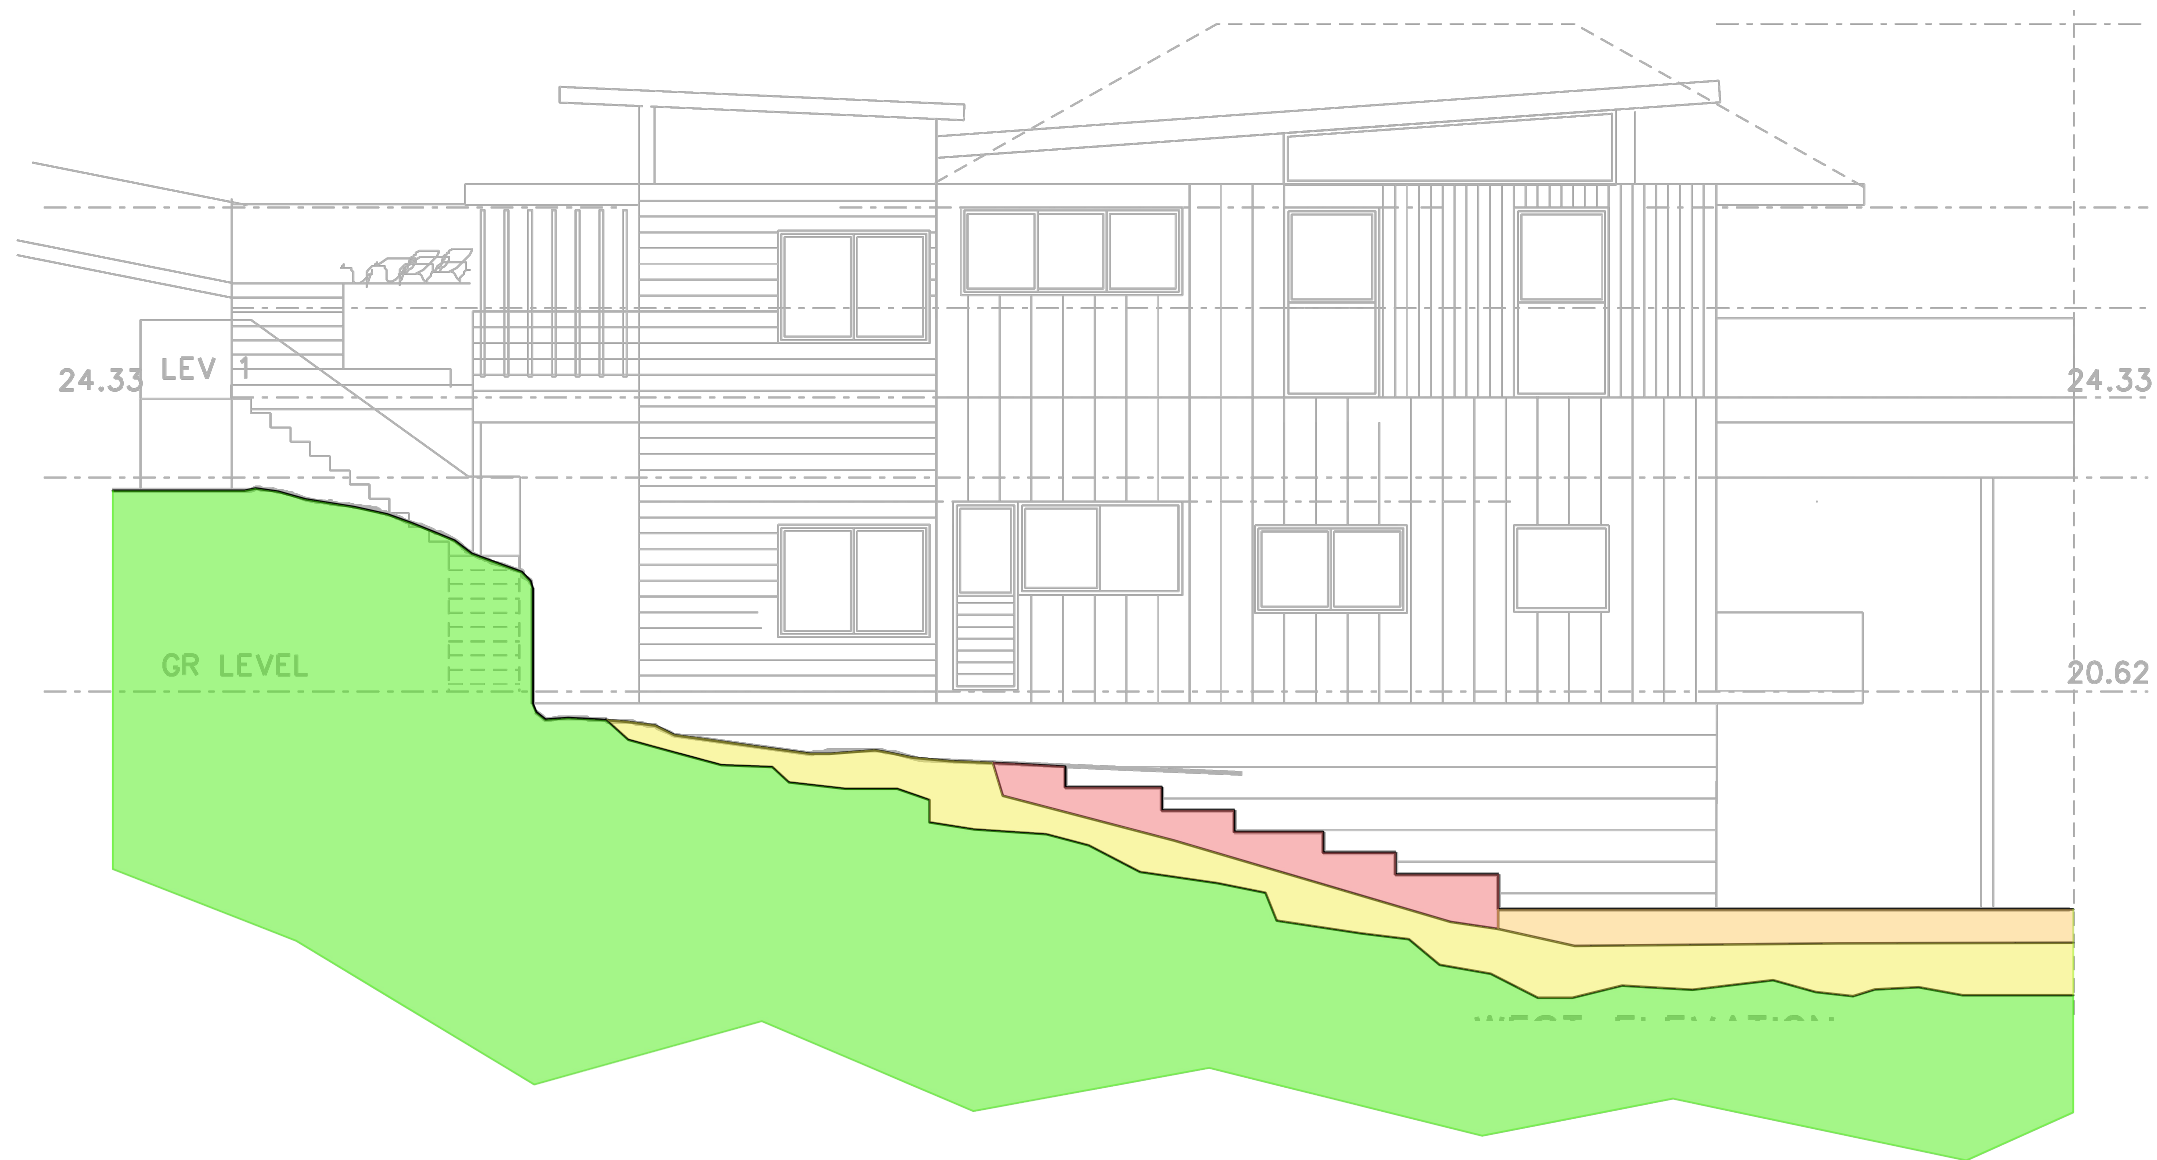
INFERRED GEOLOGICAL SECTION  
SCALE NTS

The soil profile is interpreted to consists of fill, silty/sandy top soil (O & A Horizons) and sandy clay/clayey sand (B Horizon) overlying weathered sandstone bedrock (C Horizon). Based on our observations and the results of testing onsite, we would expect competent weathered bedrock, to be found within 1000-1600mm from current surface levels across the site, where not already exposed.
