Hazardous Building Materials (HBM) Assessment

Narrabeen North Public School (3906)

Prepared for  
School Infrastructure NSW (SINSW)  
c/- Johnstaff Projects (NSW) Pty Ltd

Project 86973.02  
March 2020

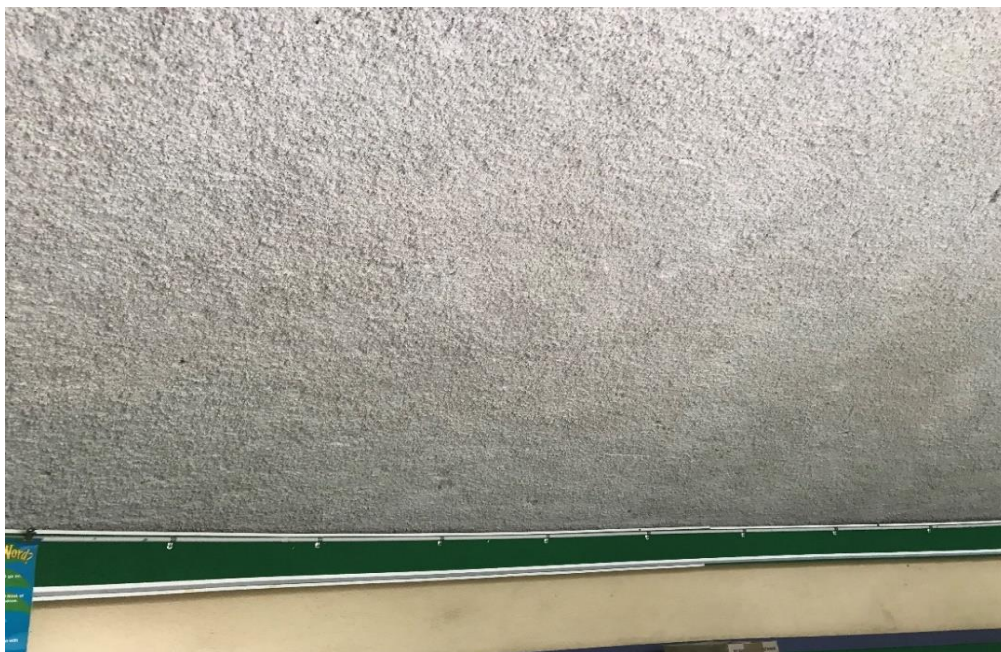
Photograph 1: B00A, R1001 - Storeroom, ceiling , vermiculite, no asbestos detected by analysis.

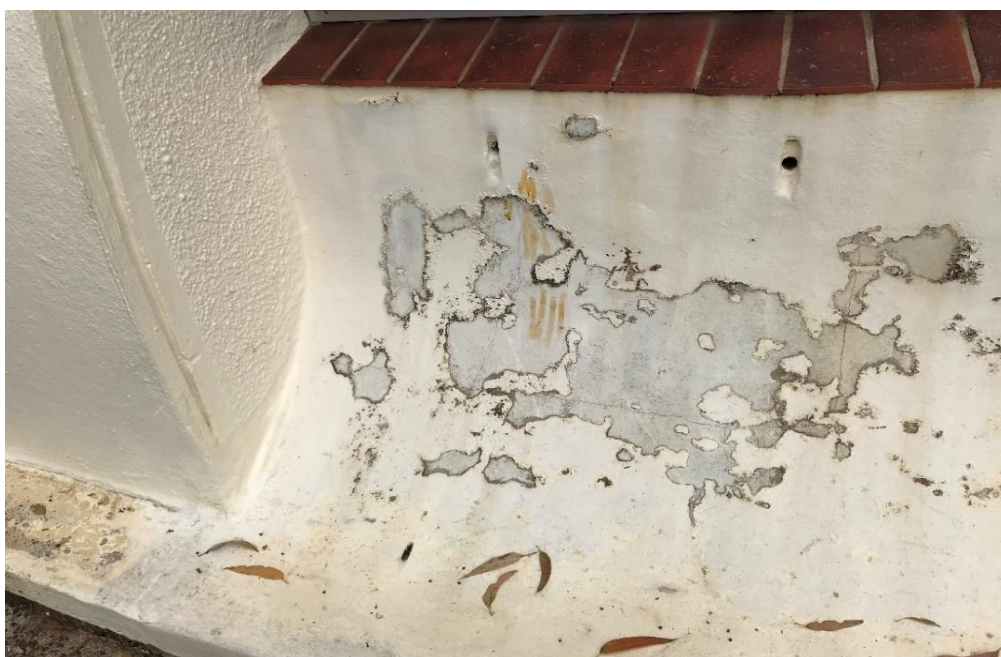
Photograph 2: B00A, exterior, throughout, walls, cream paint , negative for lead.

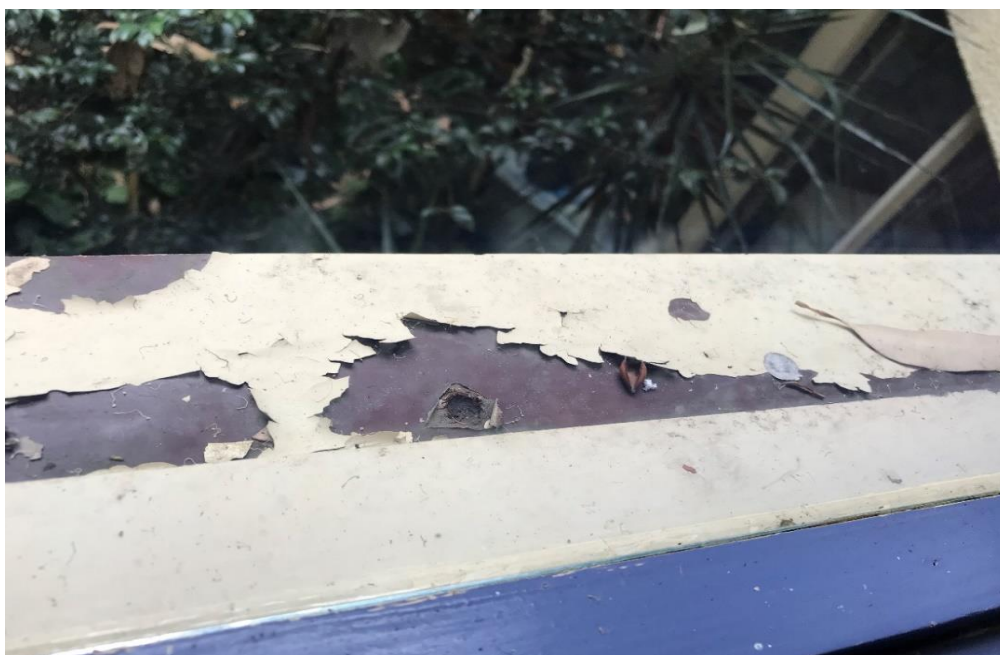
Photograph 3: B00A, exterior, throughout, walls, white paint, positive for lead.

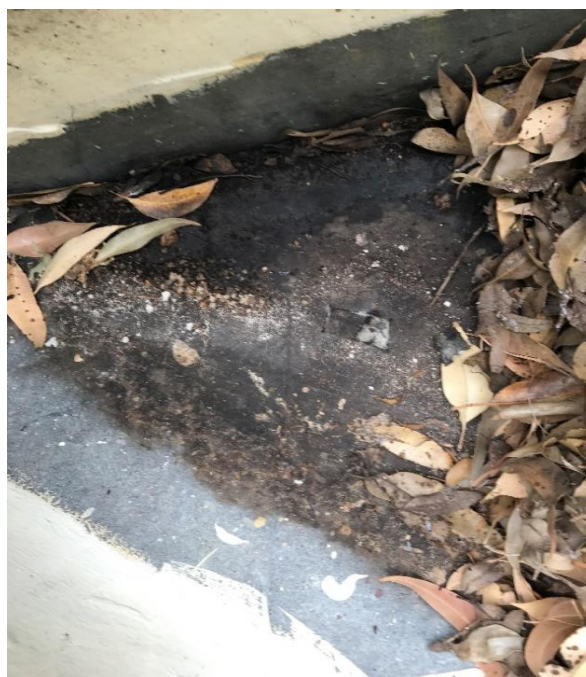
Photograph 4: B00A, exterior, western and north-eastern garden beds, lining to garden bed, bituminous membrane, asbestos detected by analysis.

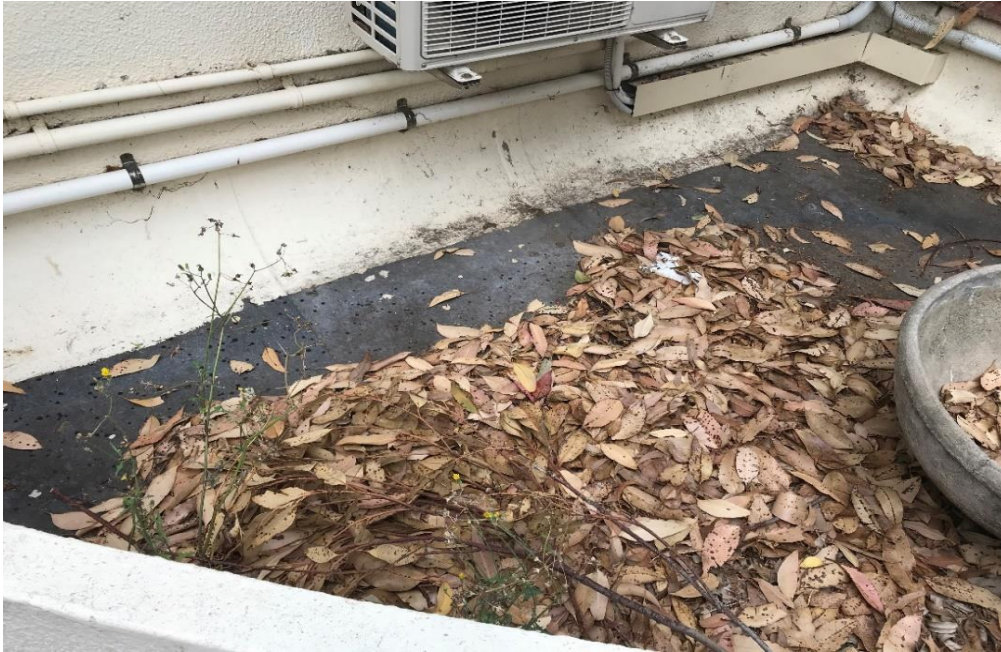
Photograph 1: B00B, exterior, north eastern garden beds, lining to garden bed , bituminous membrane, asbestos (assumed).

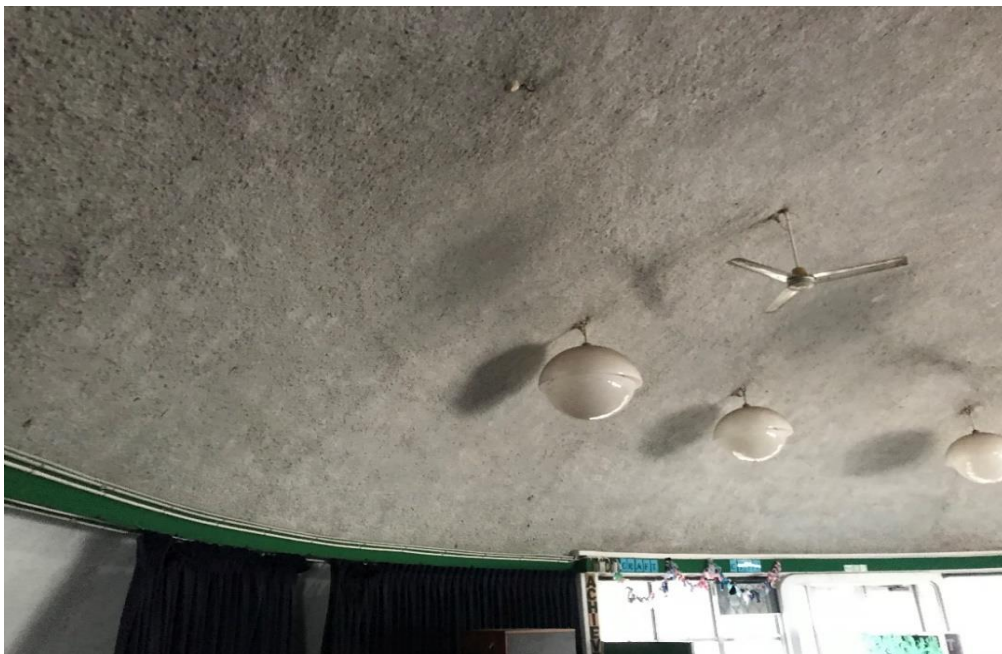
Photograph 2: B00B, R0003 - Reading Area, ceilings, vermiculite , no asbestos detected by analysis.

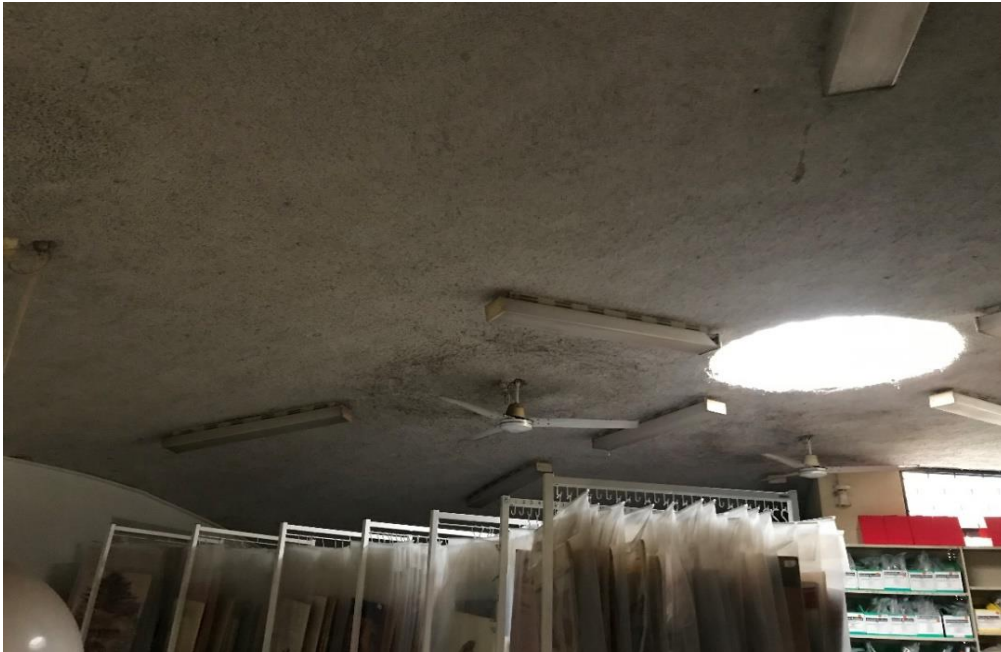
Photograph 3: B00B, R1001 - Special Programs Room, ceilings, vermiculite , no asbestos detected by analysis.

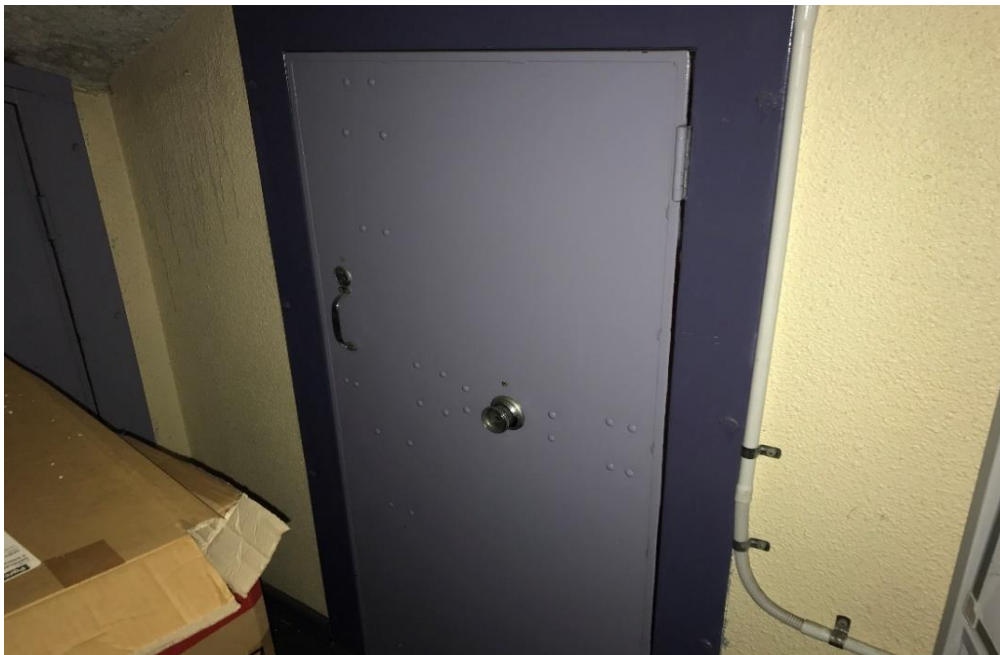
Photograph 4: B00B, R1001 - Special Programs Room, potential fire door to rear of room, internal insulation, asbestos (assumed).

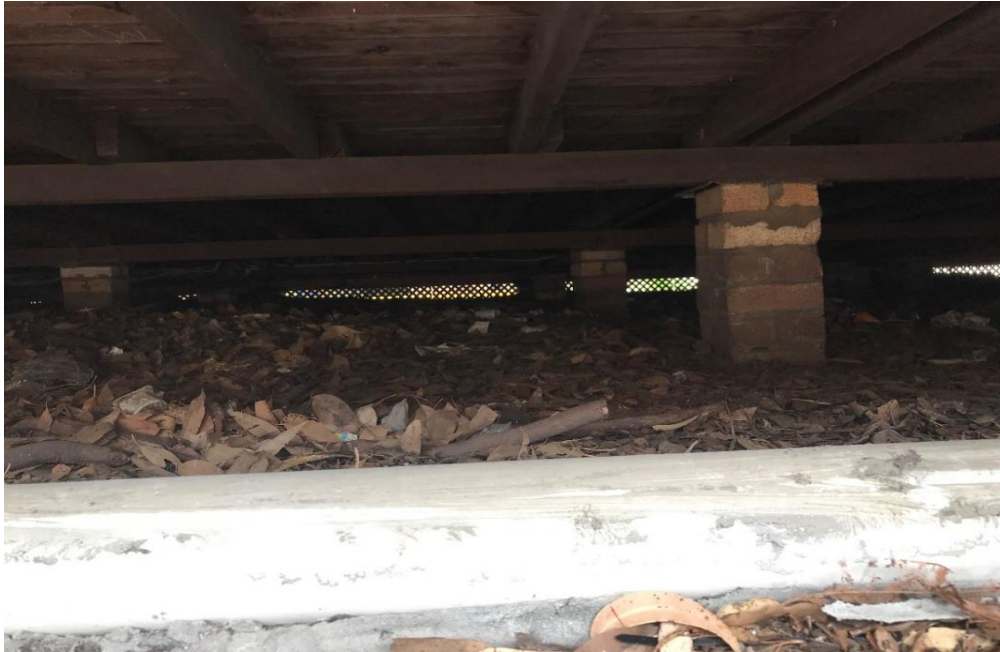
Photograph 1: B00H, exterior, subfloor, underfloor voids, packing materials, fibre cement fragments, asbestos detected by analysis.

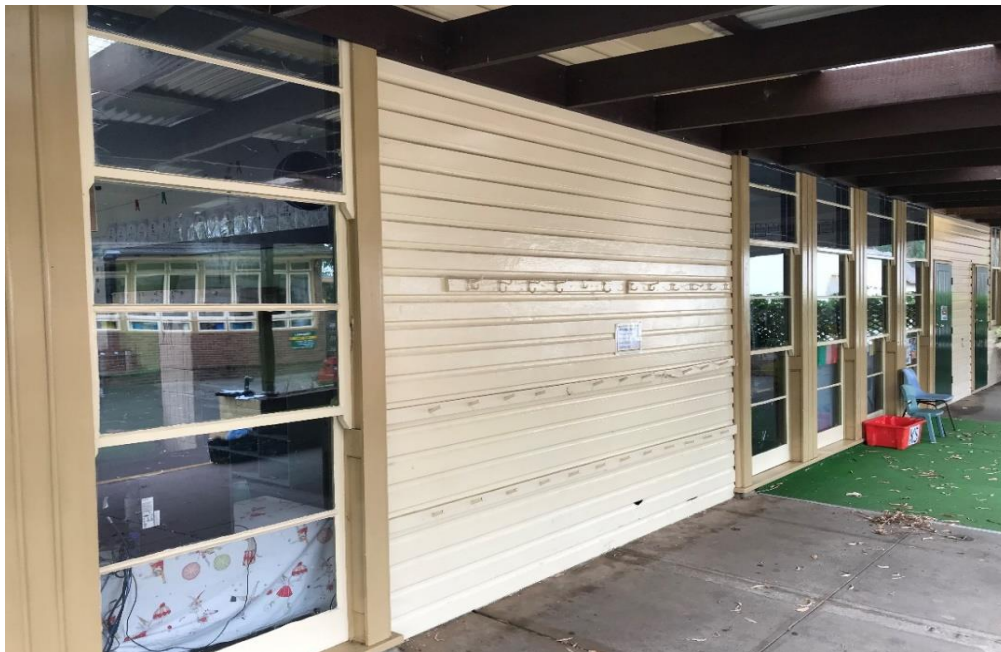
Photograph 2: B00H, exterior , typical wall, cream paint, assumed negative for lead.

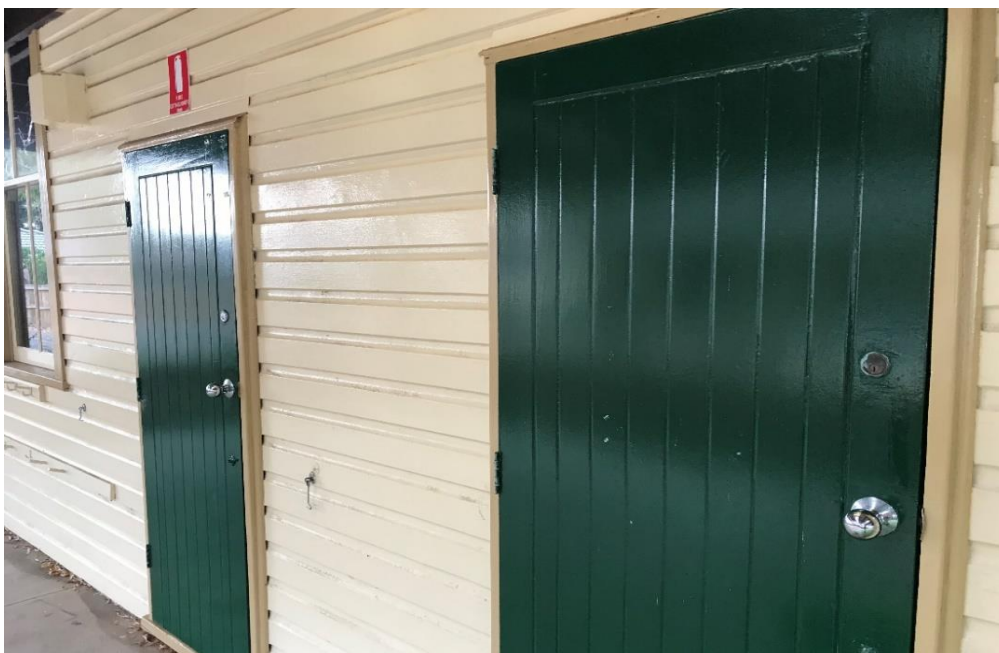
Photograph 3: B00H, exterior , typical door, green paint, assumed negative for lead.

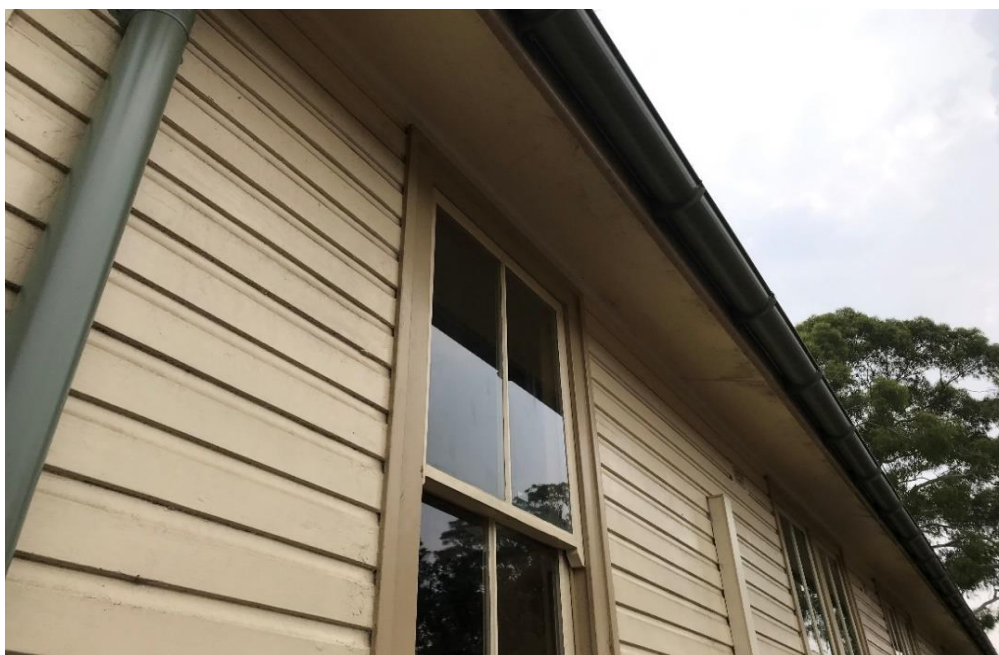
Photograph 4: B00H, exterior , typical gutter and/or downpipe , green paint, assumed negative for lead.

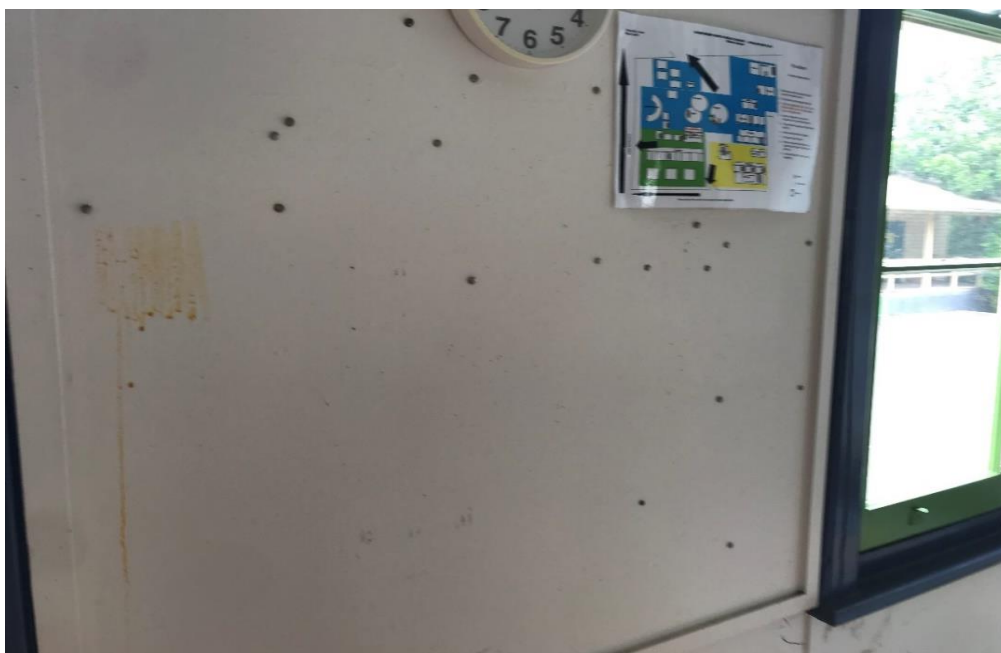
Photograph 5: B00H, interior, typical wall, white paint, negative for lead.

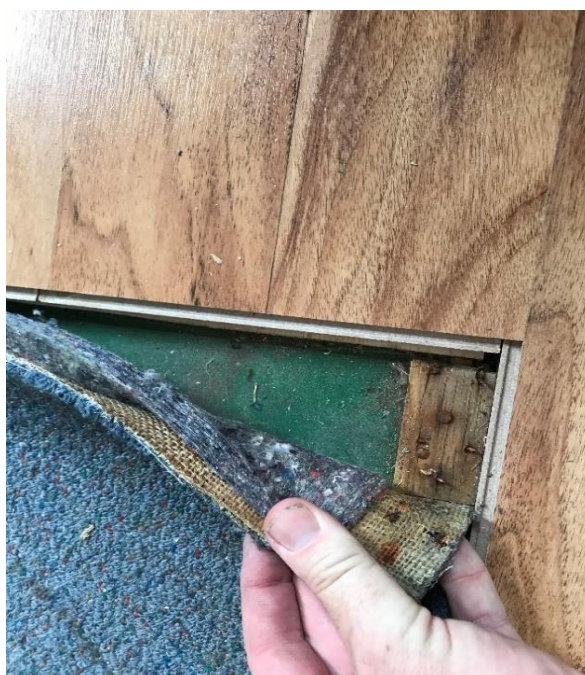
Photograph 6: B00H, R0005 - Staff Room, floor, vinyl tiles (green), asbestos detected by analysis.

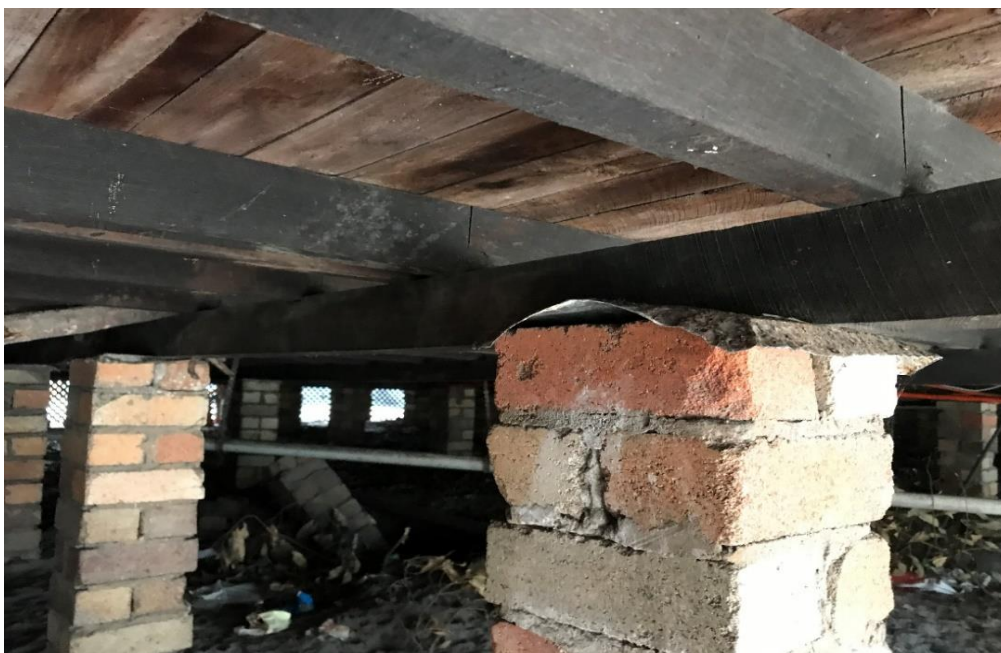
Photograph 1: B00J, exterior, subfloor, on brick piers between stilts and ant cap, fibre cement fragments, asbestos detected by analysis.

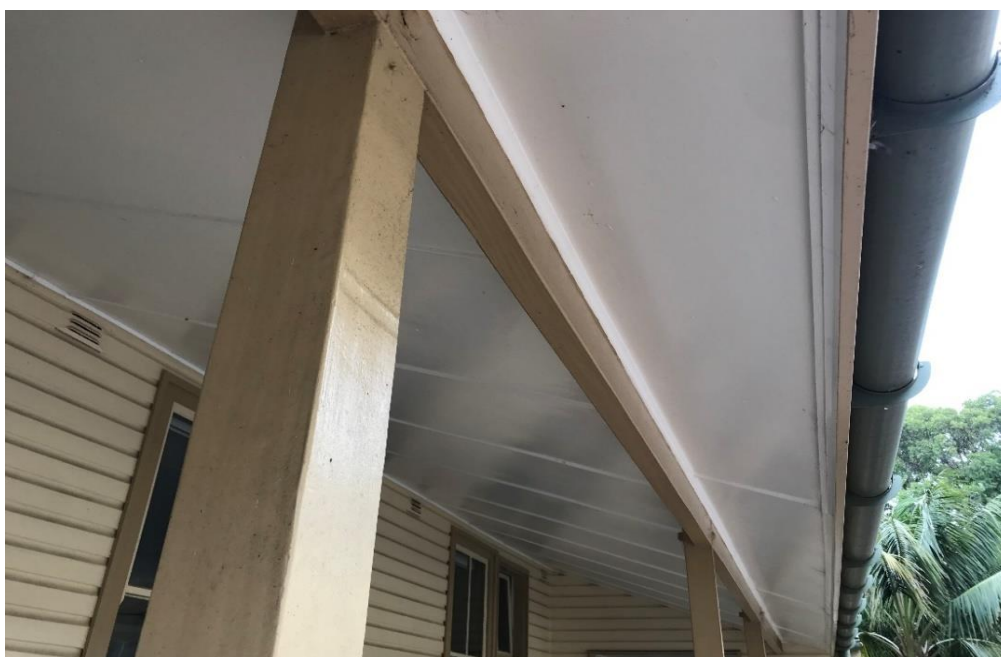
Photograph 2: B00J, exterior, eaves, fibre cement sheeting, asbestos detected by analysis.

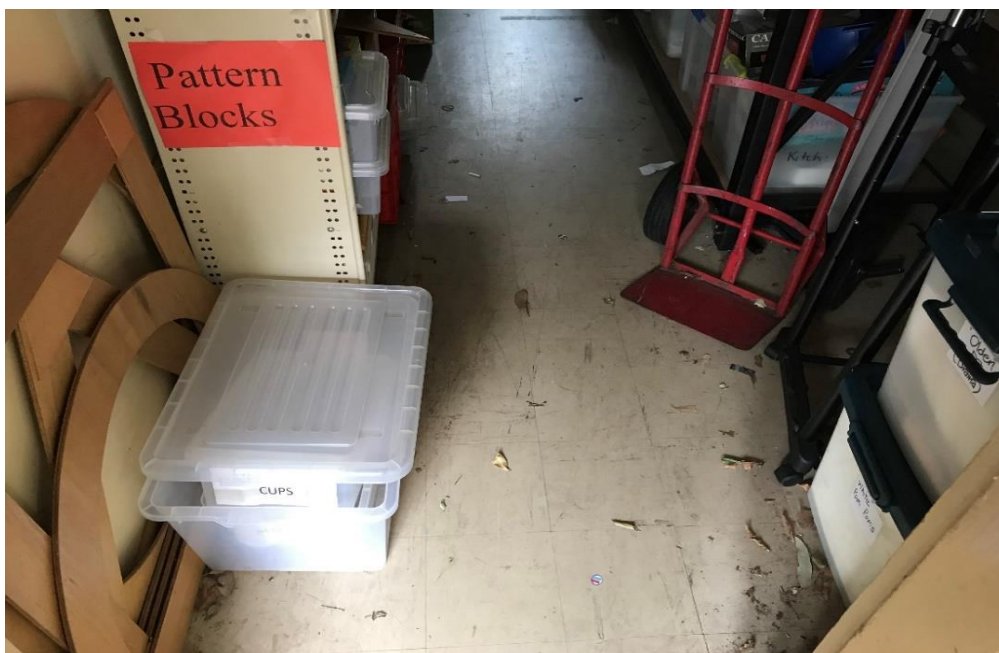
Photograph 3: B00J, R0001, floor, vinyl tiles, asbestos detected by analysis.

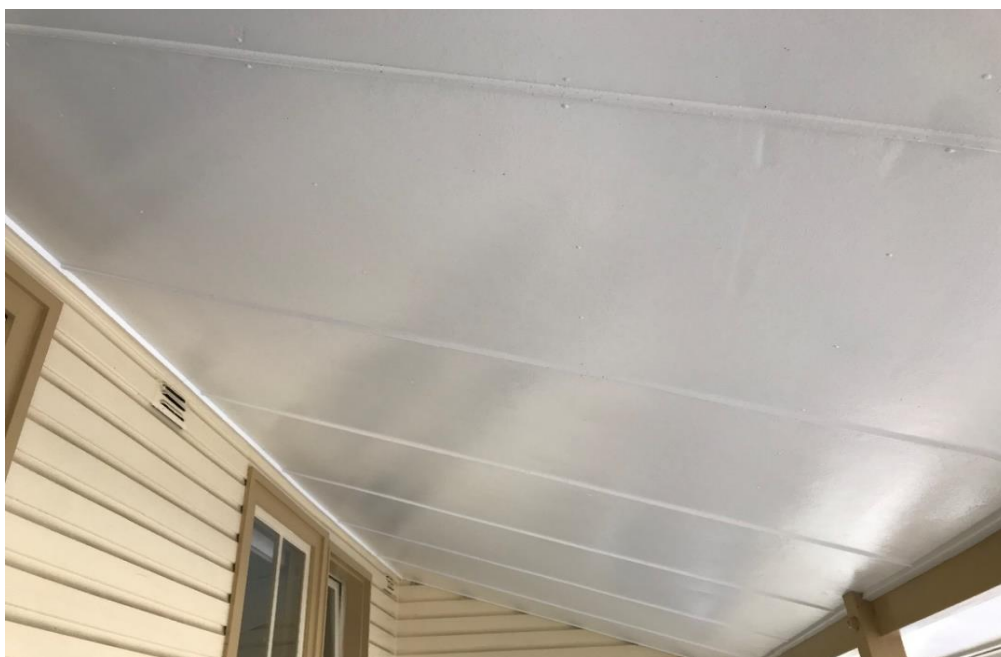
Photograph 4: B00J, exterior, movement (balcony), ceiling, fibre cement sheeting, asbestos detected by analysis.

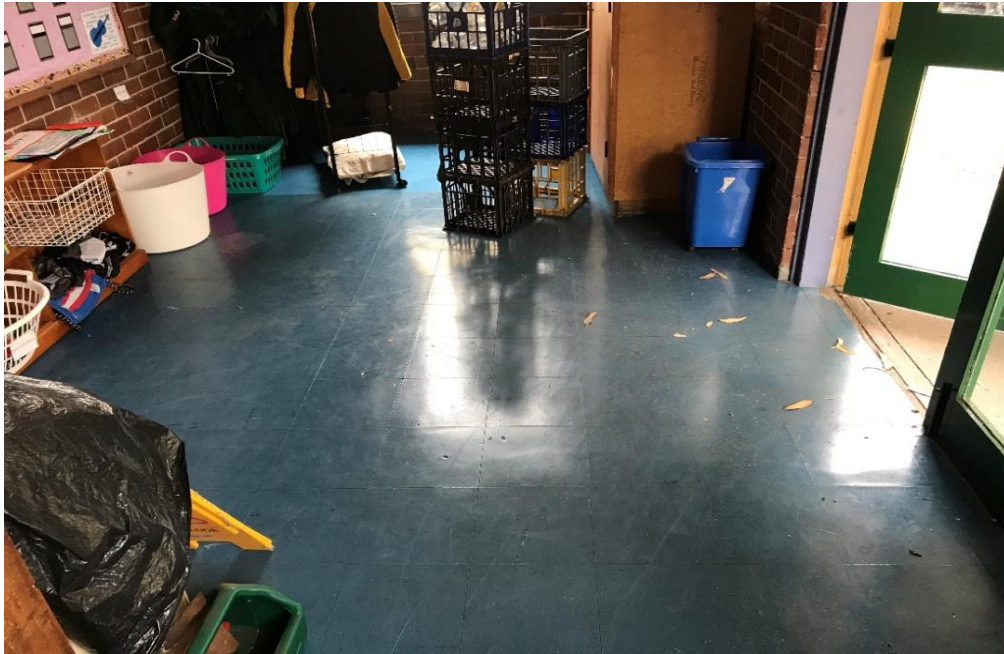
Photograph 1: B00K, R0005 - Craft Store, floor, vinyl tiles, asbestos detected by analysis.

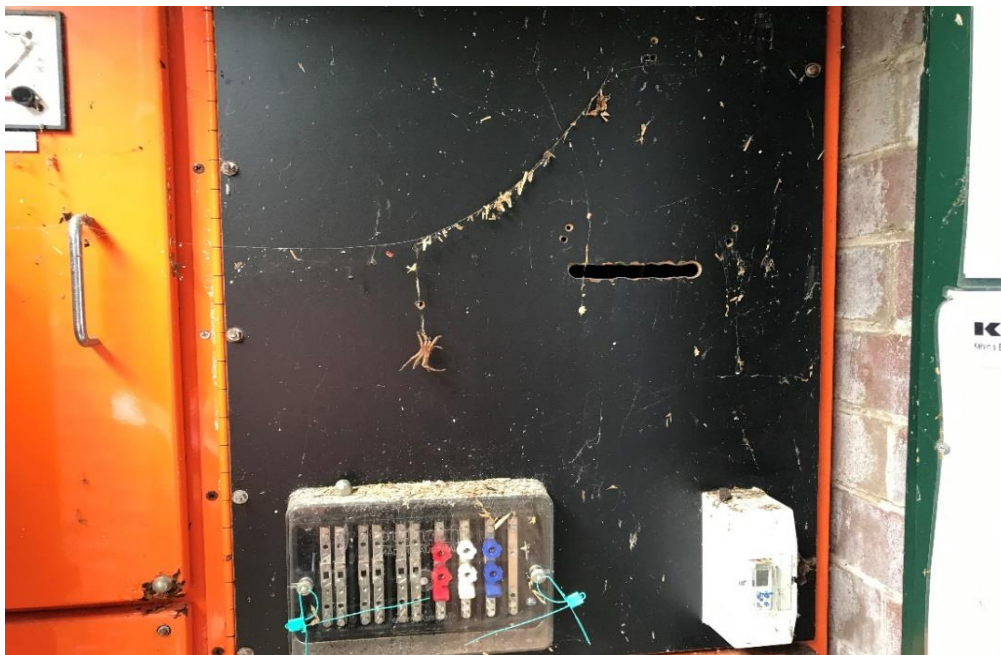
Photograph 2: B00K, R0006 -Distribution Board, electrical distribution board, resinous board, asbestos (assumed).

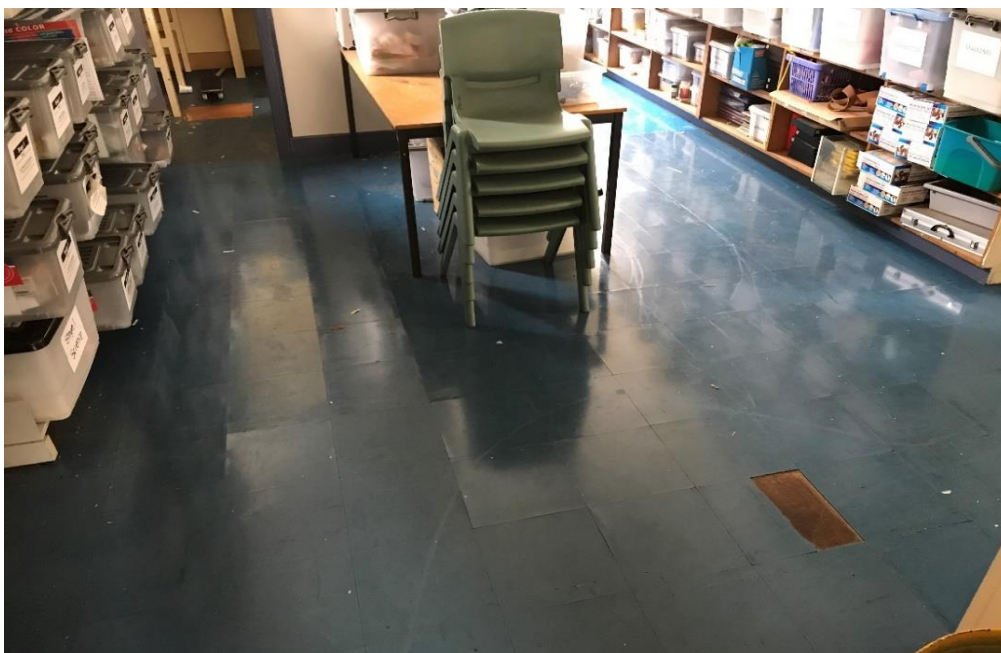
Photograph 3: B00K, R0008 - Special Movements Room, floor, vinyl tiles, asbestos detected by analysis.

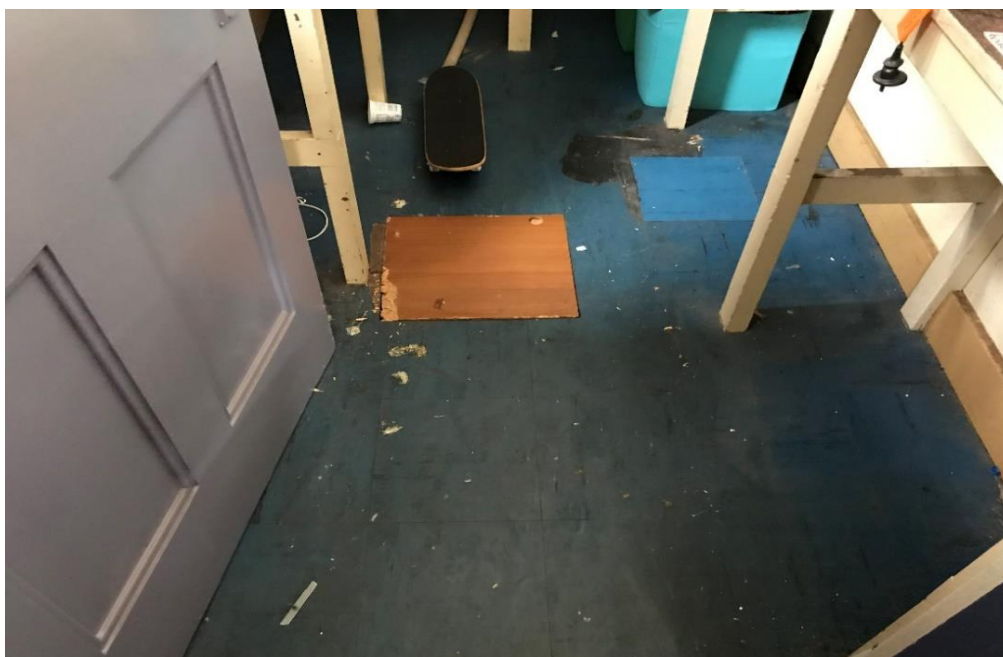
Photograph 4: B00K, R0004 - Special Programs Room, floor, vinyl tiles, asbestos detected by analysis.

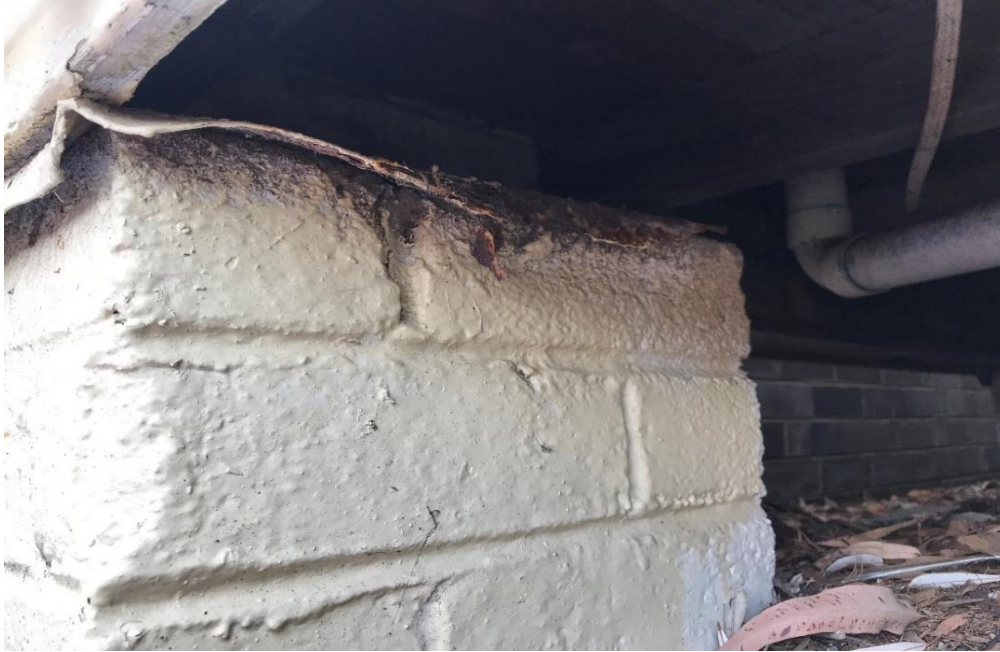
Photograph 1: B00N, exterior, subfloor, packing to piers beneath metal ant cap, fibre cement fragments, asbestos detected by analysis.

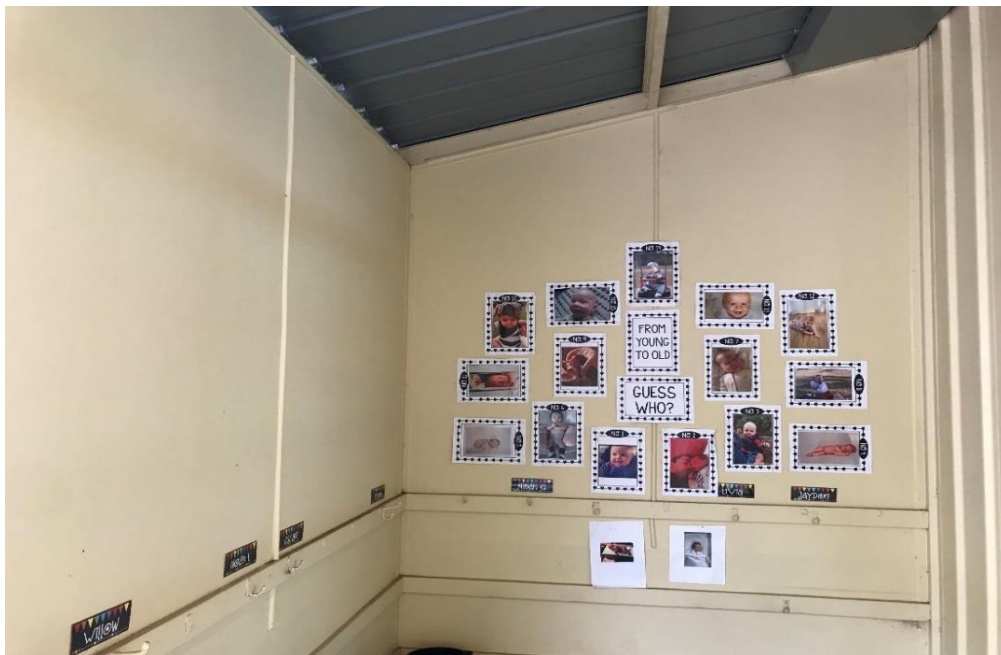
Photograph 2: B00N, R0003 - Movement (Balcony), wall linings to east and west walls , fibre cement sheet, asbestos detected by analysis.

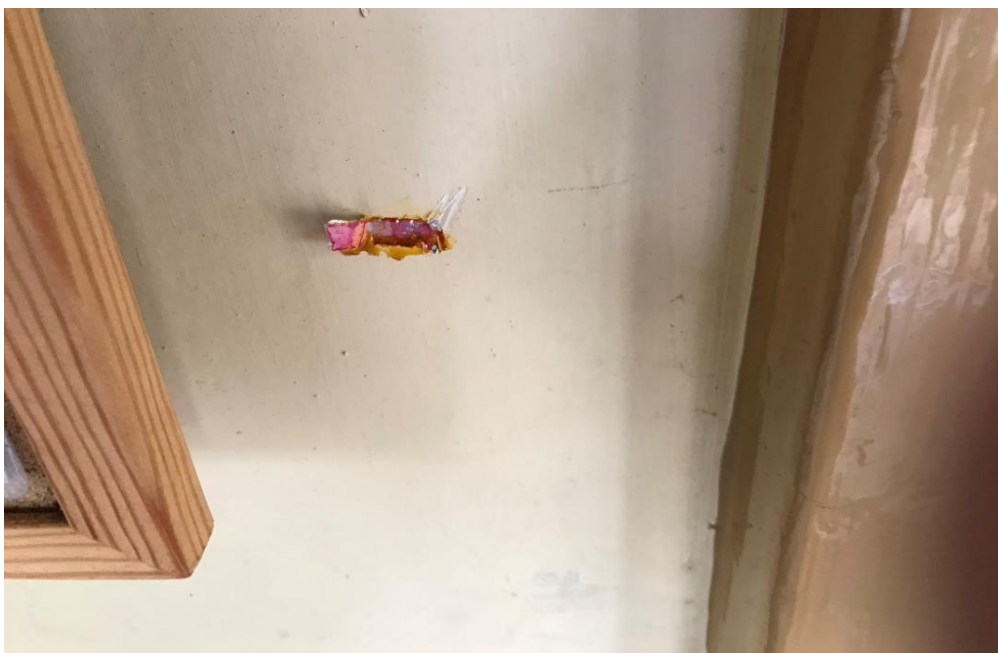
Photograph 3: B00N, exterior, throughout , undercoat to walls, white paint, positive for lead.

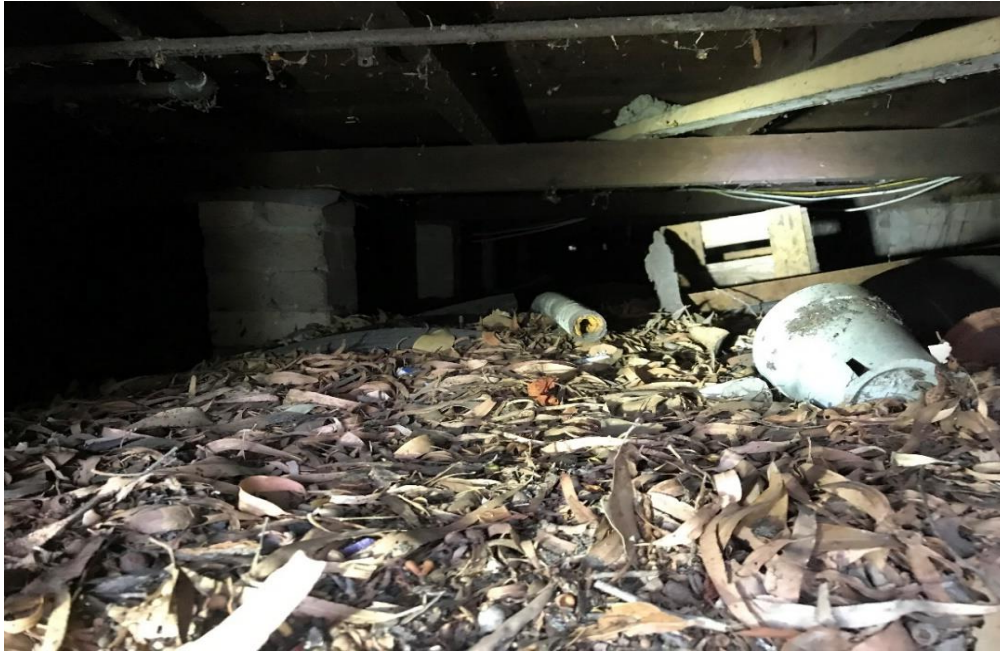
Photograph 1: B00P, exterior, subfloor, packing to piers beneath metal ant cap, fibre cement fragments, asbestos (assumed).

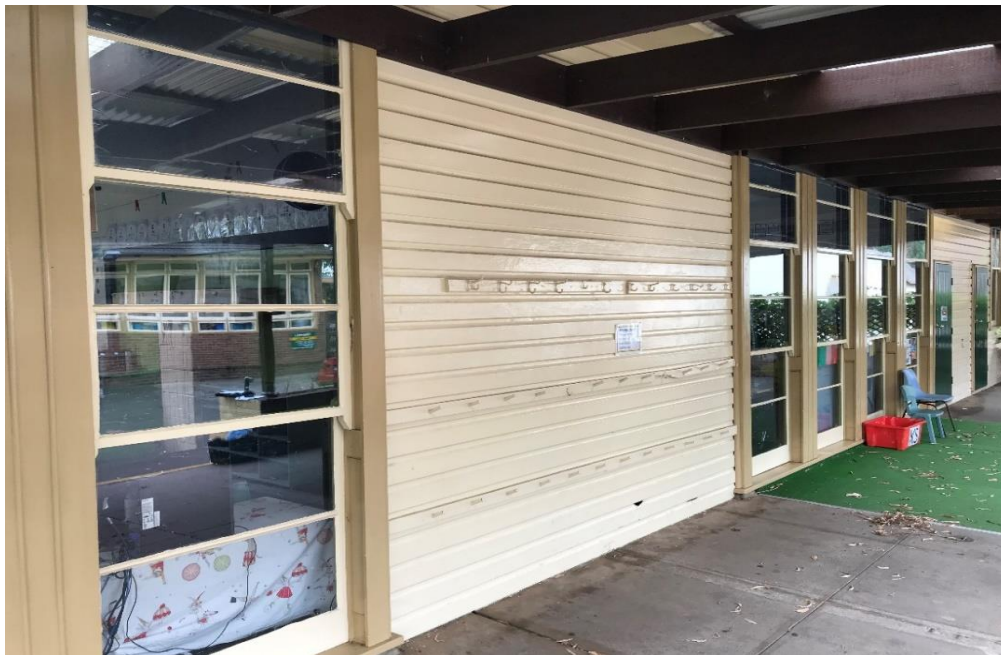
Photograph 2: B00P, exterior, typical wall, cream paint, negative for lead.

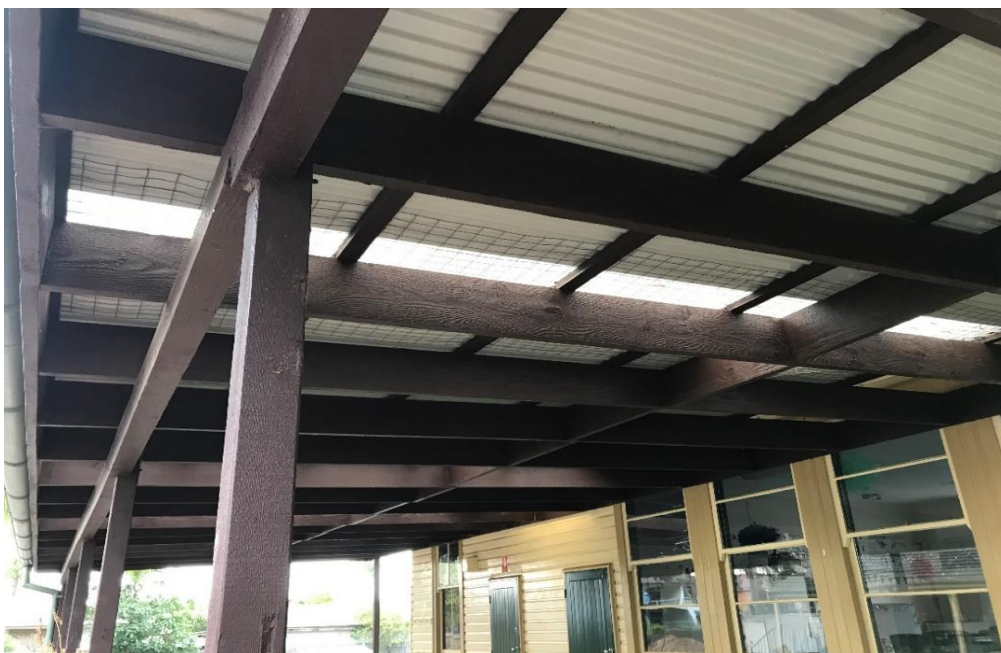
Photograph 3: B00P, exterior, balcony , posts, bearers and joists , typical brown paint, negative for lead.

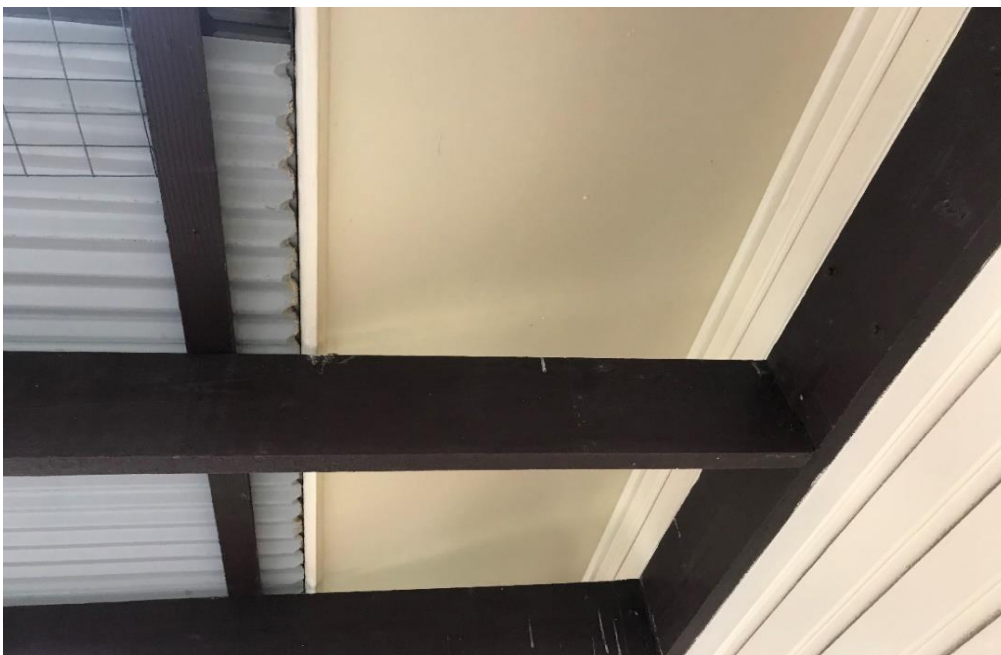
Photograph 4: B00P, R0010 - Movement (balcony), ceiling/eave, fibre cement sheeting, asbestos detected by analysis.

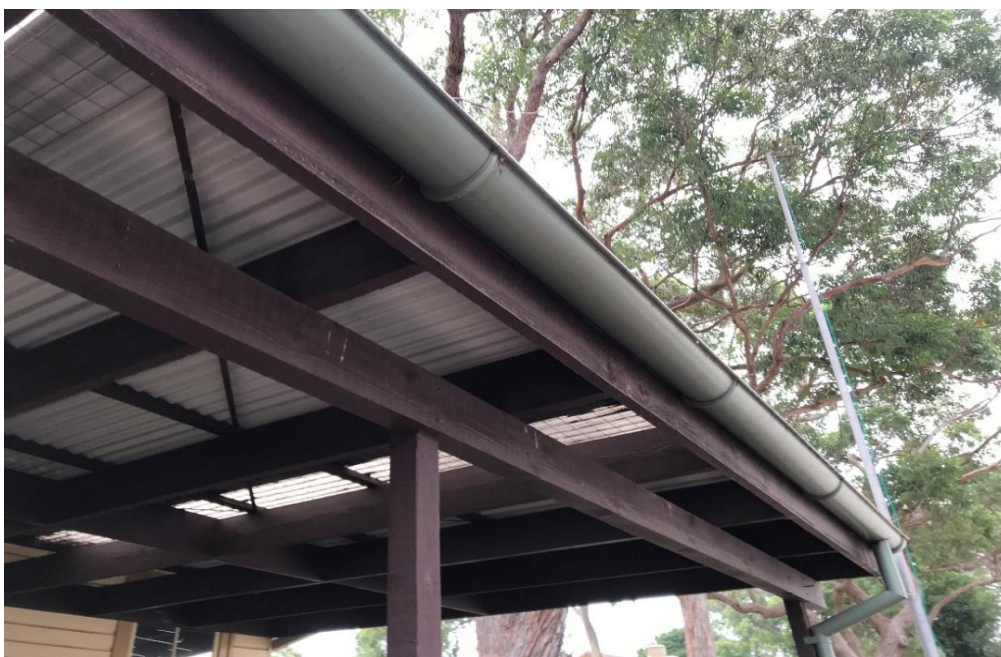
Photograph 5: B00P, exterior, gutters and downpipes, green paint, negative for lead.

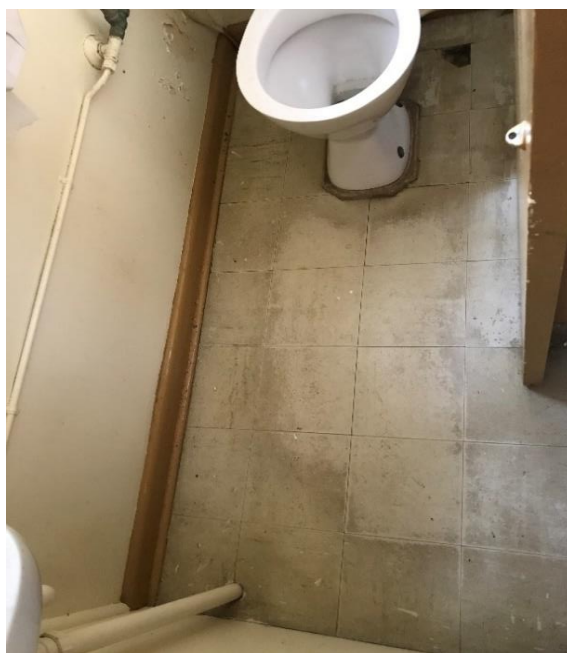
Photograph 6: B00P, R0001 - Staff Toilet, floor, vinyl tiles, asbestos detected by analysis.

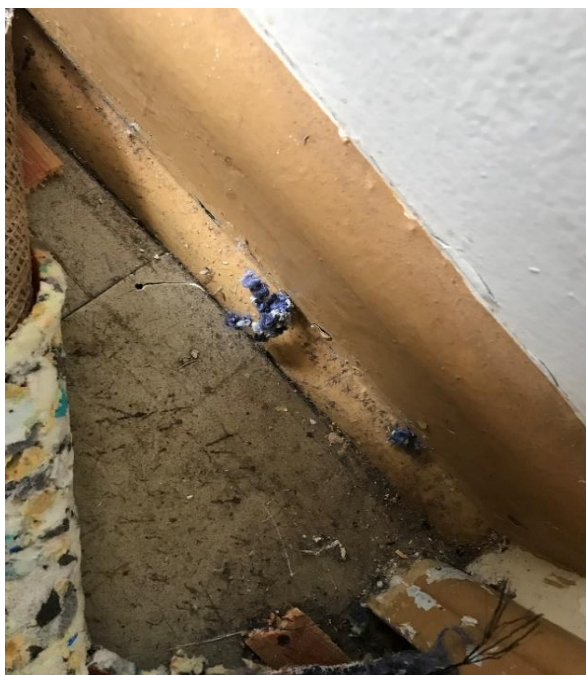
Photograph 7: B00P, R0002 - Storeroom , floor, vinyl tiles, asbestos detected by analysis.

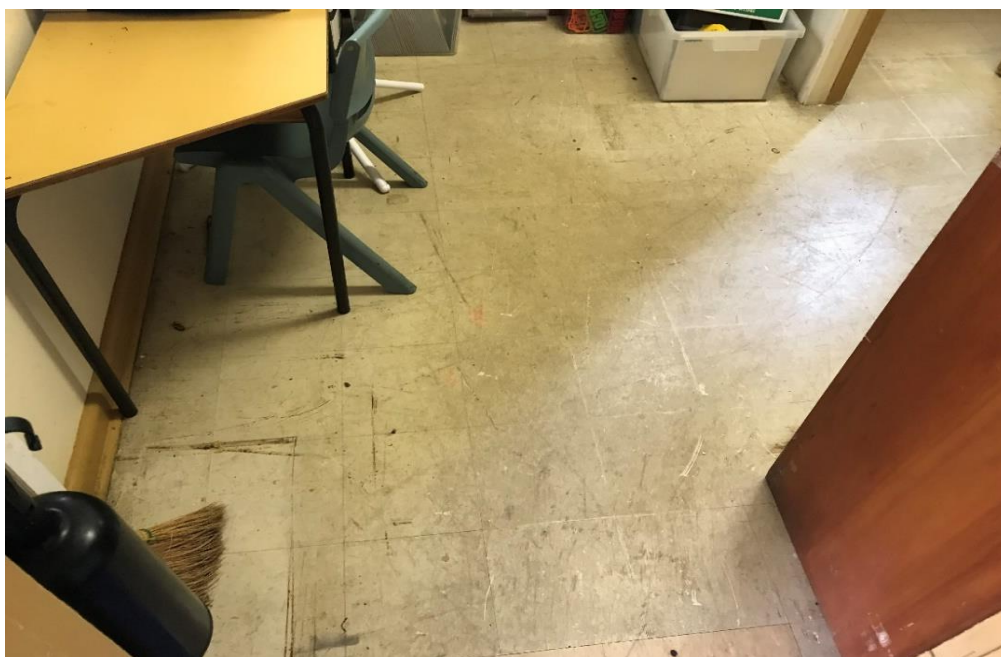
Photograph 8: B00P, R0003 - Storeroom, floor, vinyl tiles, asbestos (assumed).

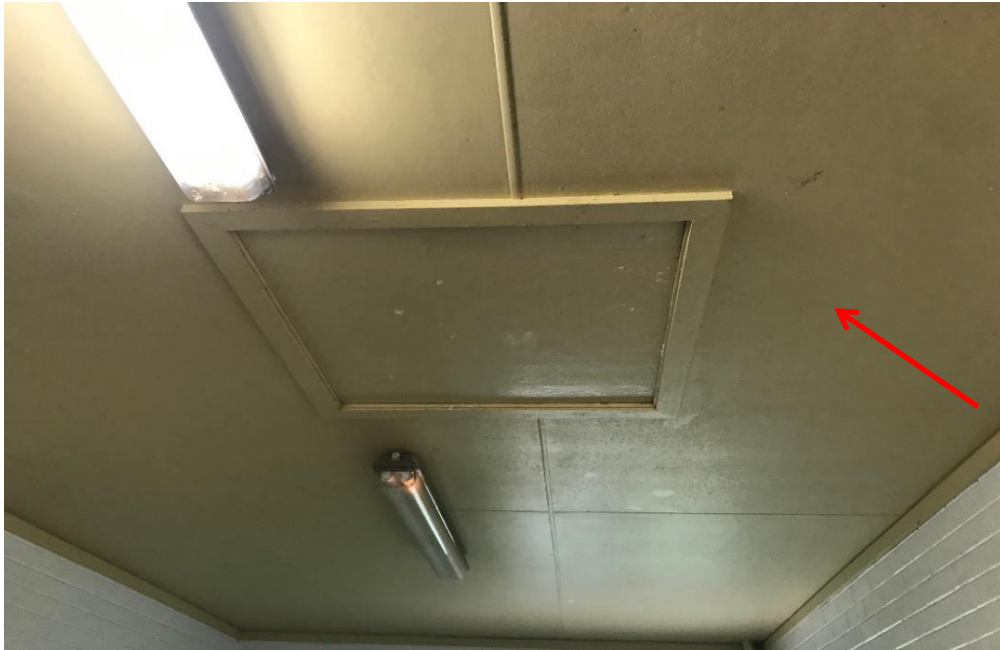
Photograph 1: B00R, R0010 - Boys Toilet, ceiling, fibre cement sheet, asbestos detected by analysis.

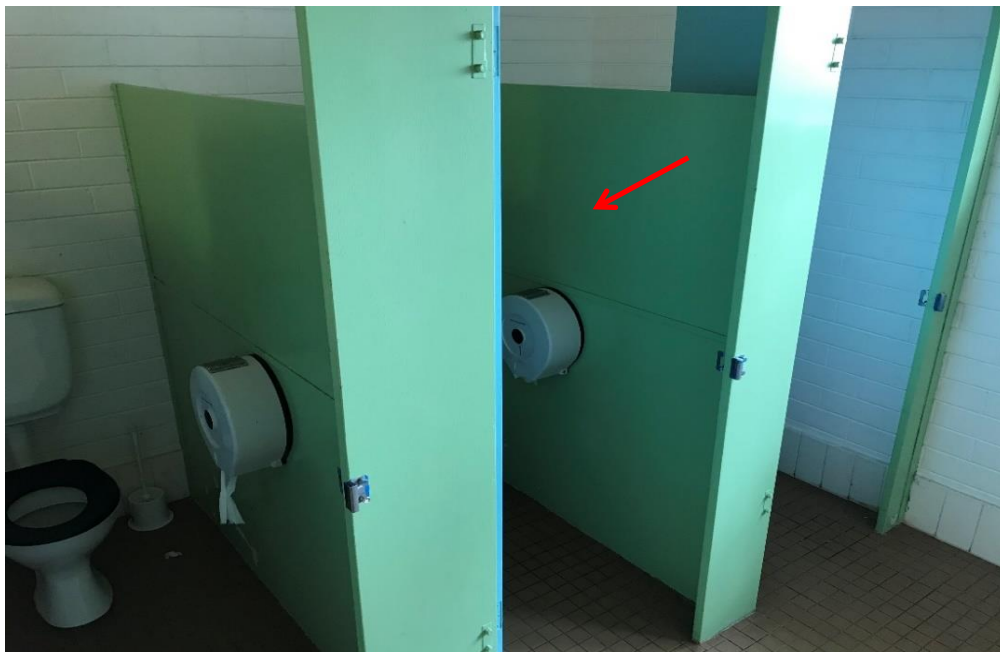
Photograph 2: B00R, R0010 - Boys Toilet, partition walls, compressed fibre cement, asbestos detected by analysis.
