Hazardous Building Materials (HBM) Assessment

Narrabeen North Public School (3906)

Prepared for  
School Infrastructure NSW (SINSW)  
c/- Johnstaff Projects (NSW) Pty Ltd

Project 86973.02  
March 2020

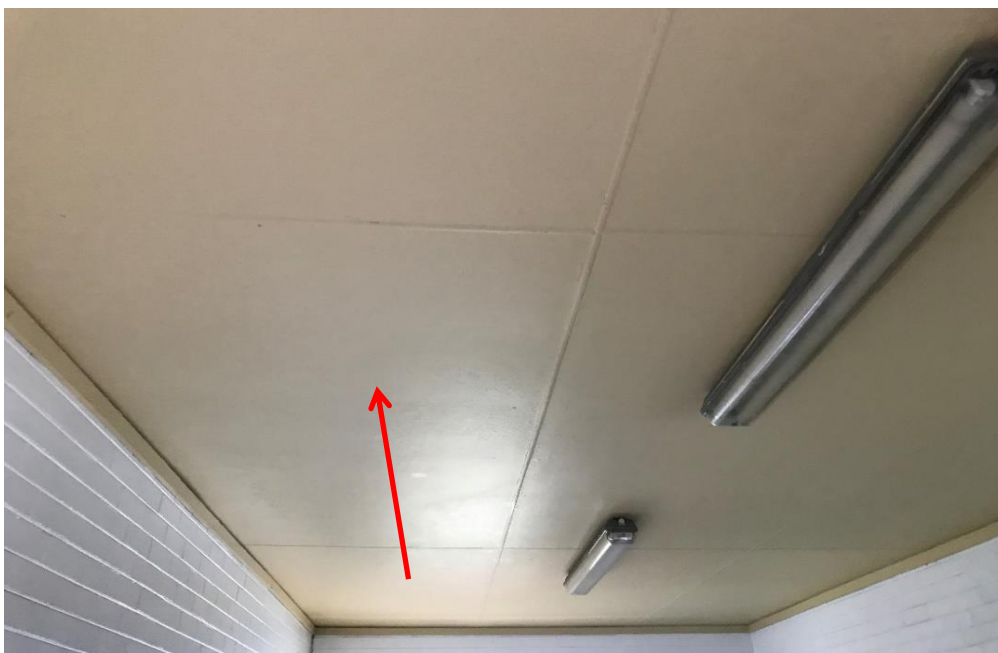
Photograph 3: B00R, R0009 - Girls Toilet , ceiling, fibre cement sheet, asbestos detected by analysis.

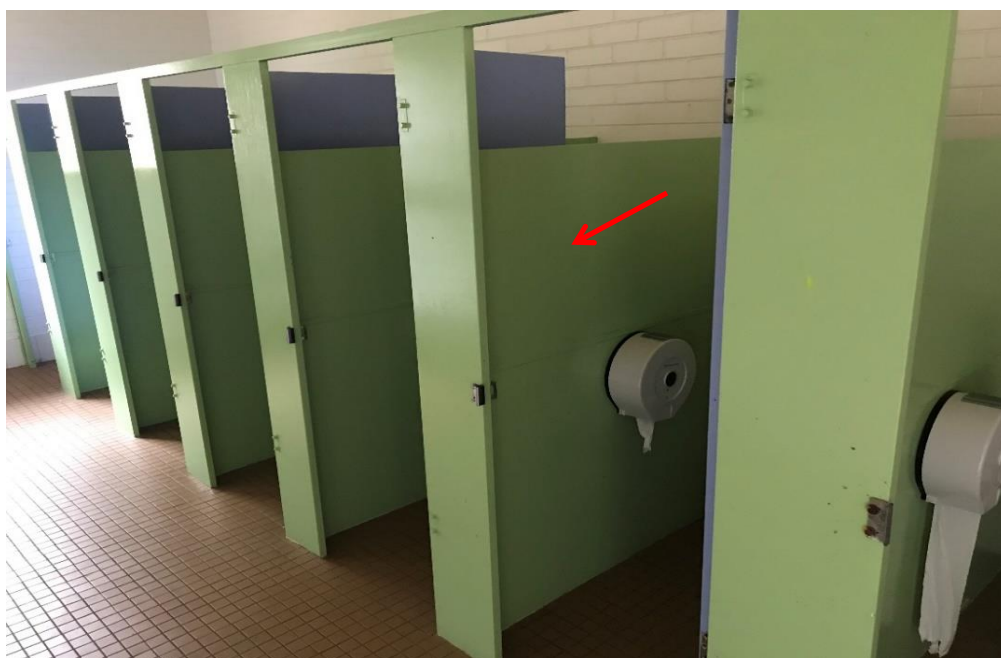
Photograph 4: B00R, R0009 - Girls Toilet , partition walls, compressed fibre cement, asbestos detected by analysis.

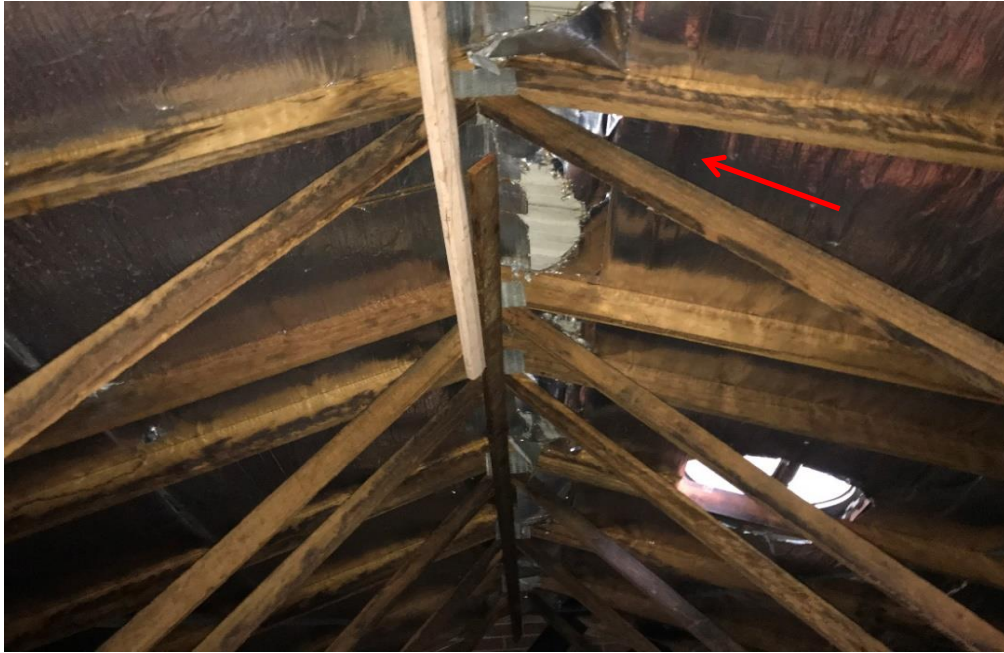
Photograph 5: B00R, interior, ceiling cavity (accessed through R0010), sarking, waterproof membrane , SMF identified visually.

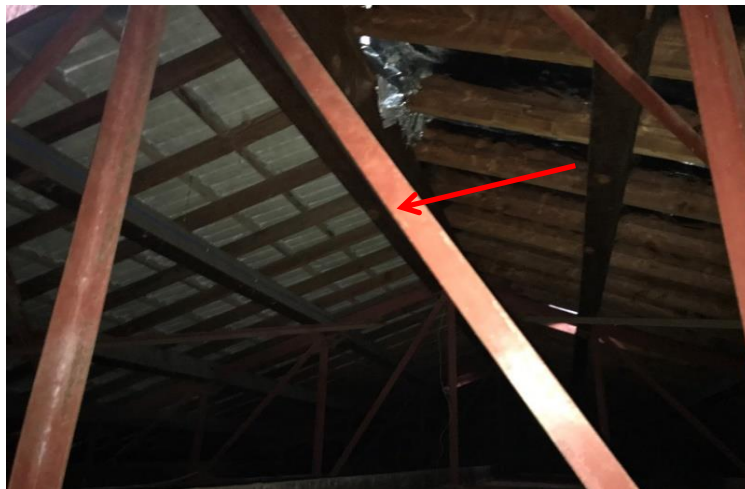
Photograph 6: B00R, interior, ceiling cavity (accessed through R0010), steel beams , red paint, positive for lead.

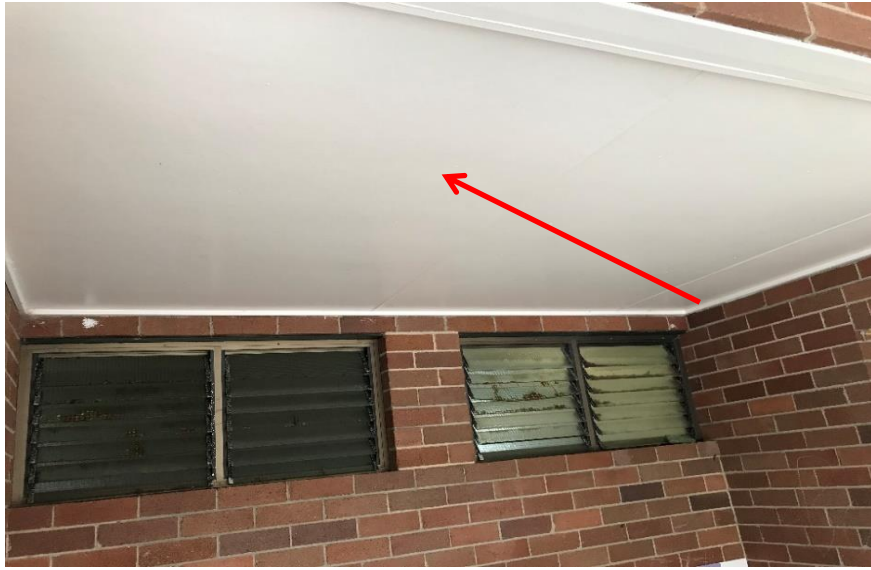
Photograph 7: B00R, R0011 - Drinking Facility , ceiling, fibre cement sheet, asbestos detected by analysis.

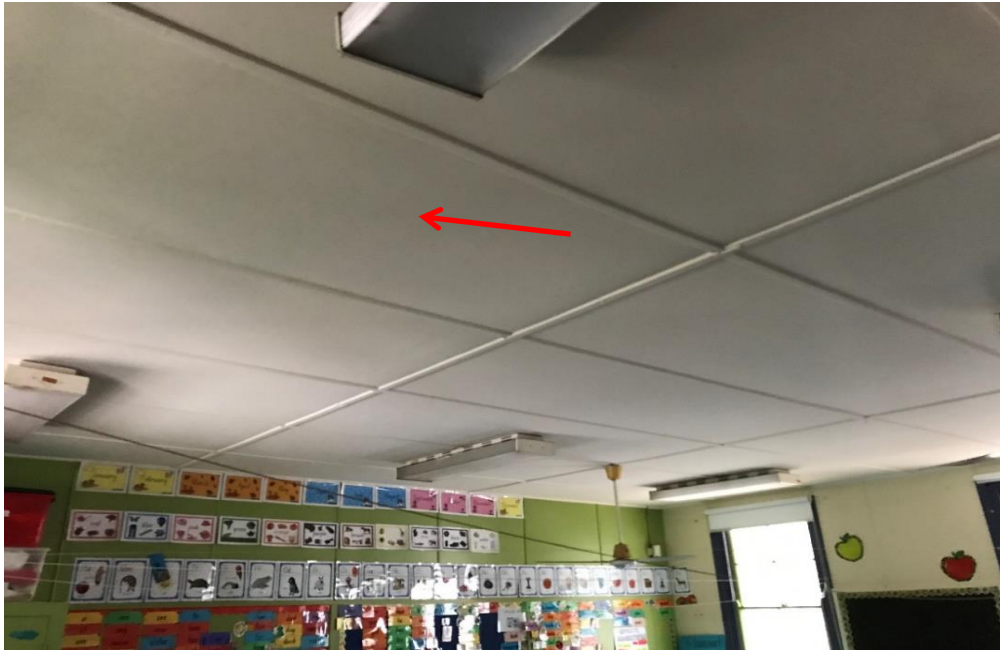
Photograph 1: B00S, R0002 - Home Base , ceiling, fibre cement sheet, asbestos detected by analysis.

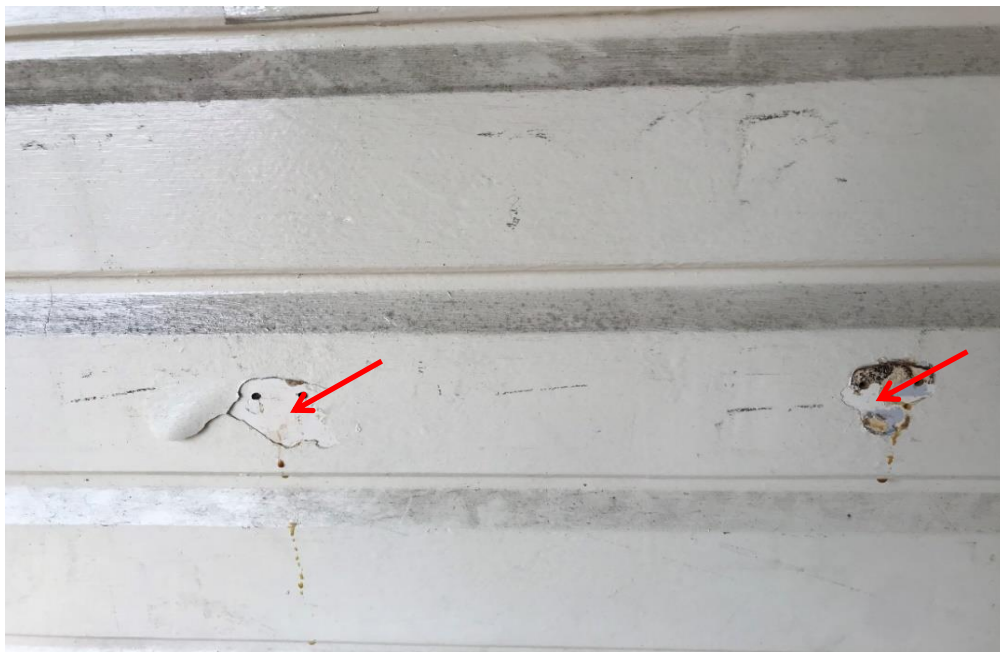
Photograph 2: B00S, exterior, throughout, walls, undercoat , white paint , positive for lead.

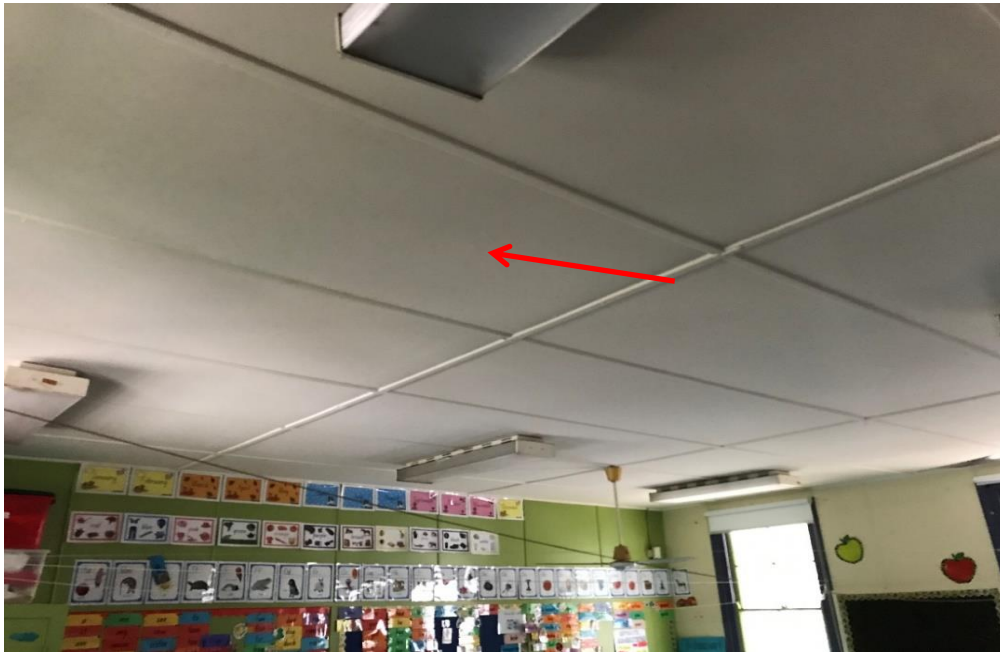
Photograph 3: B00S, R0001 - Home Base , ceiling, fibre cement sheet, asbestos detected by analysis.

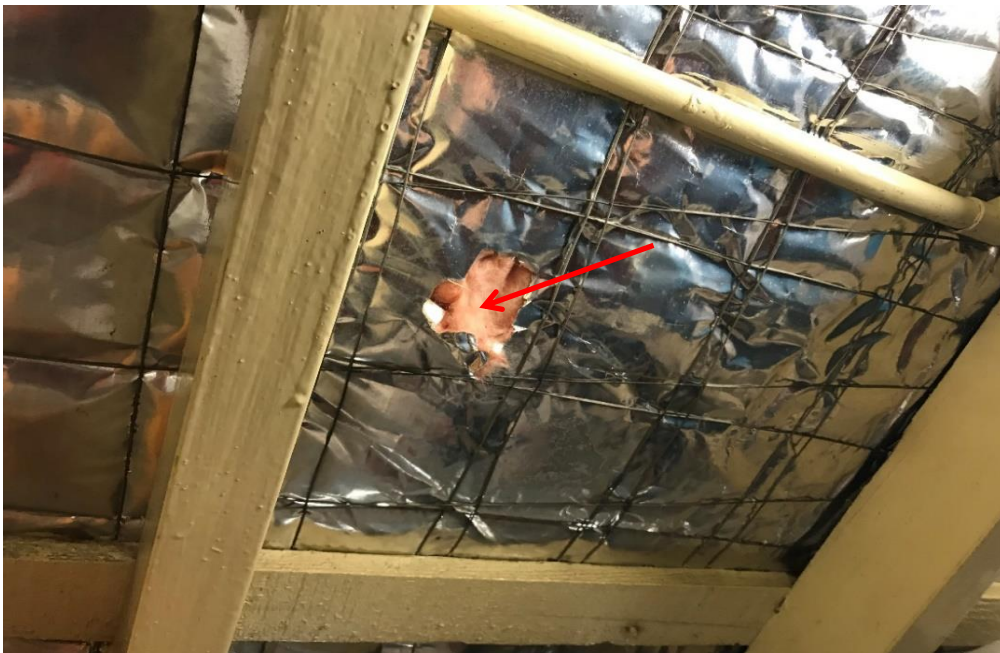
Photograph 4: B00S, R0003 - Ceiling Cavity, underside of ceiling, insulation, SMF identified visually.
